**DOE/LX/07-0227&D2
Primary Document**

**Site Evaluation Report
for Rubble Areas
at the Paducah Gaseous Diffusion Plant,
Paducah, Kentucky**

Date Issued—November 2009

Prepared by
PADUCAH REMEDIATION SERVICES, LLC
managing the
Environmental Remediation Activities at the
Paducah Gaseous Diffusion Plant
under contract DE-AC30-06EW05001

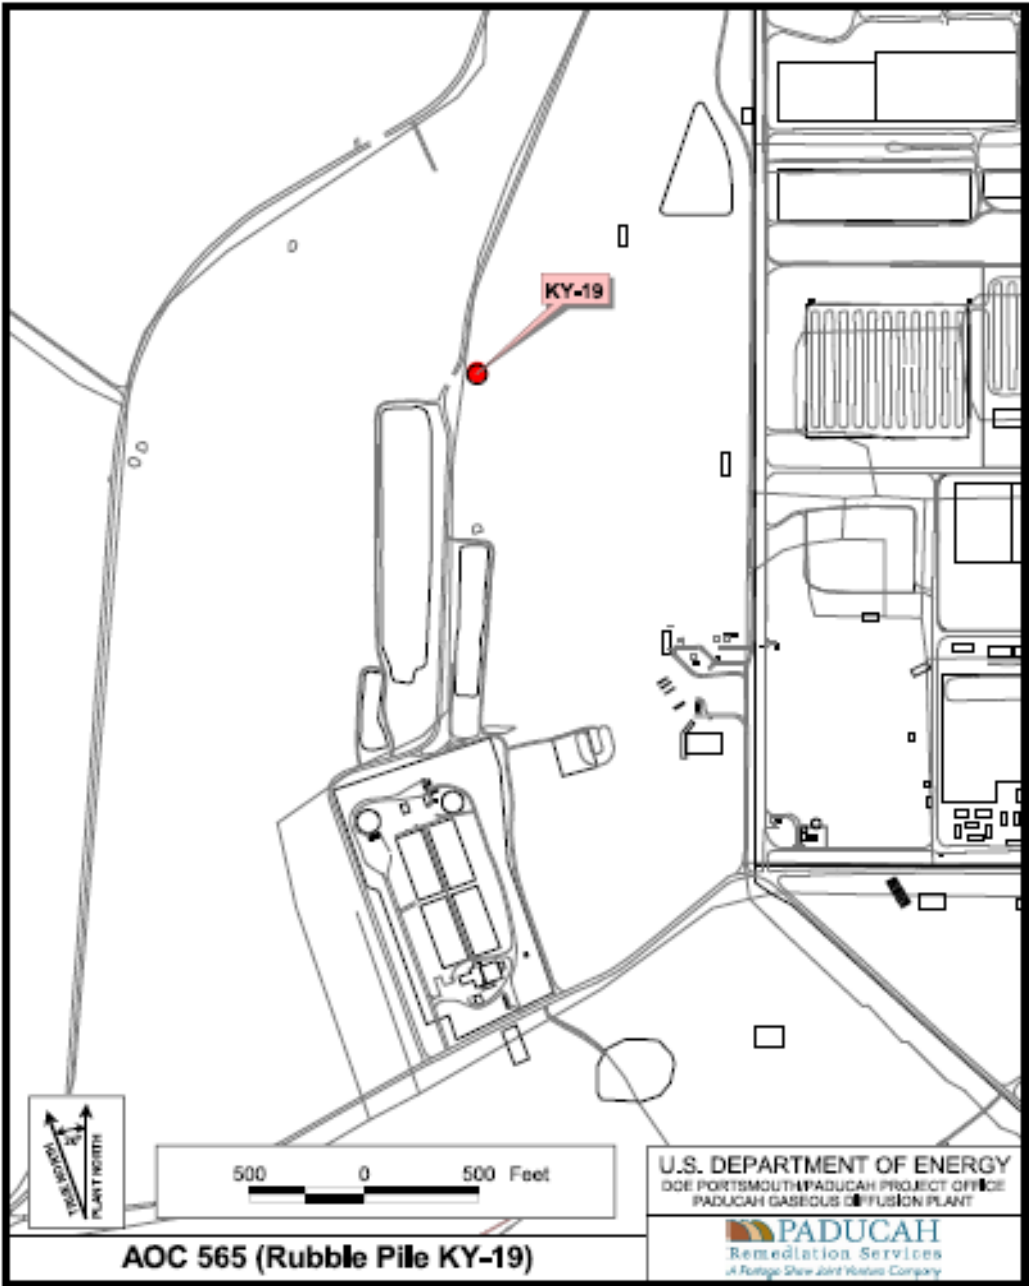
AOC 565 (Rubble Pile KY-19)

All of the rubble on or off DOE property serving a beneficial function was free of radiological contamination, no visual oil staining was noted and the origin of the rubble was undetermined, with one exception. The exception is that KY-19 had fixed radiological contamination present at 200 counts per minute (50 cpm is considered background). KY-19 includes an area of approximately 80 ft by 20 ft and includes one concrete slab and a 6 ft long, 1 inch metal pipe with fixed radiological contamination.

Laboratory results were below or near background. KY-19 rubble currently is used for bank stabilization and was noted to have fixed radiological contamination previously identified in the SAP as “unfiltered 200 counts per minute; fixed contamination.” PCBs were not detected.

Radiological survey results were at or below background for the 29 rubble areas as a result of implementing the field work as discussed and as prescribed in the approved SAP, with one exception. KY-19, used for bank stabilization, was noted to have fixed radiological contamination previously identified in the SAP as “unfiltered 200 counts per minute; fixed contamination.” No evidence was found of a release of hazardous waste or hazardous constituents that would pose a current or potential threat to human health or the environment. Additionally, no indication was found of treatment, storage, or disposal of solid or hazardous waste, with the exception of drums located off DOE property at KY-24 that appeared to contain “Formula 480 Liquid Clay Concrete” and “Quaker State Motor Oil.”

PHOTOGRAPH OF RUBBLE AREA KY-19 (AOC 565)

- No removal action is recommended for the rubble areas at this time.
- SWMU Assessment Reports are not recommended for the rubble areas. The only exception is KY-19 that indicated fixed radiological levels (200 counts per minute) above background. KY-19 is recommended as an AOC and as a result, a SWMU/AOC Assessment Report is provided in Appendix C.
- The factors described in 40 *CFR* 300.415 (b)(2) will be considered in determining whether a removal action for KY-19 (currently used for bank stabilization) is appropriate. KY-19 has been assigned to the Soils Operable Unit. If it is determined that a removal action is appropriate for this location due to actual or potential exposure of fixed radiological contamination to nearby populations, a removal notification will be made under Section X of the FFA.
