C-637 Pumphouse and Cooling Tower (Solid Waste Management Unit 89)

Facility Overview Briefing

June 22, 2023

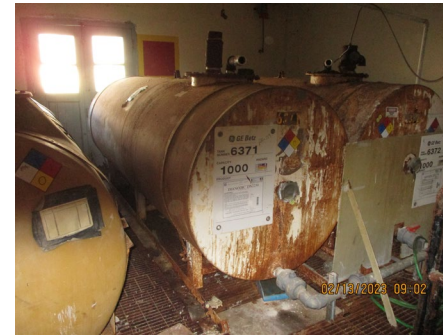
C-637-1 - West Wing
Calgon Room
(Corrosion Inhibitor
Feed Area)

- In 2012, there was a significant leak identified associated with the feed assembly.
 - Betz representatives replaced the feed assembly.
 - Area was cleaned and waste disposed.

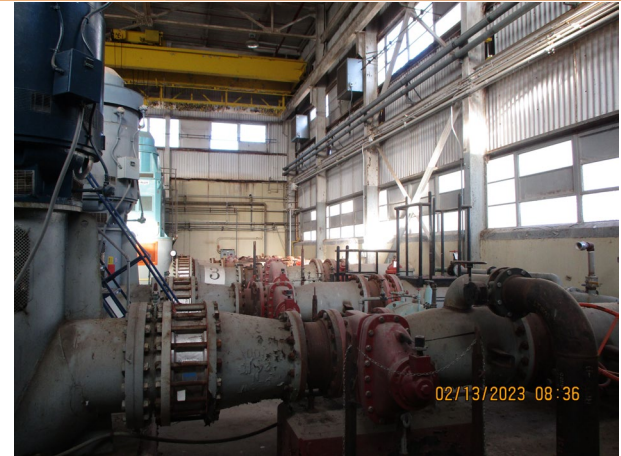
- In 2013, C-637-1 was shutdown, along with its associated cooling towers (main cooling towers and blending towers).
 - ❑ Subsequent RCW leaks from pumps and associated lines occurred with some impact to the pad and surrounding drainage ditches.

C-637-1 - Center Wing
RCW Pumps and Discharge Lines

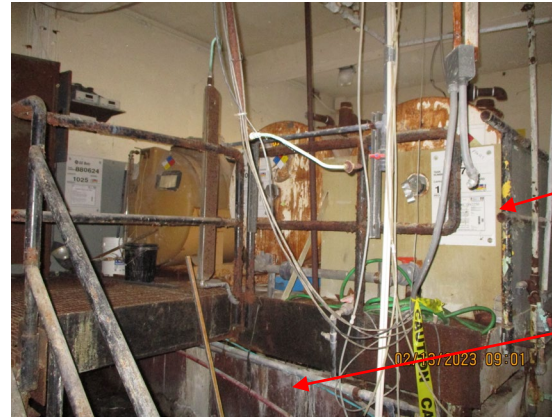
- In November 2017, solid waste exceeding Toxicity Characteristic Leaching Procedure (TCLP) limits for chromium, mercury, and lead was discovered in the bottom of the diked areas located within the cooling tower pump houses.
 - ❑ Waste was associated with the chemical tanks that contained corrosion inhibitors (including sulfuric acid).
 - ❑ Waste included crusty residues, sludges, liquids or a combination thereof.
 - ❑ Waste was removed and disposed in 2018.

C-637-1 West Wing
Diked Area beneath Corrosion Inhibitor Tanks

- Calgon room housed tanks of corrosion inhibitors; area within the dike contained solid waste exceeding TCLP limits for chromium, mercury, and lead that has been removed.

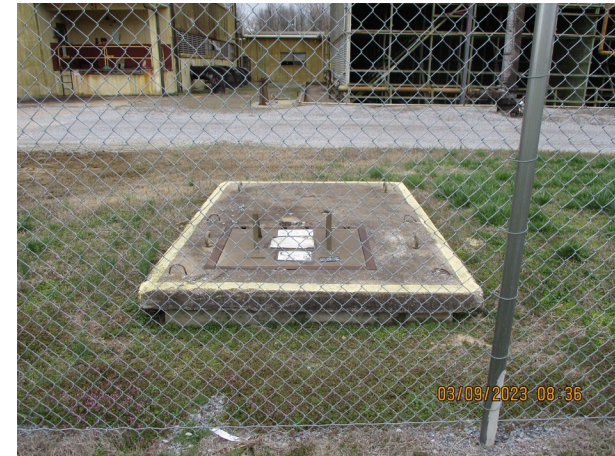
- In 2011, a leak associated with RCW H-Loop Return to Blending Tower valve was discovered; valve was replaced.
- In 2012, two system leaks occurred.
 - ❑ April - An RCW leak associated with RCW H-Loop Return to Blending Tower vault.

- Vault was pumped and leak repaired.
 - ❑ September - A water leak occurred below the #6 riser block valve where the NE Plume Containment piping tied into the riser between the riser and valve HV-184.

H-Loop Return to Blending Tower Vault

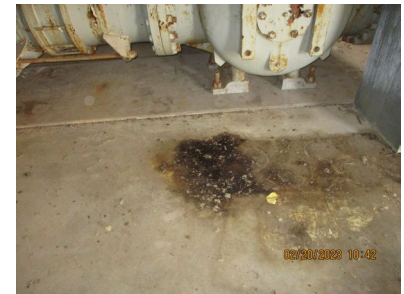
C-637-3 - Floor Staining

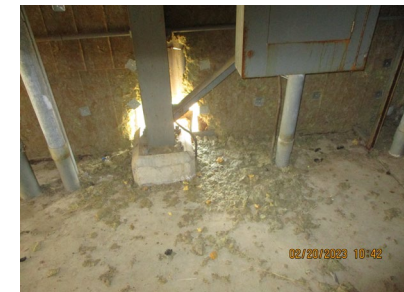
C-637-3 – Damaged Insulation

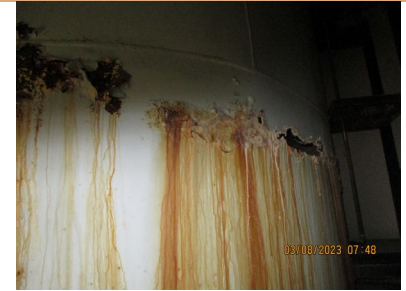
C-637-6 - Permutit® Sand Filter Tank (Corrosion Damage)
