**DOE/LX/07-0227&D1
Primary Document**

**Site Evaluation Report
for Rubble Areas
at the Paducah Gaseous Diffusion Plant,
Paducah, Kentucky**

Date Issued—September 2009

Prepared by
PADUCAH REMEDIATION SERVICES, LLC
managing the
Environmental Remediation Activities at the
Paducah Gaseous Diffusion Plant
under contract DE-AC30-06EW05001

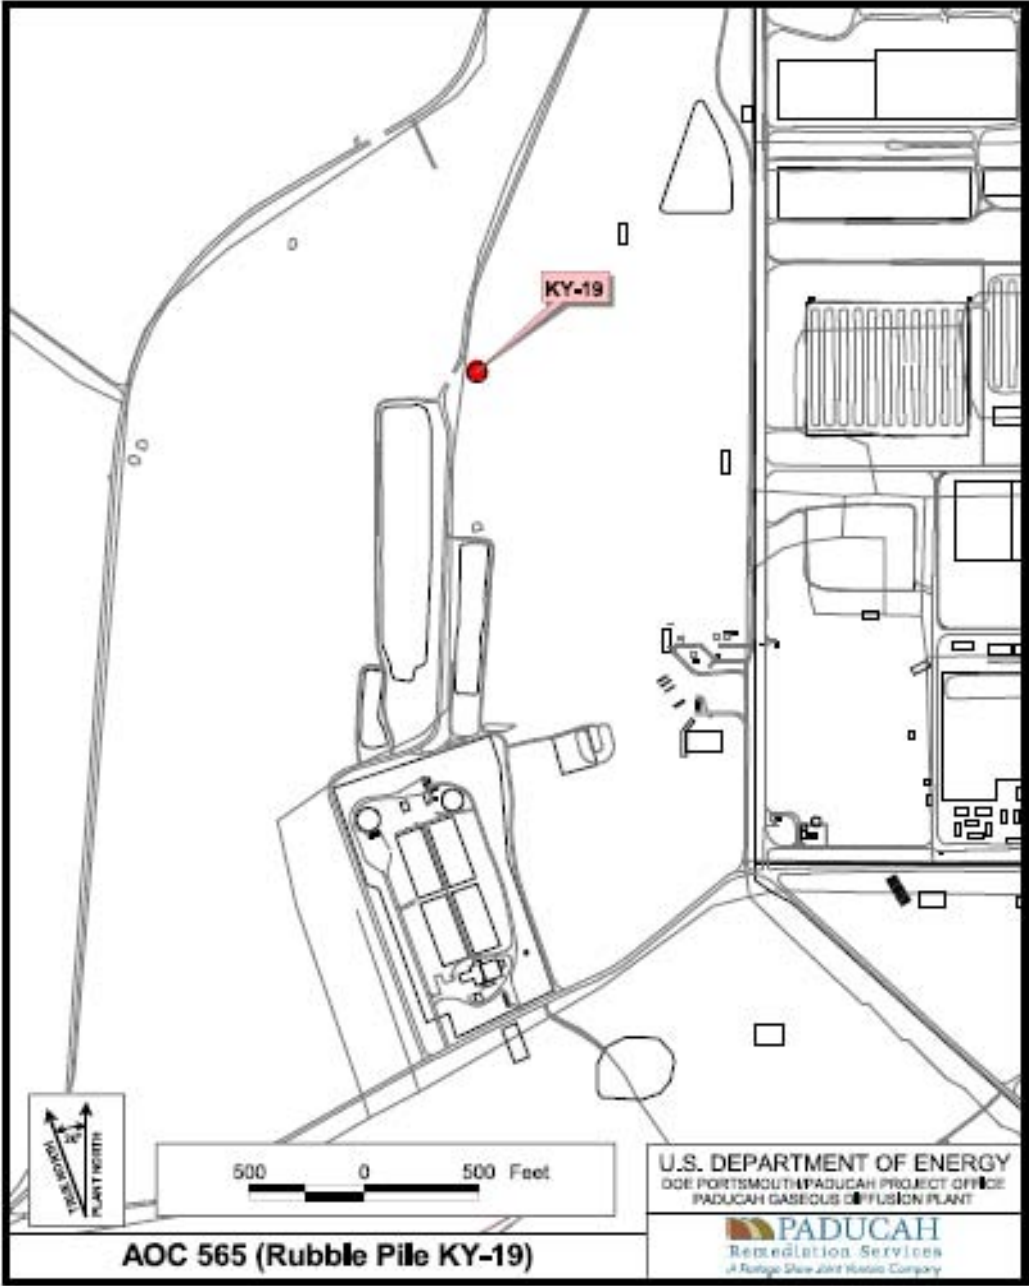
PHOTOGRAPH OF RUBBLE AREA KY-19 (AOC 565)

All of the rubble on DOE property was free of radiological contamination, no visual oil staining was noted and the origin of the rubble was undetermined, with one exception. The exception is that KY-19 had fixed radiological contamination present at 200 counts per minute (50 cpm is considered background). See Appendix A for this information noted on the checklists.

Laboratory results were below or near background. KY-19 rubble currently is used for bank stabilization and was noted to have fixed radiological contamination previously identified in the SAP as “unfiltered 200 counts per minute; fixed contamination; no measurable dose.” PCBs were not detected.

- No removal action is recommended for the rubble areas at this time.
- SWMU Assessment Reports are not recommended for the rubble areas. The only exception is KY-19 that indicated fixed radiological levels (200 counts per minute) above background. KY-19 is recommended as an AOC and as a result, a SWMU/AOC Assessment Report is provided in Appendix C.
- The factors described in 40 *CFR* 300.415 (b)(2) will be considered in determining whether a removal action for KY-19 (currently used for bank stabilization) is appropriate. KY-19 has been assigned to the Soils Operable Unit. If it is determined that a removal action is appropriate for this location due to actual or potential exposure of fixed radiological contamination to nearby populations, a removal notification will be made under Section X of the FFA.
