C-102 Hospital

Facility Overview Briefing

November 9, 2021

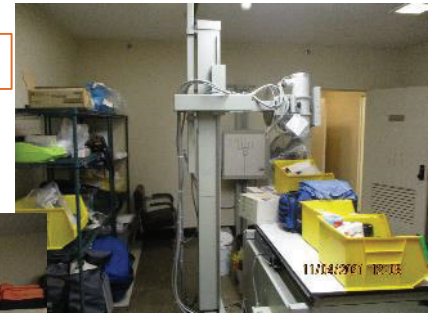
x-ray Machine

- ❑ Current waste streams include bio-hazardous wastes and office waste.
 - ❑ Lead shielding panels were not visibly identified; however, the door and thick concrete walls in the former x-ray room may contain lead.

- ❑ C-102 was originally constructed and operated as a hospital from its construction in 1953 to present.
 - ❑ The former x-ray room may contain lead in the door, thick concrete walls and/or lead shielding panels.

- ❑ Deactivation will include removal of any accessible loose items being stored (including lead aprons and any lead in the door, thick concrete wall or shielding panels in or near the former x-ray room) and ventilation duct gaskets (to the extent practicable) prior to demolition.

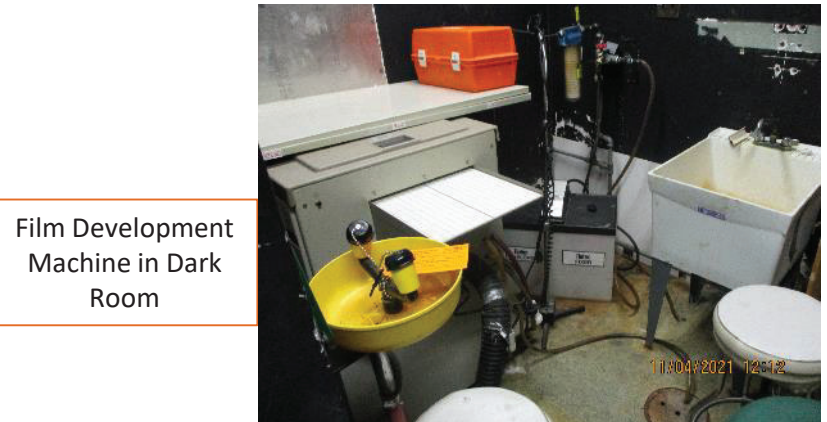
Film Development Machine in Dark Room

- ❑ Staining on the former dark room and basement floors.
 - ❑ Empty chemical boxes remain in the dark room.
 - ❑ Not used for radiological storage; however, the facility is in a Radiological Controlled Area.

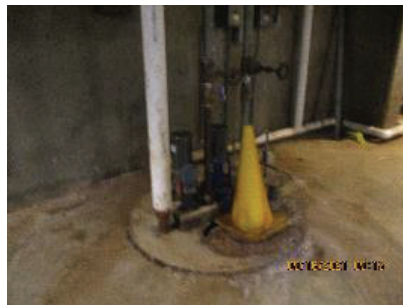
Basement Sump and Drain

- ❑ Floor drains in the hospital tie into the sanitary sewer system.
 - ❑ Floor drains in the basement tie into the storm water system.
 - ❑ Asbestos-containing materials (ACM) and lead-based paint are located throughout the facility.

- ❑ Any floor drains and sumps will be delineated, documented, and isolated prior to demolition.
 - ❑ An evaluation will be made to determine if any measures may be appropriate to stabilize and/or isolate the basement (or portions thereof) from the main floor prior to demolition.
