**REMOVAL ACTION REPORT FOR THE C-340 METALS REDUCTION PLANT
AT THE PADUCAH GASEOUS DIFFUSION PLANT, PADUCAH, KENTUCKY
(DOE/LX/07-1286&D1)**

REMOVAL ACTION REPORT FOR THE C-340 METALS REDUCTION PLANT AT THE PADUCAH GASEOUS DIFFUSION PLANT, PADUCAH, KENTUCKY

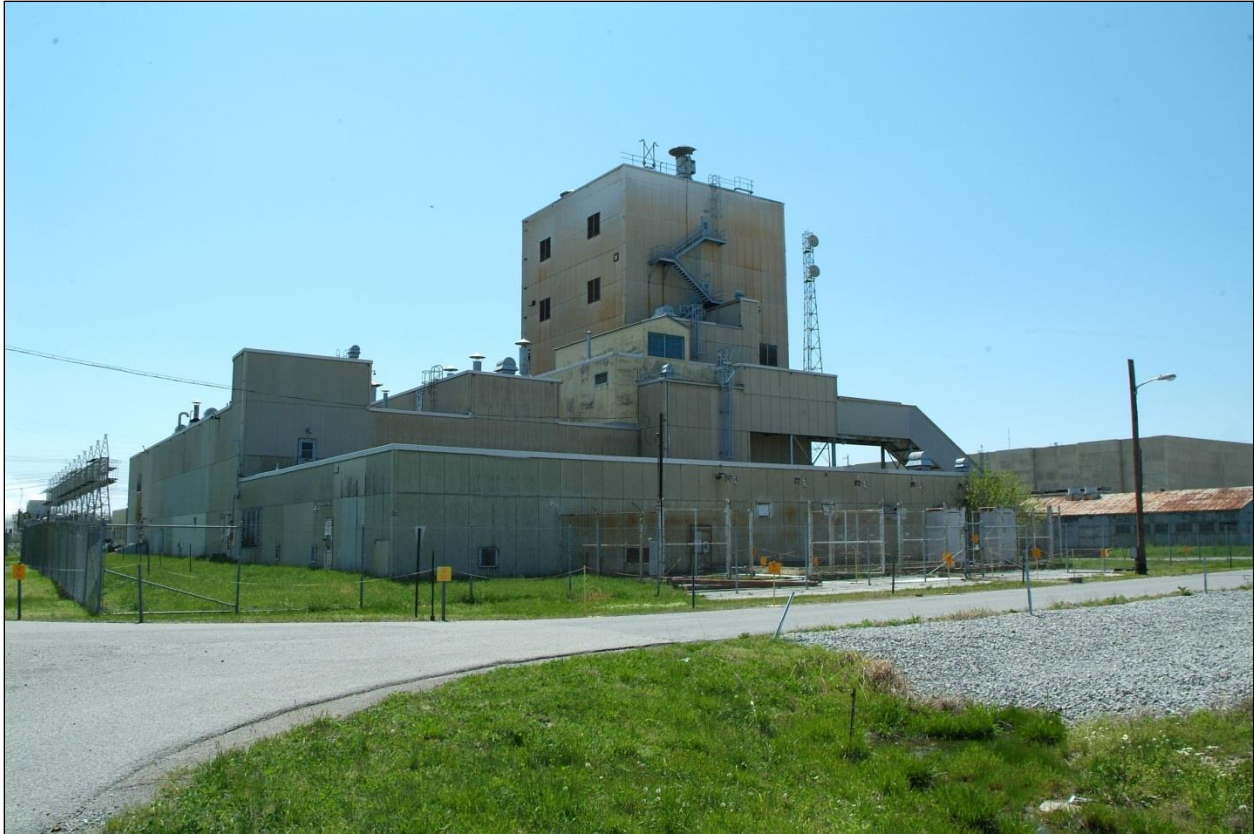
Figure 1. C-340 Complex Prior to Demolition; View is from the Northeast Corner

The demolition project involved removing the transite siding and demolishing the building structure, including any remaining piping and equipment on the slab and packaging it for disposal. Figure 1 is a photo of the C-340 Complex prior to demolition. Figure 2 shows the location of the facility. C-340 demolition did not involve removal of the slab, subslab penetrations, and/or foundations. Photos of the demolition of the C-340 progress are included in Appendix A. The slab was surveyed for radioactive materials, visually inspected for residual materials or staining, and sealed with a fixative. Pits were filled with Portland cement concrete.

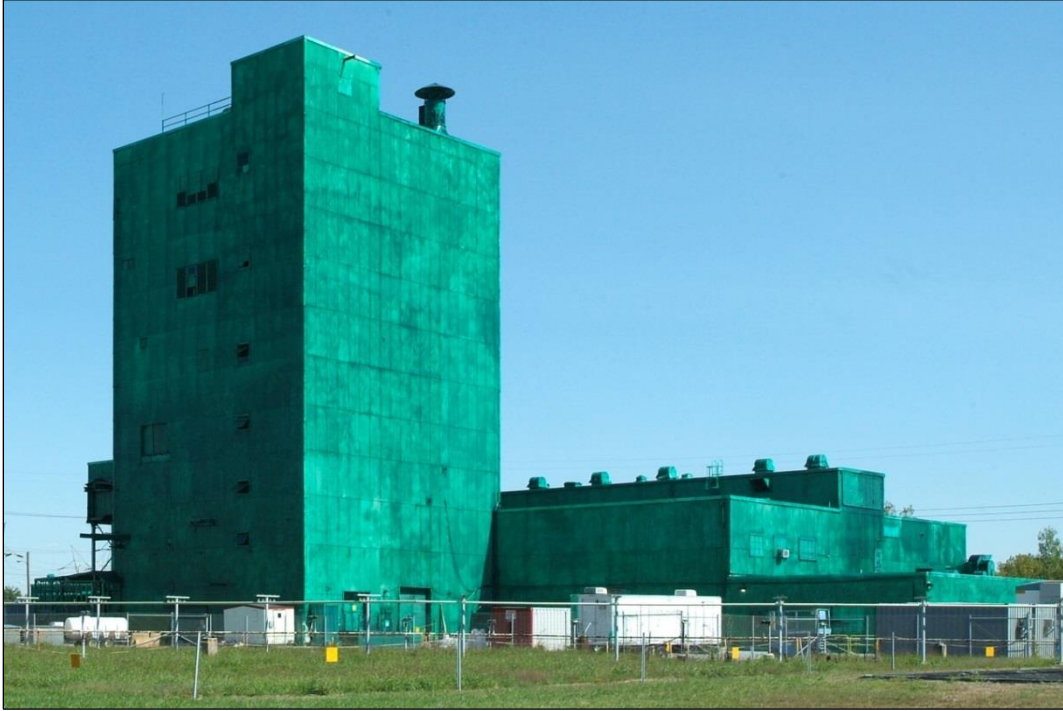
Figure A.1. C-340 Complex Prior to Demolition

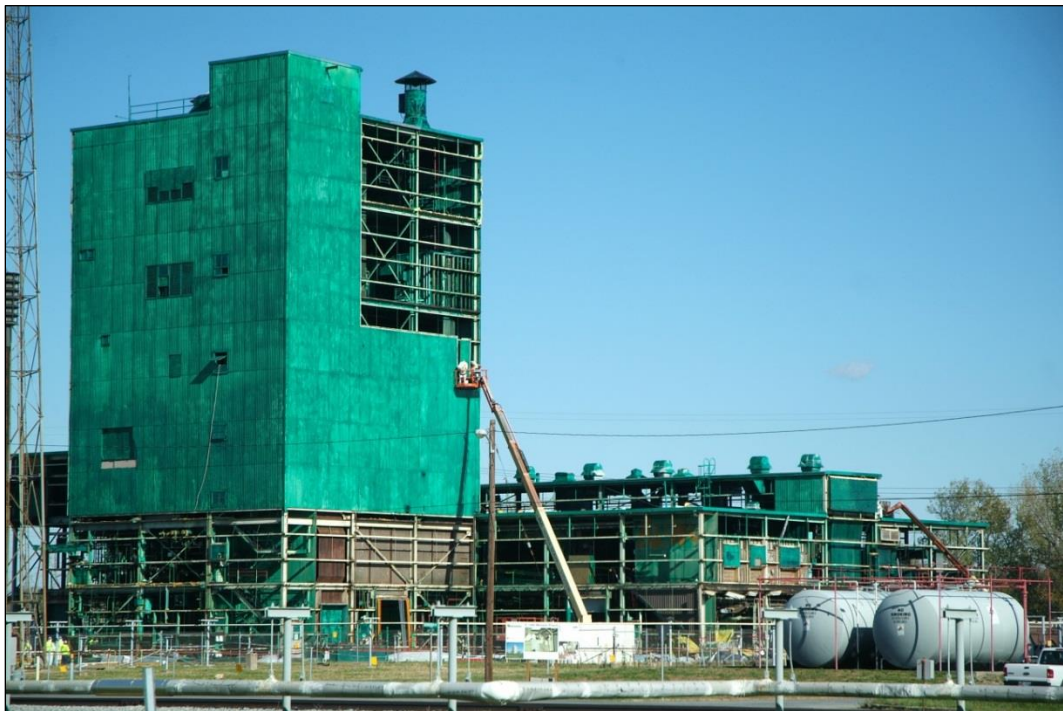
Figure A.2. A Man-lift Is Used to Reach Fixative-sprayed Transite Panels

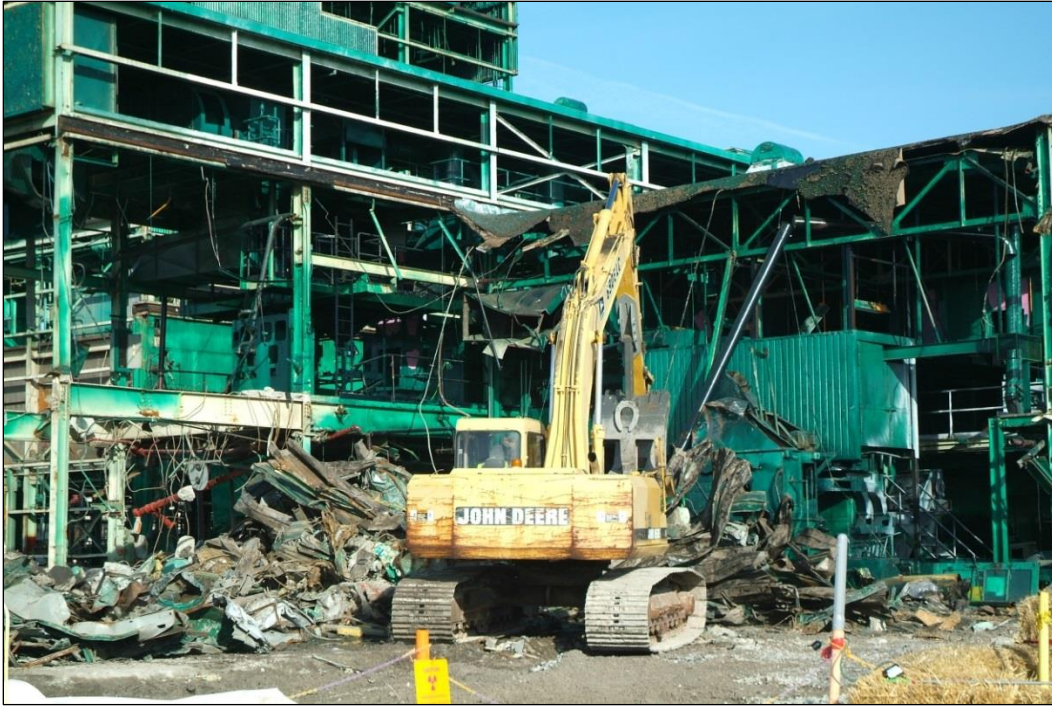
Figure A.3. Excavators with Shear Attachments Were Used to Remove Parts of the Building and Debris Generated by Demolition Activities

The demolition of the facility was accomplished using standard construction equipment, excavator-mounted shears, and excavator-mounted grapples. Primarily, a special ultra-high-reach excavator was used for taller portions of the facility. Transite was removed using manlifts. Minor demolition was accomplished with plasma and oxy-acetylene cutting torches. Demolition of the structure included removal of infrastructure that was left in place after deactivation. Examples of the infrastructure included piping, stabilized ductwork, and deactivated equipment. This piping and equipment were removed and downsized prior to packaging for disposal.

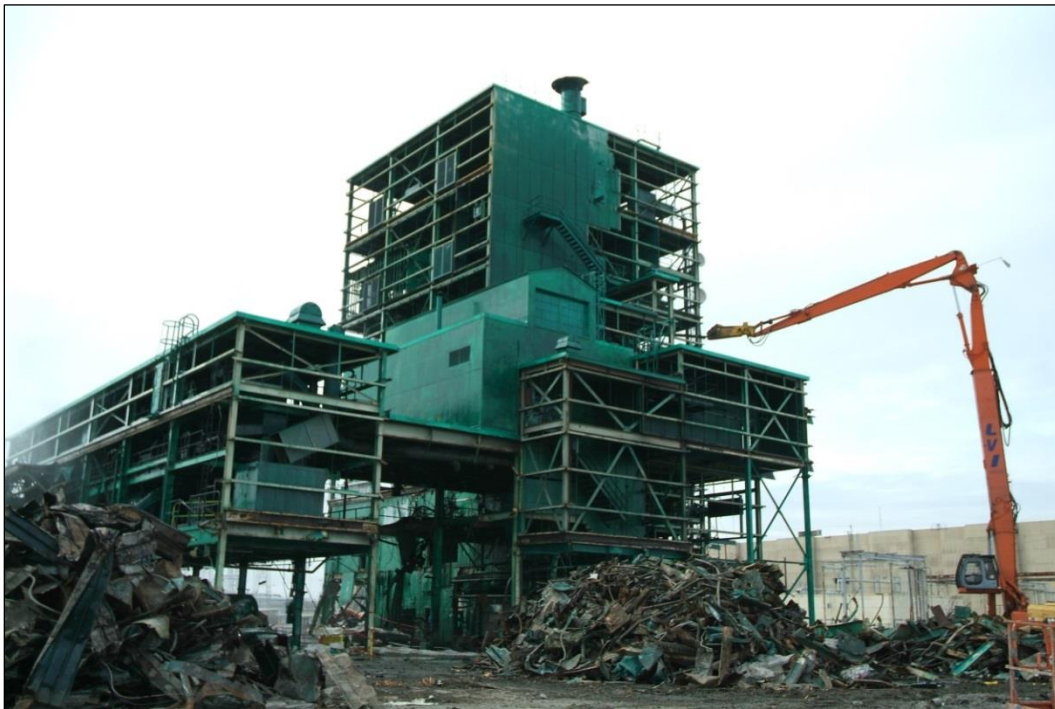
Figure A.4. An Ultra-high-reach Demolition Machine Is Used to Remove Parts of the Building That Can't Be Reached by the Smaller Excavators

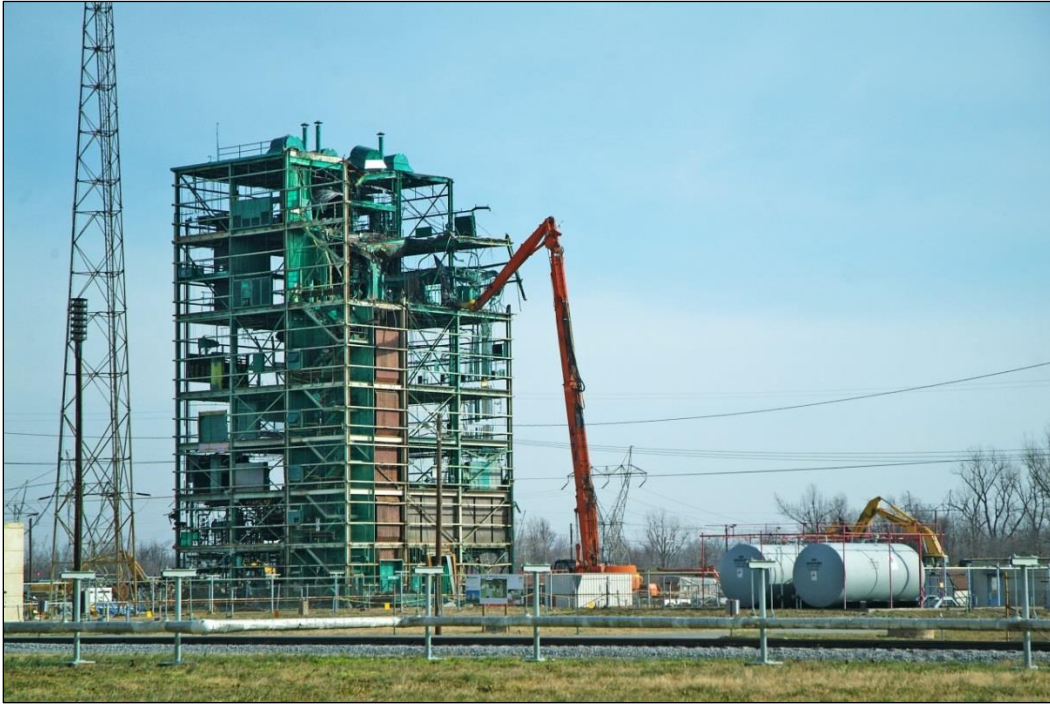
Figure A.5. An Ultra-high-reach Demolition Machine Is Used to Demolish the Metals Plant from the Top Down

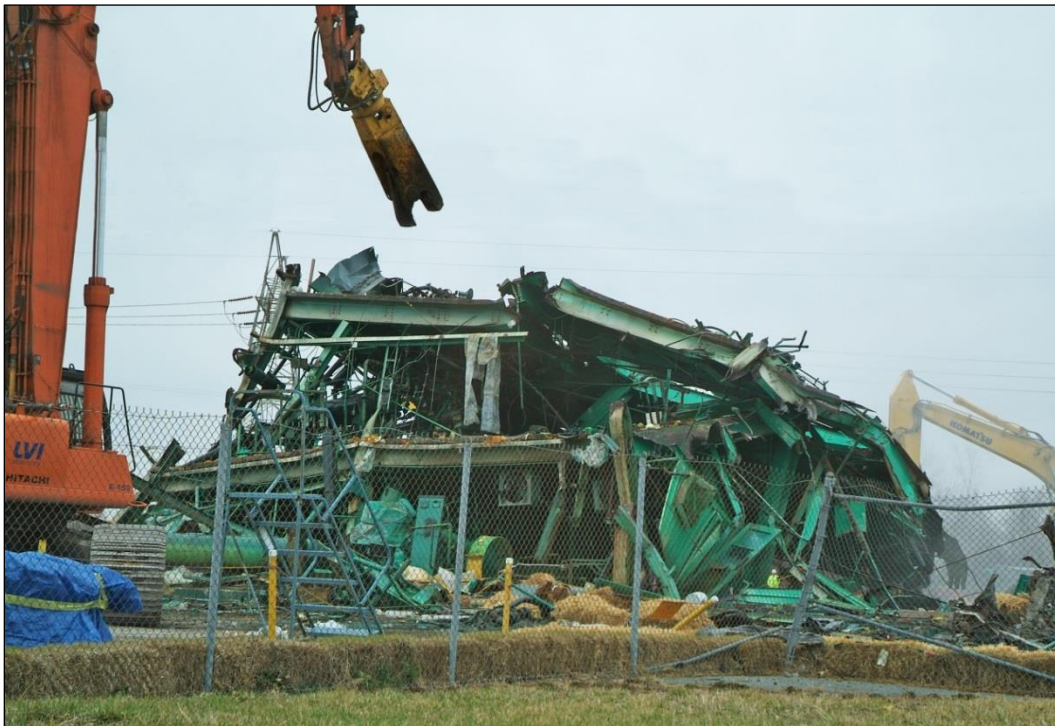
Figure A.6. The Support Beams for the Metals Plant Are Cut To Bring the Building to Slab

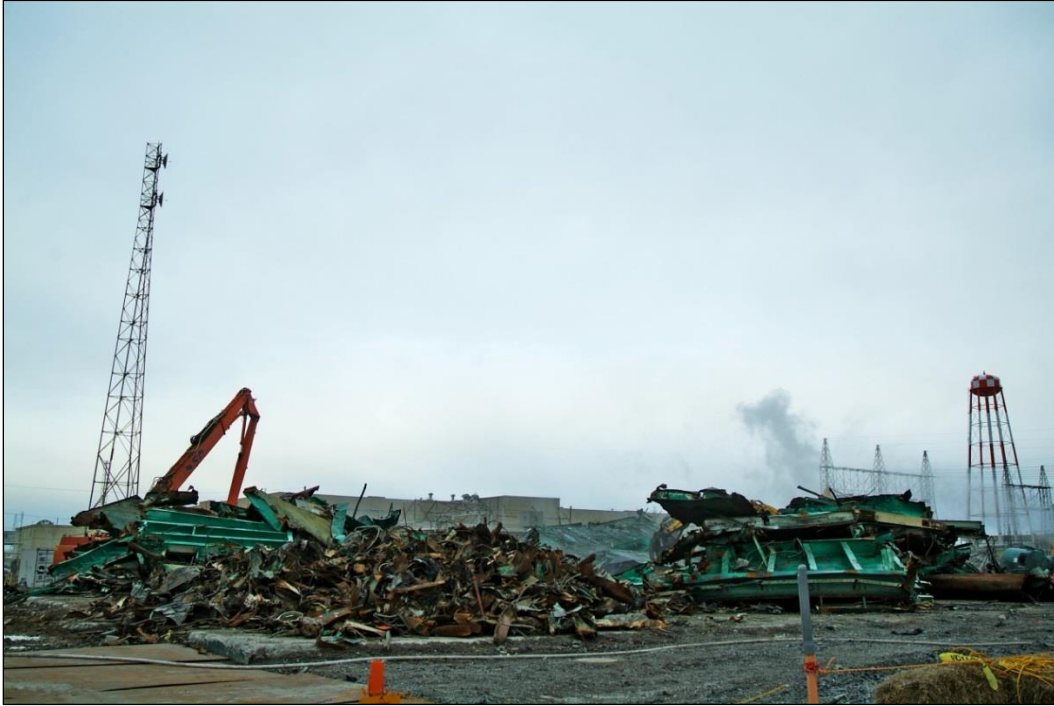
Figure A.7. Debris Is Being Sorted into Waste, Part of Which Will Be Shipped to an Approved Disposal Facility and the Rest Taken to the On-site C-746-U Landfill

Implementation of the removal action generated 118,034 ft³ of demolition debris, not including wastewater. The demolition material was segregated into two primary waste streams. The demolition generated 64,028 ft³ of debris that met the waste acceptance criteria and was disposed in the on-site C-746-U Landfill, in accordance with ARARs. Disposal of this waste stream, which included the transit removed from the building exterior, was completed in July 2013.

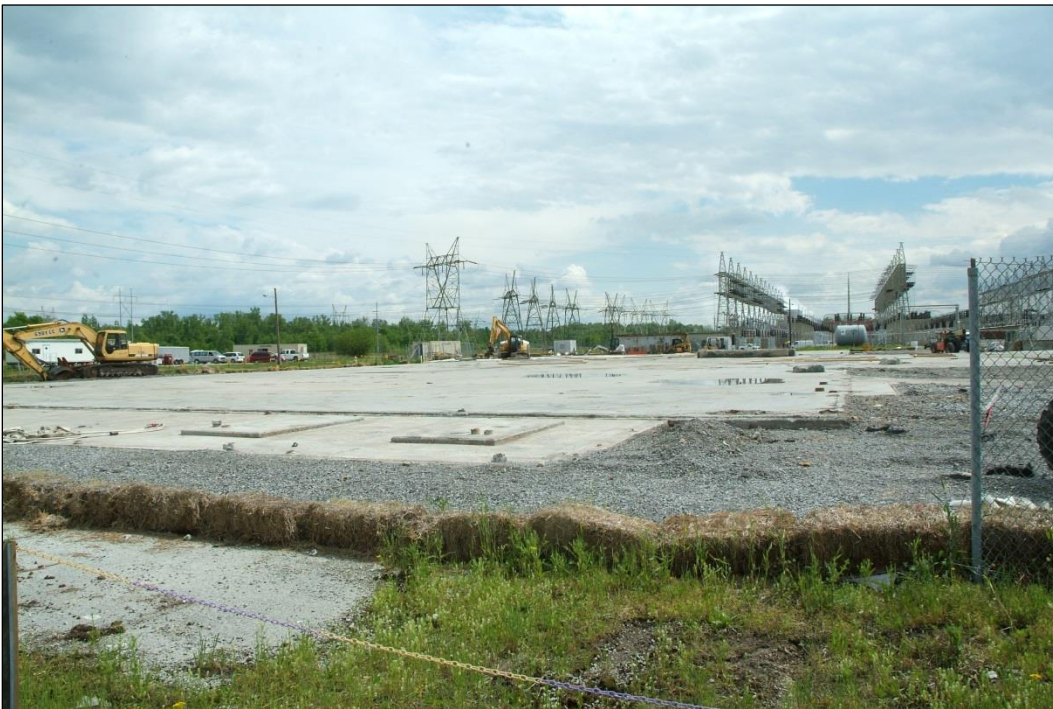
Figure A.8. C-340 Complex after Demolition
