**TRANSMITTAL OF THE D1 REMOVAL ACTION REPORT FOR THE C-746-A EAST  
END SMELTER AT THE PADUCAH GASEOUS DIFFUSION PLANT, PADUCAH,  
KENTUCKY (DOE/LX/07-0360&D1)**

## **REMOVAL ACTION REPORT FOR THE C-746-A EAST END SMELTER AT THE PADUCAH GASEOUS DIFFUSION PLANT, PADUCAH, KENTUCKY**

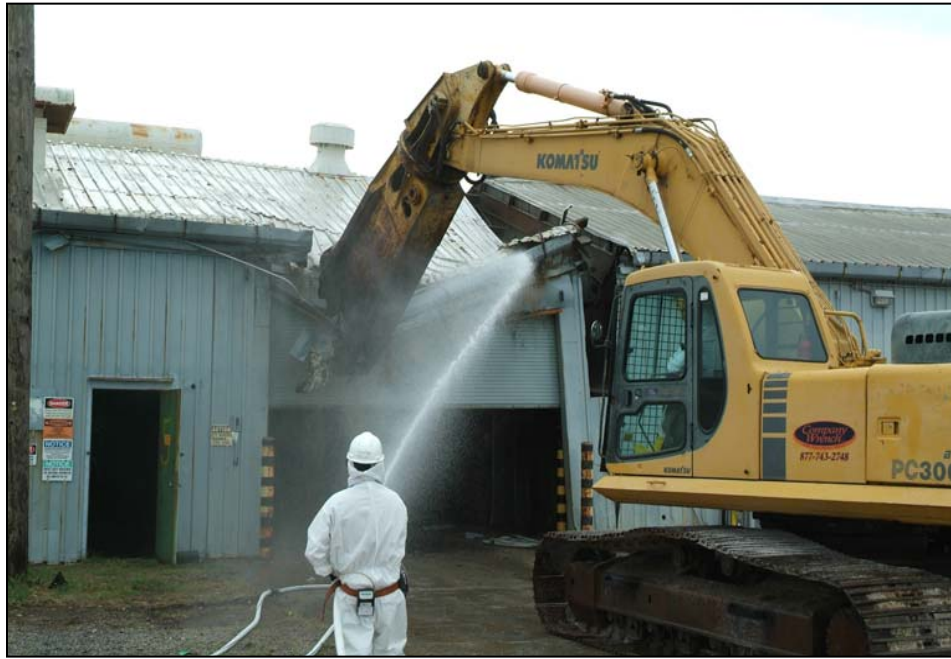
**Initial Demolition Entry**

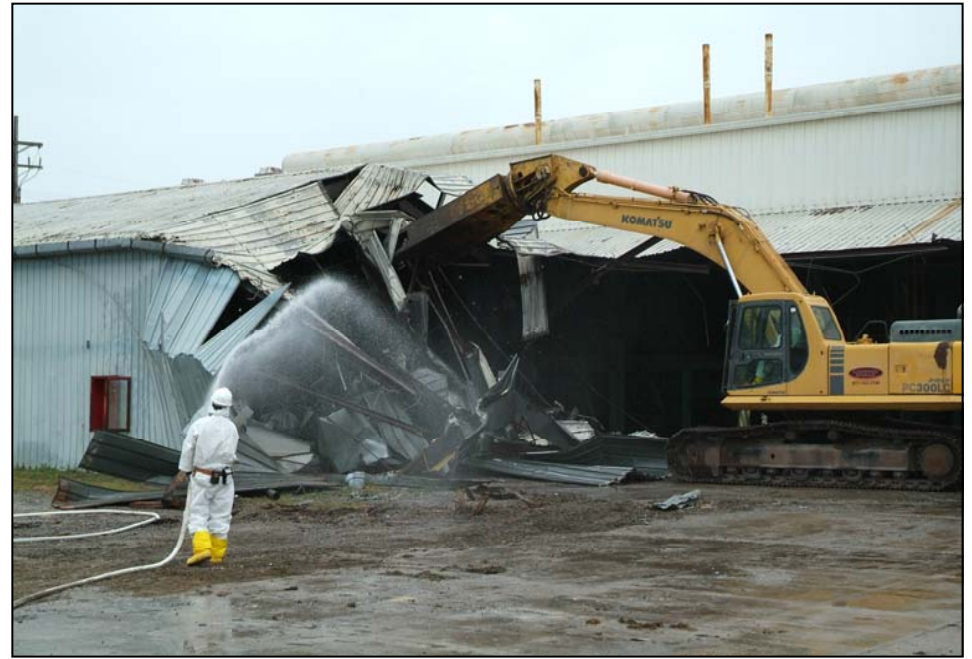
**Removal of Siding**

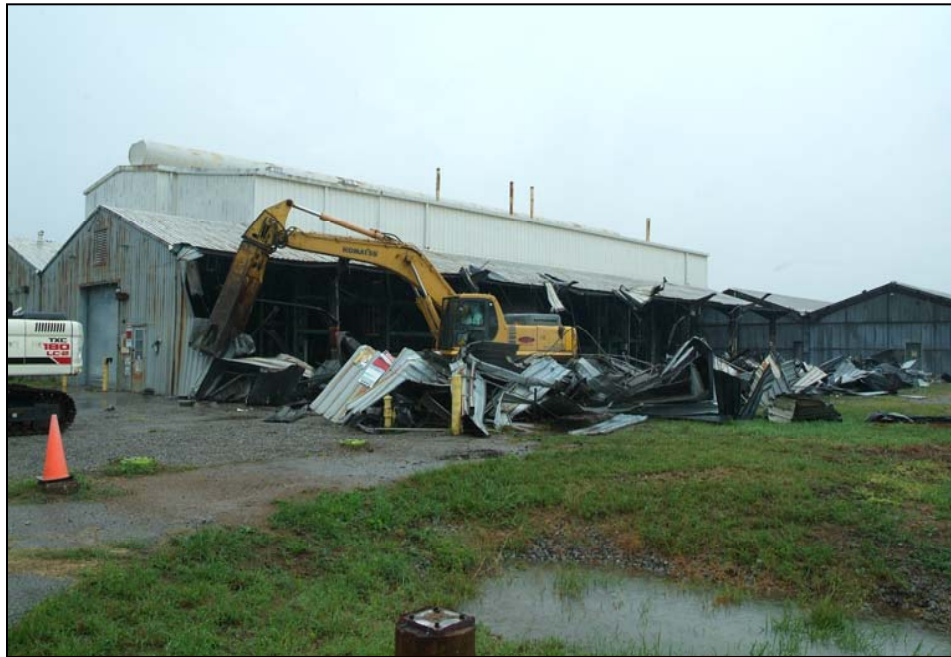
**Removal of Siding**

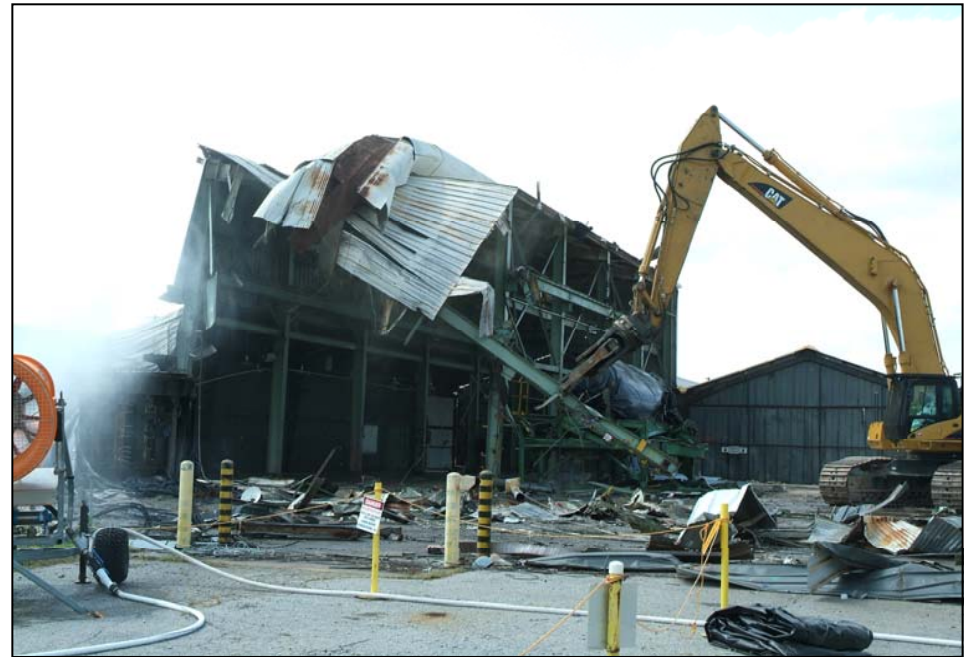
**Removal of Structural Member**

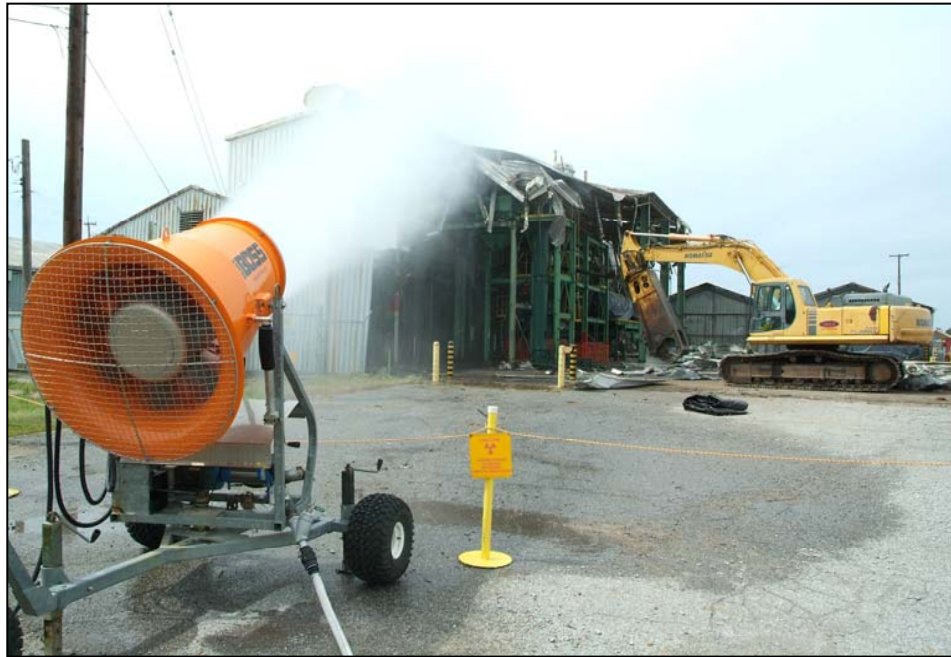
**Dust Control**

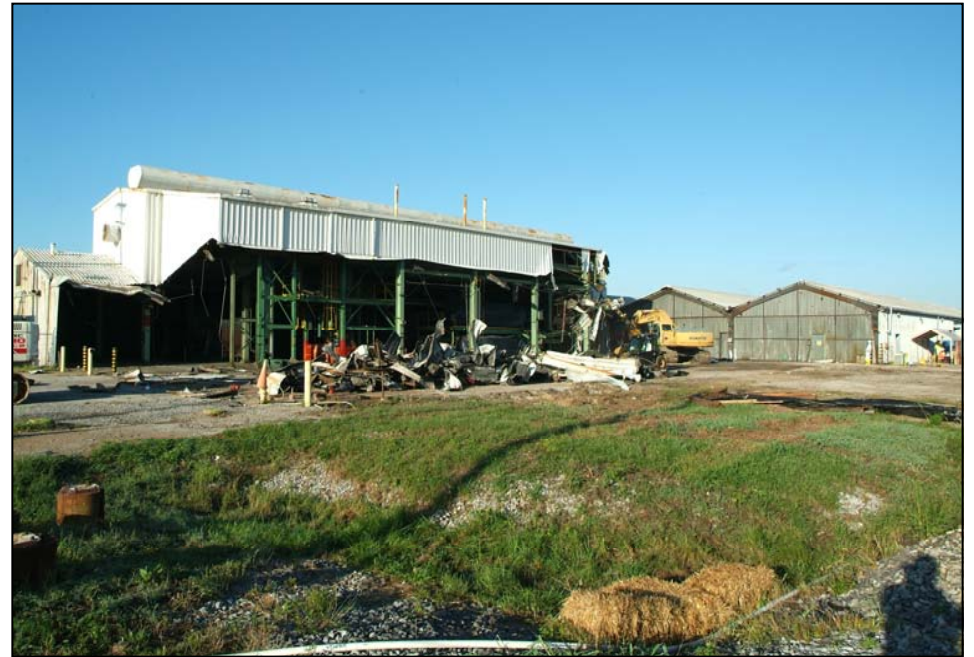
**Demolition in Progress**

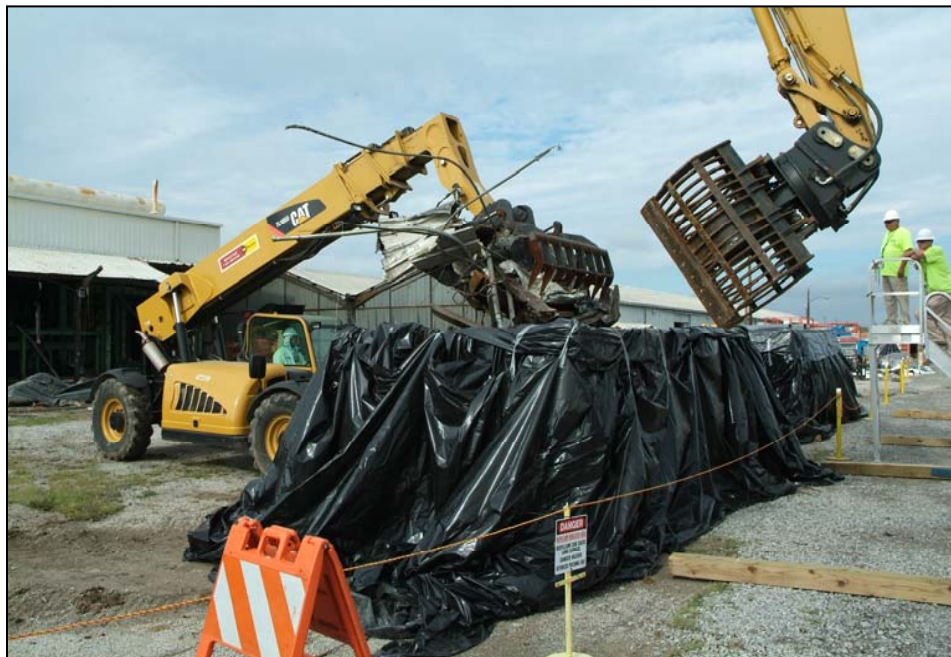
**Packaging for Shipment**

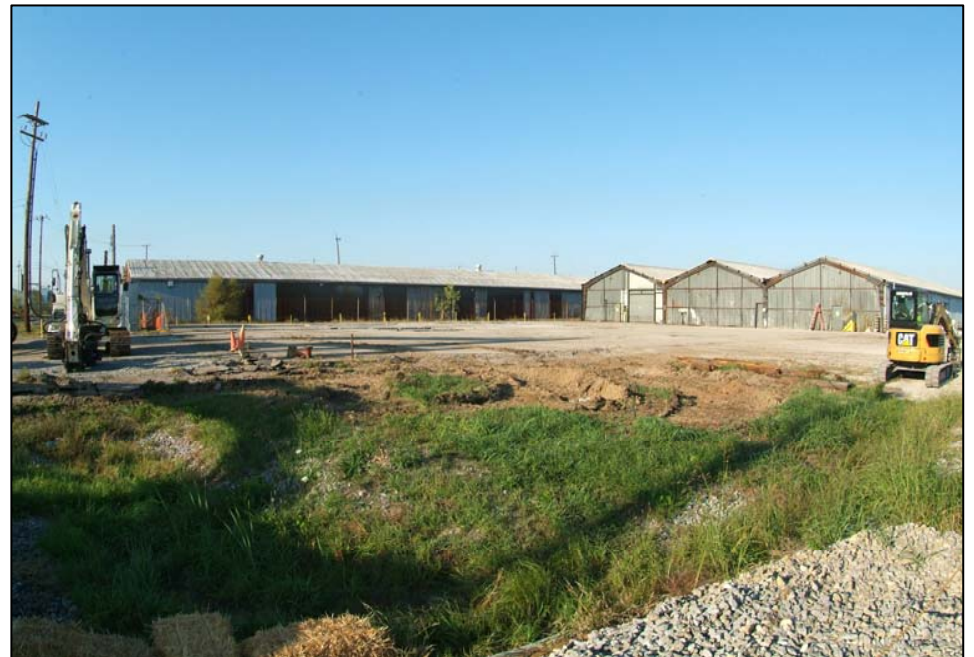
**Slab After Building Demolition**
