## C-100 Administrative Building

Facility Overview Briefing

November 9, 2021

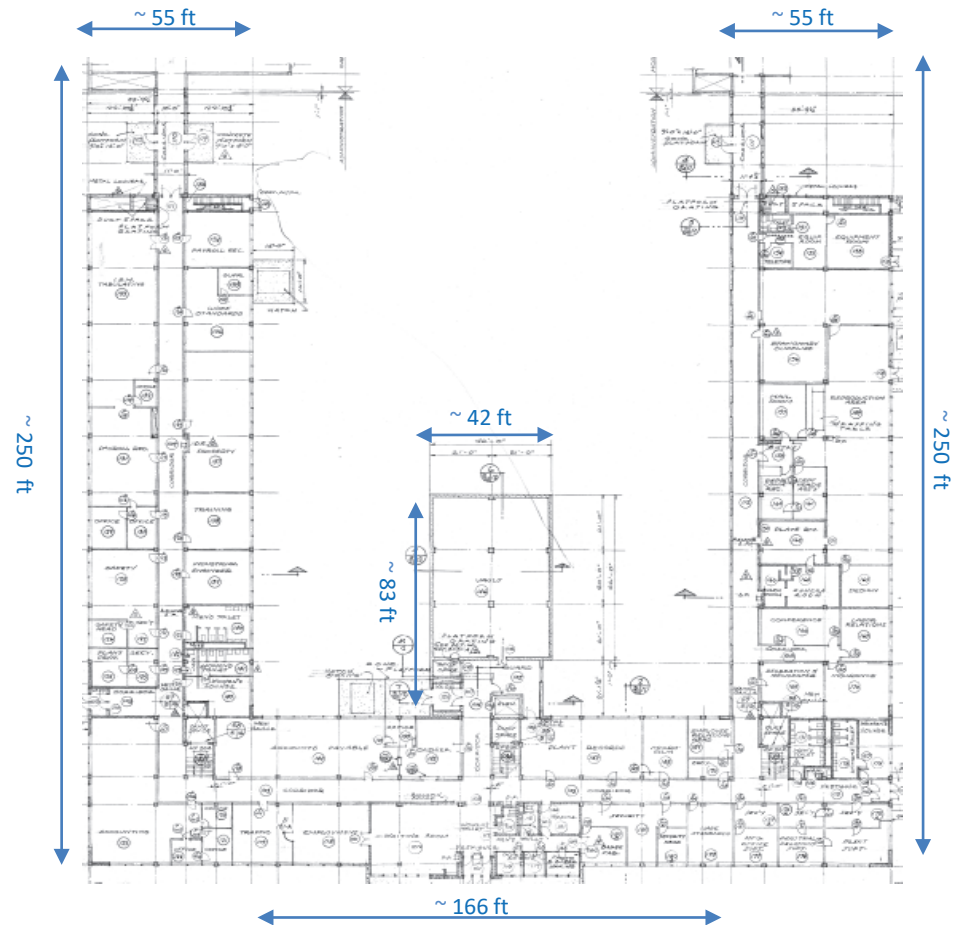
- C-100 is located outside the Paducah Site security fence, west of C-333. The facility was constructed in 1953.
- The facility is a U-shaped reinforced concrete structure on an 8-inch concrete slab with a network of partial basements/tunnels.

- ❑ Main two-story structure with a basement, two-story vault, and an elevator.
  - ❑ Two single story east and west wings with below grade piping tunnels connecting each wing to the main two story structure basement and the partial basements located on the north end of each wing (these partial basements are also accessible via external hatches).

First Floor Plan View Excerpt from Engineering Drawing  
BI-5-A, dated 1953

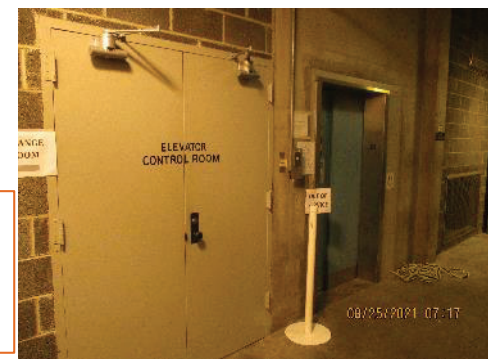
- C-100 is equipped with an elevator.
  - ❑ The elevator pit periodically floods with storm water (a timeframe for the initial occurrence of flooding is unknown).
  - ❑ A drain in the elevator pit has been plugged (date unknown).
  - ❑ A tank containing hydraulic oil is stored in the elevator equipment room.
  - ❑ The elevator pit flooded most recently in August 2021.
    - A sheen was observed on top of the water in the elevator pit.
    - Water was removed from the pit and placed in generator staging area (GSA) G-100-02.
    - The water has been moved and is being stored in C-752-A pending characterization and disposition.
    - The GSA has been closed.

Elevator and Elevator Control Room in the Basement

- Based on the unknown quantity and date of a chromated water release in the basement; a sheen in water in the elevator pit; and floor stains and cracks in the basement floor, it is recommended that the underlying slab and soils undergo further CERCLA evaluation as part of a future site evaluation conducted under Appendix 4 of the SMP.
  - ❑ Consideration will be given to coordinate the timing of the future C-100 site evaluation to occur prior to removal of the C-100 aboveground structure. The development of a schedule for future site evaluations, including C-100, will be addressed as part of the fiscal year 2022 or 2023 SMP scoping.

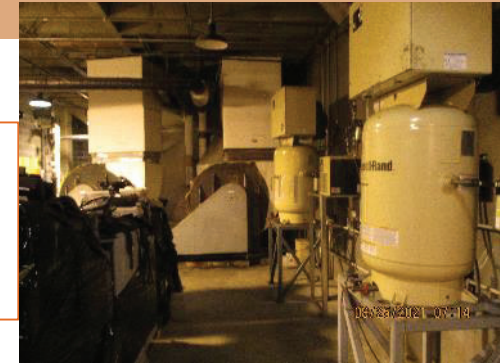
Air Compressor  
Tanks in  
Southwest  
Equipment  
Room

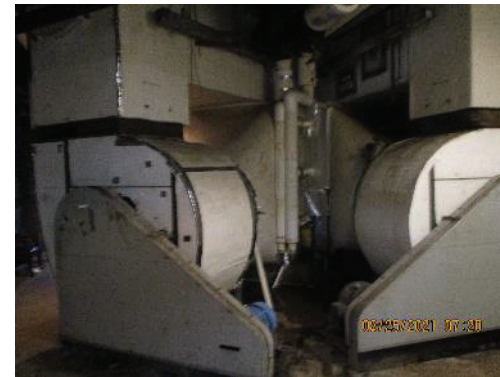
- The basement houses facility infrastructure equipment (e.g., power supply, heat exchangers, air moving fans, steam system surge tanks, utilities, etc.).
- An RCW valve malfunctioned, which required cleanup of a portion of the basement (prior to 1993).
- Residual chromate may be in floor drains (quantity unknown).
- PCB spills
  - ❑ Three known light ballast spills/leaks (4/30/90; 4/8/91; 4/24/97).
    - Debris was removed.
    - Areas were decontaminated.
    - Areas were verified clean.
  - ❑ On August 1, 1991, water containing detectable PCBs spilled from a drum in the basement.
    - Contents were contained.
    - Area was decontaminated.
    - Area was verified clean.
- USEC leased the facility in the early 1990s and continued to use it until USEC ceased operations in 2014.
- The facility was transitioned from USEC to DOE in 2014.

Heat Exchangers  
and Air Movers in  
Central Equipment  
Room

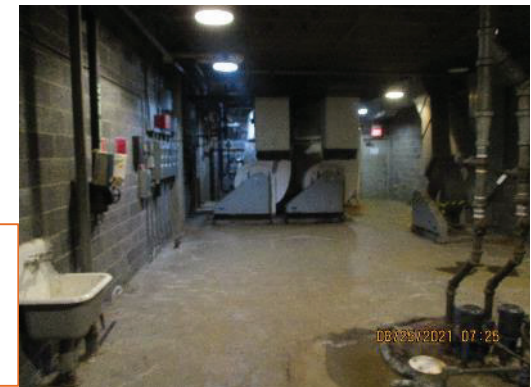
Heat Exchangers, Air  
Movers, X-Fan in  
Northeast  
Equipment Room

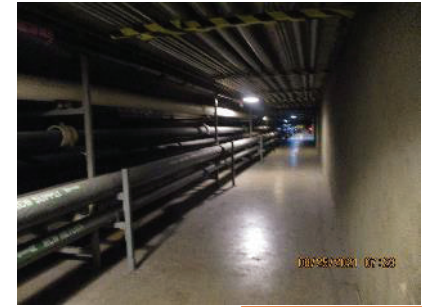
Utilities  
East Wing  
Tunnel

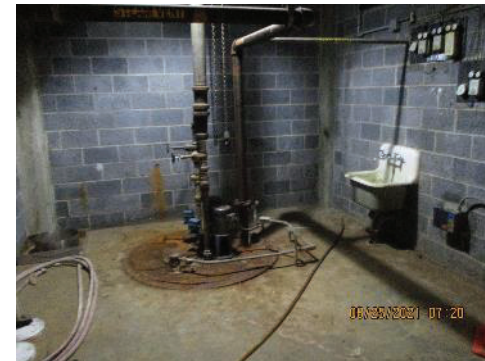
- ❑ Sump pits are present in the basement and discharge to the storm sewer system.
  - ❑ Battery Room located in the basement.
  - ❑ Two dry-type electrical transformers located in the basement.

Floor Sump Pit  
in Central  
Equipment  
Room

- As part of the demolition of the aboveground structure, the appropriate best management practices (BMPs) will be evaluated and implemented (as needed) to prevent/minimize the pooling and/or migration of storm water that may come into contact with any contamination that may exist on the pad/subsurface structure(s). For example, the following BMPs will be implemented as necessary:
  - ❑ Radiological surveying will occur following demolition.
  - ❑ Decontamination and/or application of fixatives and/or barriers to contaminated surfaces above regulatory posting limits.
  - ❑ Isolation measures and other types of barriers to minimize and/or control runoff/pooling of contaminated storm water [e.g., seal inlets to drains/sumps/subsurface structure(s)].

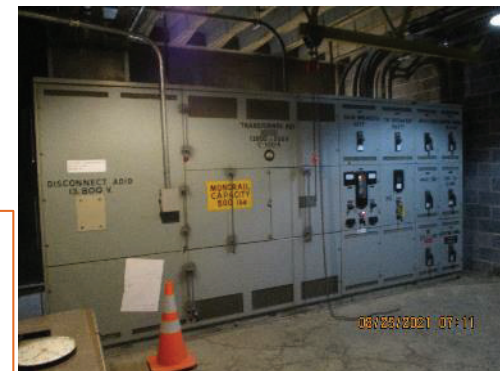
Basement  
Northwest  
Corner Electrical  
Switchgear Room
