# C-203 Emergency Vehicle Shelter

Facility Overview Briefing

March 4, 2021

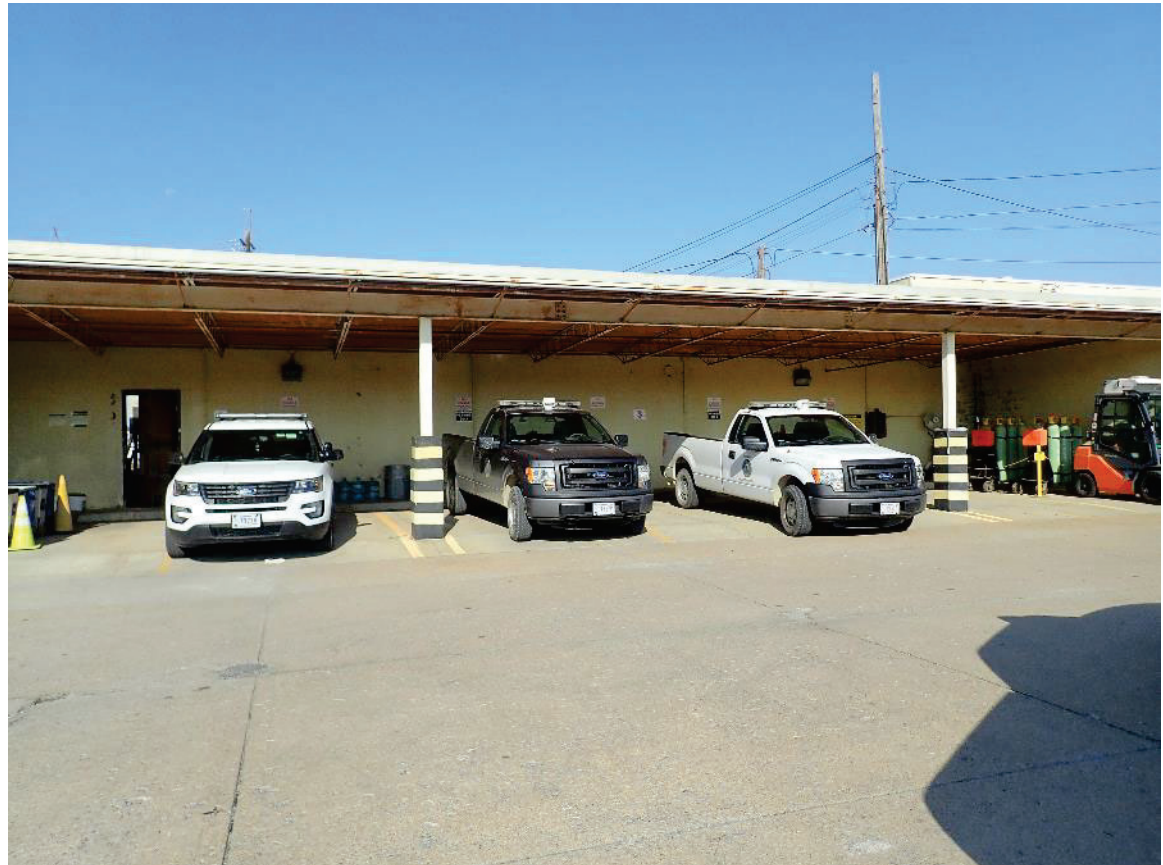
C-203 Facility Photos: 10/2020

- Continues to operate and serve as a vehicle shelter for emergency response operations.
- Walkdown inspection in October 2020 confirmed no unusual conditions.
  - Emergency vehicles parked.
  - Forklift.
  - The following miscellaneous items were present.
    - Potable 5 gal drinking water containers,
    - Empty breathing air cylinders pending refill,
    - Portable laundry baskets.
- The portable cylinder carts storing the air cylinders are designated as Radioactive Material Areas (RMAs) due to fixed radiological contamination from legacy use; they will be removed prior to demolition.

- Deactivation will include removal of any accessible loose items being stored and designated as RMAs (to the extent practicable) prior to demolition.
