C-205 Respirator Issue Facility

Facility Overview Briefing

November 9, 2021

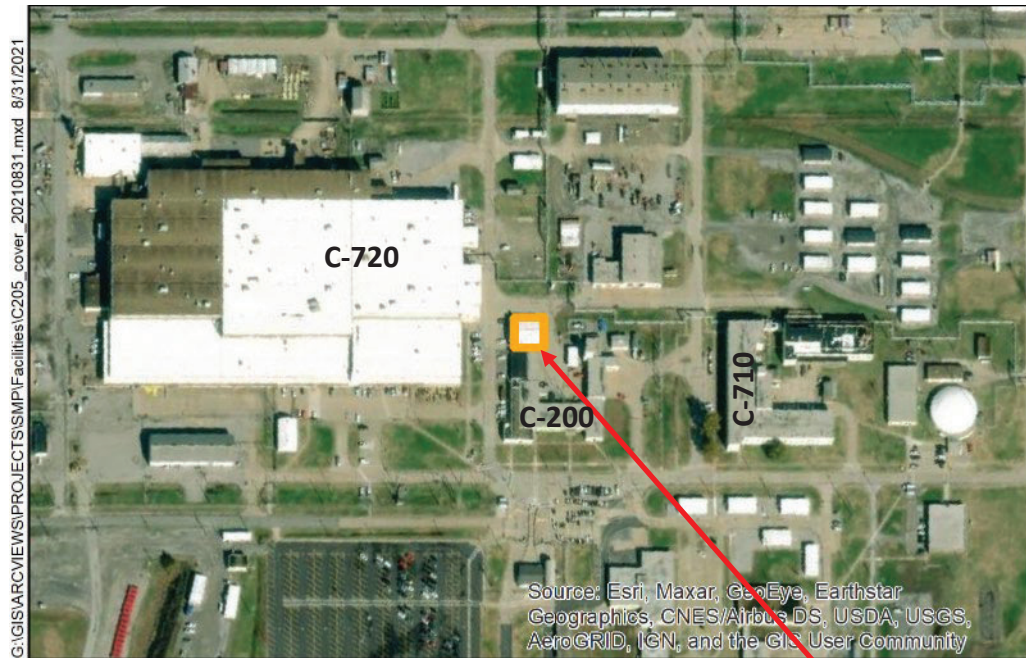
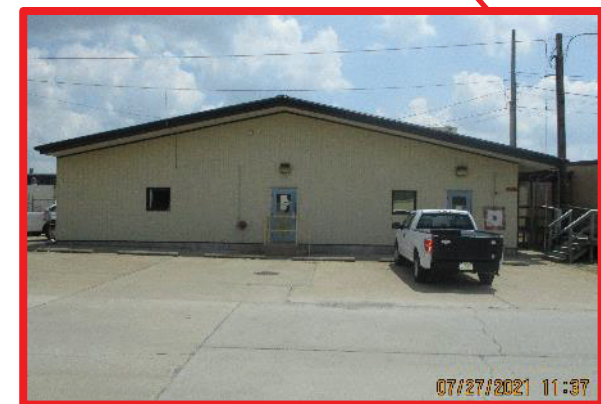
C-205 Facility Photo: 7/2021

- C-205 is located within the Paducah Site security fence, west of the C-710 Technical Services Building and east of the C-720 Building.
- The facility was constructed in 1996.
- The facility is a prefabricated metal structure on a concrete slab poured over an existing slab/parking area with an estimated concrete slab thickness ranging from ~ 3 inches to ~ 14 inches.
 - ❑ The facility has multiple points of entry (several pedestrian doors and one roll-up door) and houses a centrally located loft/mezzanine area.
 - ❑ The facility is divided into 6 main sections; some of which contain office areas and a breakroom.
 - Respirator Issue Area
 - Customer Entrance Area
 - Private Restroom
 - Respirator Maintenance Area
 - Storage Room
 - Compressor Room
- The facility is approximately 3,600 ft².
 - ❑ Measuring ~ 60 ft x ~ 60 ft.

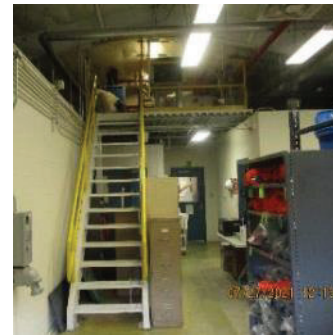
Loft/mezzanine with overhead view of office and storage area

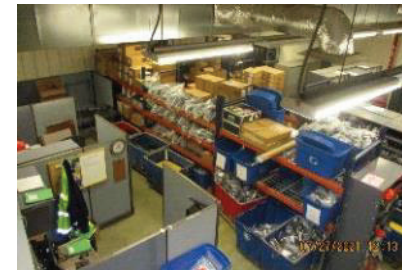
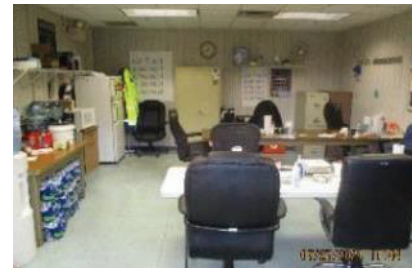
Customer Entrance and Breakroom

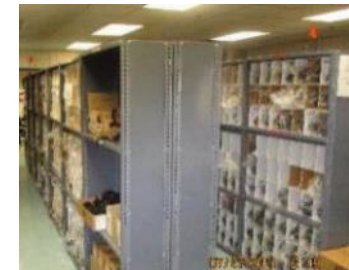
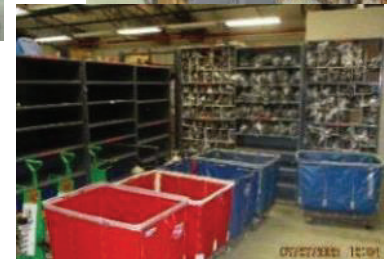
Respirator Storage

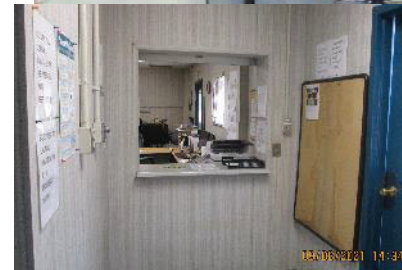
C-205 Facility Photos: 7/2021

- C-205 remains operational and operates as a respirator issue facility and includes repair of all respirator equipment (respirator aerosol particle leak-testing is no longer performed within the facility).

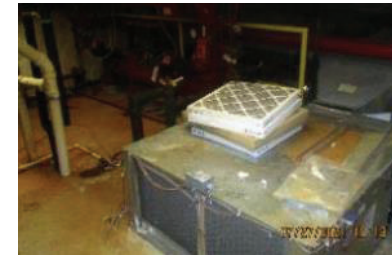
- Walkdown inspection conducted in July 2021 and employee interviews confirmed no unusual conditions.
 - ❑ No sumps or pits are present.
 - ❑ Floor drains associated with the restroom, loft/mezzanine area, and compressor room tie into the sanitary sewer system.

HVAC and floor drain

- ❑ Deactivation will include removal of any accessible loose items being stored (to the extent practicable) prior to demolition.
 - ❑ Any floor drains will be delineated, documented, and isolated prior to demolition.

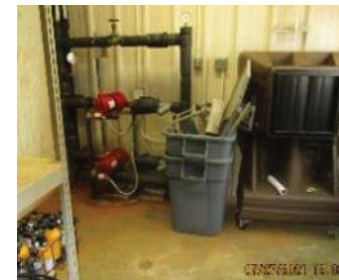
- Chilled water recirculating system had been upgraded and no longer contained chromium when facility was built; leak occurred in 2021 that drained into the sanitary sewer system.

Chilled recirculating water system and floor drain
