C-320 Communication Building

Facility Overview Briefing

March 4, 2021

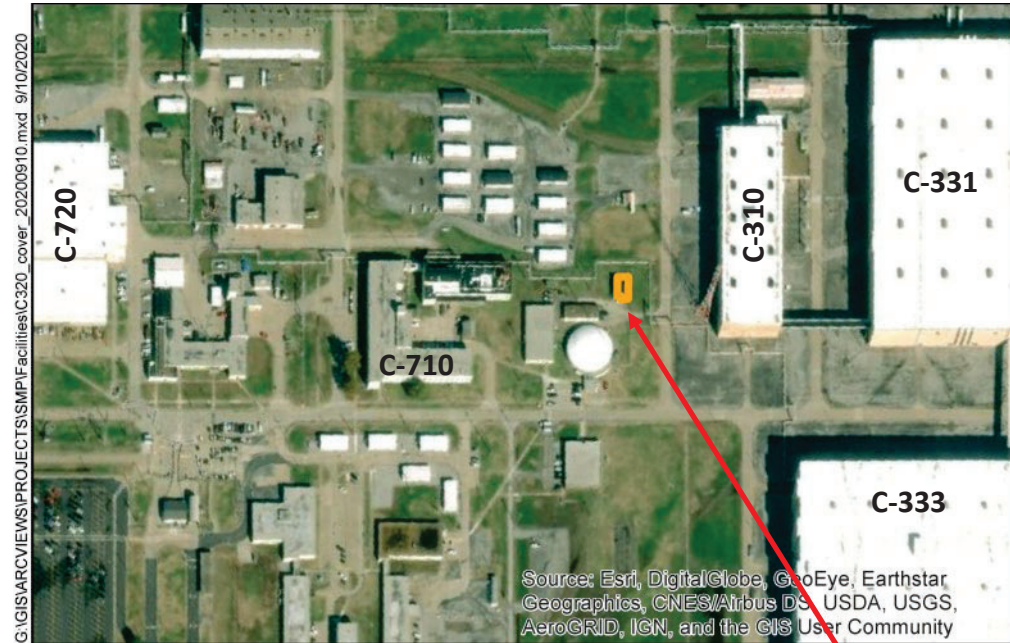
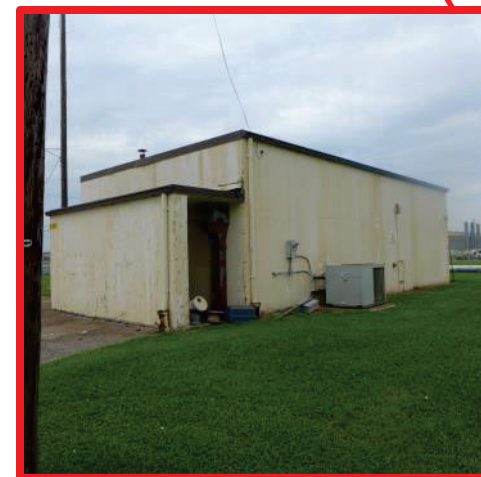
C-320 Facility Photo: 8/2020

- C-320 is located within the Paducah Site security fence, west of C-710 and north of the C-300 Central Control Building.
- Construction was initiated in 1952 and completed in 1954 (engineering drawing D3-1-A).
- The facility is a one-story rectangular building constructed with reinforced concrete with a small roofed annex structure on the south entrance covering a concrete pit.
- The concrete pit served as part of the original HVAC ventilation system for exterior air intake (see backup engineering drawing D3-101-M).
- The facility is approximately 1,116 ft².
 - ❑ Measuring ~42 ft x ~24 ft and ~49 ft x ~24 ft.

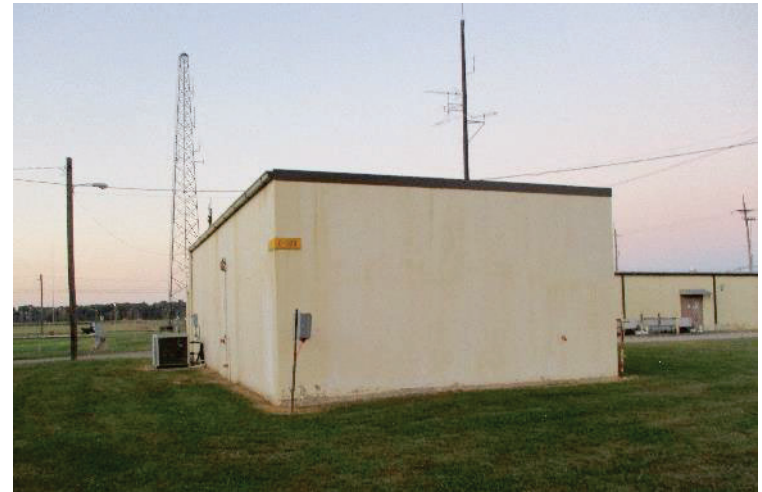
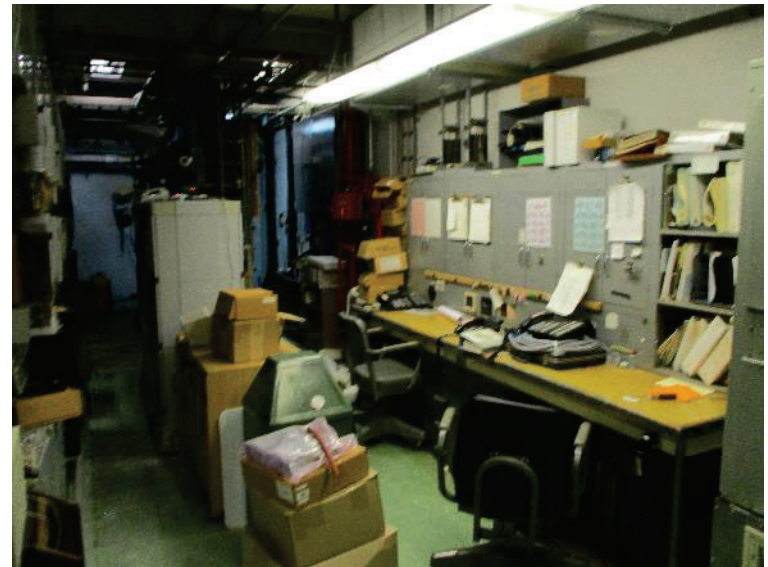
C-320 Facility Photos: 10/2020

- C-320 continuously has been operated since its initial construction, in conjunction with the C-300, C-302, and C-303 facilities to support the Paducah Site central operations and control function.
- C-320 houses the PAX telecommunication system for the entire site, including a backup emergency PA system and a fire sprinkler system.
- The facility includes a 48-V DC battery bank (lead acid batteries) and other batteries associated with the telephone Uninterruptible Power Supplies (UPS).
- USEC leased the facility in the early 1990s and continued to use it to support the site's telecommunication system until USEC ceased operations in 2014.
- The facility was transitioned from USEC to DOE in 2014 and continues to be operated for its above mentioned purpose.

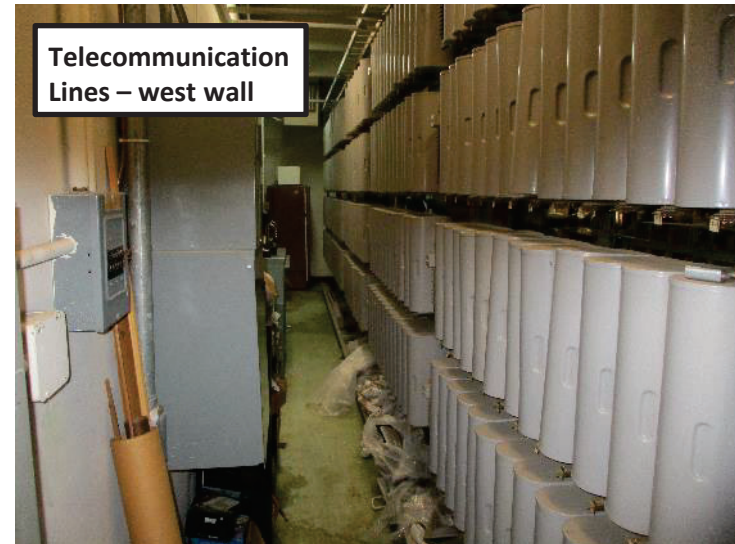
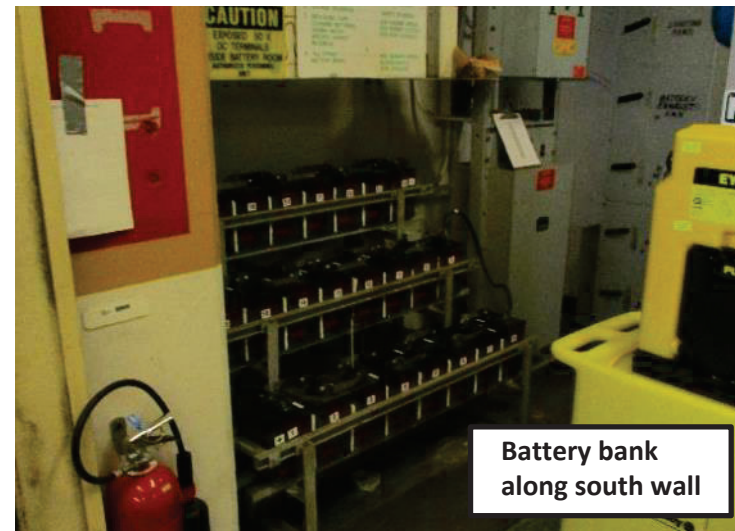
- C-320 is still operational and continues to support its intended function for telecommunications.
- Walkdown inspection conducted in October 2020 and employee interviews confirmed no unusual conditions.
 - ❑ Active telecommunication lines throughout the facility.
 - ❑ Battery banks to provide power for the telecommunication operations.
 - ❑ Empty concrete pit at south entrance that was part of the original HVAC ventilation system.
 - ❑ No known chemical spills.

- ❑ Deactivation will include removal of any accessible loose items being stored, to the extent practicable, prior to demolition.
- Pending ceasing of operation, deactivation, and availability of funding, proceeding with demolition and disposal of C-320 (aboveground structure) outside of the FFA/CERCLA process, contingent upon the fact that no additional changes have occurred that would affect the CERCLA determination of the facility prior to demolition, is recommended.
