# C-400-A Shed

Facility Overview Briefing  
May 11, 2020

DOE briefed EPA and Kentucky on November 6, 2019, with details concerning the demolition and disposal of this facility. This briefing reflects those discussions and includes incorporation of comments received from EPA and Kentucky during those discussions.

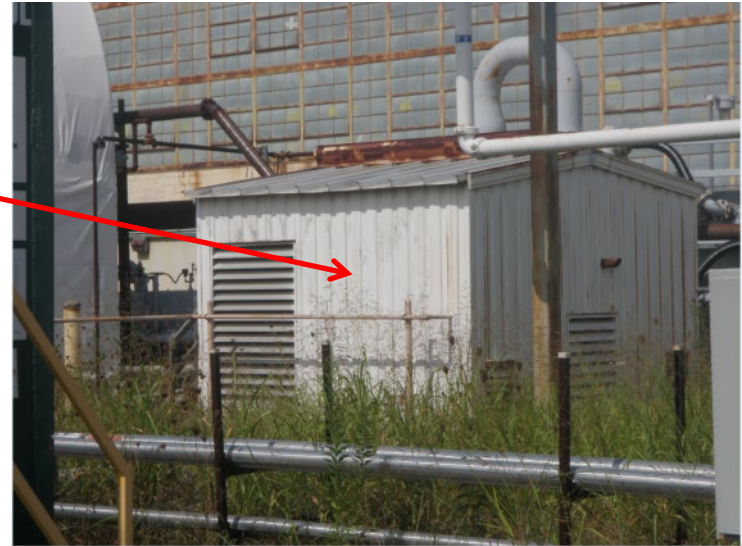
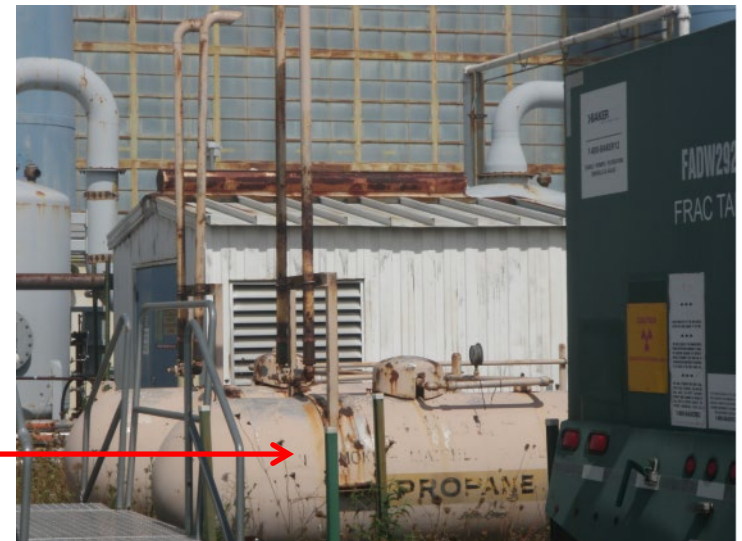
- Housed an emergency backup generator for the C-400 Criticality Access alarm system (CAAS).
- No chemicals were stored within the shed.
- Existing documents and interviews of employees who worked at C-400 dating back to the 1970s indicate the shed was used exclusively for the above stated purpose.
- Propane gas stored outside the facility provided fuel for the generator.

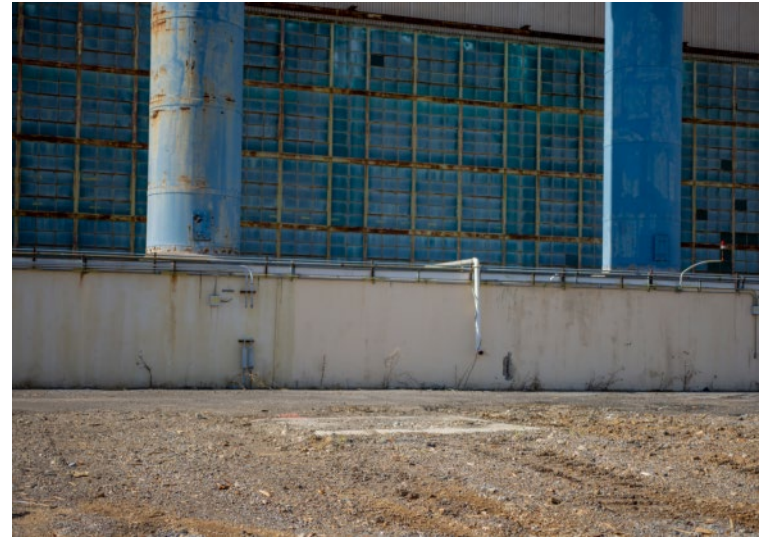
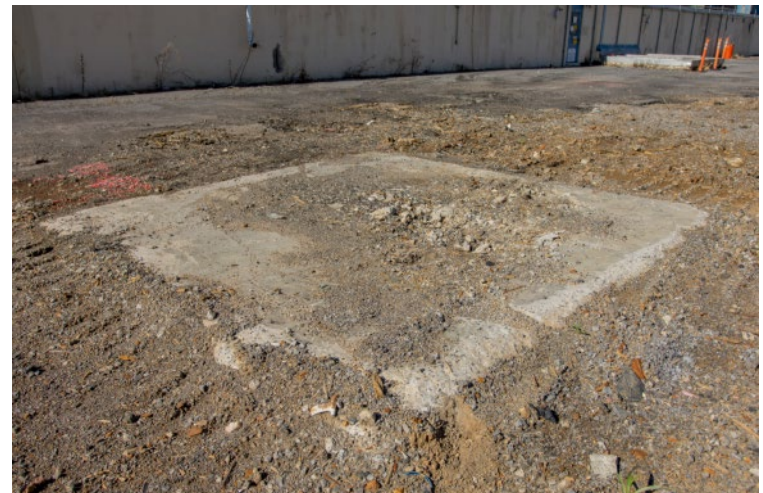
- The C-400 Interim Remedial Action (IRA) treatment system on the east side of the C-400 building was removed (August, 2019) to support field access for the upcoming C-400 remedial field investigation.
- In addition to removal of the C-400 IRA infrastructure, the “aboveground” portion of the C-400-A shed was also demolished and disposed (August 2019)
- The demolition debris from removal of C-400-A met the WAC for disposal in the U-Landfill.
- Remaining concrete pad and surrounding soils were left in place.

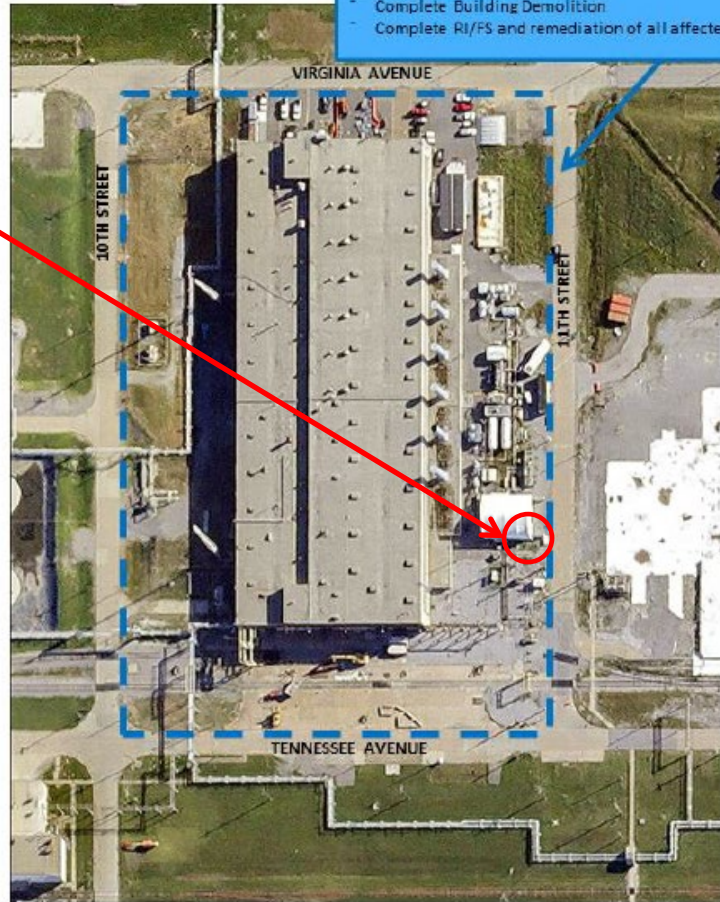
- Aerial footprint of ~350,000 ft<sup>2</sup> (8 acres)
- Address all contaminants (e.g., TCE, Rad, PCBs, metals)
- Complete Deactivation
- Complete Building Demolition
- Complete RI/FS and remediation of all affected media

- No evidence of environmental releases from C-400-A operations based on:
  - Process Knowledge;
  - Interviews; and
  - Visual Inspections.
- Within the C-400 Complex footprint and bordered by certain Solid Waste Management Units.
- No information to indicate a release or threatened release of a hazardous substance into the environment from operations at this facility or the facility itself that would require an evaluation for a potential response action to protect future public health or welfare or the environment.
