C-410-D Fluorine Storage Building

Facility Overview Briefing

March 4, 2021

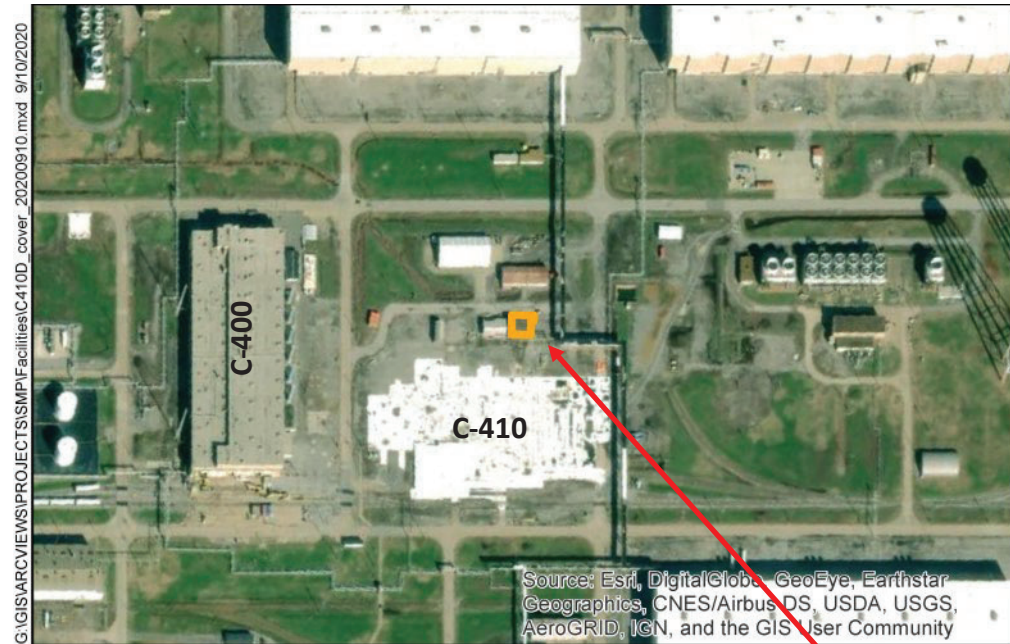
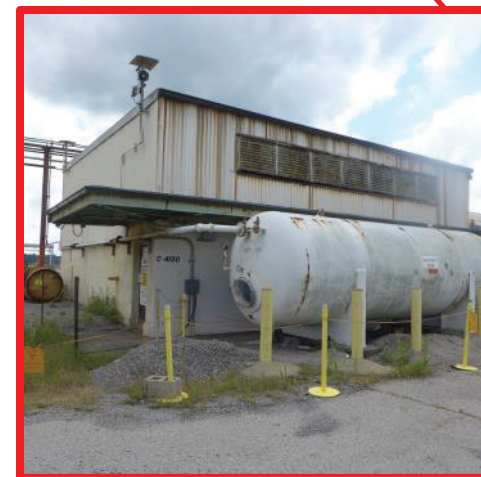
C-410-D Facility Photo: 8/2020

- C-410-D is located within the Paducah Site security fence, north of C-410 and east of C-400.
- Construction was completed in 1953.
- The facility consists of a concrete base structure with an upper portion of structural steel and corrugated siding.
- The facility is approximately 1,512 ft².
 - ❑ Measuring ~42 ft x ~36 ft.

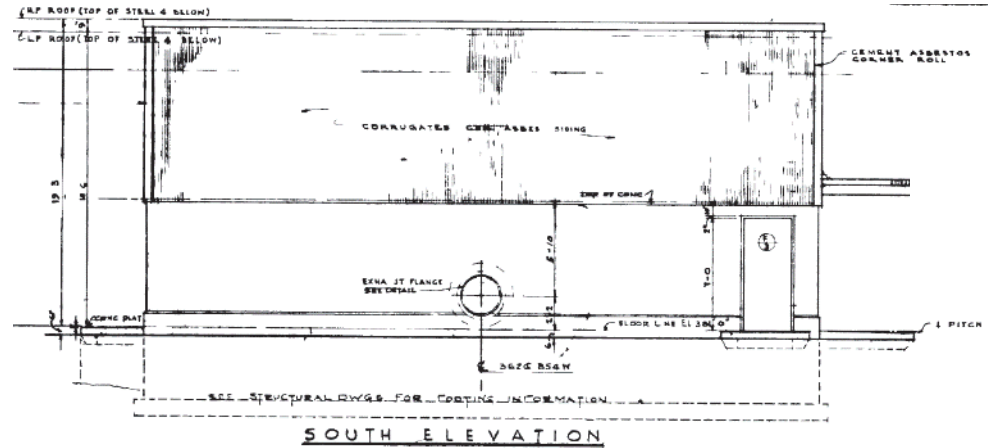
Side View: Excerpt from Engineering Drawing E1-33-A, Rev E dated 1951

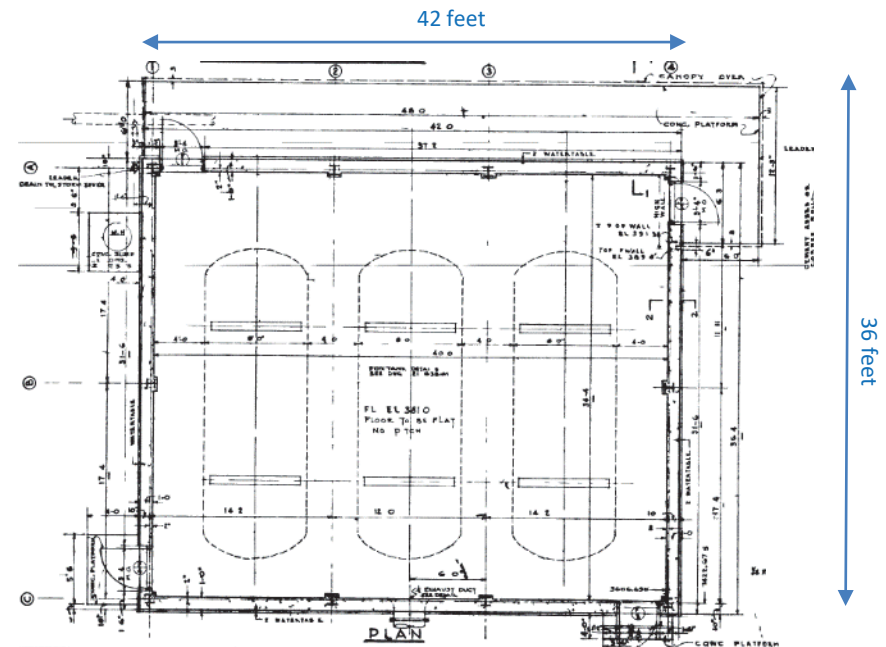
Floor Plan View: Excerpt from Engineering Drawing E1-33-A, Rev E dated 1951

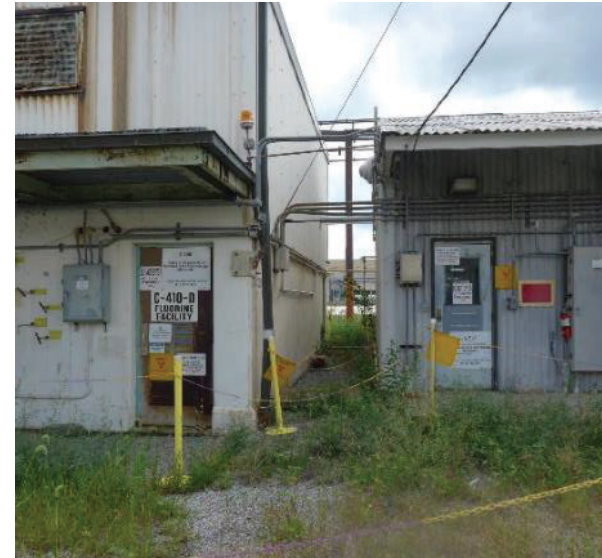
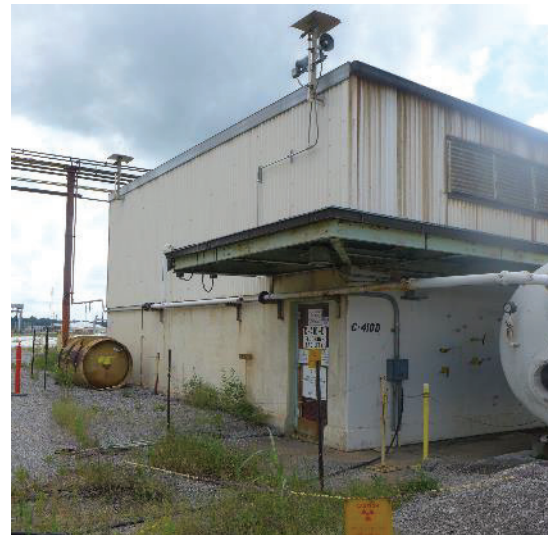
C-410-D Facility Photos: 8/2020

- C-410-D operated as a support facility to the C-410 Feed Plant and was used to store fluorine needed for routine site operations from 1953 to 2019.
- The cylinder located on the east side of C-410-D is one of the two known cylinders that were used to supply the laboratory with fluorine from 1954 to approximately 1966.
- During USEC lease of the facility in the early 1990s, USEC continued to use C-410-D to store fluorine needed for routine site operations and in the mid-1990s added a Criticality Accident Alarm System (CAAS) system that included horns, an air tank, and an air compressor.

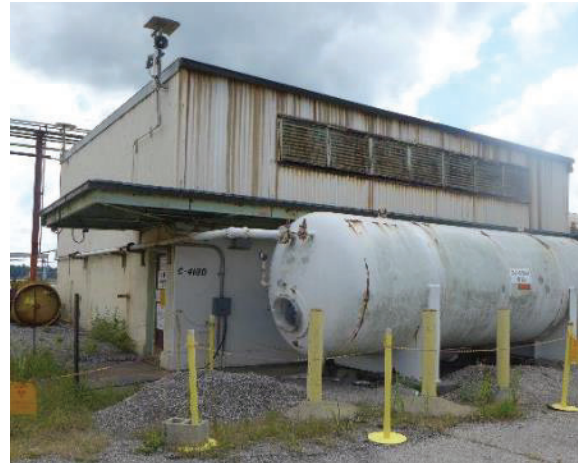
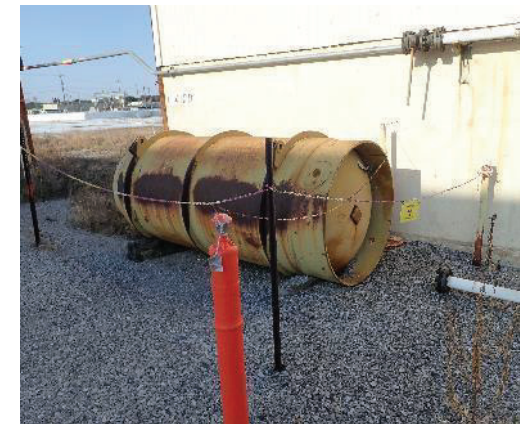
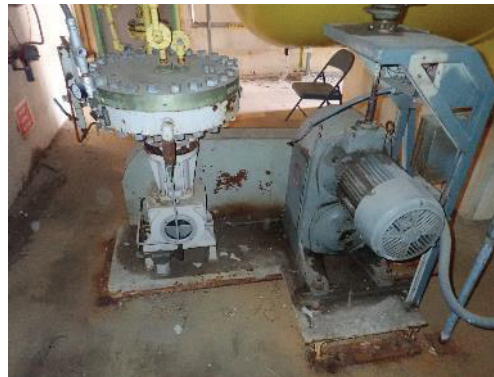
- C-410-D transitioned from USEC to DOE in 2014 and continued to operate until 2019, when the system components, fluorine tanks, and lines were evacuated; and the system was air gapped at C-350.
 - ❑ Industrial Hygiene instrumentation for hydrogen fluoride and fluorine detection registered no detectable material remaining in the system components or lines.
- In 2019, the CAAS system was converted to an electronic system and the air tank and air compressor where taken out-of-service.
- The cylinder located outside of C-410-D also was evacuated in 2019 when the installed system components and lines in C-410-D and C-410-K were evacuated.
 - ❑ Industrial Hygiene instrumentation for hydrogen fluoride and fluorine detection registered no detectable material remaining.

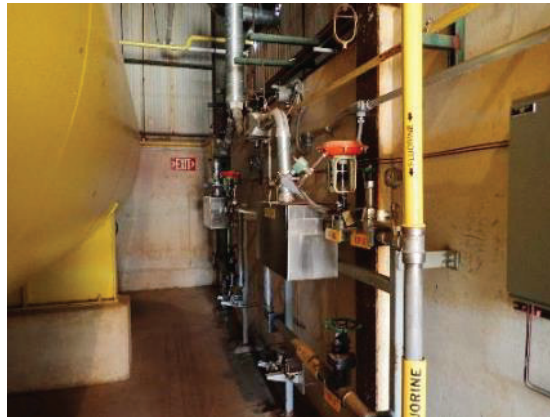
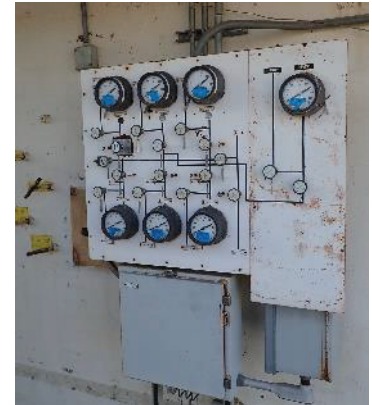
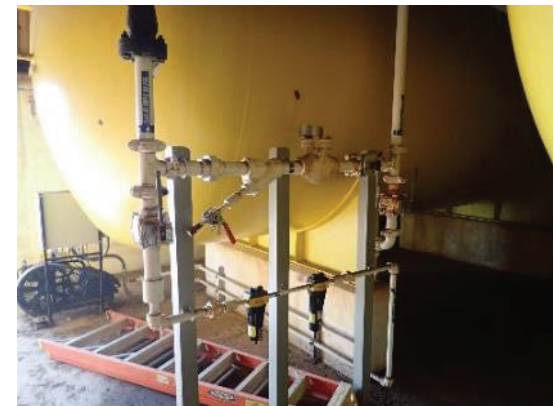
C-410-D Facility Photos: 10/2020

- C-410-D is no longer operational; the fluorine tanks, CAAS air tank, and system components have been evacuated, lines have been purged and air gapped.
- C-410-D currently supports CAAS horns.
- Walkdown inspection conducted in October 2020 confirmed no unusual conditions.
 - No floor sumps or floor drains.
 - Household type products were stored and used at the facility.
 - Small oil stain from a small historical air compressor leak.
 - Fluorine tanks and CAAS air tank evacuated, lines purged and air gapped.
 - Asbestos containing materials are present in the transite panels and roof.
 - Instrument panels present.
 - Due to the presence of fixed contamination on some of the piping, the entire facility is designated as a radioactive material area (RMA).
 - Historical atmospheric releases of fluorine gas have occurred.
