# C-635 Pumphouse and Cooling Tower (Solid Waste Management Unit 88)

Facility Overview Briefing

August 31, 2022

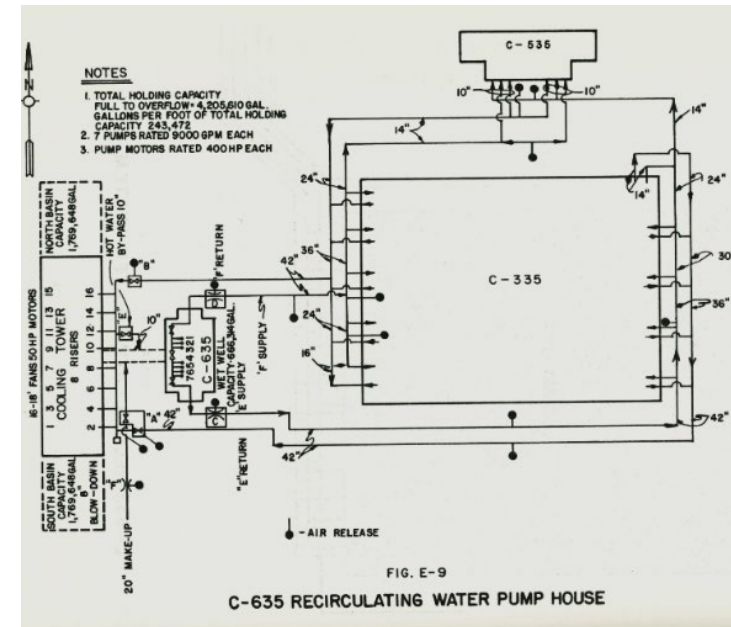
C-635 Cooling Tower Diagram: 7/1962

- ❑ Cooled water was pumped from the pump house through underground supply headers to the process building and into heat exchanger units where the water temperature rose as the water absorbed heat from the process equipment. Heated water was then returned through underground return mains (gravity feed) to the cooling towers where the heated water was distributed through various sections of the cooling tower and released via evaporation. The cooled water was then collected into the cooling tower basin where it then flowed by gravity via a flume into the wet well located underneath the pump house.

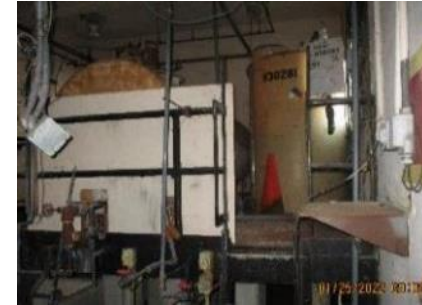
C-635-1 - West Wing  
Calgon Room  
(Corrosion Inhibitor  
Feed Area)

- Corrosion inhibitors were fed to help maintain piping and equipment integrity. (Note: For a brief period, prior to 1962, corrosion inhibitors also were dissolved in 500 gal stainless steel tanks; pumped into the plant water line at C-611, and introduced into the RCW system as make-up water.)

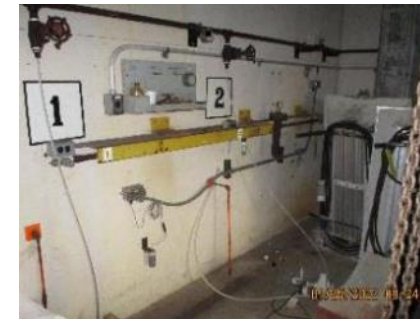
C-635-1 - West Wing  
Chlorine Feed Header

- ❑ Chlorine, sulfuric acid, and corrosion inhibitors were routinely fed into the RCW system via the wet well located beneath C-635-1.
    - Chlorine was fed to control the growth of algae and other microbiological organisms.

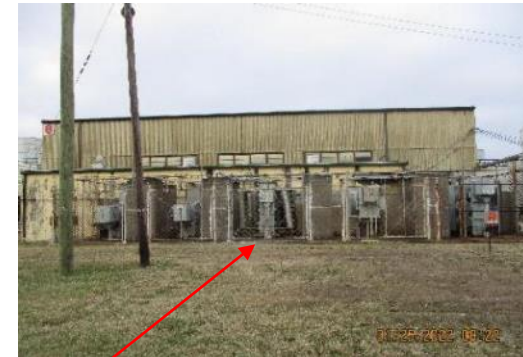
C-635-1 - East Wing  
External Transformers

- ❑ An internal fault in the transformer caused the main fluid tank to rupture releasing approximately 336 gals of non-polychlorinated biphenyl (non-PCB) oil to the ground and transformer pad and DMSA-OS-10 (SWMU 221).

- ❑ Contaminated soil and gravel at the spill site were removed and disposed.

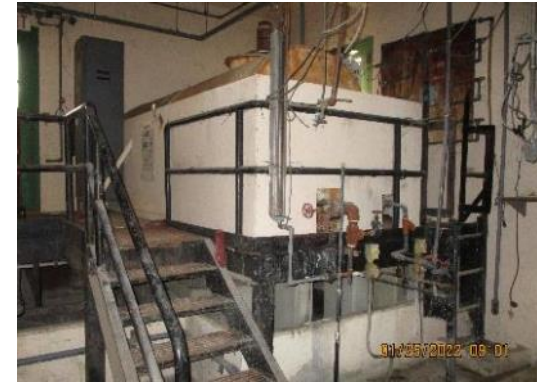
C-635-1 - West Wing  
Diked Area Beneath Corrosion Inhibitor Tanks

- Calgon room housed tanks of corrosion inhibitors; area within the dikes contained solid waste exceeding TCLP limits for chromium, mercury, and lead that have been removed.

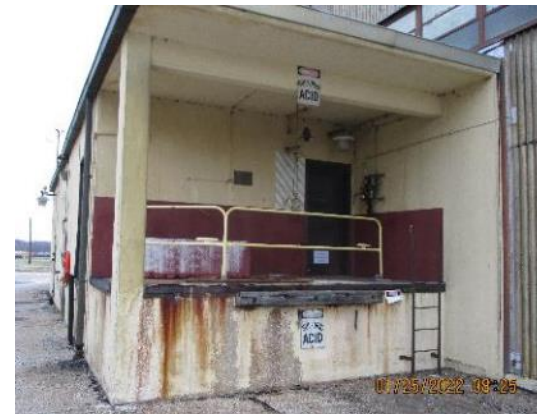
C-635-1 - West Wing  
Sulfuric Acid Pig and Tank Area

- In 2019, the 90-day accumulation area for the sulfuric acid pigs and tanks was closed.

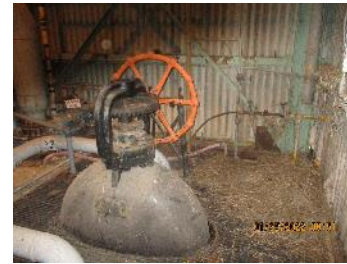
C-635-1 - Center Structure Sump (back corner)

- Minor oil staining around several of the RCW pumps.
- Chromated water leaks have occurred within the center structure of the facility.
- No known chemical spills except for the above noted chromated water leaks.

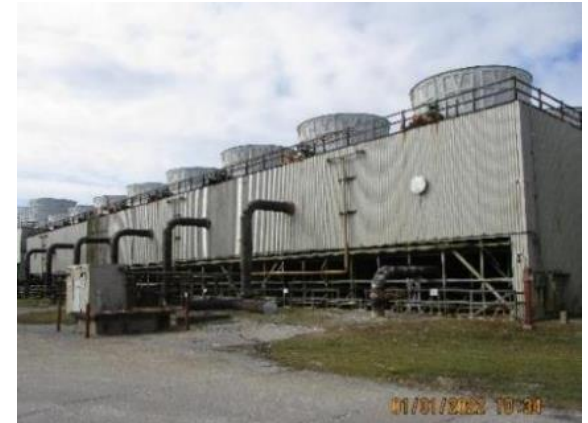
C-635-2 Cooling Tower – East Side

- Brown rot fungi growth quickly became a problem for the cooling towers.
  - ❑ In 1958, a program was initiated to combat fungus deterioration.
  - ❑ Replaced infected wood with new pressure treated redwood.
    - Cooling tower structural members, fill, mist eliminators, outer wall, cell partitions, and deck were originally constructed of California redwood.
  - ❑ Treated remaining wood with fungicide solutions (most susceptible areas only).
  - ❑ All cell plenum chambers, tower deck, outer sidewalls, and tower tops were treated periodically with one of two types of fungicide solutions:
    - Sodium pentachlorophenate.
    - Double diffusion method – first spraying with a solution of zinc sulphate and arsenic acid followed by a second spraying with a solution of sodium bichromate.
  - ❑ Fungicide treatment was discontinued in 1987.

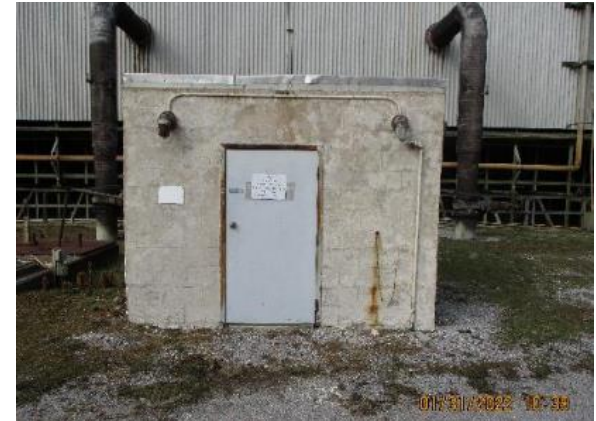
C-635-2 Sprinkler System - External View

- In 1981, RCW sprinkler alarms were installed.

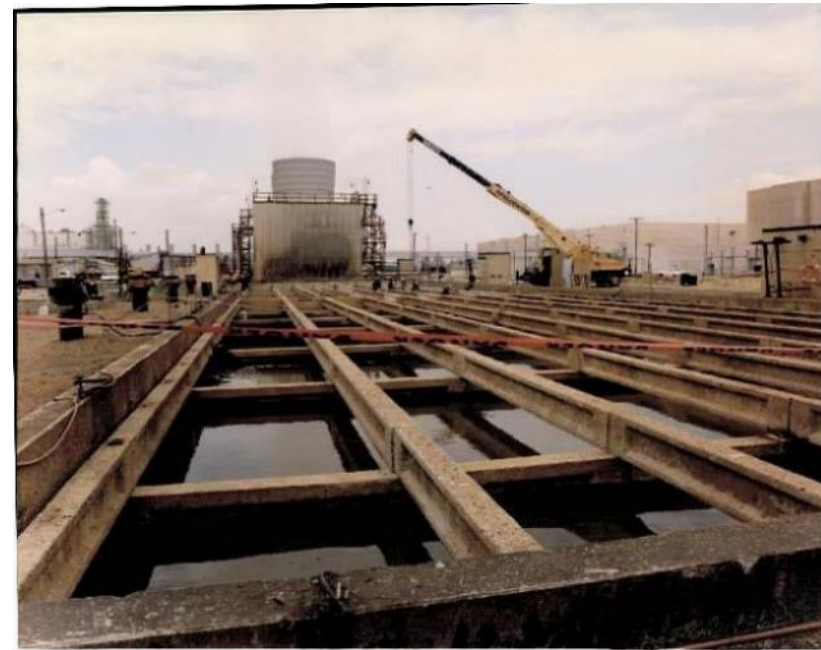
Historical photo of main cooling tower replacement project  
(Photo of C-631 Main Cooling Tower)

- In 1989-1990, the main cooling tower was replaced down to the basin.
  - ❑ A construction permit was not put in place for rebuilding of the C-635-2 cooling tower.
  - ❑ Due to potential chromium emissions, KY issued a notice of violation.
  - ❑ A permit was developed and issued; violation was withdrawn.
  - ❑ While the overall footprint of the cooling tower remained the same, the height of the new cooling tower was reduced from approximately 49 ft to approximately 30 ft.

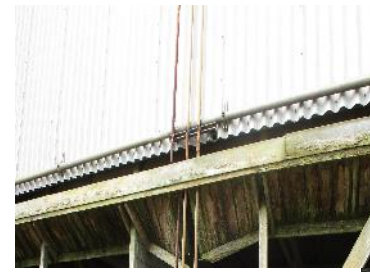
C-635-2 - Examples of Structural Damage

- ❑ Historical use of sodium pentachlorophenate; zinc sulphate; arsenic acid; and sodium bichromate for fungicide treatment of wood.
- ❑ Historical chromated water leaks have occurred and were immediately addressed.

- ❑ Deactivation will include removal of any accessible loose items being stored and certain equipment (e.g., risers, fans, fan motors, and shrouds, etc.) (to the extent practicable) prior to demolition.
