C-720-H Warehouse

Facility Overview Briefing

July 13, 2021

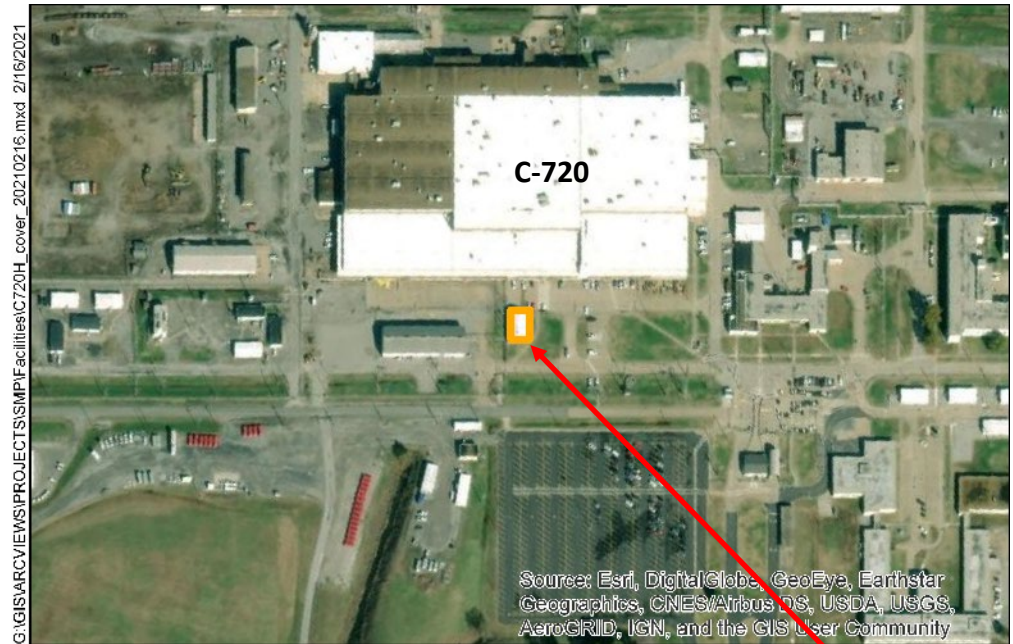
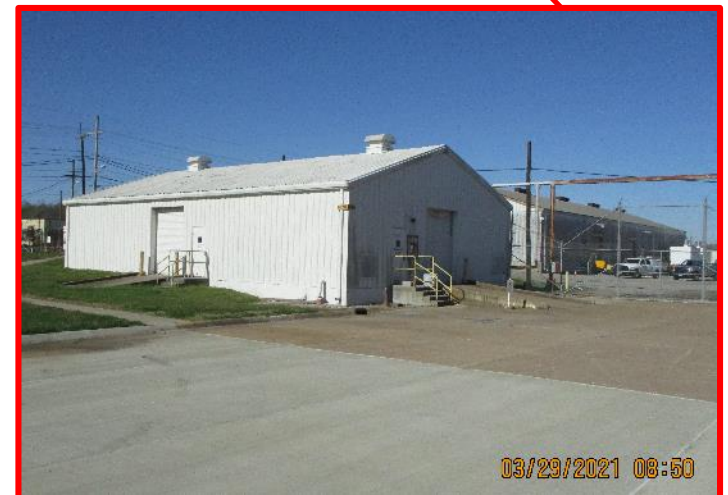
C-720-H Facility Photo: 3/2021

- C-720-H is located within the Paducah Site security fence, south of the C-720 Machine Shop and Stores Building.
- Constructed in 1978.
- Construction consists of a prefabricated metal building on a poured-concrete slab (6-inch thick).
- The facility is approximately 2,560 ft².
 - ❑ Measuring ~ 40 ft x ~ 64 ft.

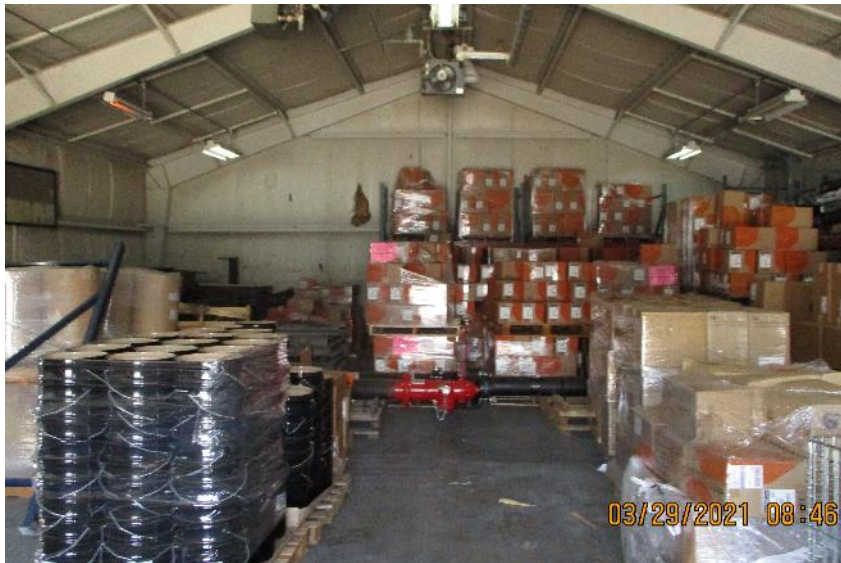
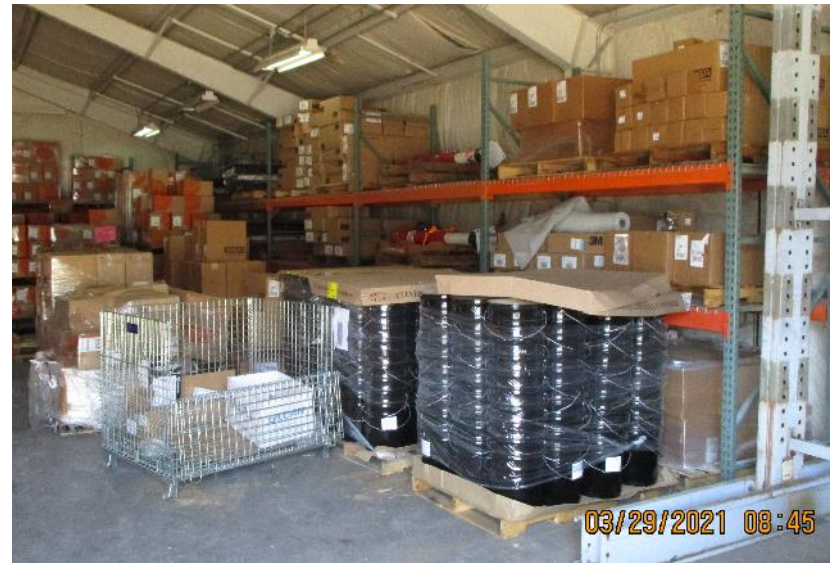
Warehoused Supplies

- C-720-H currently contains a variety of material being warehoused for Plant Stores (primarily overstocked items).
- No chemicals are stored in C-720-H.

- ❑ Deactivation will include removal of any accessible loose items being stored (to the extent practicable) prior to demolition.
 - ❑ Any floor drains will be delineated, documented, and isolated prior to demolition.

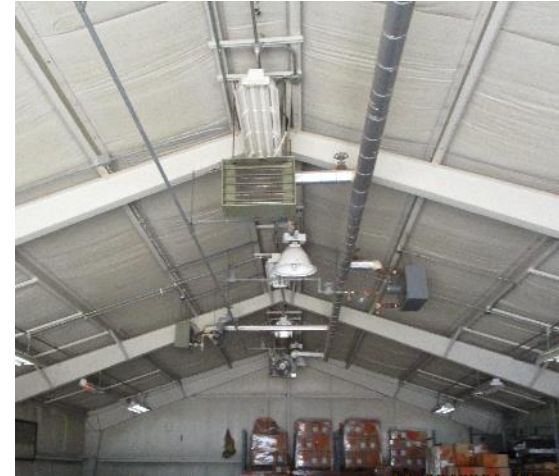
Ceiling View
Showing
Heaters/
Lighting

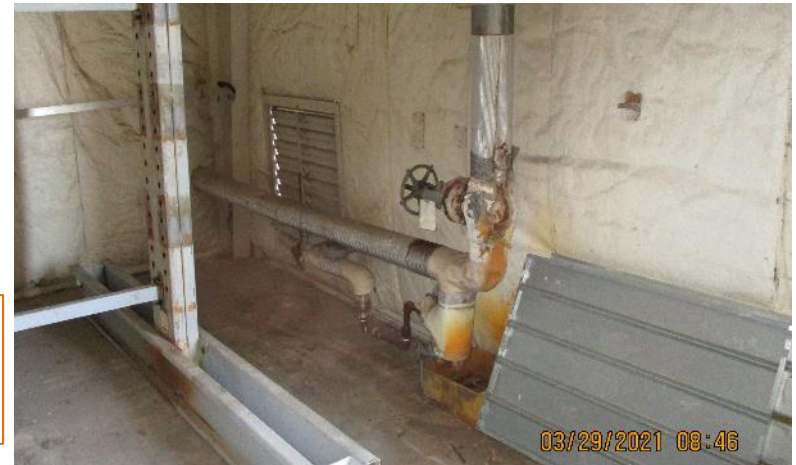
Steam and
Condensate Piping in
Northwest Corner of
C-720-H
