C-721 Gas Manifold Storage Building

Facility Overview Briefing

March 4, 2021

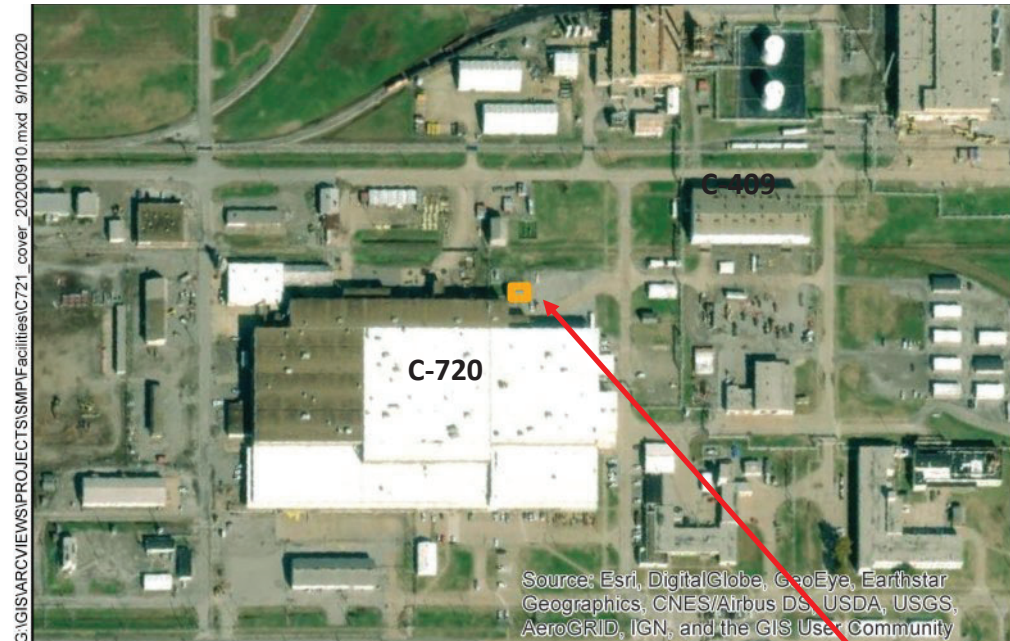
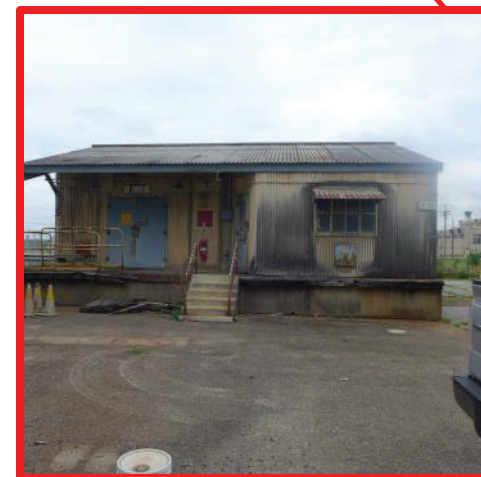
C-721 Facility Photo: 8/2020

- C-721 is located within the Paducah Site security fence on the north side of the C-720 Building.
- Construction was initiated in 1952 and completed in 1953.
- Originally constructed as an open structural steel frame on an elevated concrete pad. See Engineering drawings in backup section:
 - E16-1-A
 - E16-1-M, Rev 3
 - E16-1-S, Rev 5
- The facility is approximately 962 ft².
 - Measuring ~ 26 ft x 37 ft

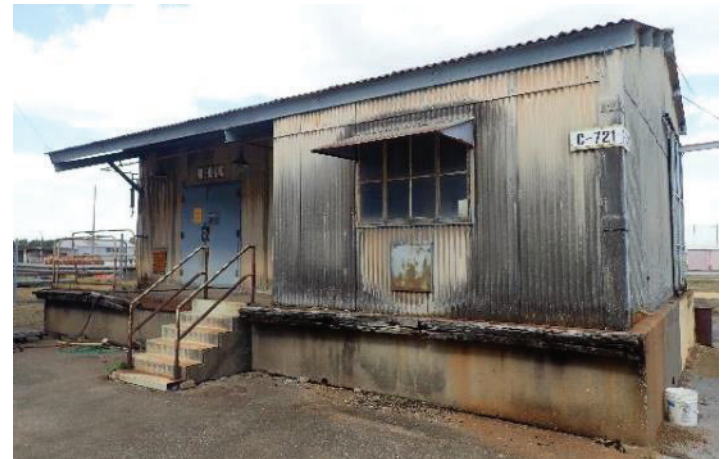
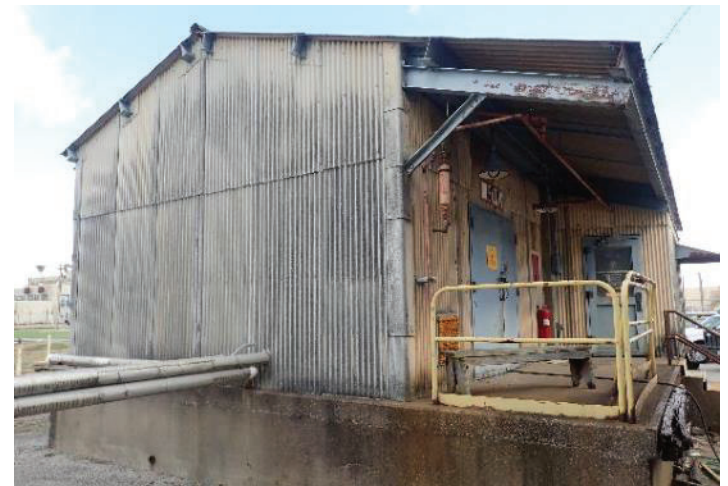
C-721 Facility Photos: 8/2020

- The building was originally constructed in 1953 as a gas manifold facility. Oxygen gas and pyrofax (propane) gas were distributed via hard-piping from the C-721 building to the C-720 building.
- In 1954, the facility underwent modification and was subsequently converted to support calibration of radiological instruments.
- Radiological calibration involved the use of the steel well containing the cobalt source and other sealed sources that were stored within the building.

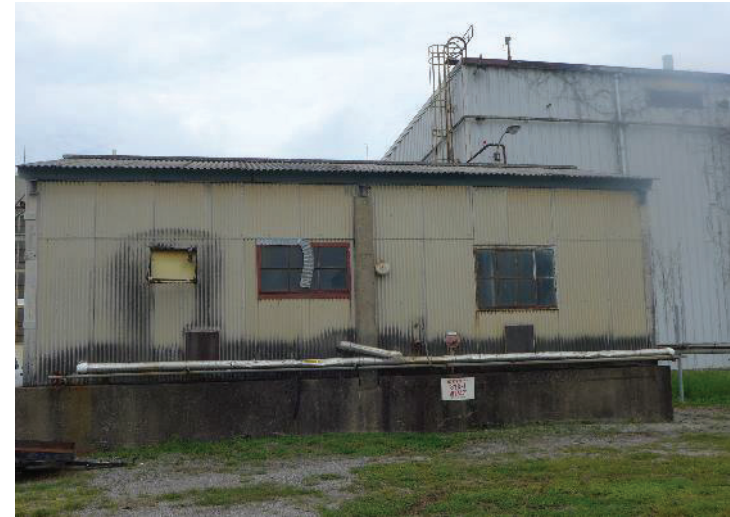
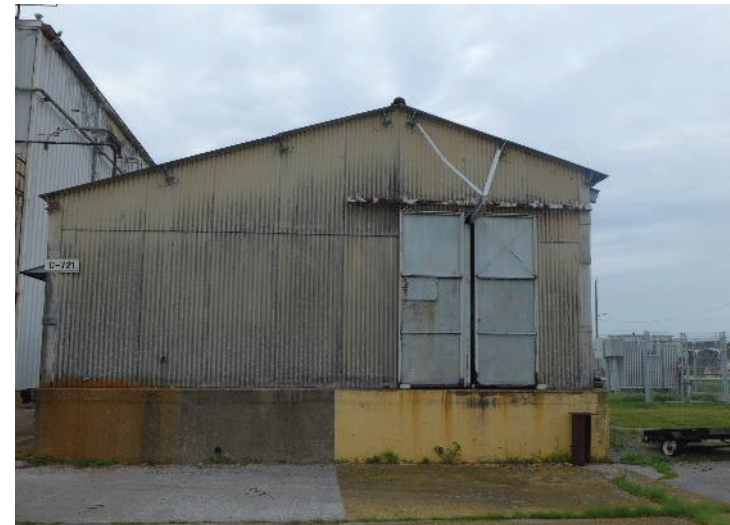
C-721 Facility Photos: 8/2020

- The facilities ceased being used for radiological calibration in the 1980s, but it continued to be used for material storage for the following organizations.
 - Fire Services
 - Health Physics
 - Stores
 - Environmental Services
- Leased by USEC from the early 1990s until USEC ceased operation in 2014.
- After transition from USEC back to DOE in 2014, the building continued to be used by DOE contractors for storage of materials by Fire Services and Health Physics.

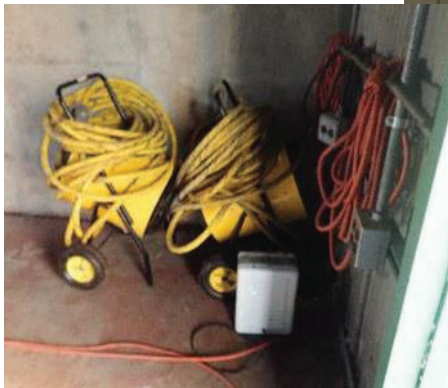
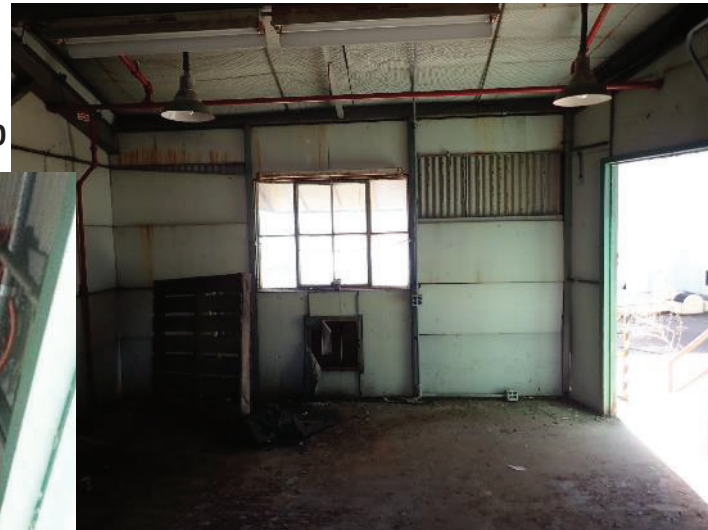
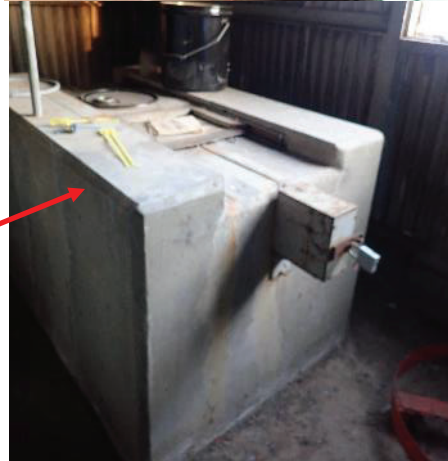
- Walkdown inspection conducted in October 2020 confirmed the presence of the following:
 - The access structure to the steel cobalt well.
 - Various other miscellaneous items still present (e.g., air monitors, file cabinet).

Portable Heaters: – 10/2020

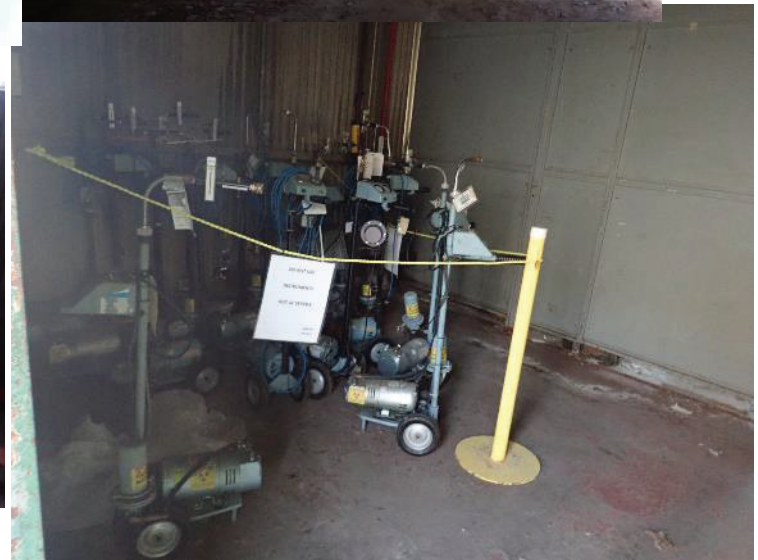
Air monitoring equipment designated as an RMA: Photo – 10/2020

- Deactivation will include removal of any accessible loose items being stored and designated as RMAs (to the extent practicable) prior to demolition.

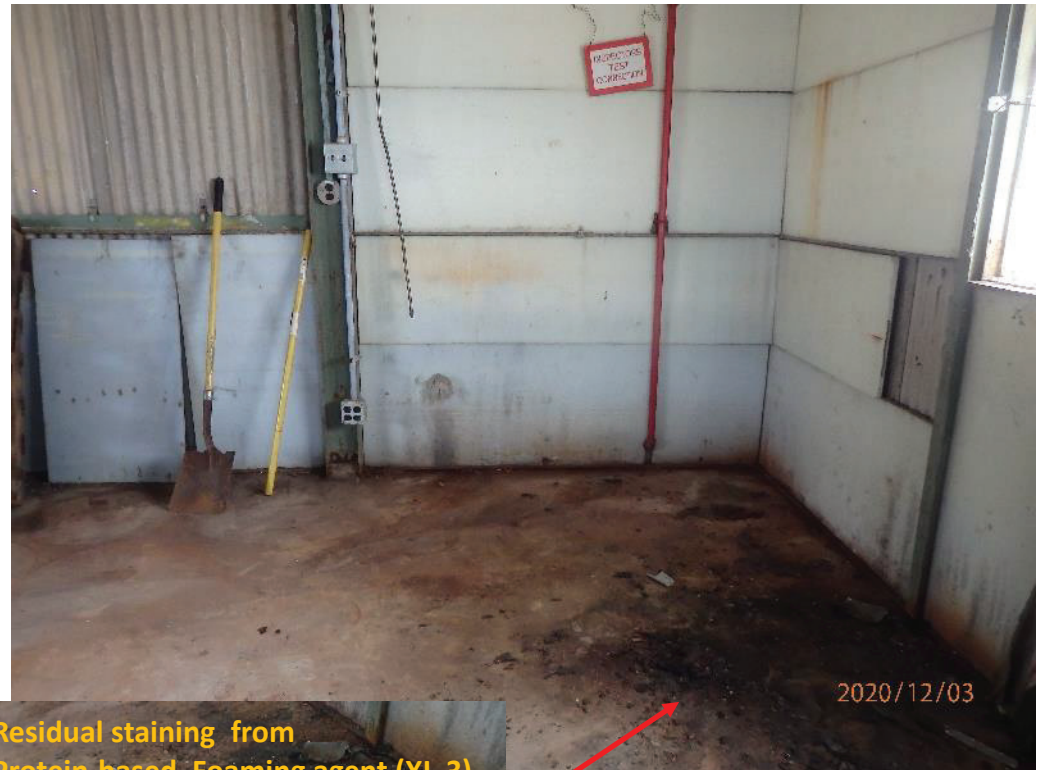
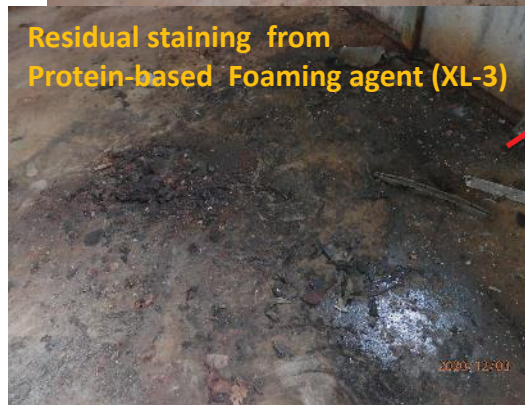
- Items previously stored at C-721:
 - Gases (e.g., oxygen, propane).
 - Fire retardant foaming agents.
 - Oils/greases.
 - Radioactive Material Areas.
- Evidence of past spills and leaks:
 - Leaking valve on stored propane tanks.
 - Leaking container of fire foaming agent (see chemical storage index in backup).
 - AFFF agent.
 - Protein/XL-3 agent.
 - Visible staining on floor.
 - Fire extinguisher dry powder agent on floor (Amerex ABC).
- Building materials used for construction could contain lead-based paints and asbestos materials, both of which can be effectively verified during a pre-demolition inspection and properly managed using standard demolition/waste management practices.

Residual staining from Protein-based Foaming agent (XL-3)

- Contained to inside floor and will be further evaluated during the proposed SE for the soils and slab. See MSDS in backup.

- Based on the documented historical spills and leaks (e.g., fire retardant foaming agent), it is recommended the underlying slab and soils undergo further CERCLA evaluation of as part of a future site evaluation (SE) conducted under Appendix 4 of the SMP.

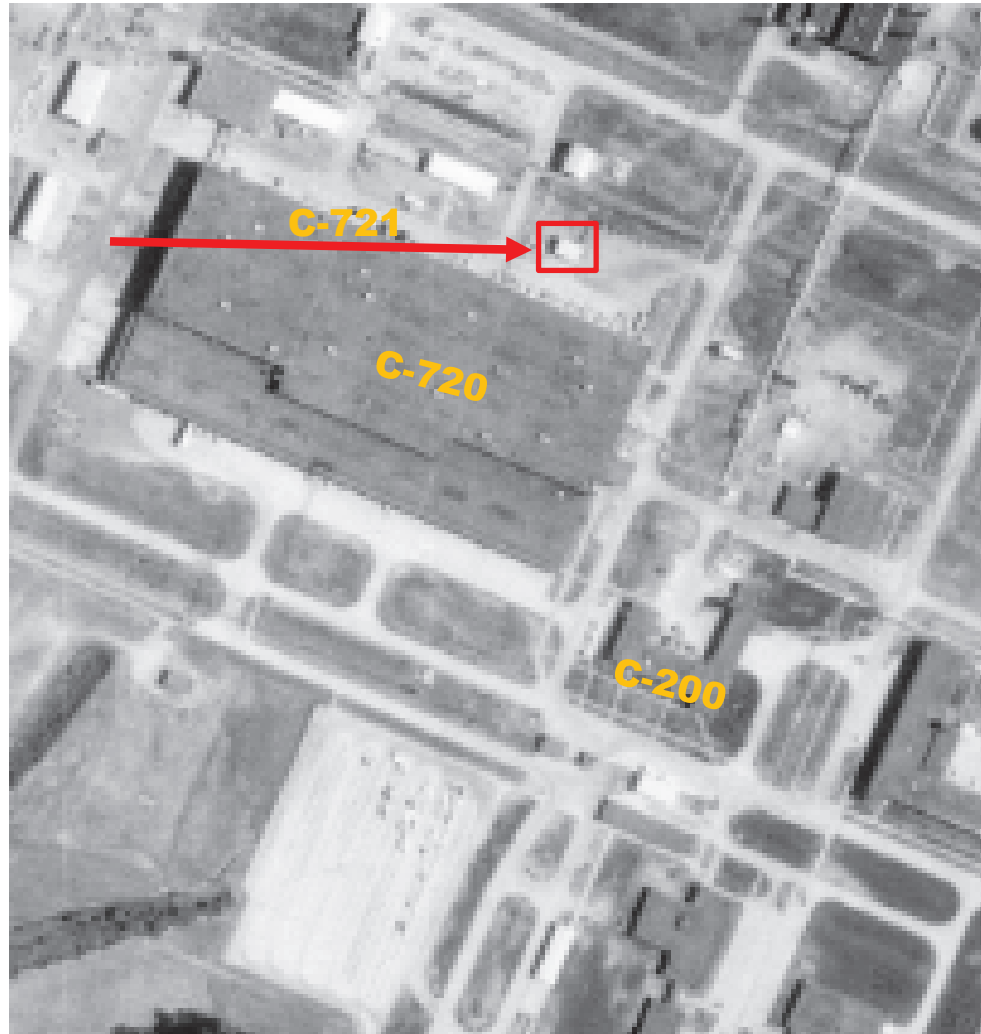
C-721 Gas Manifold Storage Building (Aerial Photograph)

Modified from Aerial Photo: July 3, 1971 (ADZ-4LL-53)
