# C-730 Maintenance Service Building

## Facility Overview Briefing

July 16, 2021

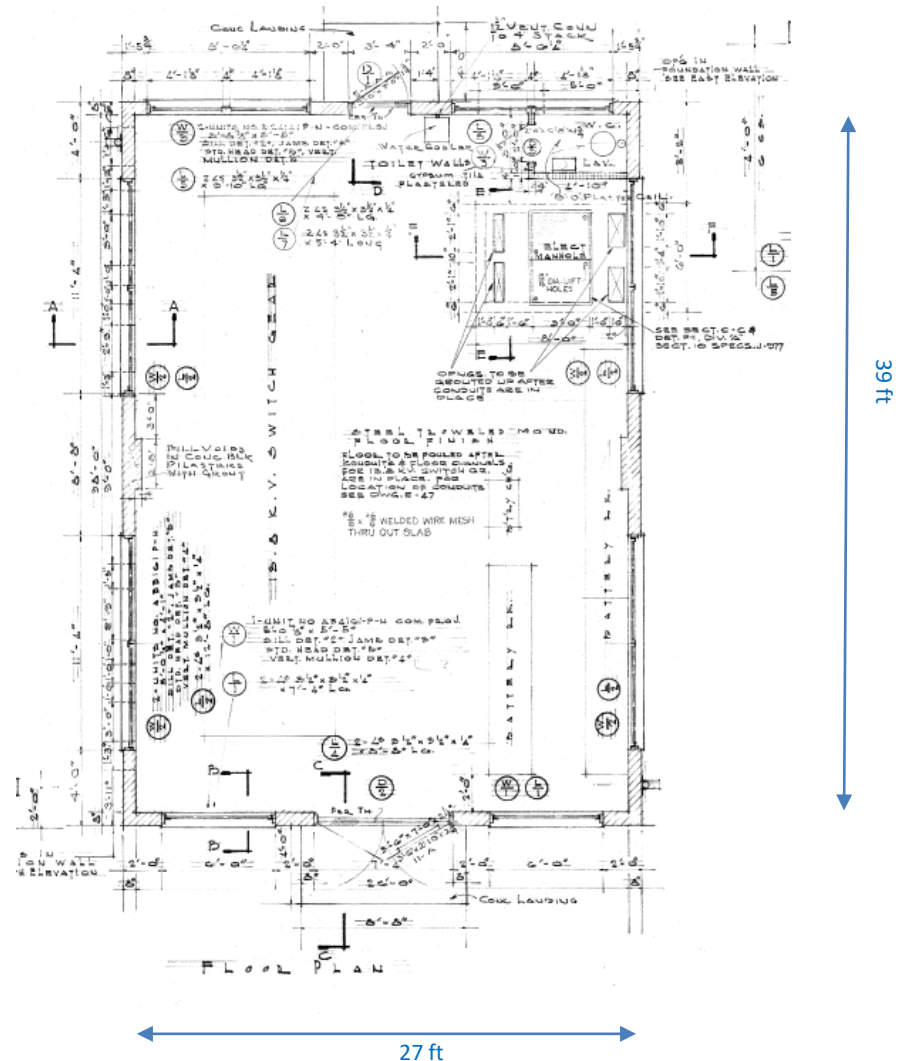
Floor Plan View: Excerpt from Engineering Drawing B-50\_0001\_000C\_U-020454, dated 1951

- C-730 is located outside the Paducah Site security fence, south of the C-720 Maintenance and Stores Building.
- The facility was constructed in the early 1950s and has undergone various modifications since its original construction.
- The facility is constructed of unit masonry on a 6-inch concrete slab.
  - ❑ Electrical manhole measuring ~8 ft x ~5 ft x ~3 ft includes a sump that drains to the sanitary sewer system.
  - ❑ Restroom and laboratory sink drain to sanitary sewer system.
- The facility is approximately 1,053 ft<sup>2</sup>.
  - ❑ Measuring ~27 ft x ~39 ft.

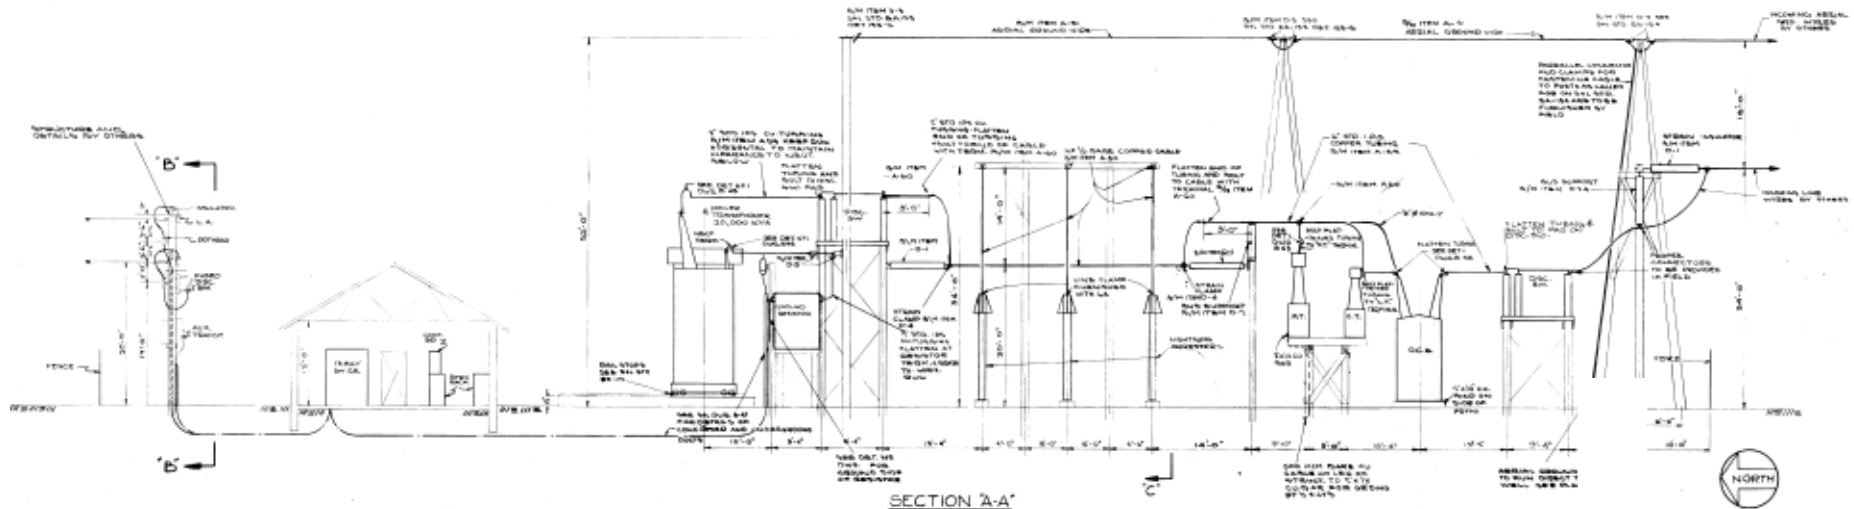
Excerpt from Engineering Drawing E-46\_0001\_000A\_U-022119, dated 1951

- C-730 was originally constructed as a switch house that supported a substation used for plant construction in the early 1950s.
  - ❑ The facility, measuring ~27 ft x ~39 ft, contained the following.
    - 13.8 K.V. switchgear
    - Battery racks (with batteries), battery charger
    - Water cooler
    - Electrical manhole
    - Restroom facility
  - ❑ The C-730 facility and substation was located within a fenced-in area measuring ~124 ft x ~227 ft.
  - ❑ At some point (year unknown – estimated to be late 1950s/early 1960s), the interior components of the switch house were dismantled and removed and the only interior components associated with the original construction of C-730 that remained were the electrical manhole and restroom facility (NOTE: The substation and fence were also removed).

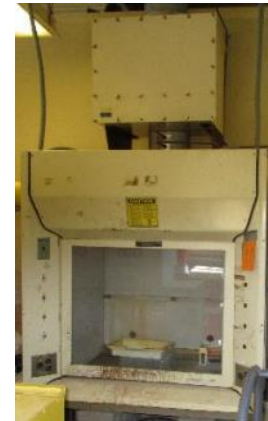
Laboratory Fume Hood

- Fume hood was installed.
  - Laboratory sink was installed.
  - Bench top instruments were installed.
  - Analyzed transformer and lube oils (acidity, interfacial tension, water content and gas analysis) and water (total organic halides analysis).

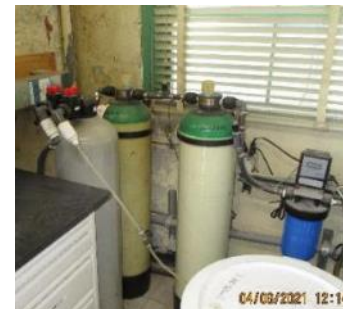
- In early 1990, the interior of C-730 was converted to support the Phase II Groundwater Investigation and routine groundwater sampling activities.
  - ❑ Deionized water system was installed.

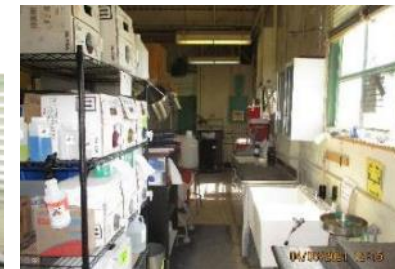
Sampling Area with Laboratory Sink

- ❑ Electrical manhole that includes a sump is present.
  - ❑ Drains associated with restroom, electrical manhole sump, laboratory sink, and ice machine drain to the sanitary sewer system.

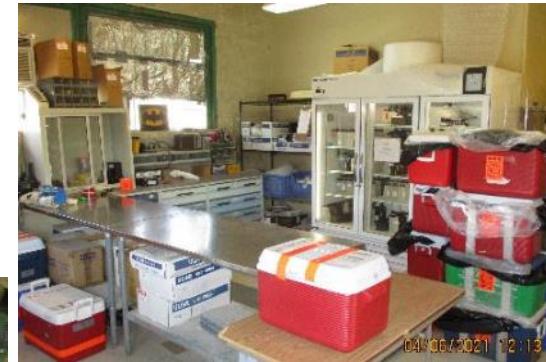
Sampling Staging Area

- C-730 has undergone multiple modifications since its construction in the early 1950s; however, it currently operates as a staging area for sampling activities associated with the Environmental Monitoring Program.

- Walkdown inspection conducted in April 2021 and employee interviews confirmed no unusual conditions.
  - ❑ Contains various types of chemicals used to support sampling activities (e.g., pH buffer solution, sodium thiosulfate, sodium hydroxide, nitric acid, sulfuric acid, hydrochloric acid, etc.)

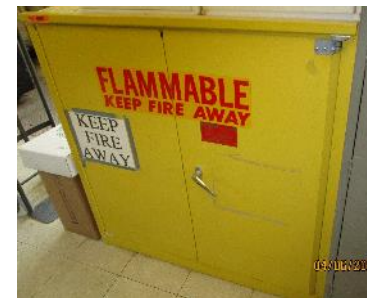
- ❑ Flammable cabinet containing aerosol sprays (e.g., wasp spray, hornet spray, spray paint, WD-40, etc.)
  - ❑ No known chemical spills.

Flammable Cabinet -  
Contains wasp spray,  
hornet spray and other  
types of aerosol sprays

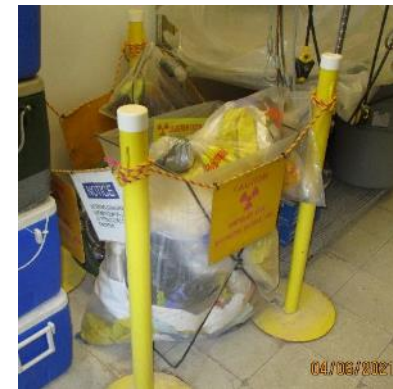
RMA – Used  
Sampling PPE

- ❑ No generator staging area (GSA) or satellite accumulation area (SAA).
  - ❑ Not used for radiological storage; however, facility does contain a radioactive material area for used sampling PPE.

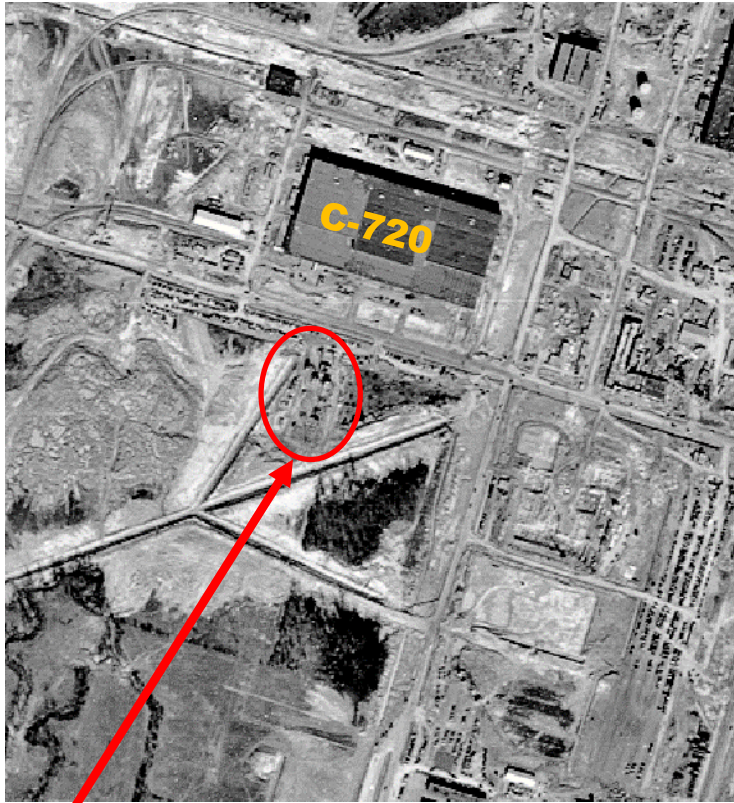
Modified from Aerial Photo: February 21, 1952 (52PGDP65)

**C-730 Building and Switchyard Substation Area**

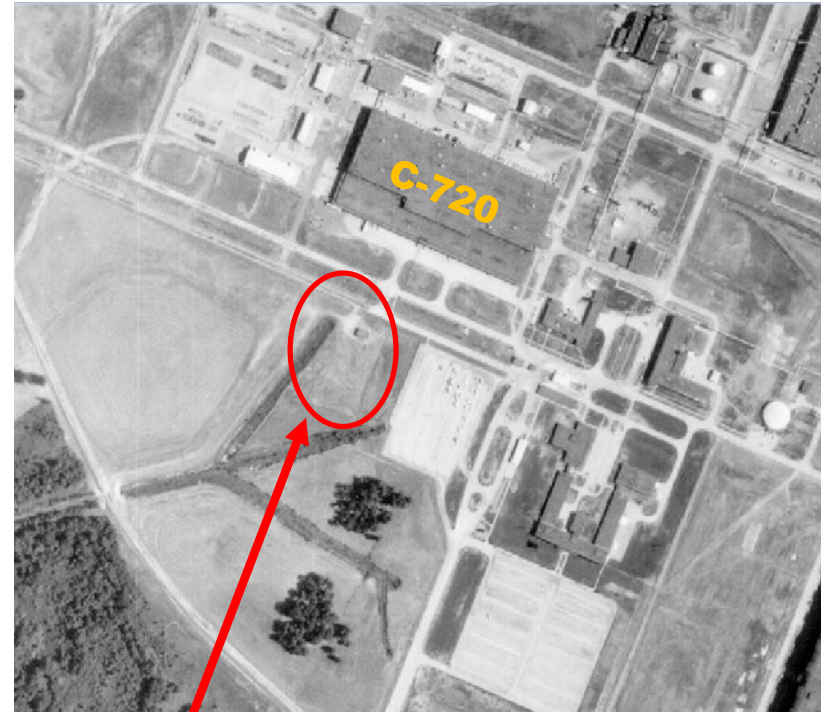
Modified from Aerial Photo: July 3, 1971 (71PGD053)

**C-730 Building and Empty Switchyard Substation Area**
