C-731 Railroad Repair Equipment Storage Building

Facility Overview Briefing

March 4, 2021

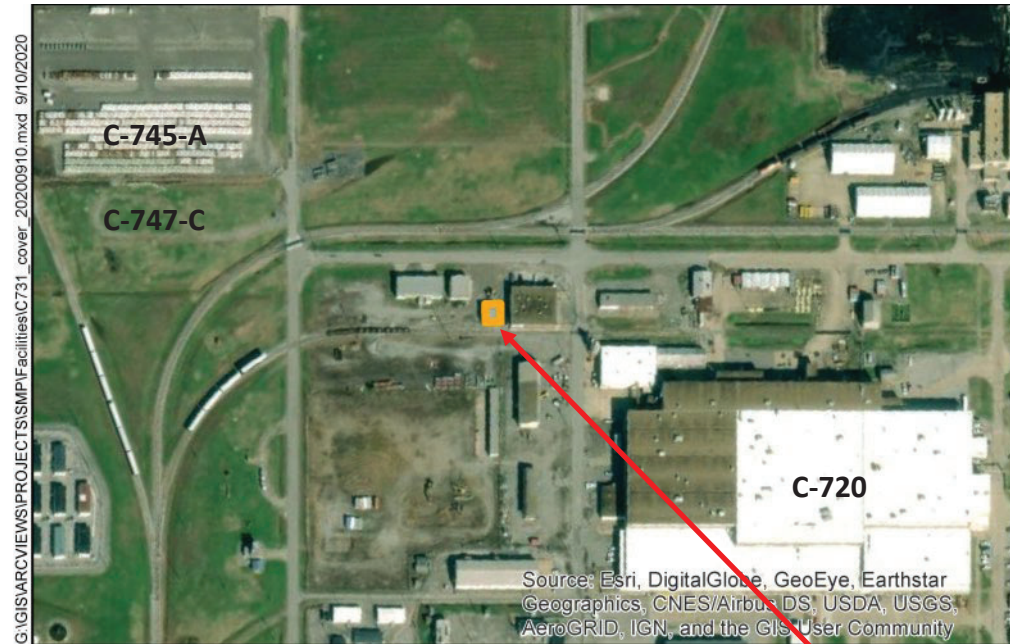
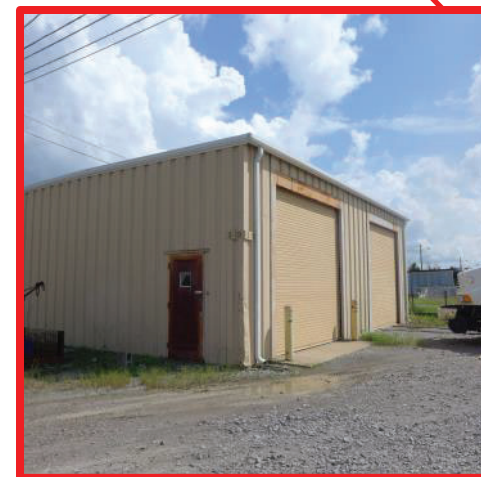
C-731 Facility Photo: 8/2020

- Located within the Paducah Site security fence to the northwest of the C-720 facility along Rail Track No. 4 (see Slide 4).
- The C-731 facility was constructed in 1981.
- The C-731 facility is a prefabricated metal building.
- The facility is approximately 1,280 ft².
 - Measuring ~ 32 ft x 40 ft

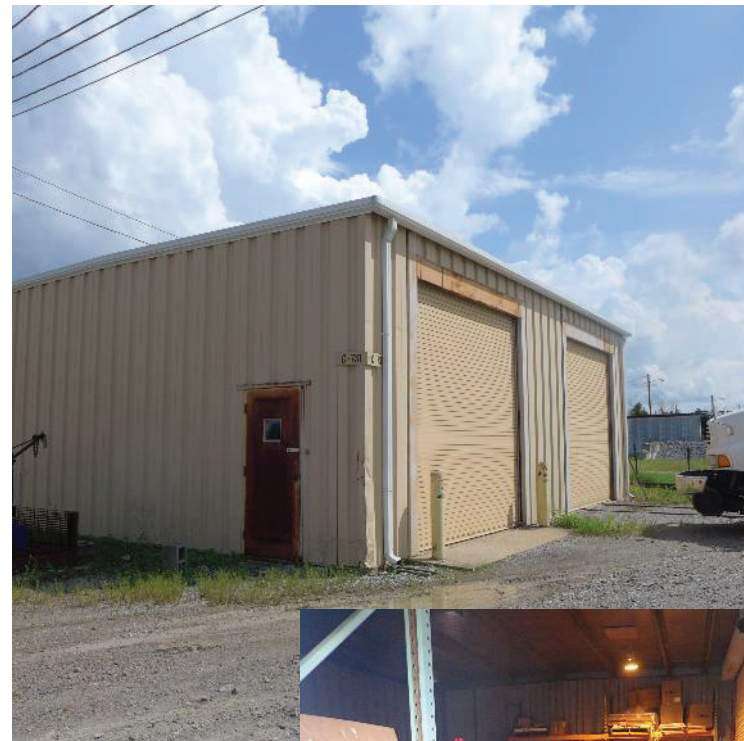
C-731 Facility Photos:
10/2020

- The C-731 facility continues to operate, but is no longer used for storage of railroad repair equipment.
- Upon transition of the facility from USEC to DOE in 2014, the responsible DOE contractors began utilizing the facility for storage of replacement parts for the following:
 - Repair of the sanitary water system.
 - Repair of the fire water system.
- The facility has no known history of storing any chemicals or waste.

- Walkdown inspection of the facility, employee interviews, and other reviewed historical information did not identify any unusual conditions that would pose a potential threat of environmental release during future demolition of the aboveground structure.
