C-746-A North Warehouse

Facility Overview Briefing
Presented August 17, 2020
Updated May 20, 2021

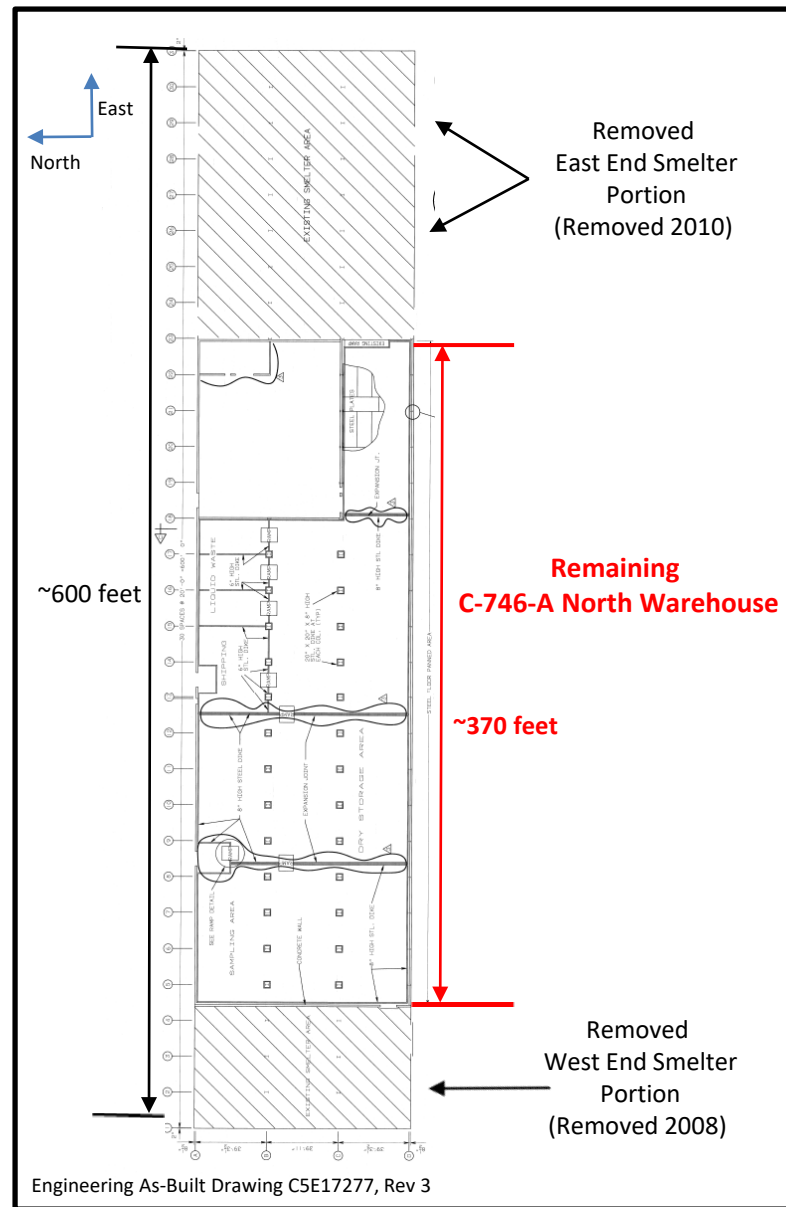
- Constructed in the early 1950s:
 - Engineering Design Drawings
 - Plant Documents
 - Interviews
- Single-floor, prefabricated steel building with a poured 8-inch concrete slab; originally consisted of 3 segments:
 - East End (EE) Smelter
 - C-746-A North Warehouse
 - West End (WE) Smelter
- Overall building size at original construction measured ~600 x 120 feet, but the EE and WE Smelters have been removed leaving the C-746-A North Warehouse, measuring ~370 feet x ~120 feet.

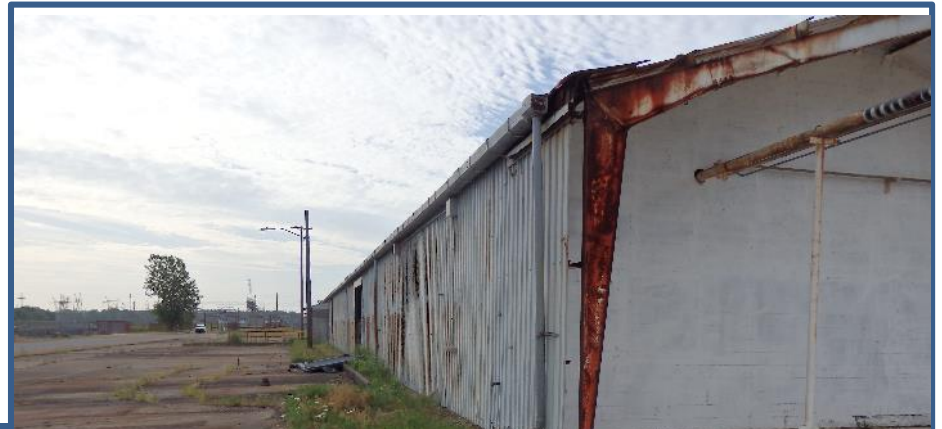
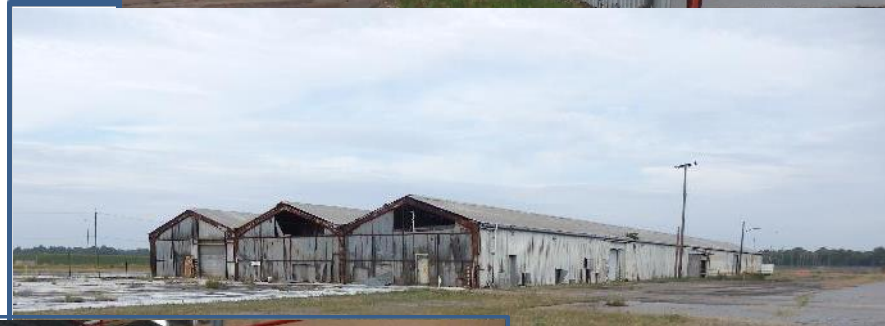
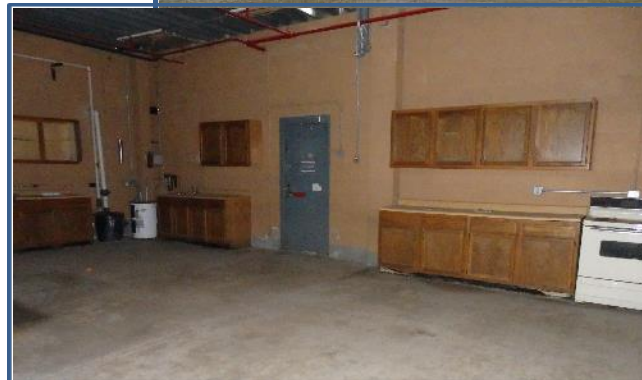
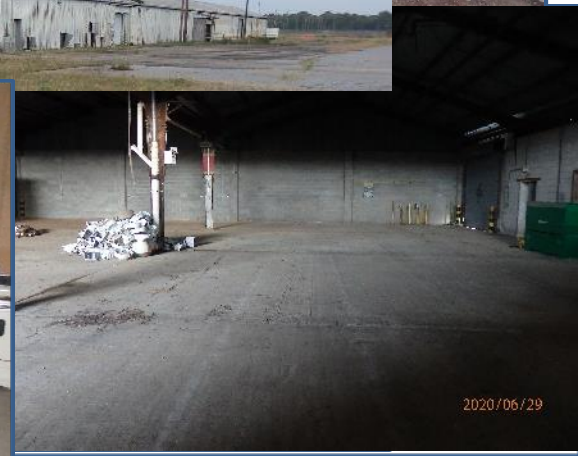
- Ceased RCRA waste operations in 2010.
- Deactivation and RCRA clean closure completed in 2011.
- Limited non-RCRA infrastructure items remaining (e.g., light fixtures, electrical component housing and wiring, empty cabinets, portable heaters/fans).
- Listed in Appendix 6 of the SMP pending further CERCLA determination.

Removed light fixtures

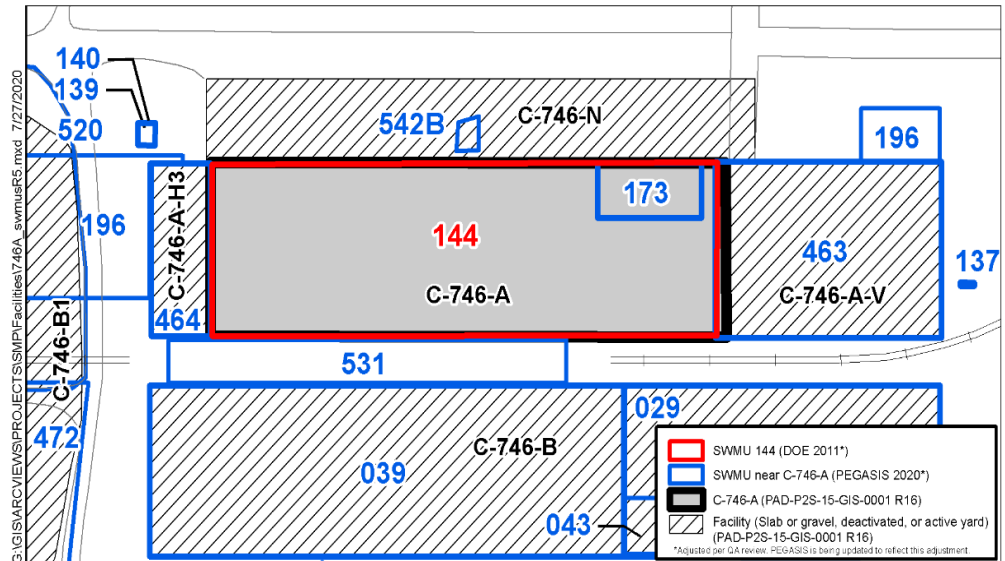
SWMUs – Adjacent to C-746-A	
SWMU No.	Facility Name
144	C-746-A Hazardous & Mixed Waste Storage Facility
173	C-746-A Trash Sorting Facility
196	C-746-A Septic System
463	C-746-A East End Smelter
464	C-746-A West End Smelter
531	Aluminum Slag Reacting Area (C-746-H4) near the C-746-A Facility
542b	G-746-A-01, S-746-A-01, S-746-A-02 (GSA/SSAs located outside C-746-B)

- The C-746-A North Warehouse was designated as SWMU 144 based on converting it to a RCRA treatment and storage facility.

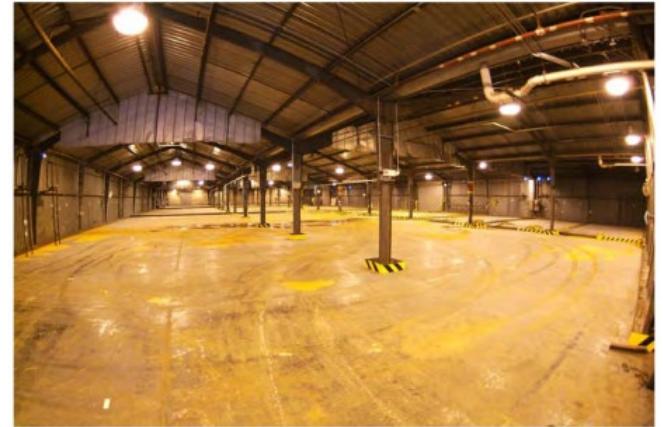
SWMU 144 - Metal pan area facing east
C-746-A Hazardous and Mixed Waste Storage Facility
February 14, 2011

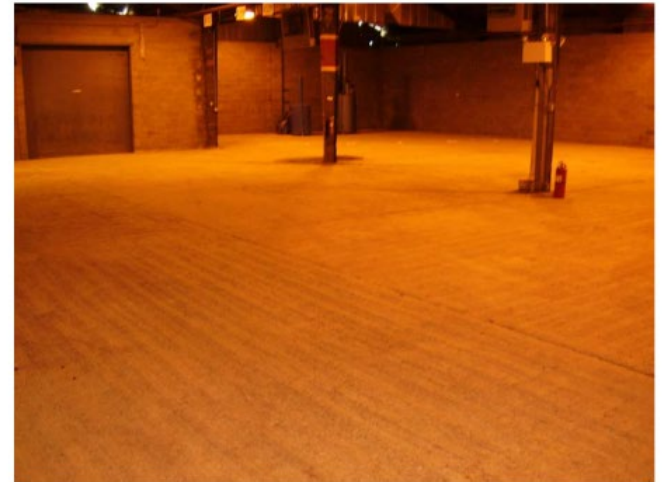
SWMU 144 - Concrete area facing southeast
C-746-A Hazardous and Mixed Waste Storage Facility
June 3, 2011
