KY/B-262
Addendum 1
Volume 1
Revision 1

PADUCAH GASEOUS DIFFUSION PLANT

PRELIMINARY ASSESSMENT

PADUCAH GASEOUS DIFFUSION PLANT
SOLID WASTE MANAGEMENT UNITS

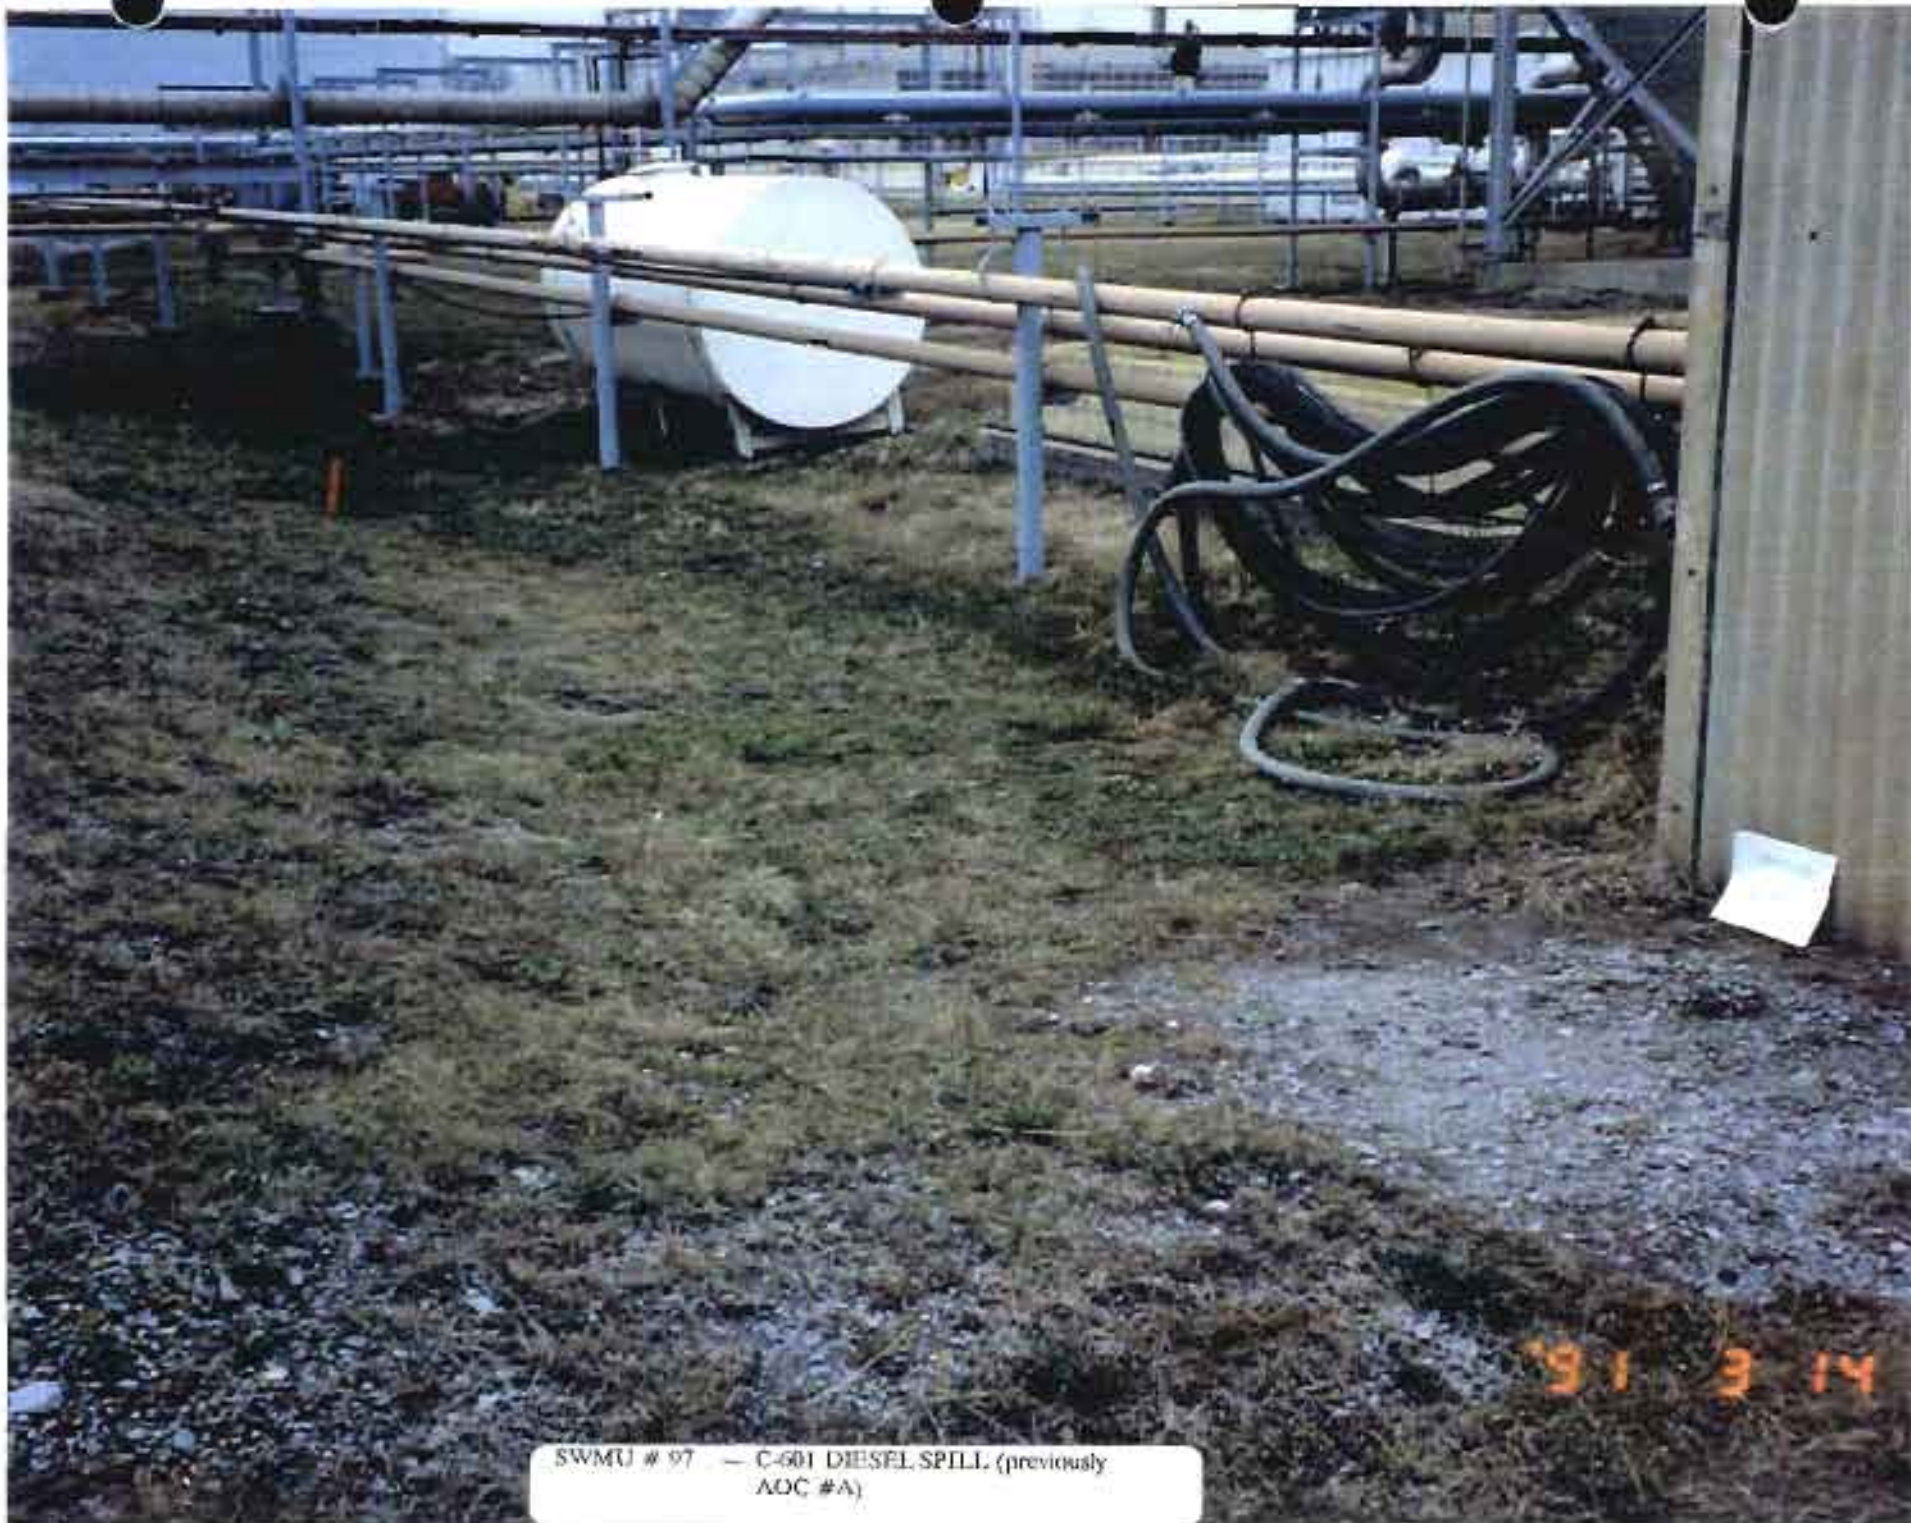
SWMU # 97 — C-601 DIESEL SPILL (previously AOC #A)

WASTE DESCRIPTION: Diesel fuel constituents were observed in soils during the Phase II investigation

This unit underwent a prioritized RFI under the CERCLA ACO. It was determined that it was not a source of Off-site contamination. However, Polycyclic Aromatic hydrocarbons were detected at up to 8 parts per million from the Phase II Site Investigation under an Administrative Consent Order. PCB was detected in a sample at less than one part per million. See the Phase II Investigation Report for additional details. This unit will be further addressed with WAG 9 in accordance with the RFI schedule outlined in the HSWA Permit.

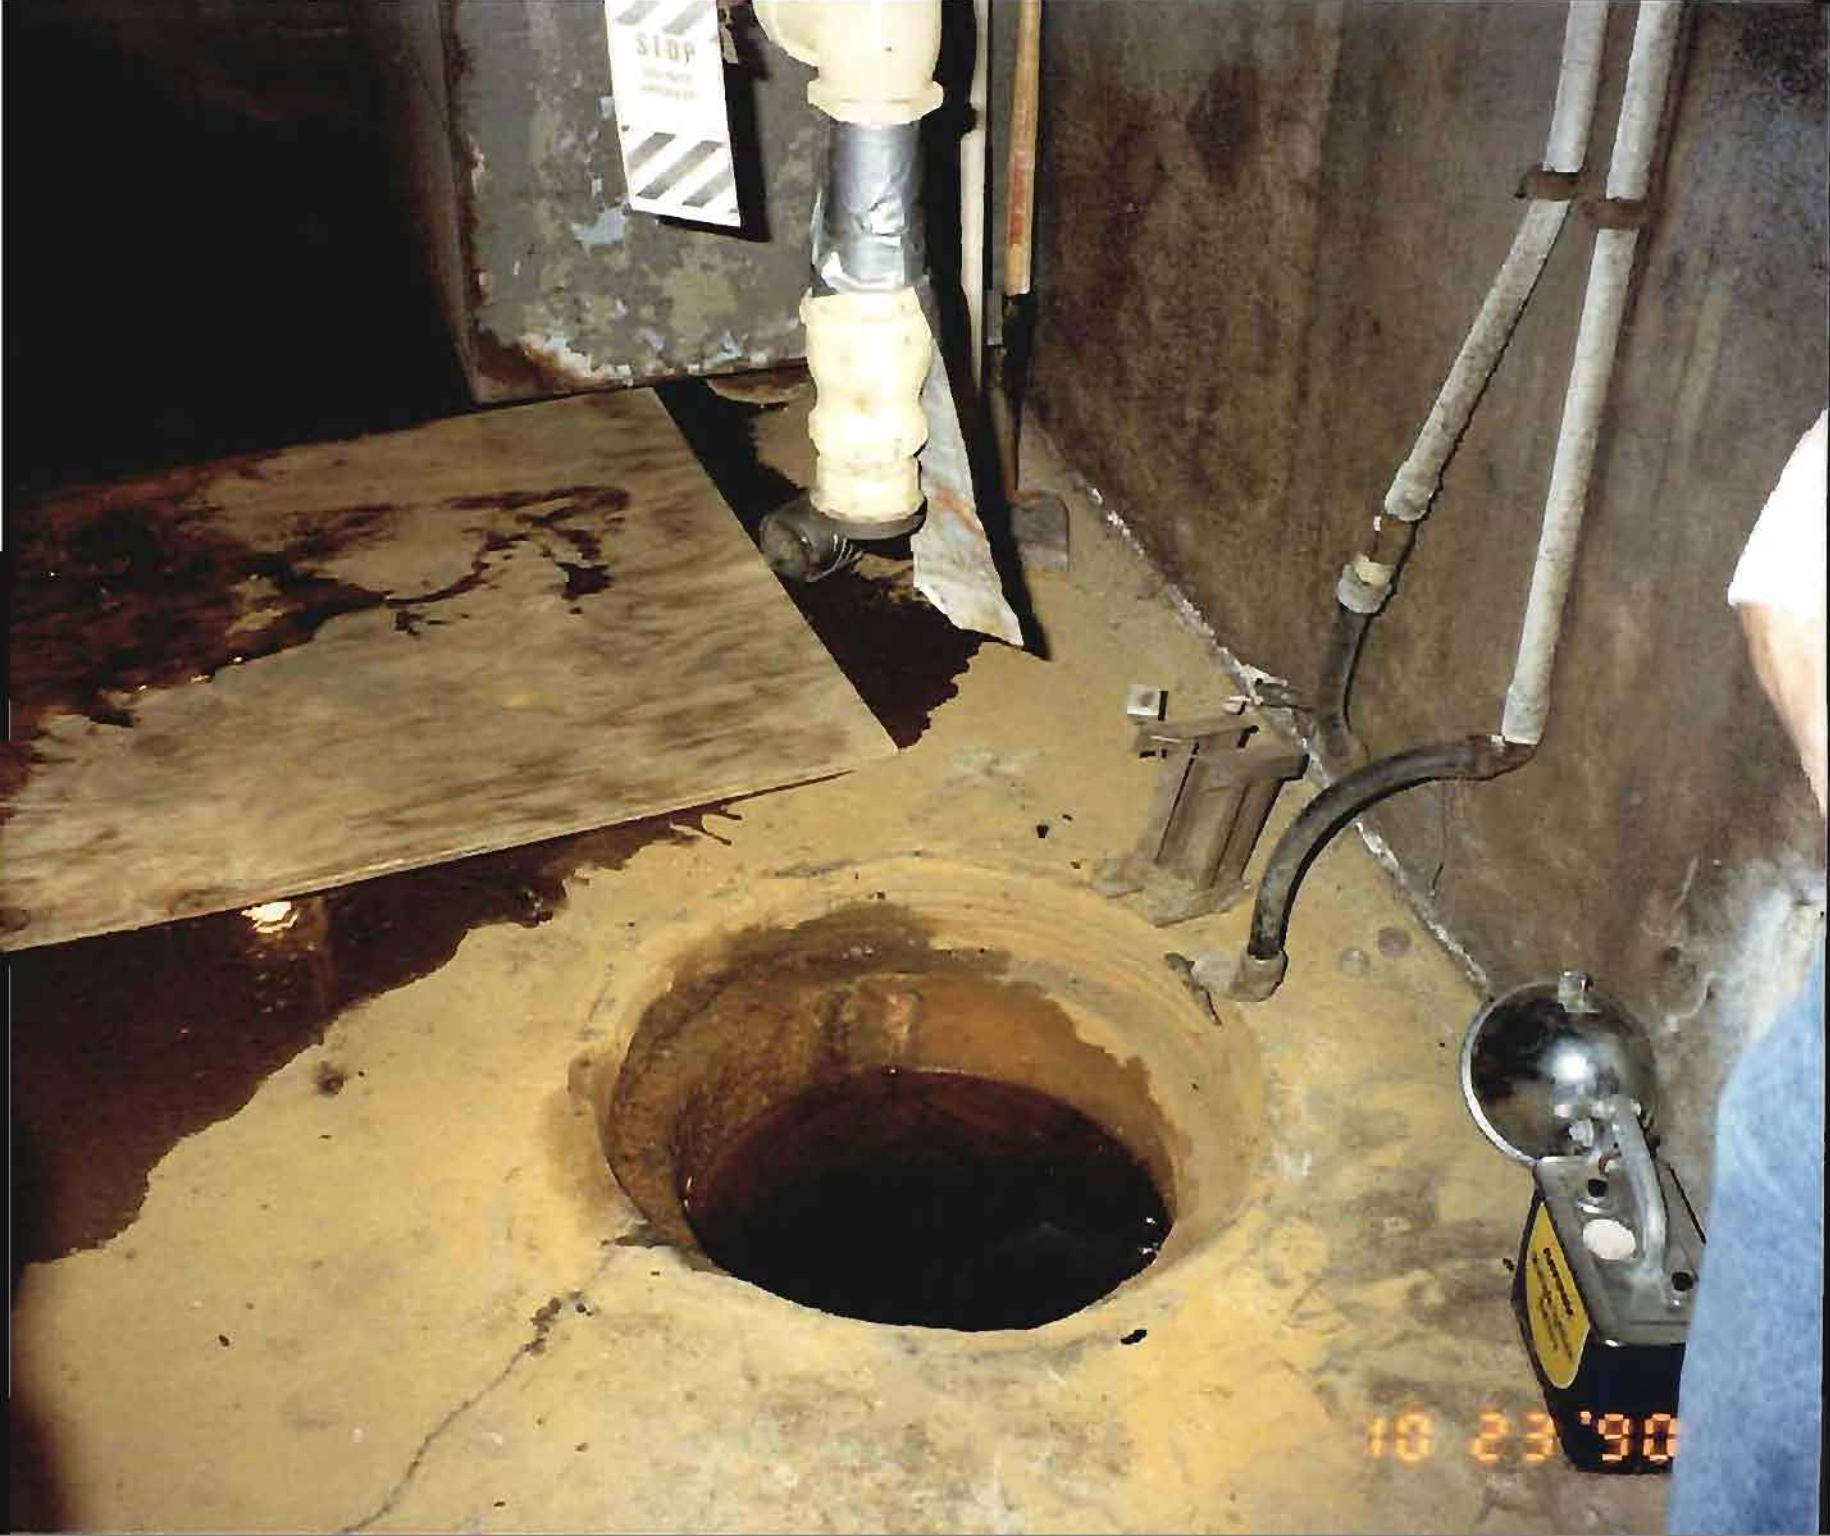
DESCRIPTION OF RELEASE: TCE may have leaked from the sump area prior to being routed to the storm sewer. Refer to Phase II report for additional details.

This unit underwent a prioritized RFI under the CERCLA ACO. The C-400 area has been identified as a significant contributor to the offsite contamination. Releases from the area will be addressed under the ACO ROD.

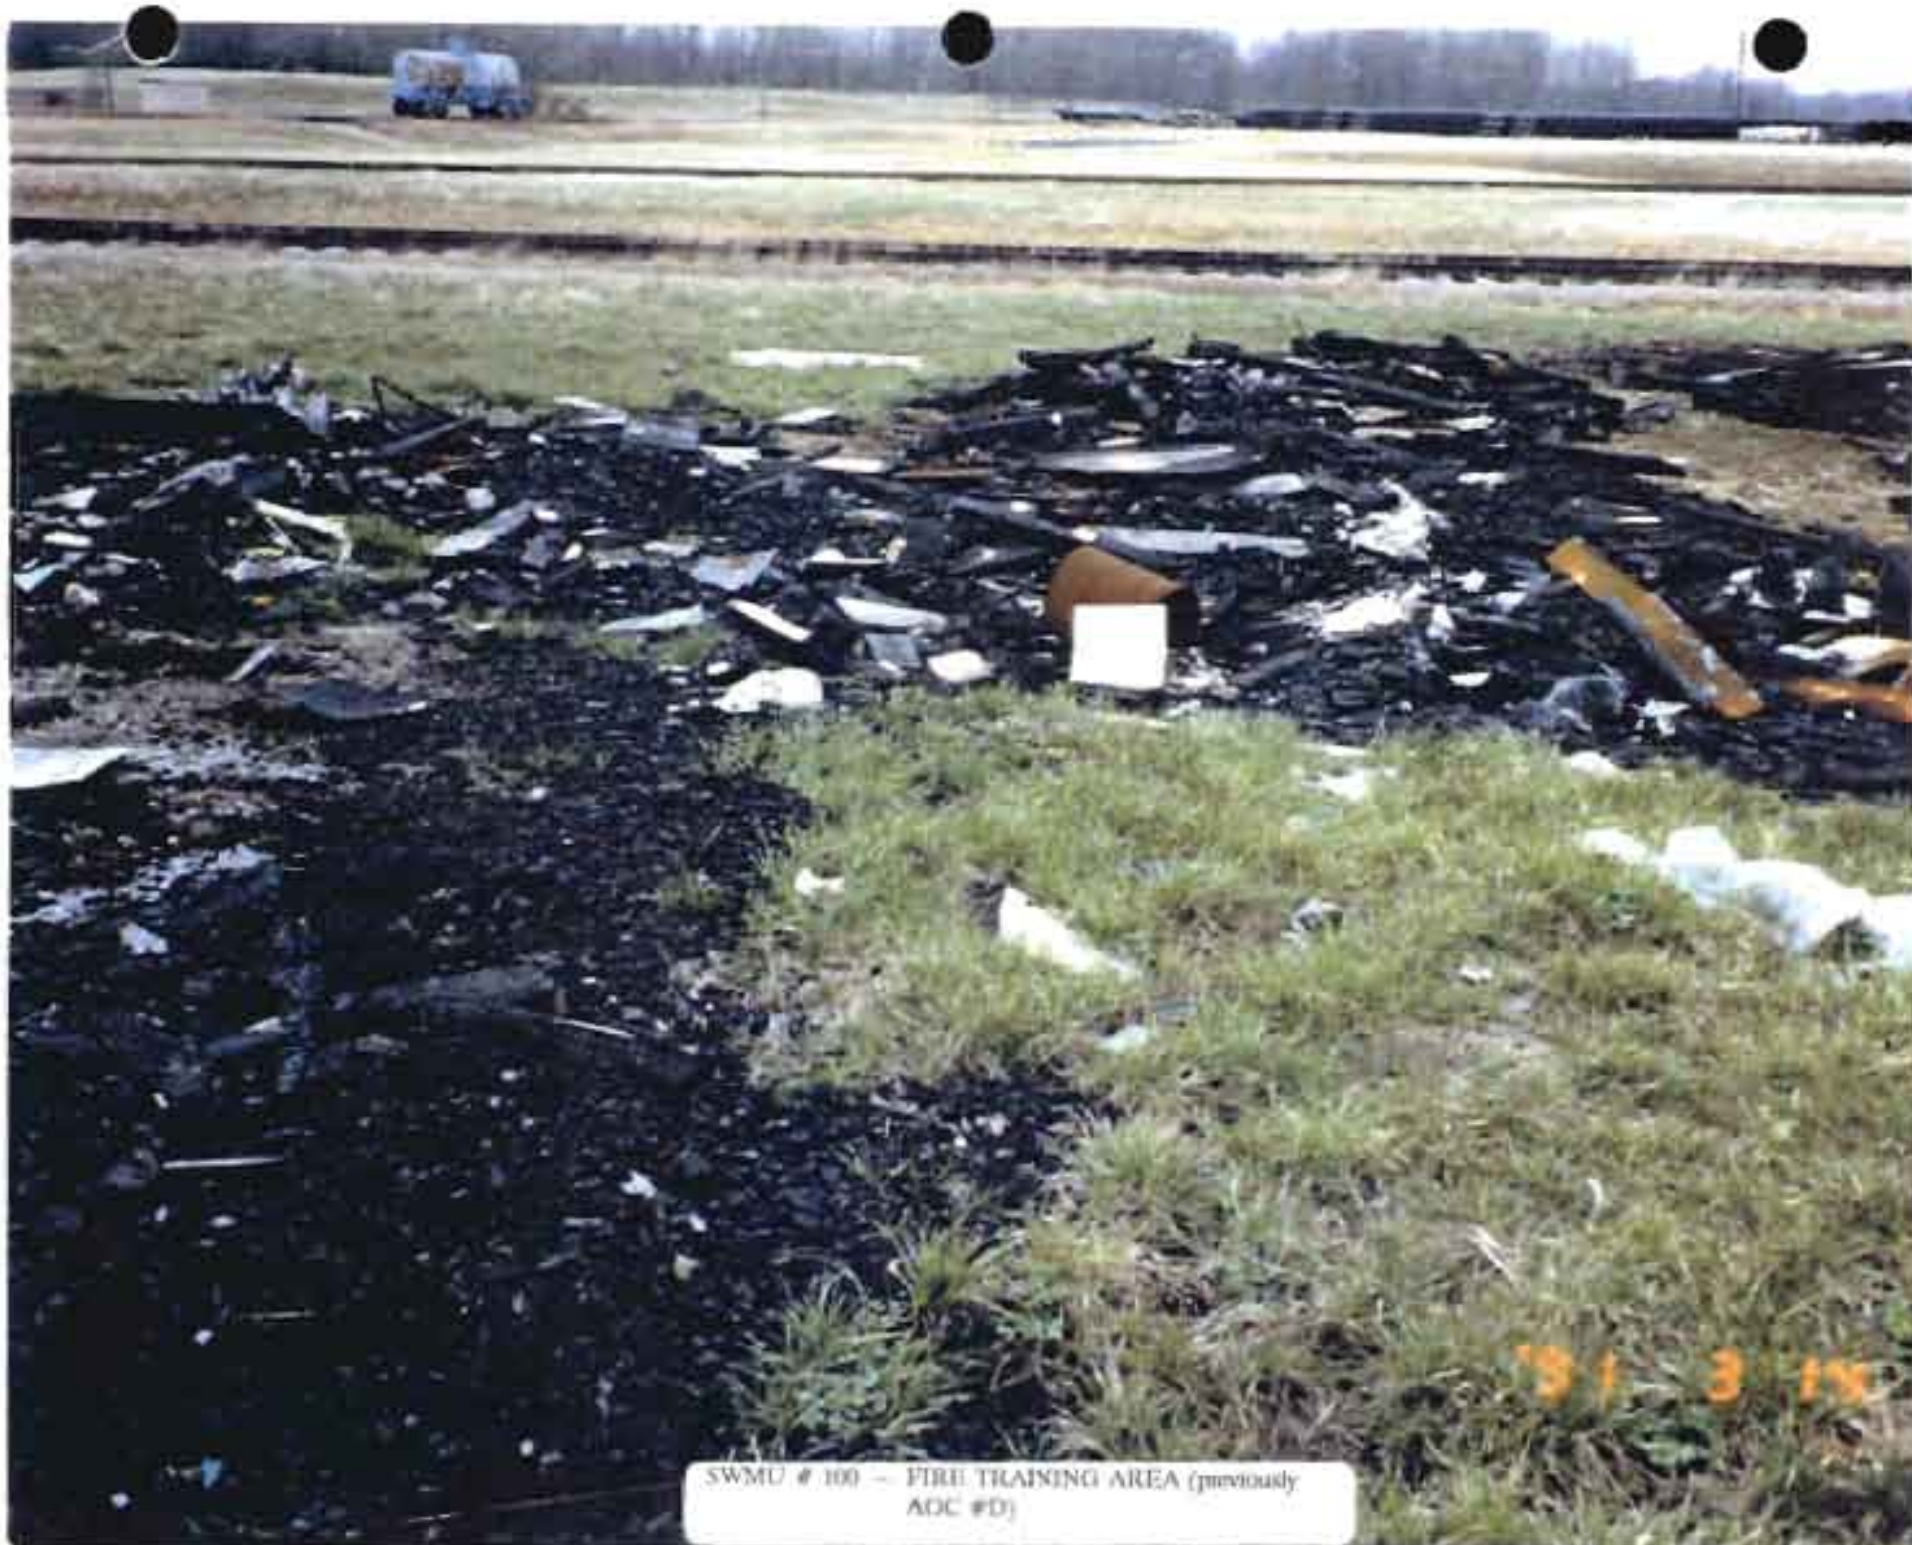
SWMU # 100 - FIRE TRAINING AREA (previously ADC #D)

FUNCTION: Combustible liquids may have been burned in pits for fire training exercises, the area is still utilized for fire training with the combustible liquids contained in a metal pan

SITE/PROCESS DESCRIPTION: Waste oils, solvents, and other combustible liquids may have been burned at this location for fire training exercises

This area underwent a prioritized RFI under the CERCLA ACO. Results of prioritized investigation did not indicate this unit to be a significant contribution to offsite contamination. This area will be addressed with WAG 1. The RFI plan for this WAG will be submitted in accordance with the schedule in the HSWA permit.

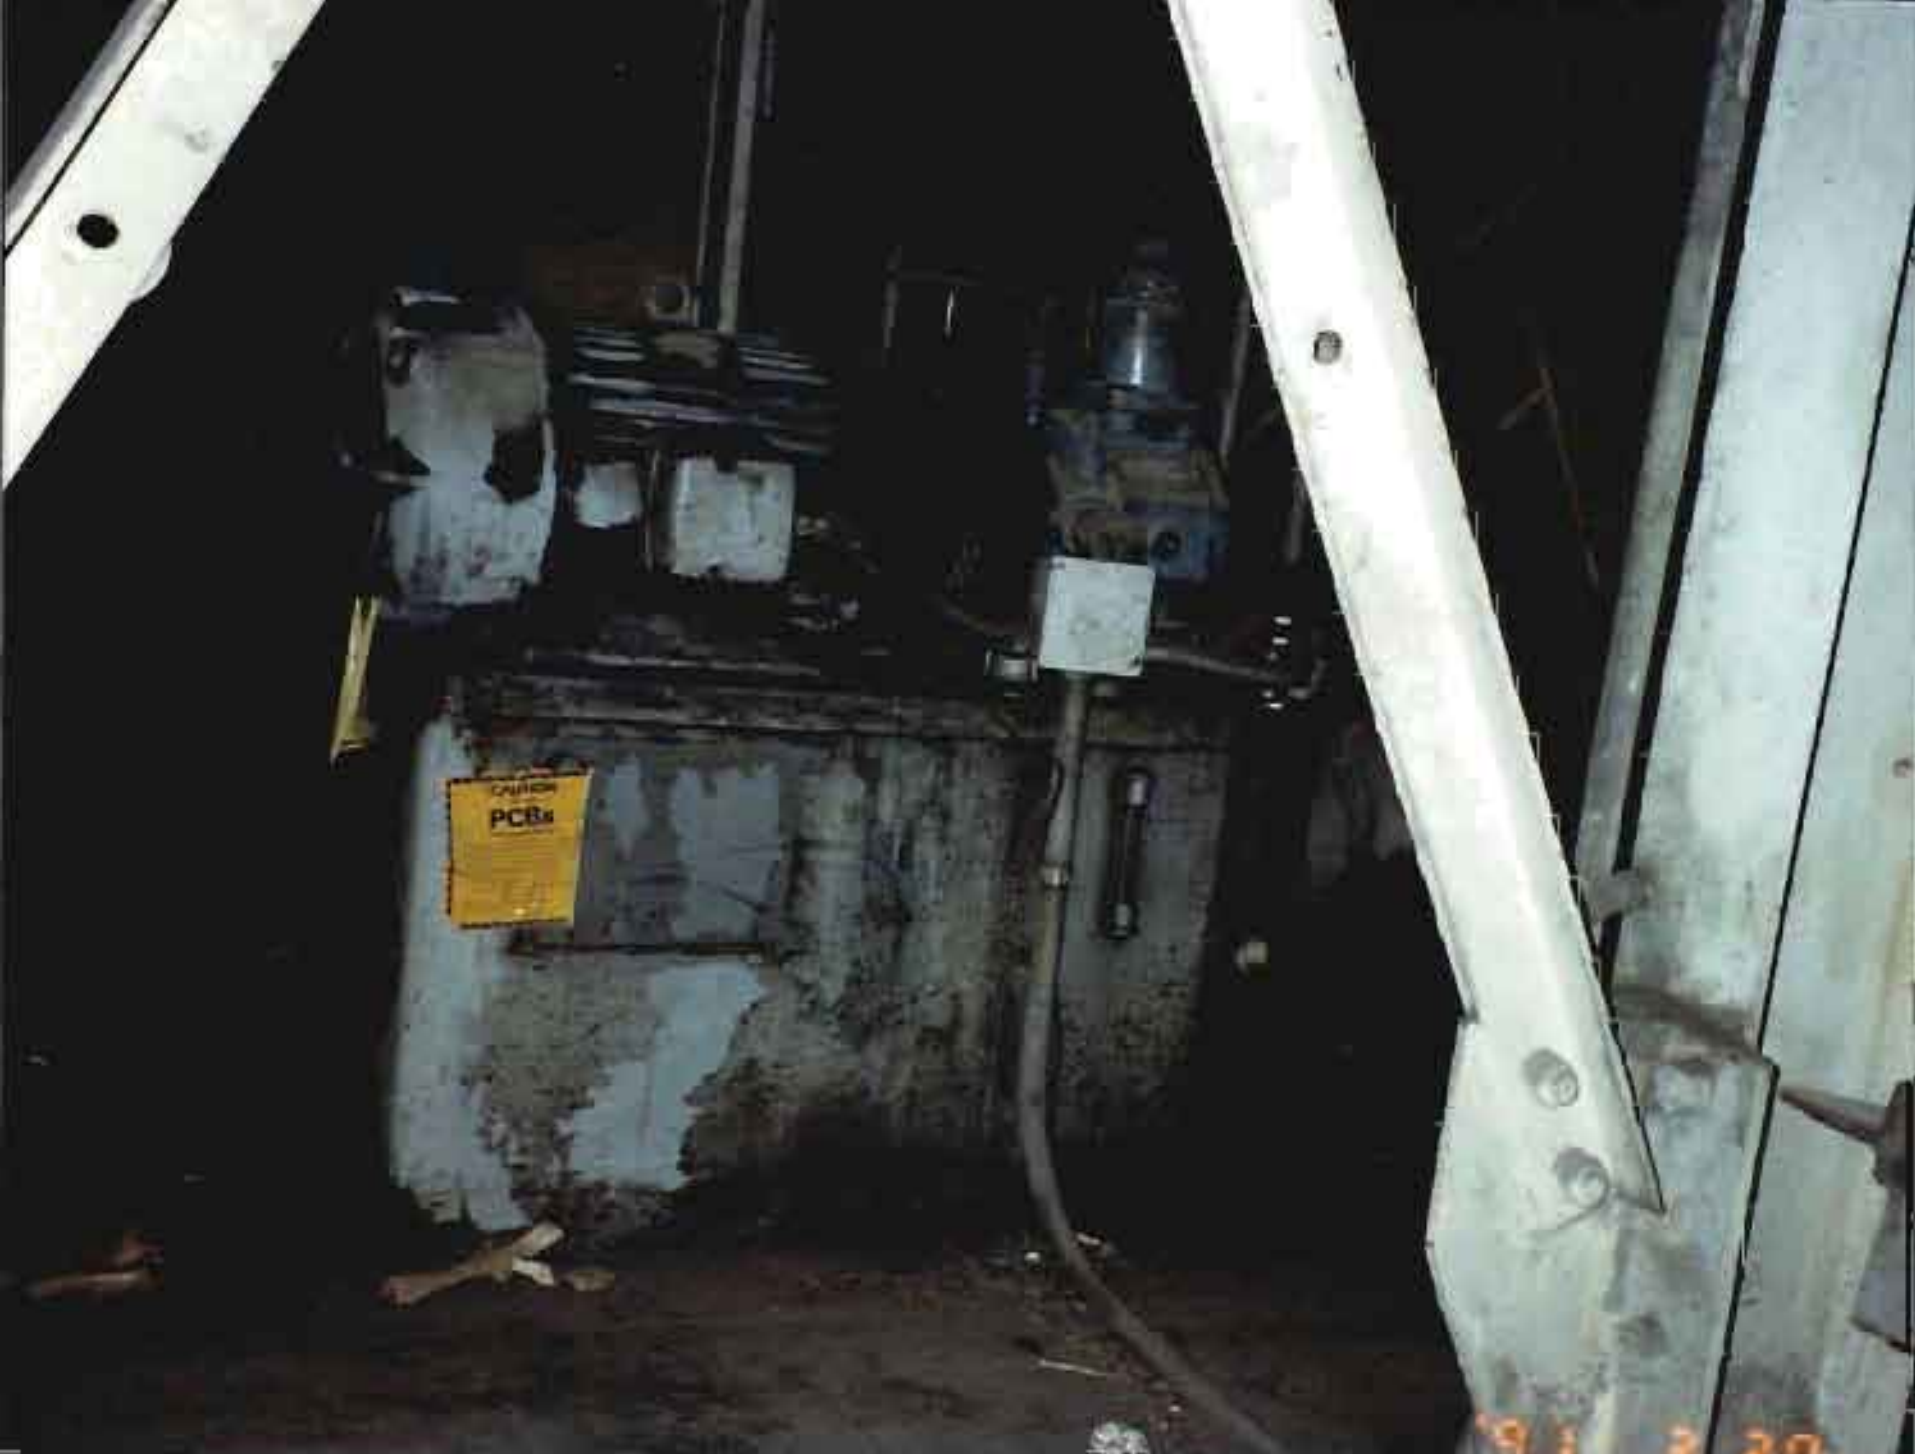
A Federal Facilities Compliance Agreement (FFCA) between U.S. DOE and the U.S. EPA has been developed under TSCA to address the removal and clean-up of PCB contaminated material associated with the hydraulic systems.

Any past releases from the hydraulic systems that occurred prior to plugging the floor drains would discharge to the surface ditches and storm sewer system that is adjacent to the C-340 Building. Both the surface ditches and storm sewer at the C-340 Building discharges into the KPDES outfall ditch 011. PCB contamination in the surface ditches and the KPDES 011 will be addressed under the CERCLA ACO. The storm sewer system is scheduled to be addressed during RFI no. 8.

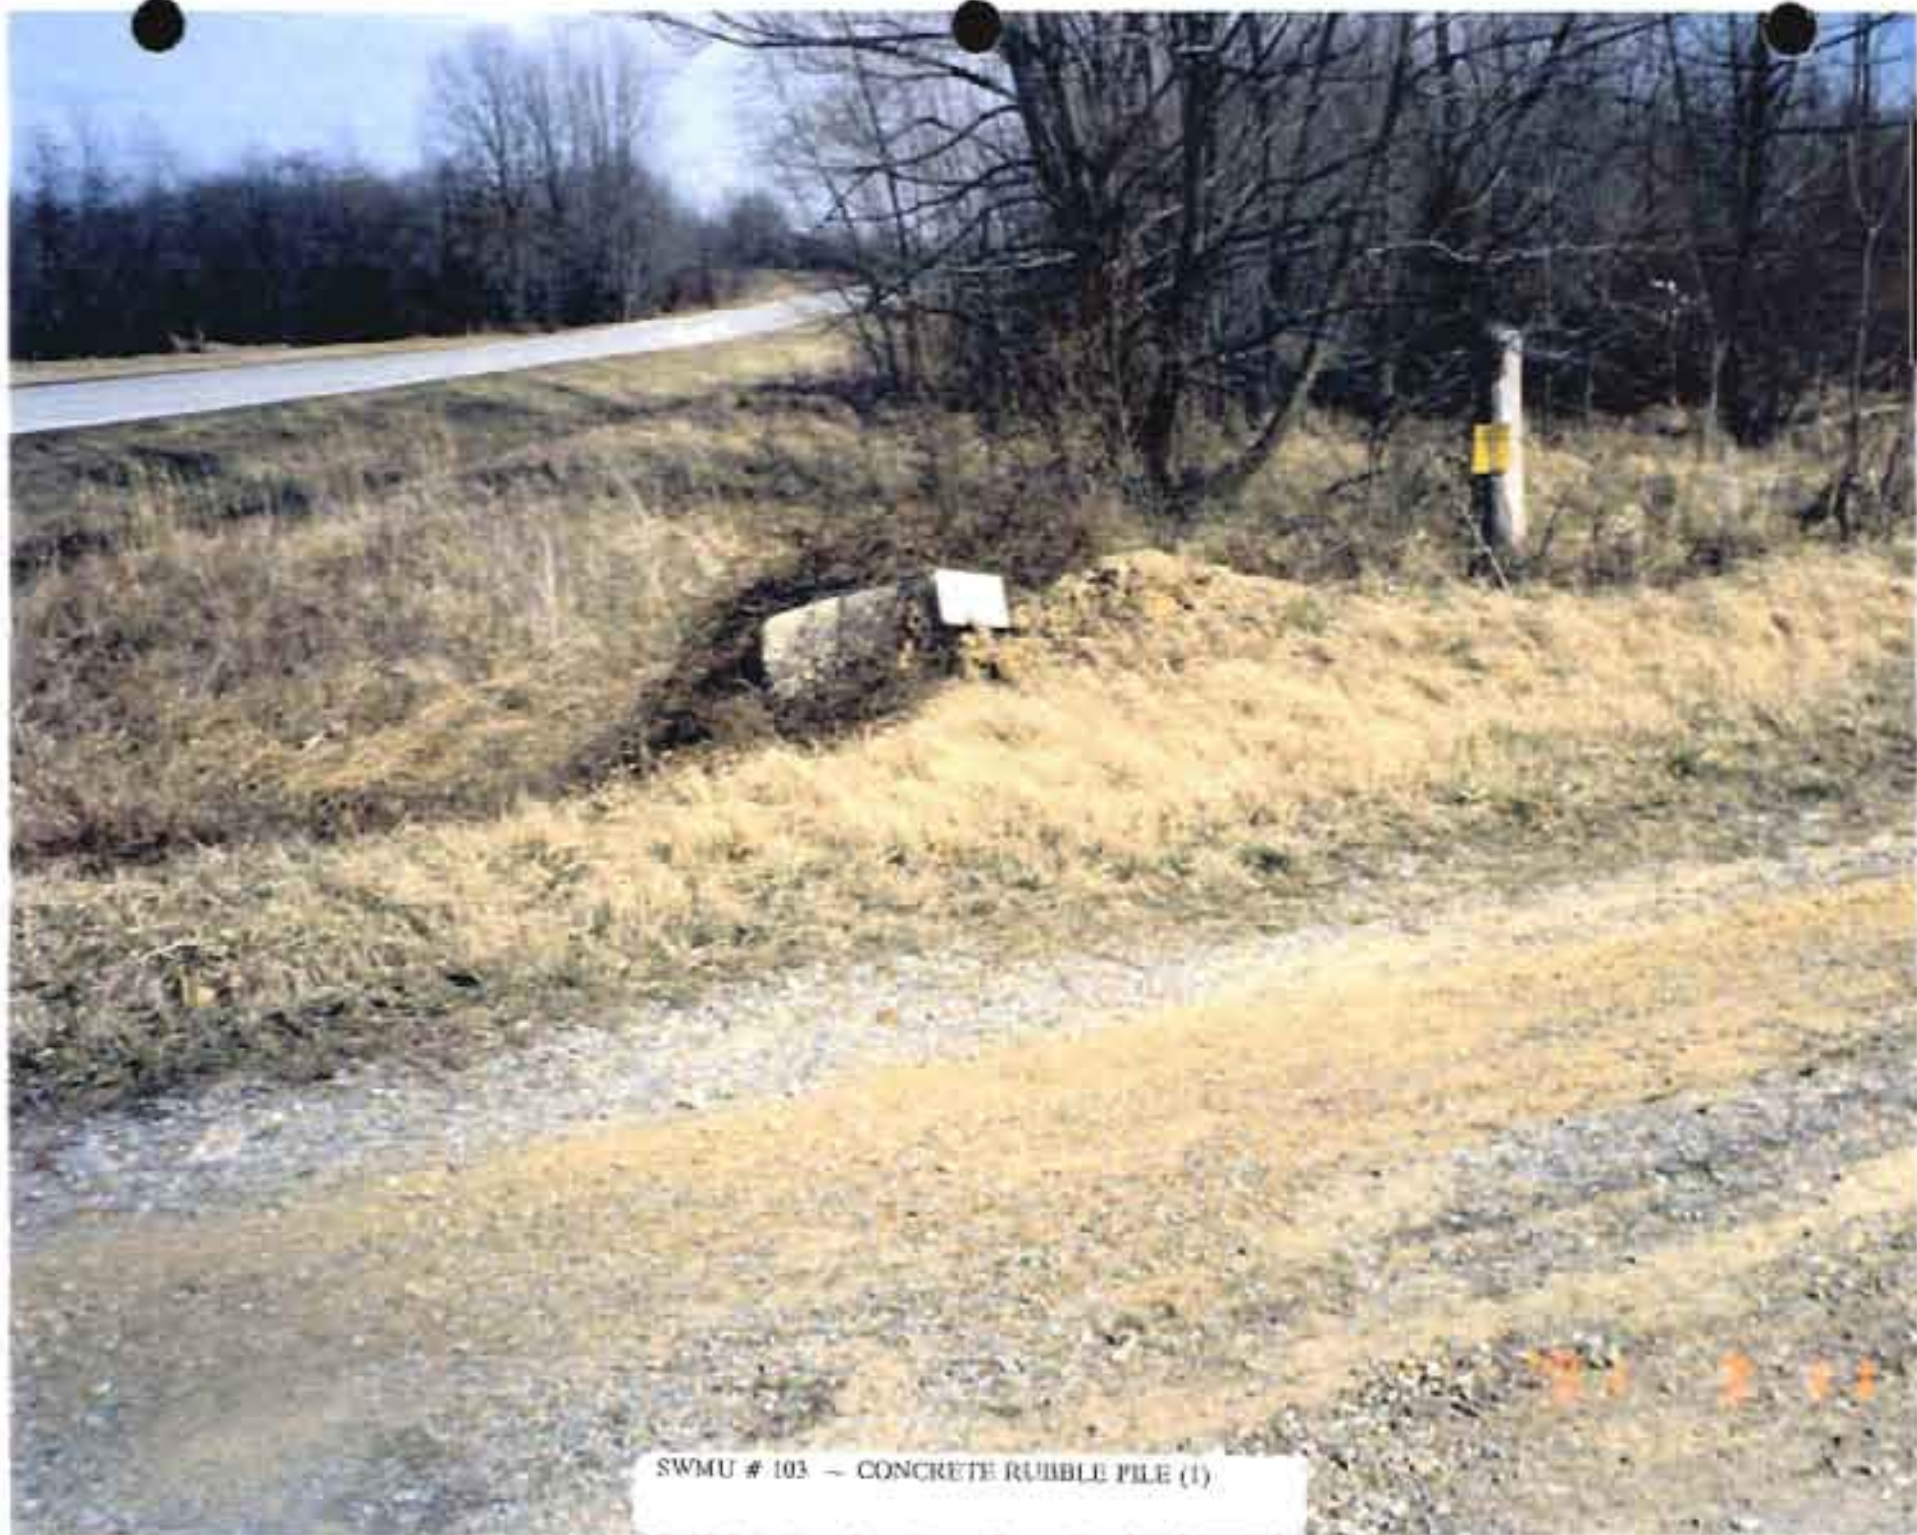
SWMU # 103 - CONCRETE RUBBLE PILE (1)

DOCUMENTATION OF NO RELEASE: Beta/Gamma scan found no elevated readings on
rubble. Gamma soil survey showed no above
criteria concentrations in soil around rubble.

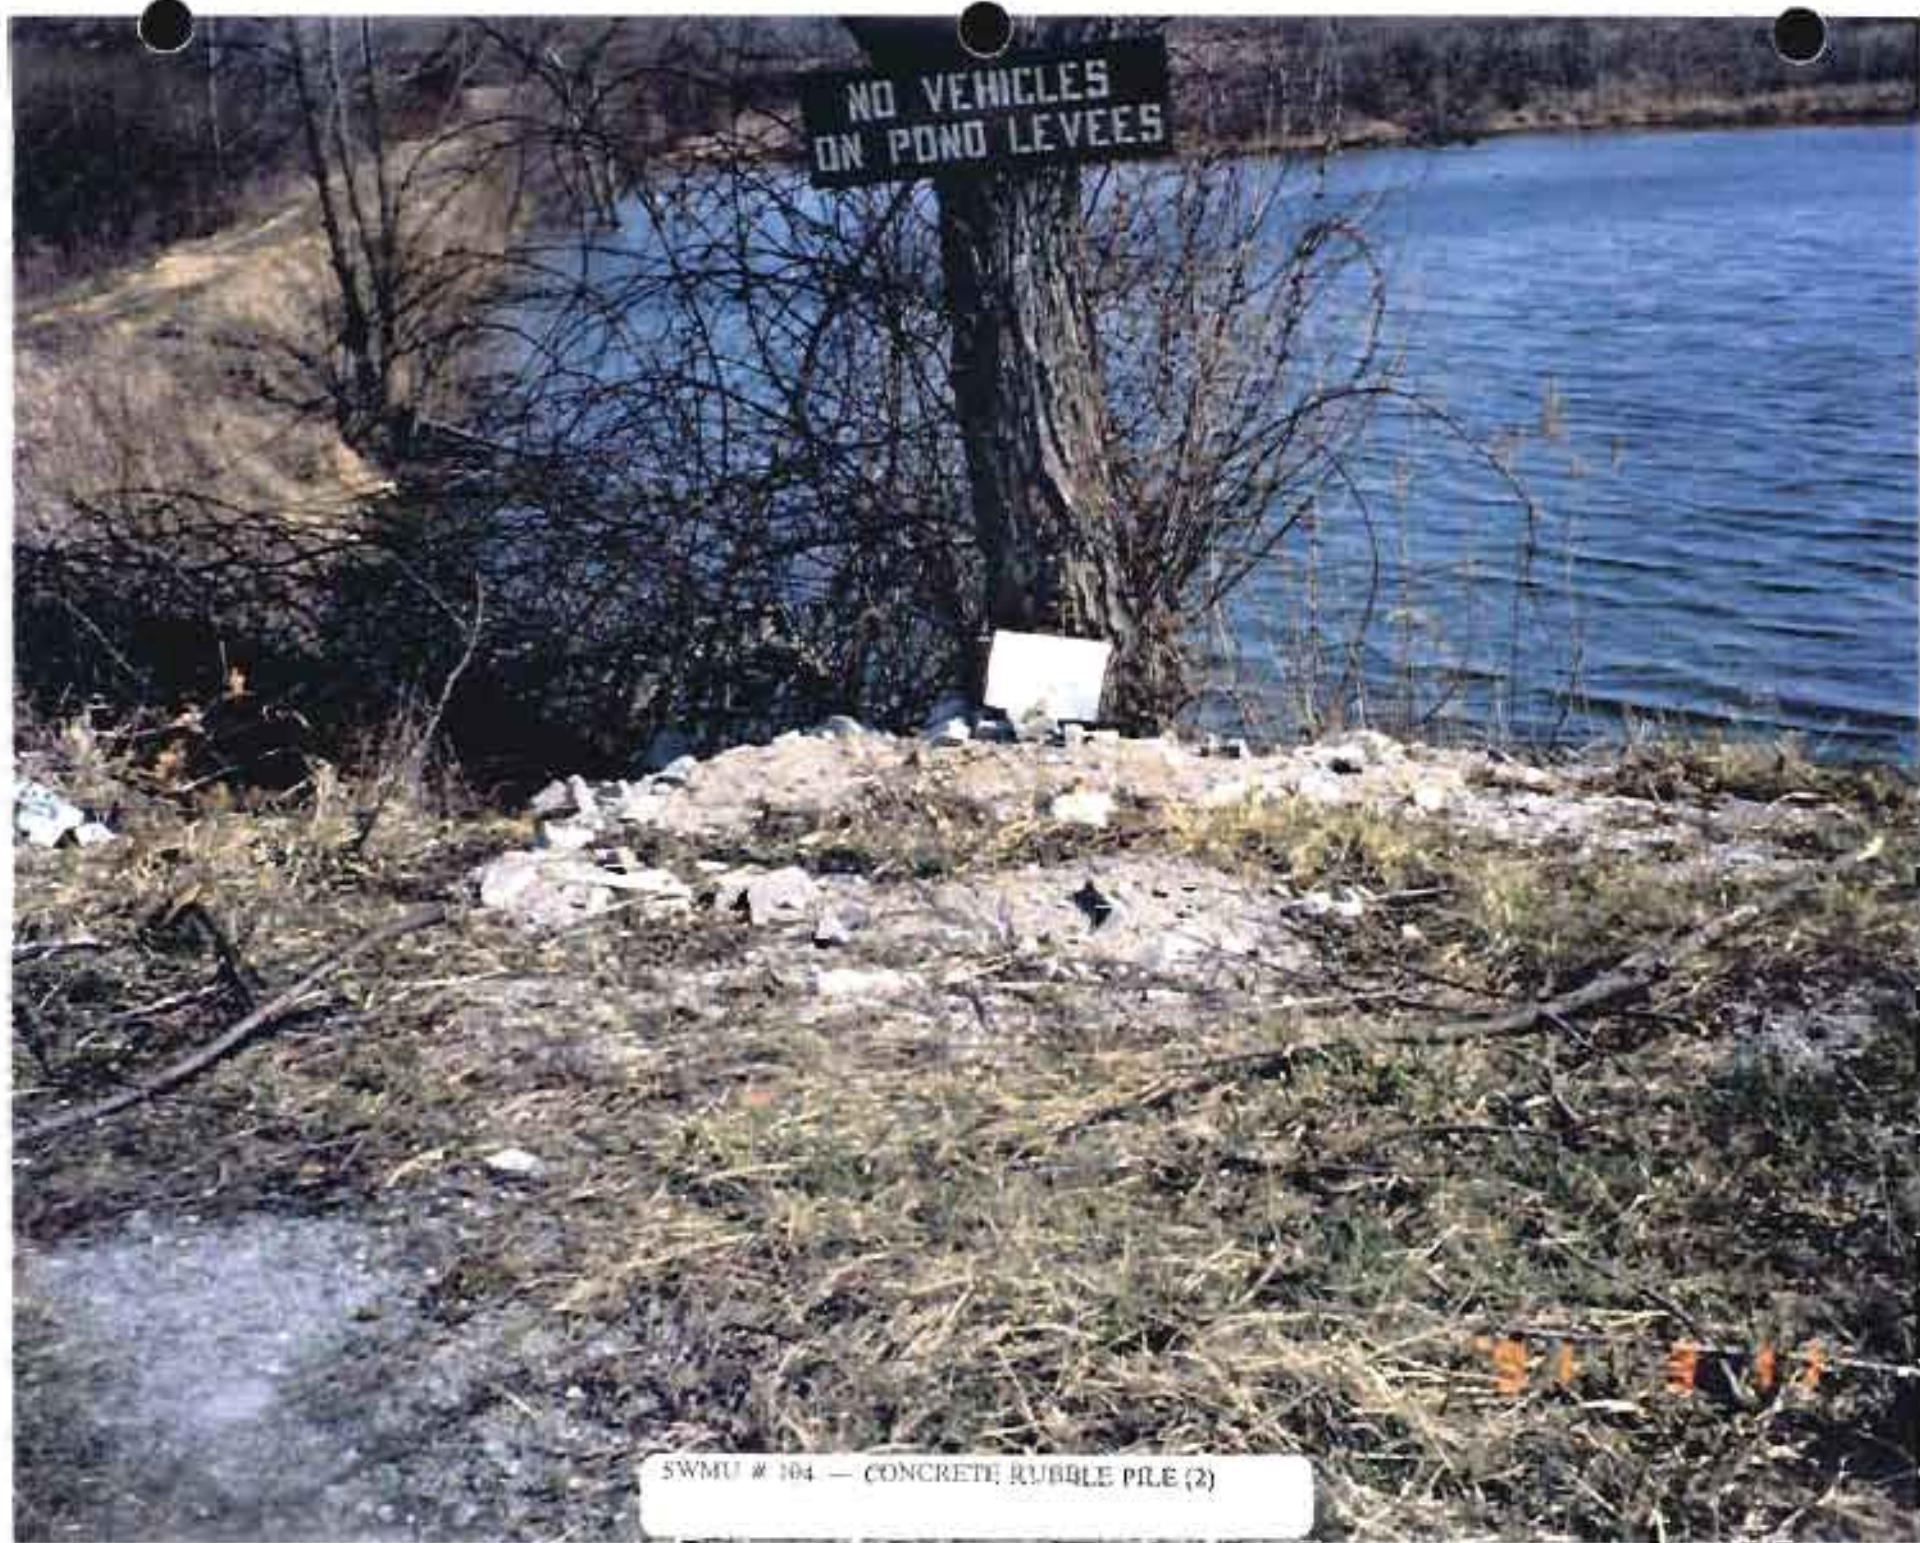
SWMU # 104 — CONCRETE RUBBLE PILE (2)

DOCUMENTATION OF NO RELEASE: Found no elevated Beta/Gama readings on rubble or soil.

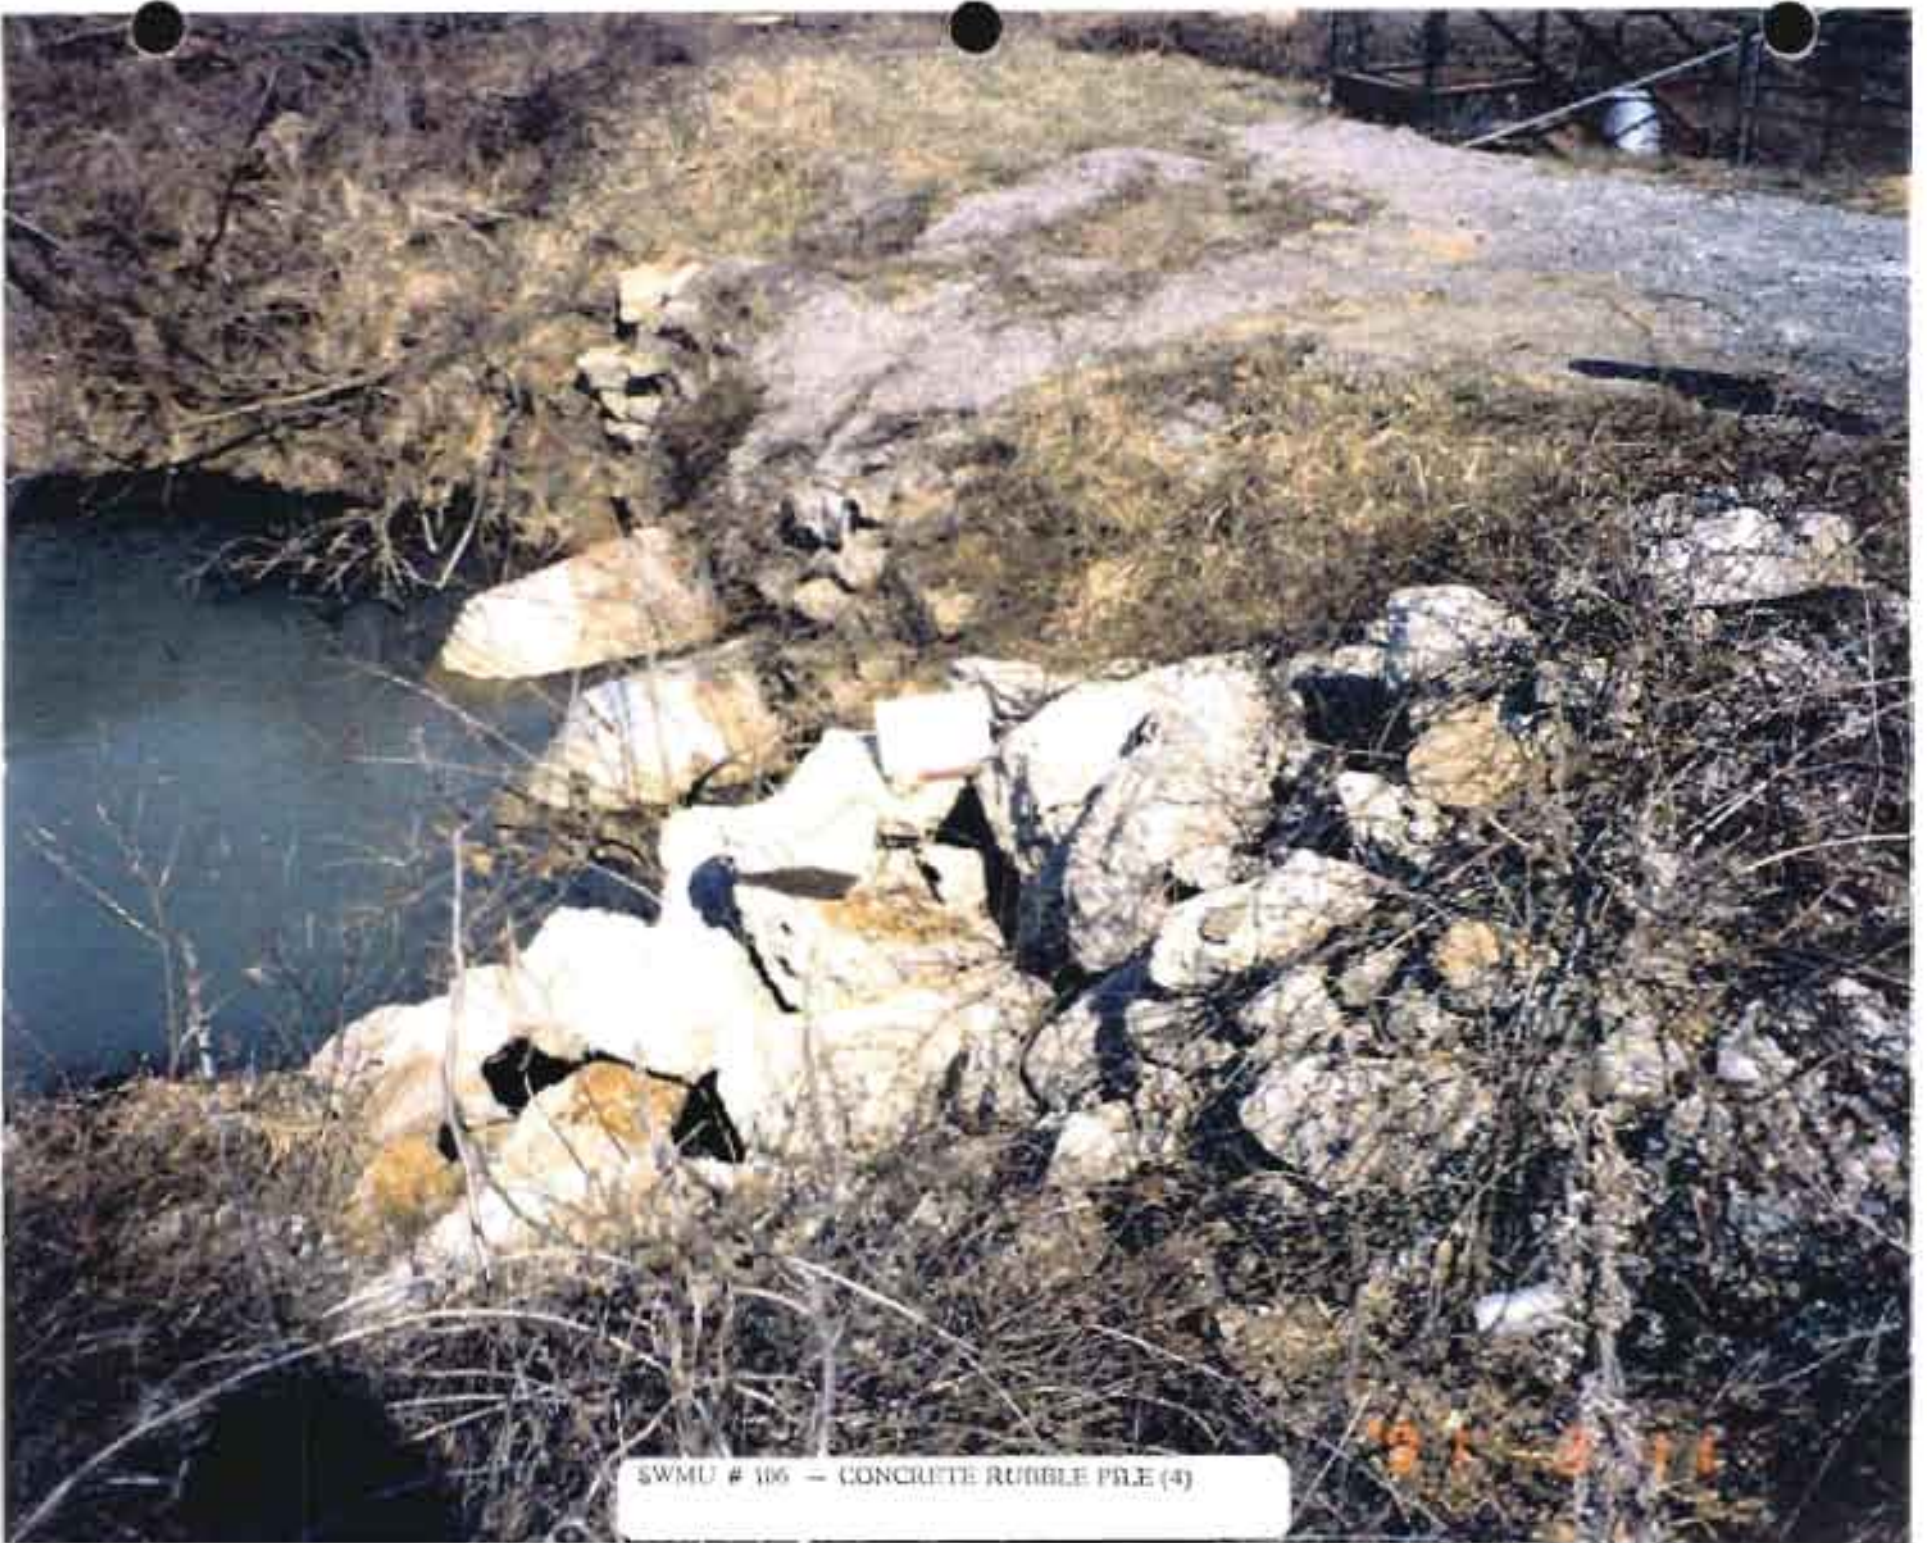
SWMU # 106 - CONCRETE RUBBLE PILE (4)

DESCRIPTION OF RELEASE: Beta/Gamma scan found some contamination on concrete
slabs. Maximum reading was approx. 1600 cpm. Soil
Gamma investigation had no elevated findings.
