KY/B-262
Addendum 1
Volume 1
Revision 1

PADUCAH GASEOUS DIFFUSION PLANT

PRELIMINARY ASSESSMENT

PADUCAH GASEOUS DIFFUSION PLANT
SOLID WASTE MANAGEMENT UNITS

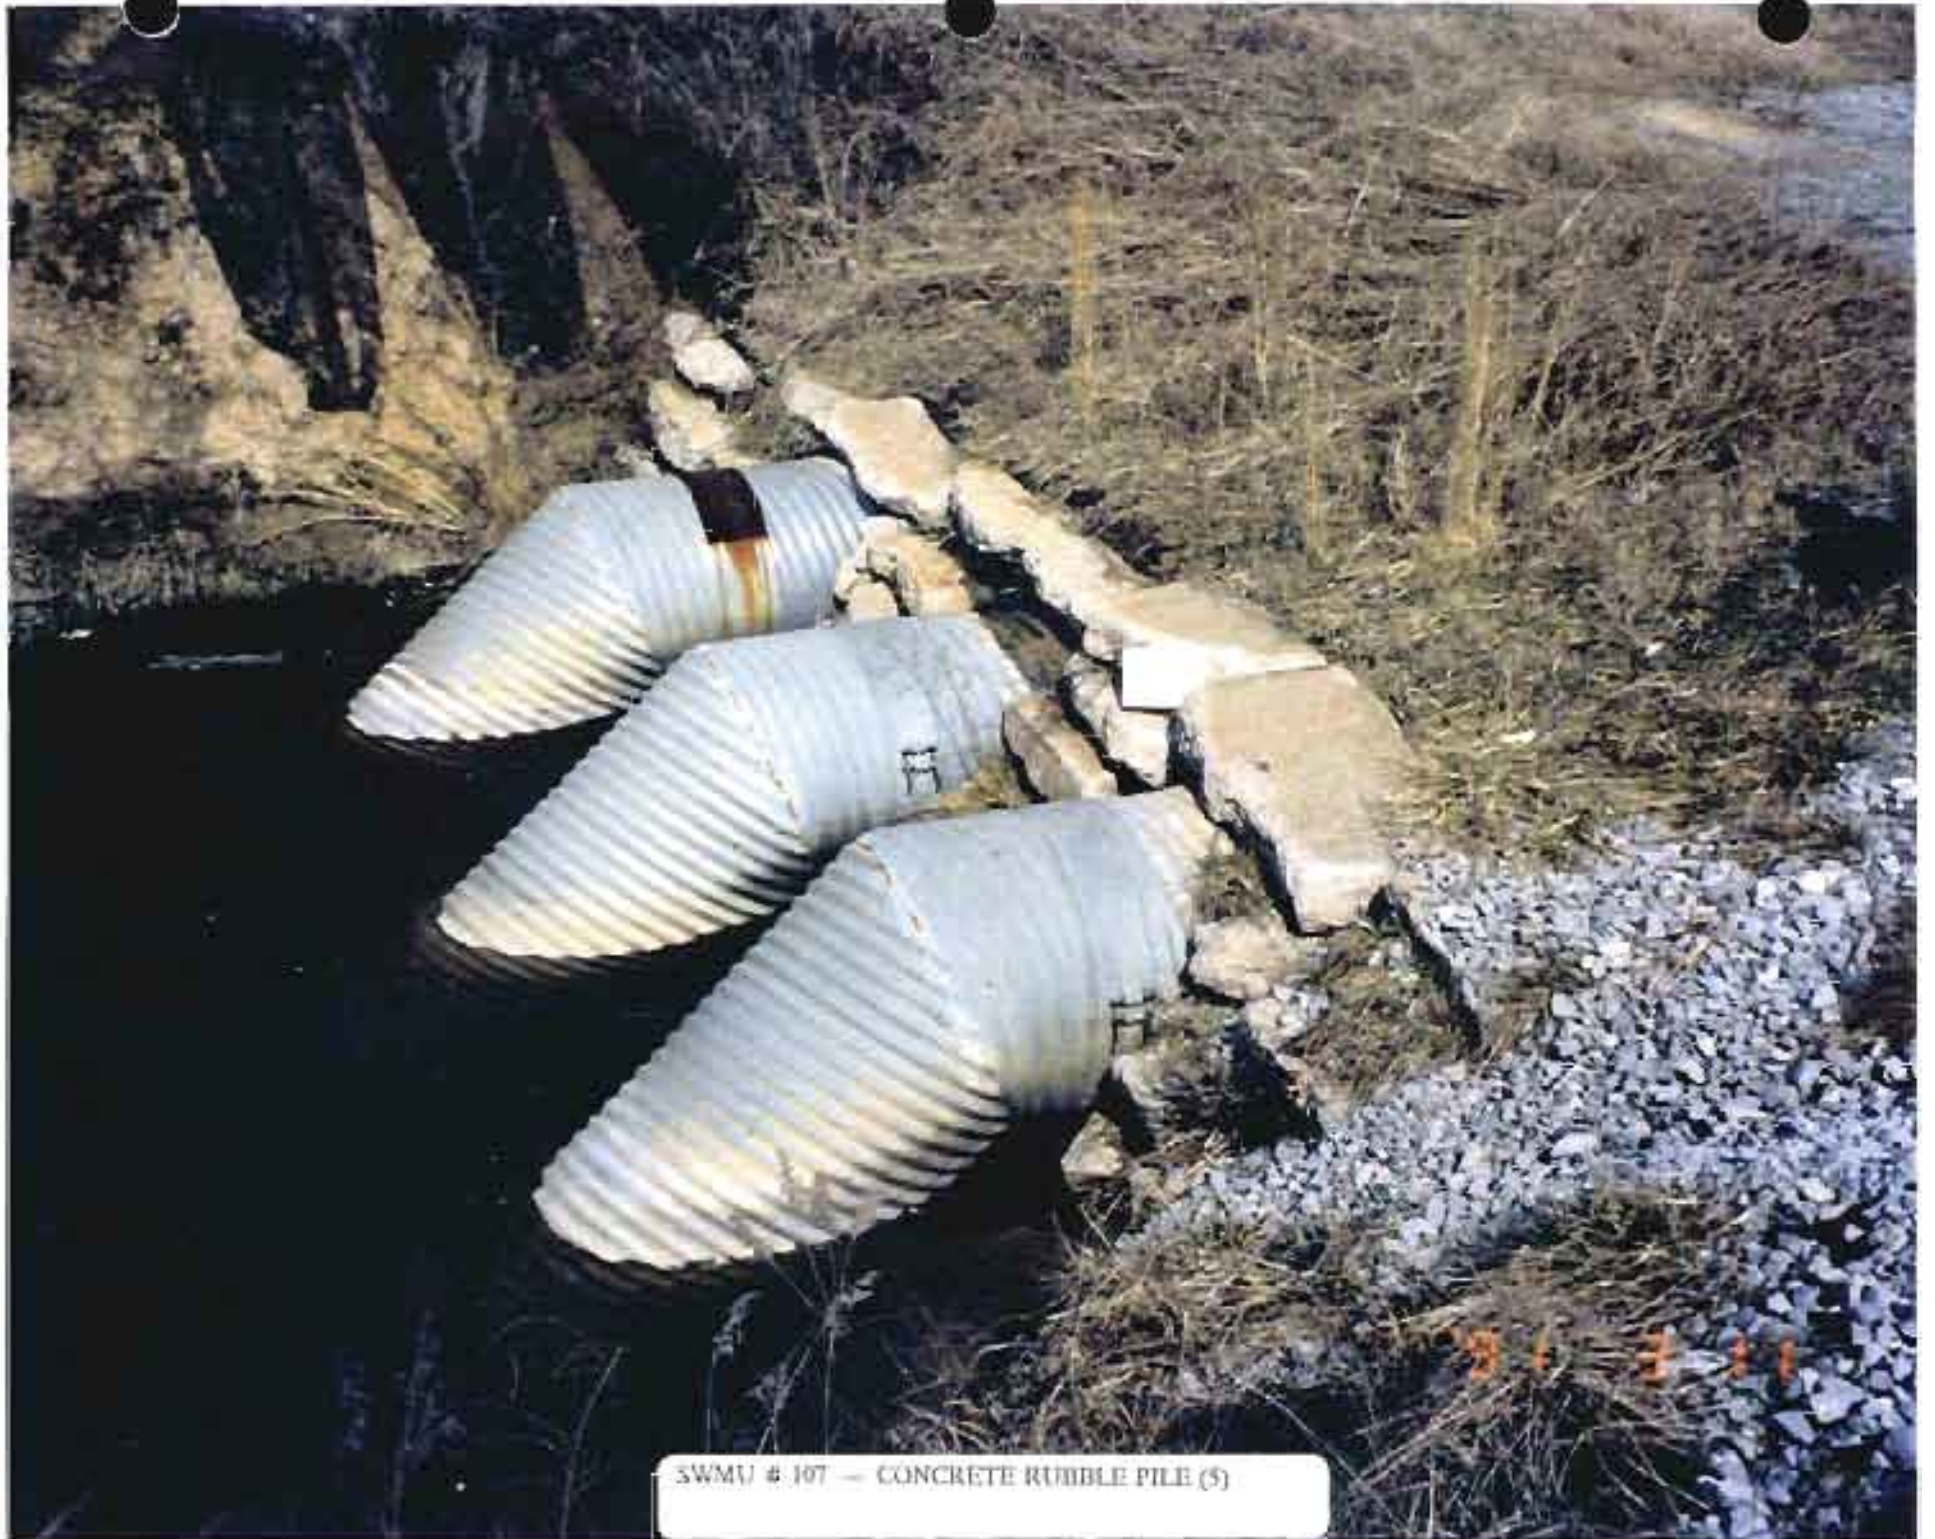
SWMU # 107 - CONCRETE RUBBLE PILE (5)

DESCRIPTION OF RELEASE: Contamination found on five different slabs reading
approx. 400 cpm over background. No soil
contamination was found.

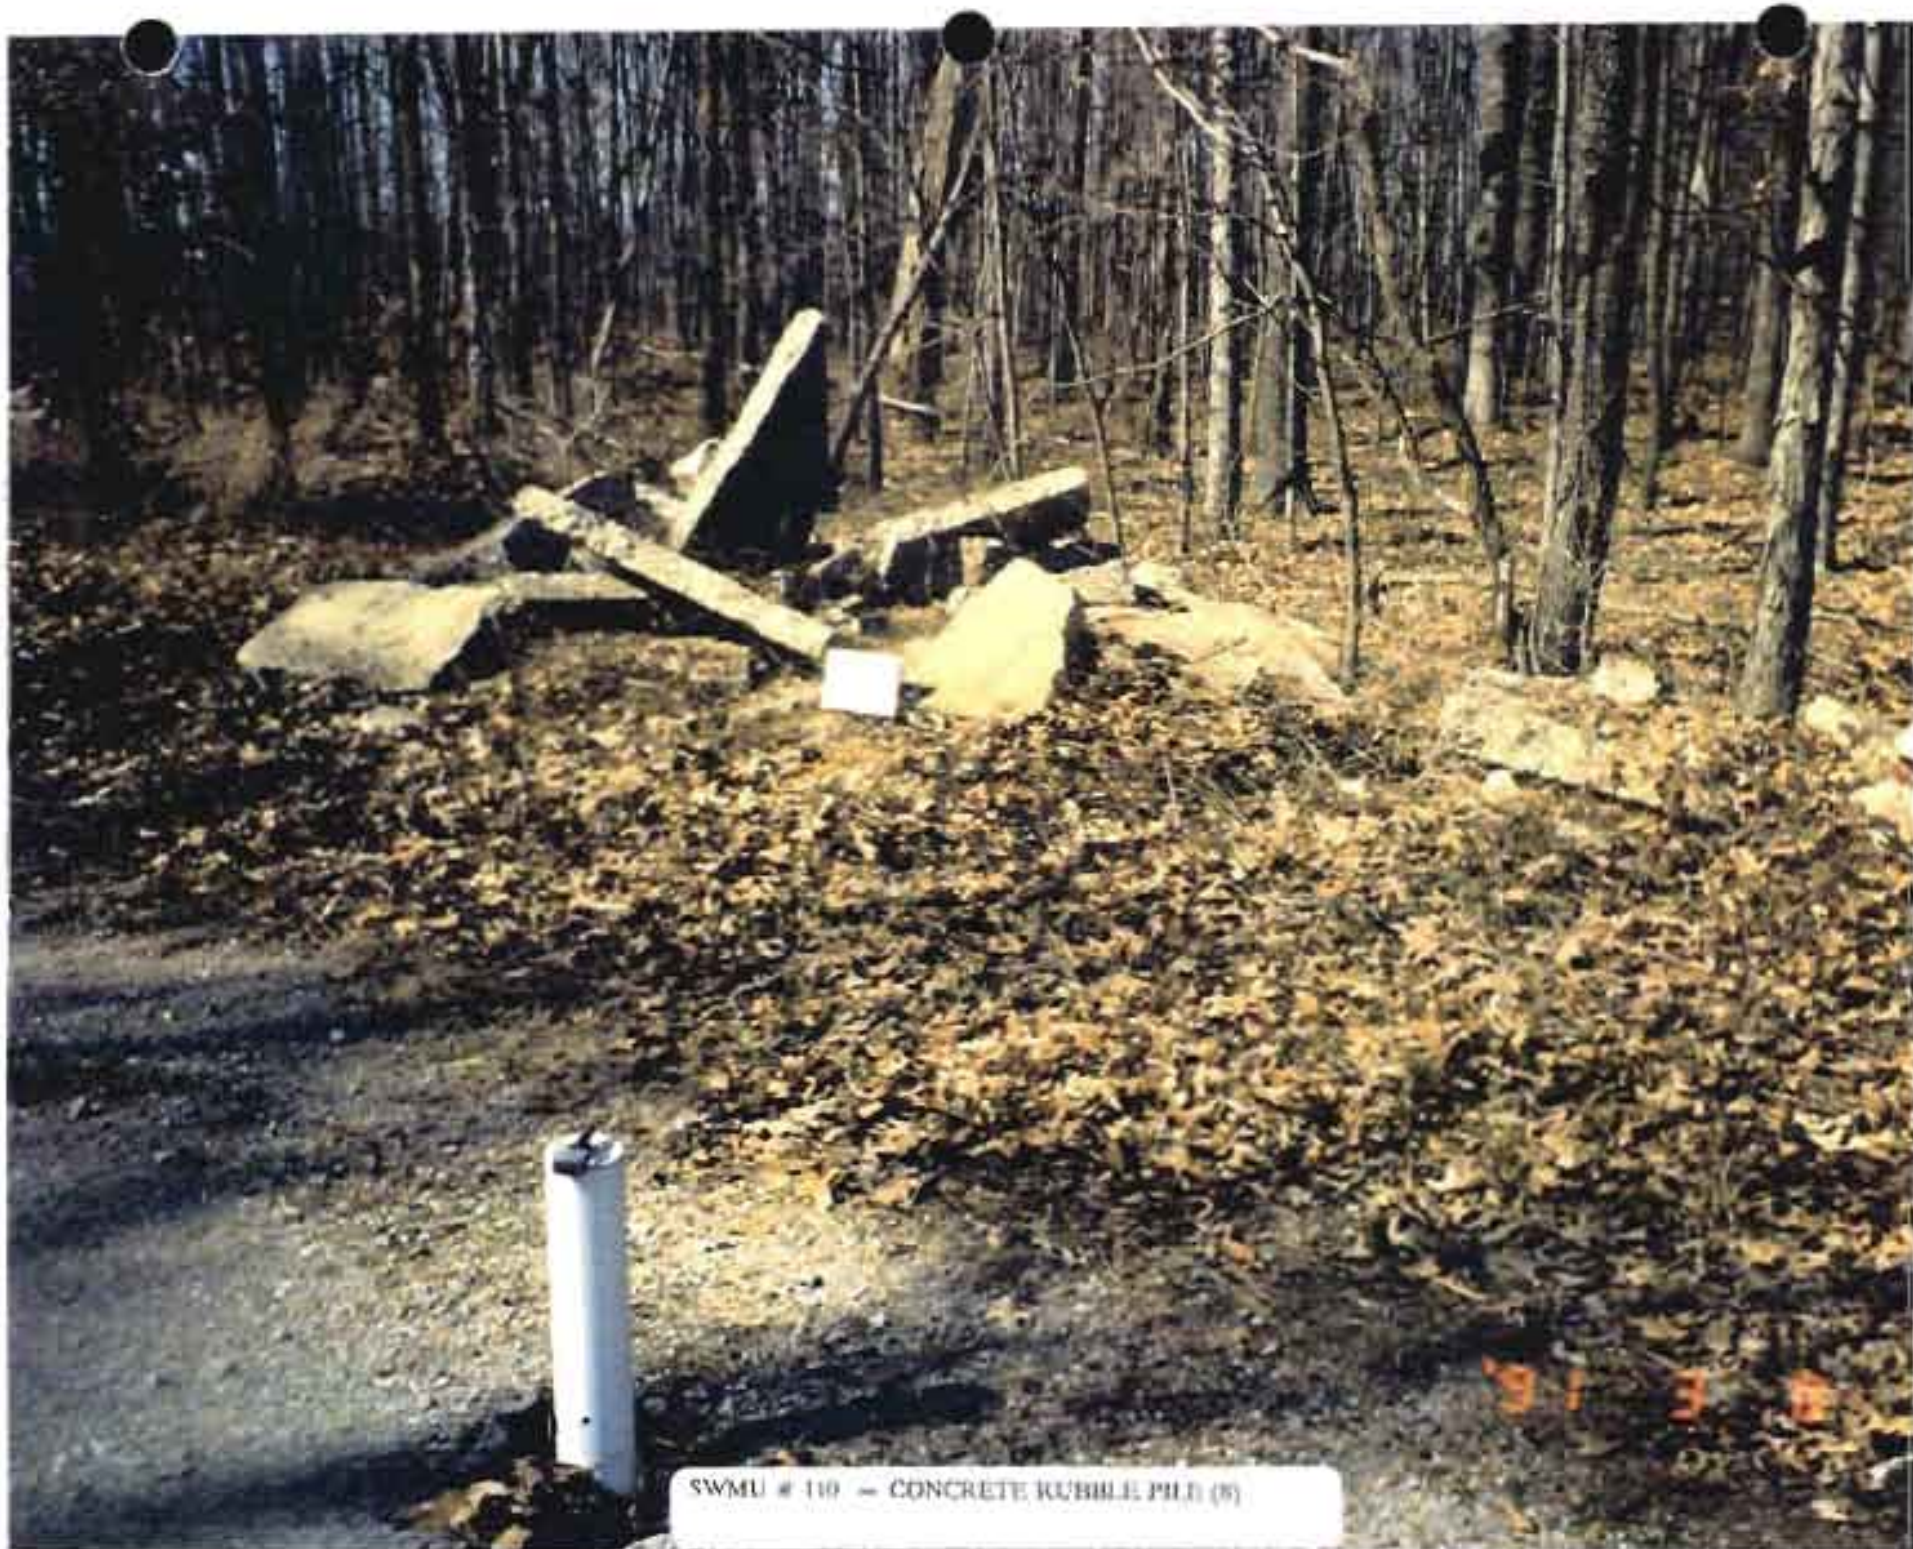
SWMU # 110 - CONCRETE RUBBLE PILE (B)

DESCRIPTION OF RELEASE: Beta/Gamma scan found contamination primarily in
expansion joint tar that is attached to various slabs
of concrete. Approximately 150 cpm over background
was an average finding on these areas. Found no
detectable soil contamination.

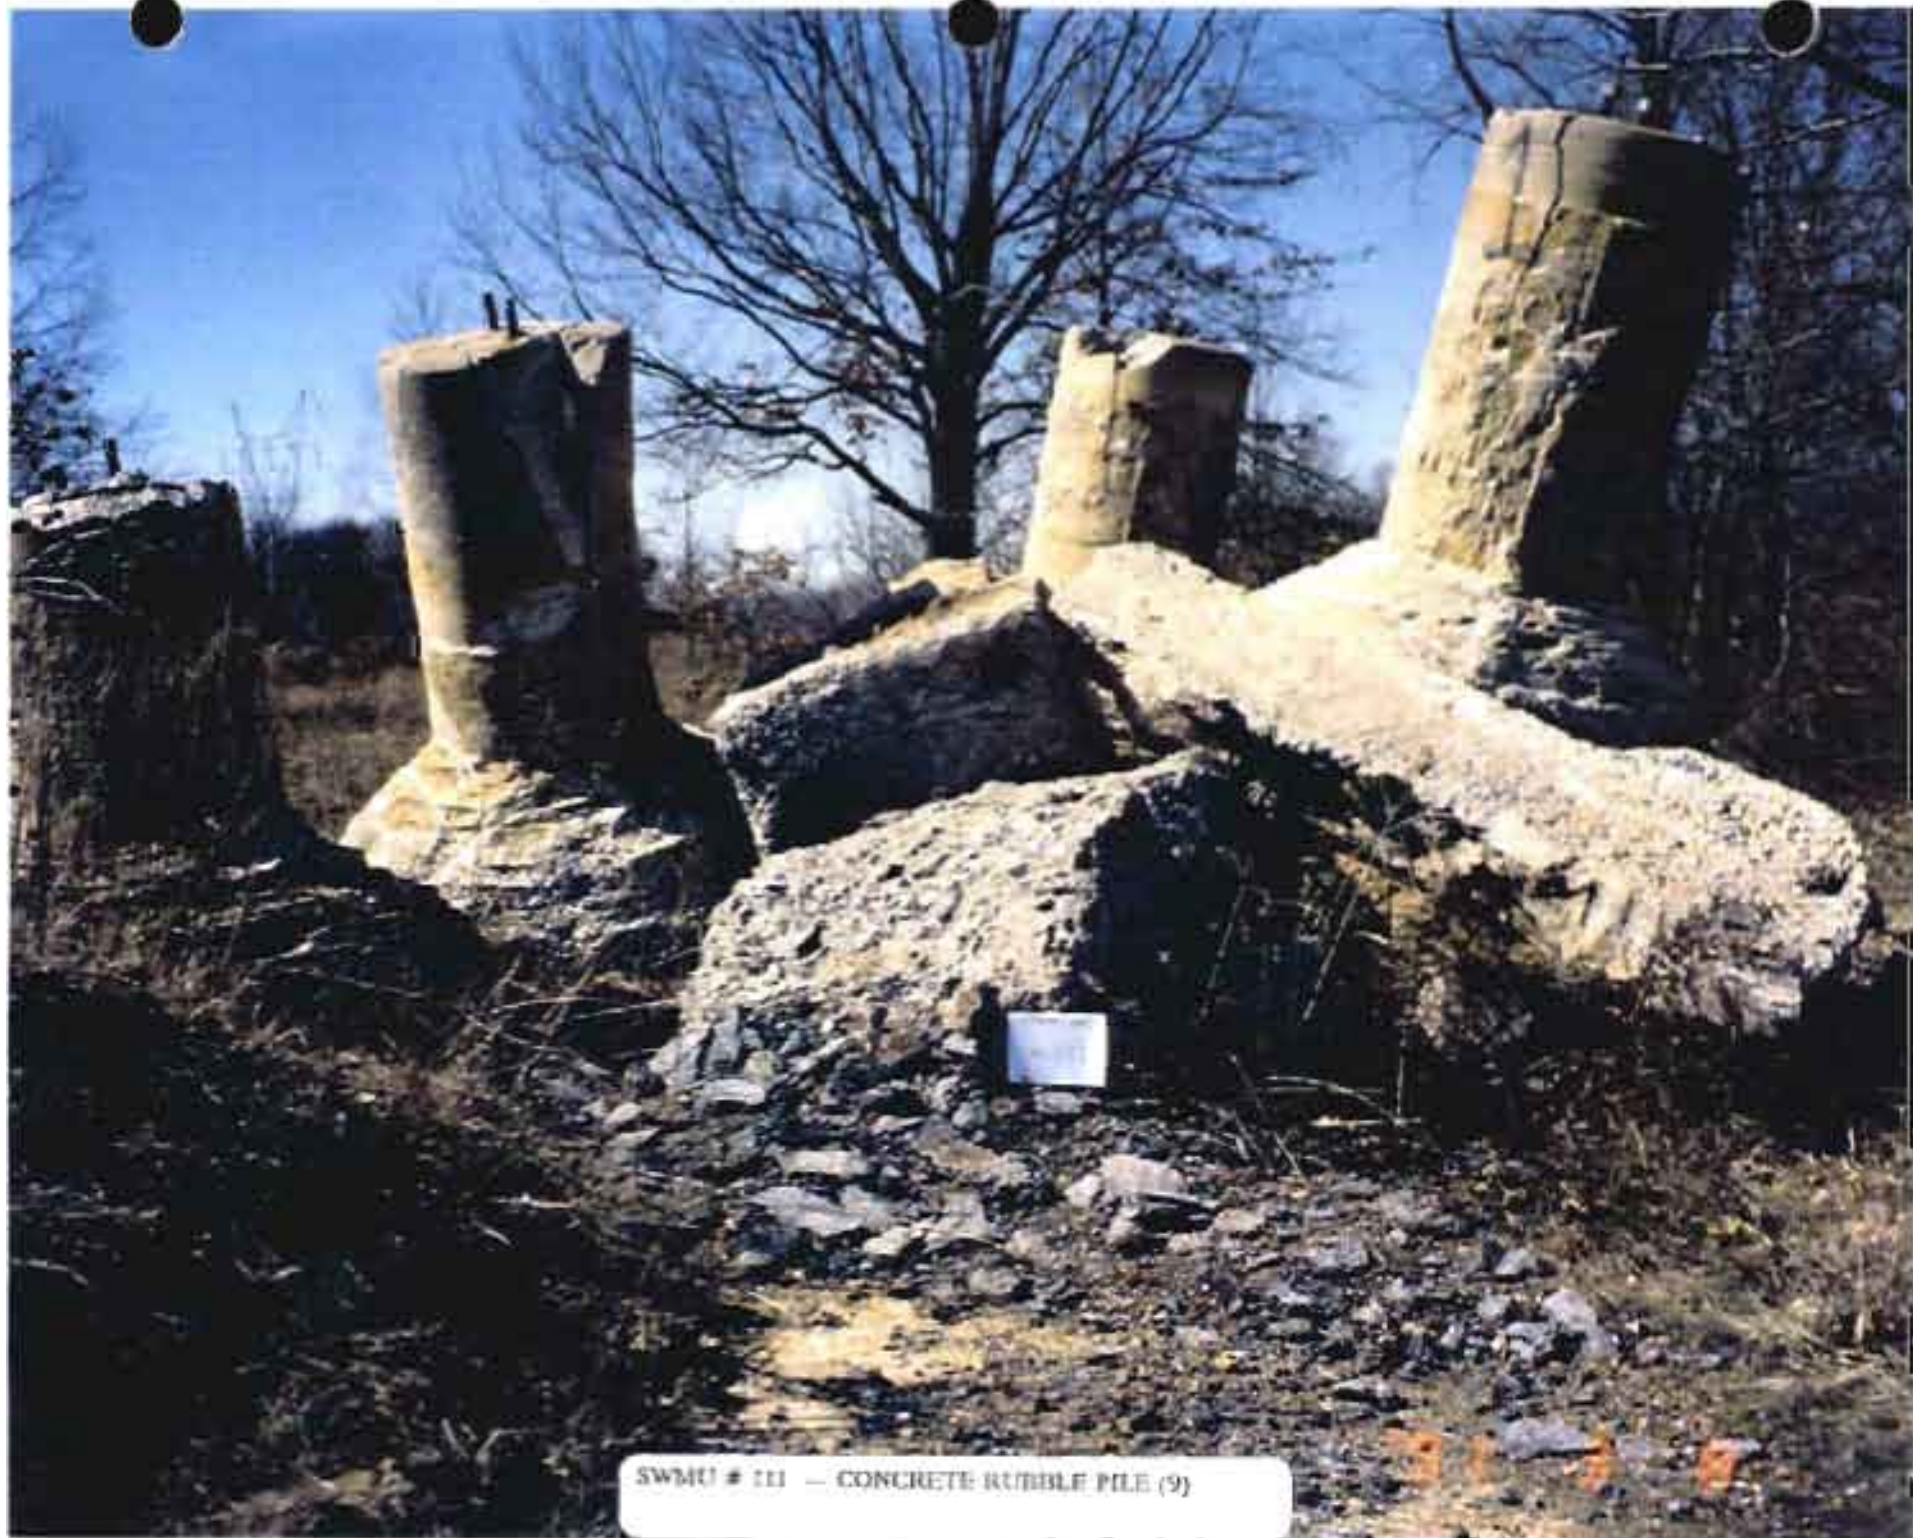
SWMU # 111 — CONCRETE RUBBLE PILE (9)

DESCRIPTION OF RELEASE: Radiation surveys found that surface contamination was present on different locations in the rubble piles. Surface soil samples did reflect measured concentrations of U-total above background readings.

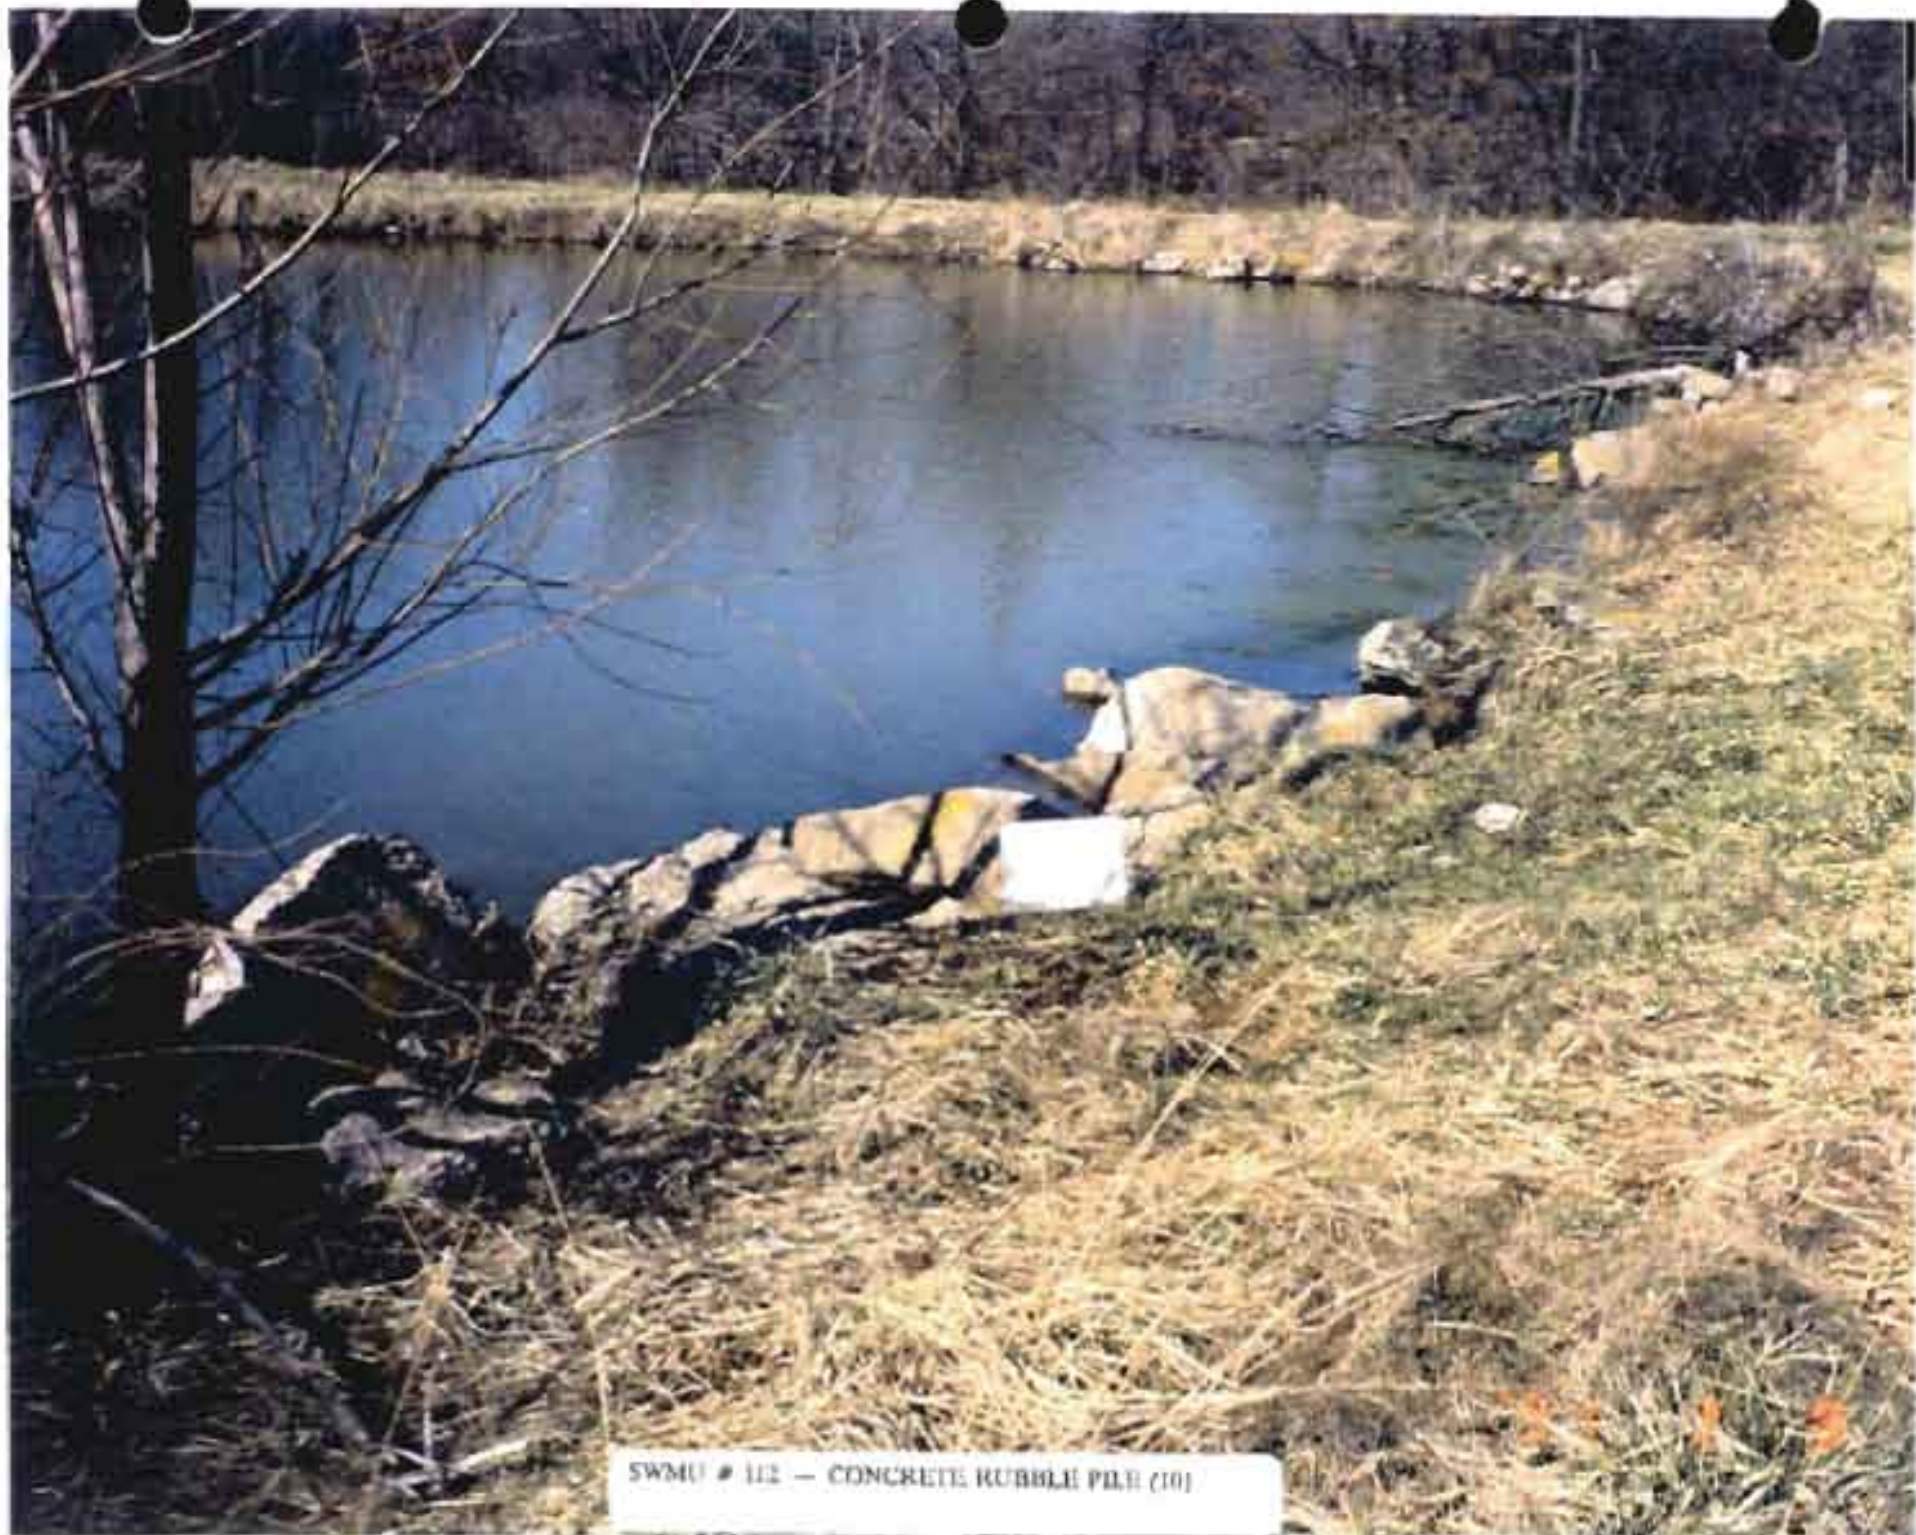
SWMU # 112 - CONCRETE RUBBLE PILE (10)

DOCUMENTATION OF NO RELEASE: Rubble is sparse and mostly underwater.
Beta/Gamma scan found no detectable
contamination.

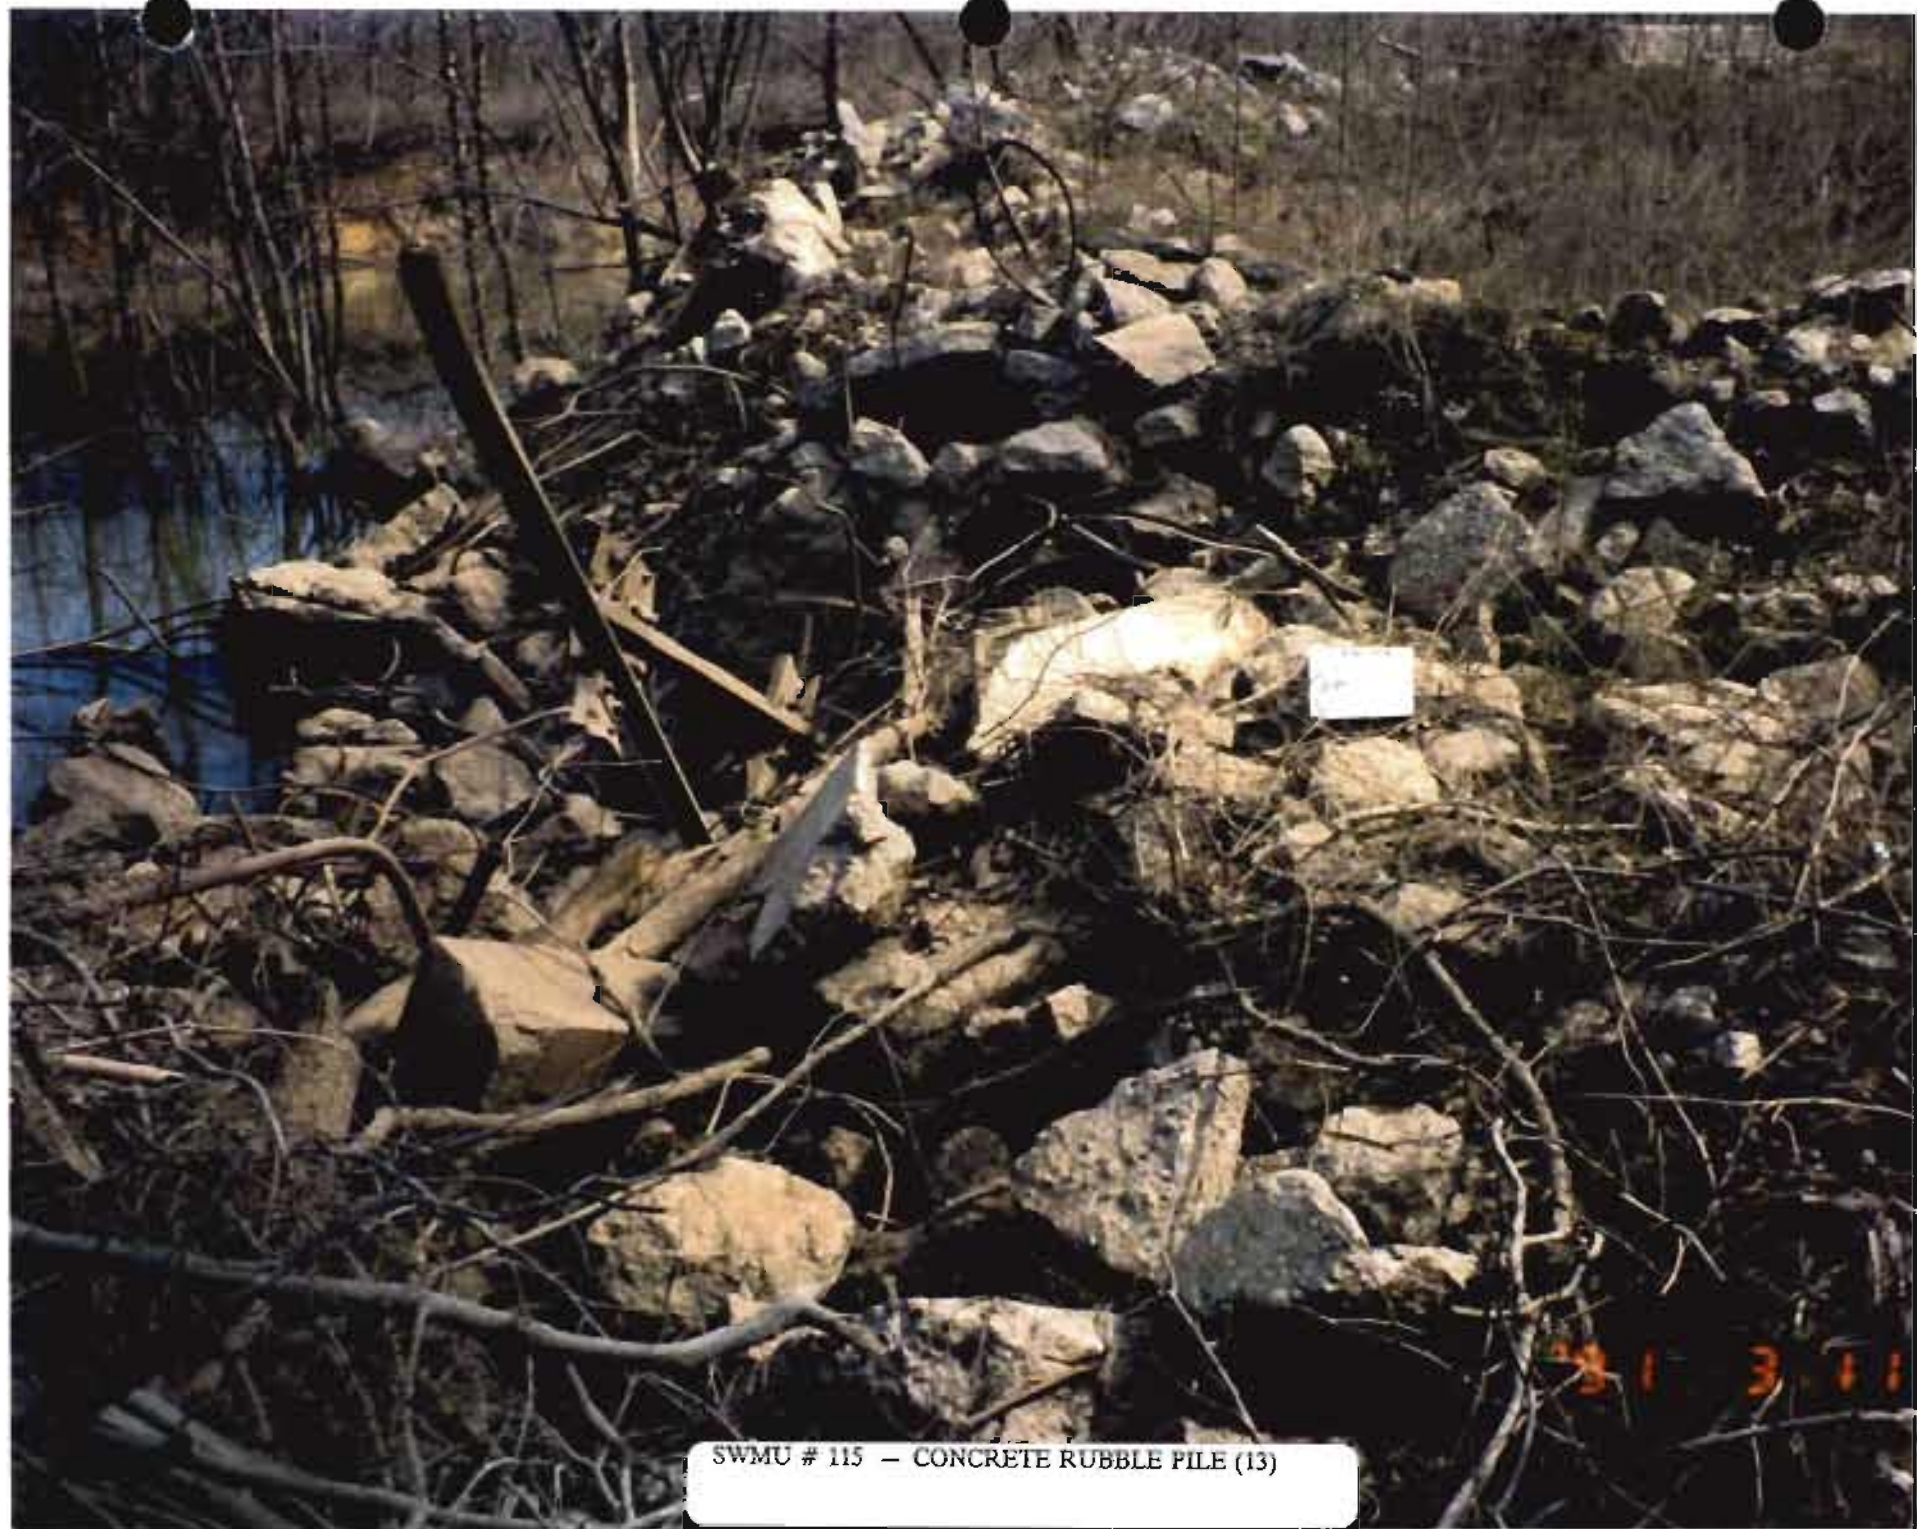
SWMU # 115 - CONCRETE RUBBLE PILE (13)

DOCUMENTATION OF NO RELEASE: Beta/Gamma scan and soil investigation showed no detectable contamination

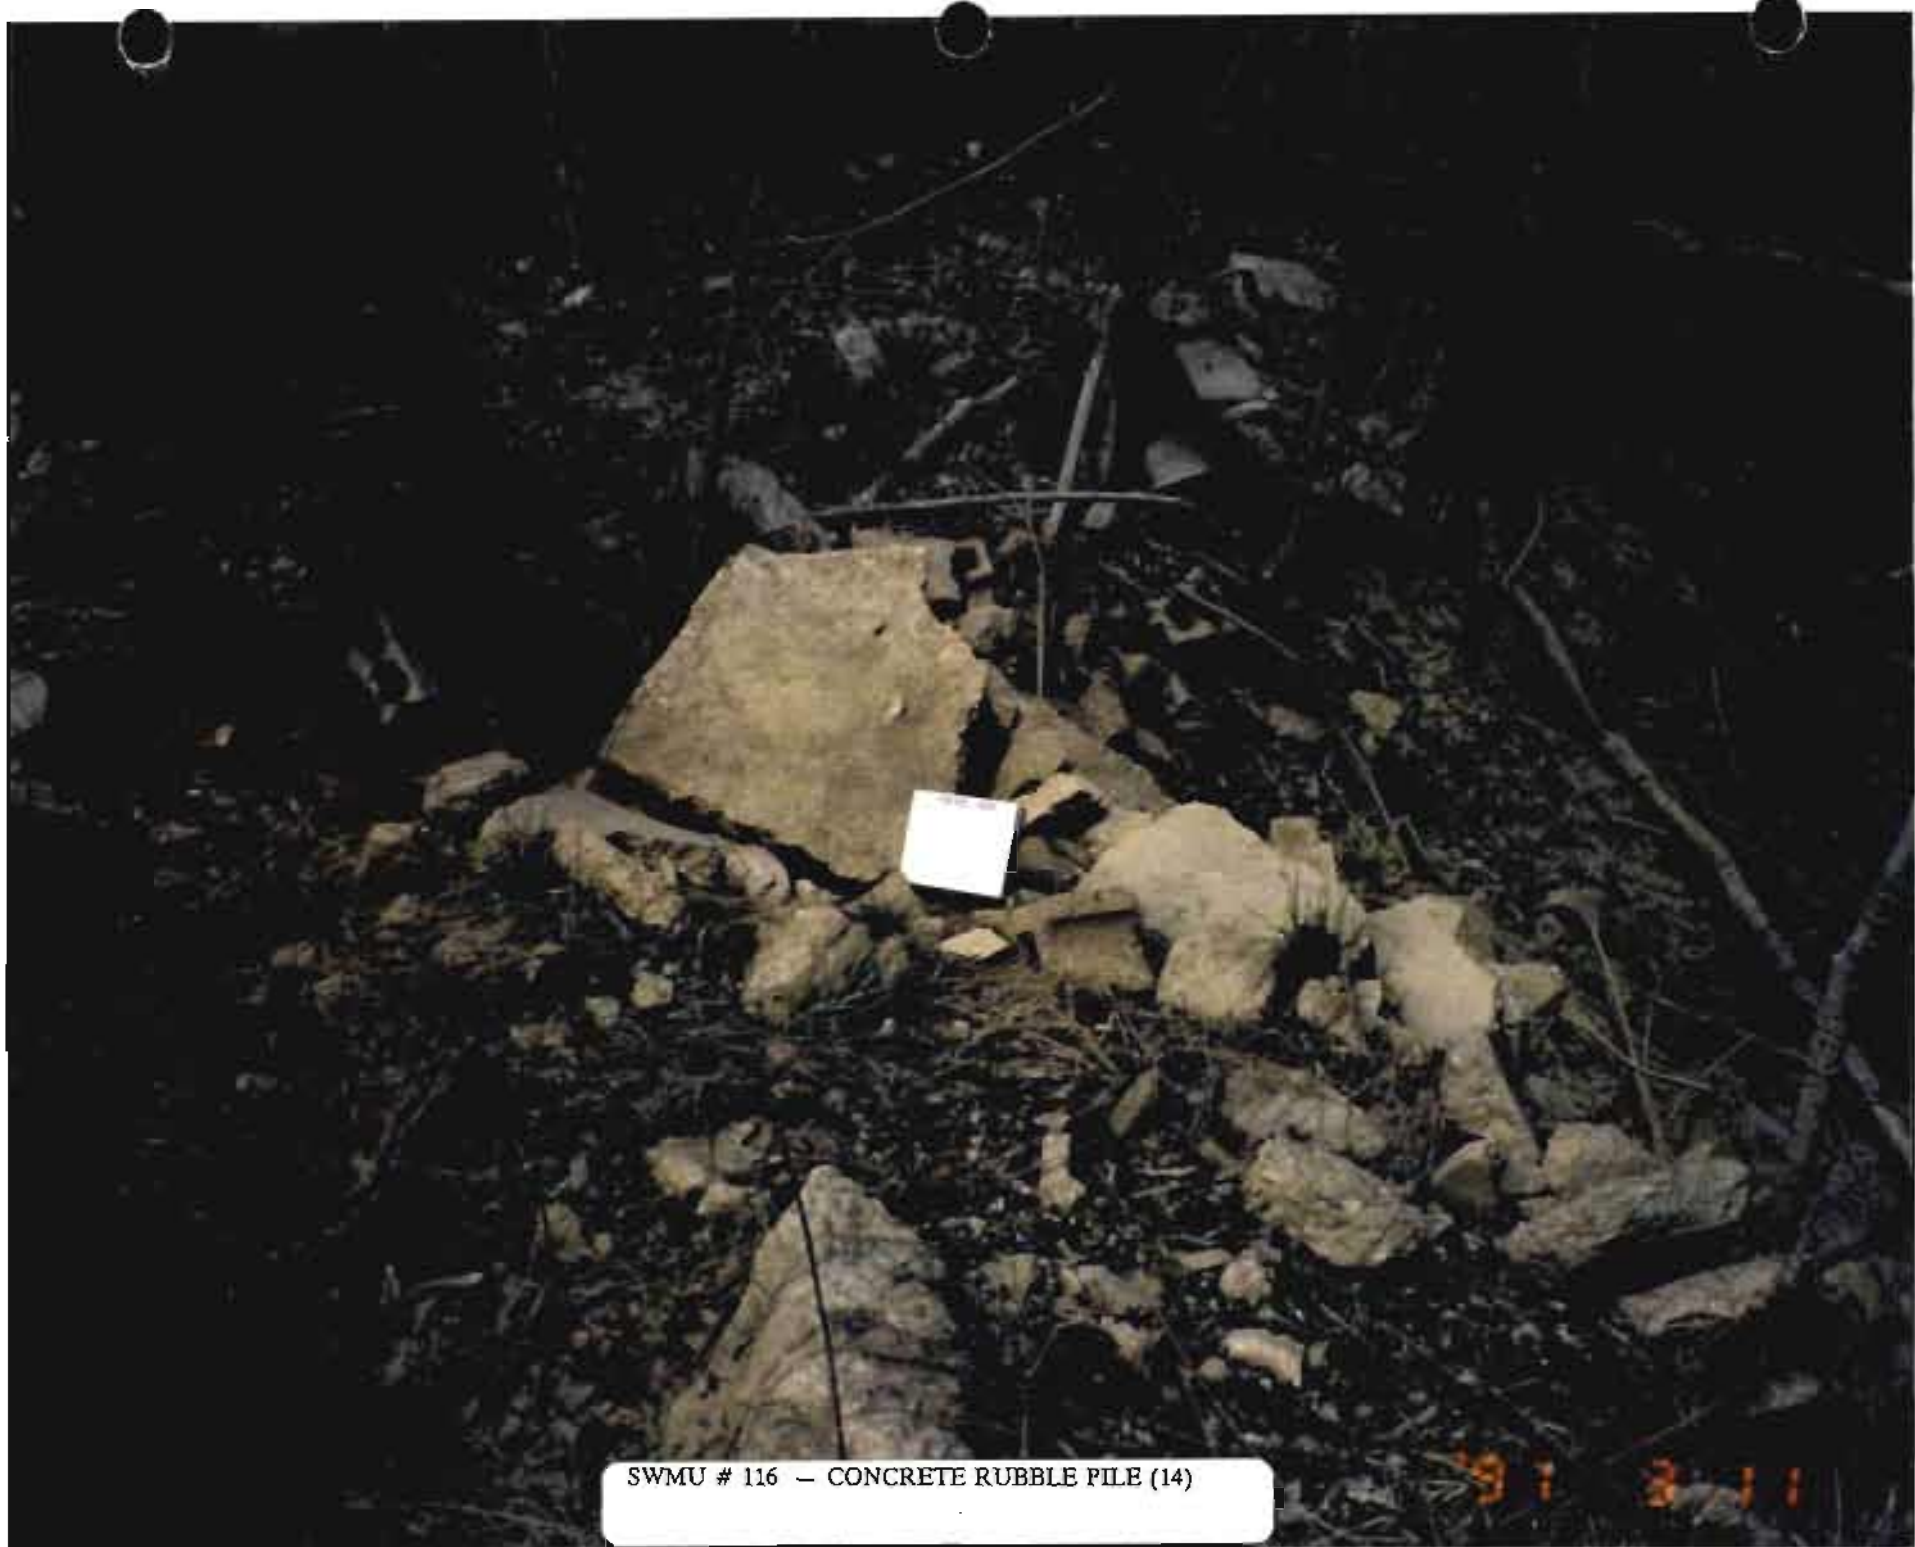
SWMU # 116 - CONCRETE RUBBLE PILE (14)

DOCUMENTATION OF NO RELEASE: Beta/Gamma and Soil Gamma surveys revealed no detectable contamination over background.

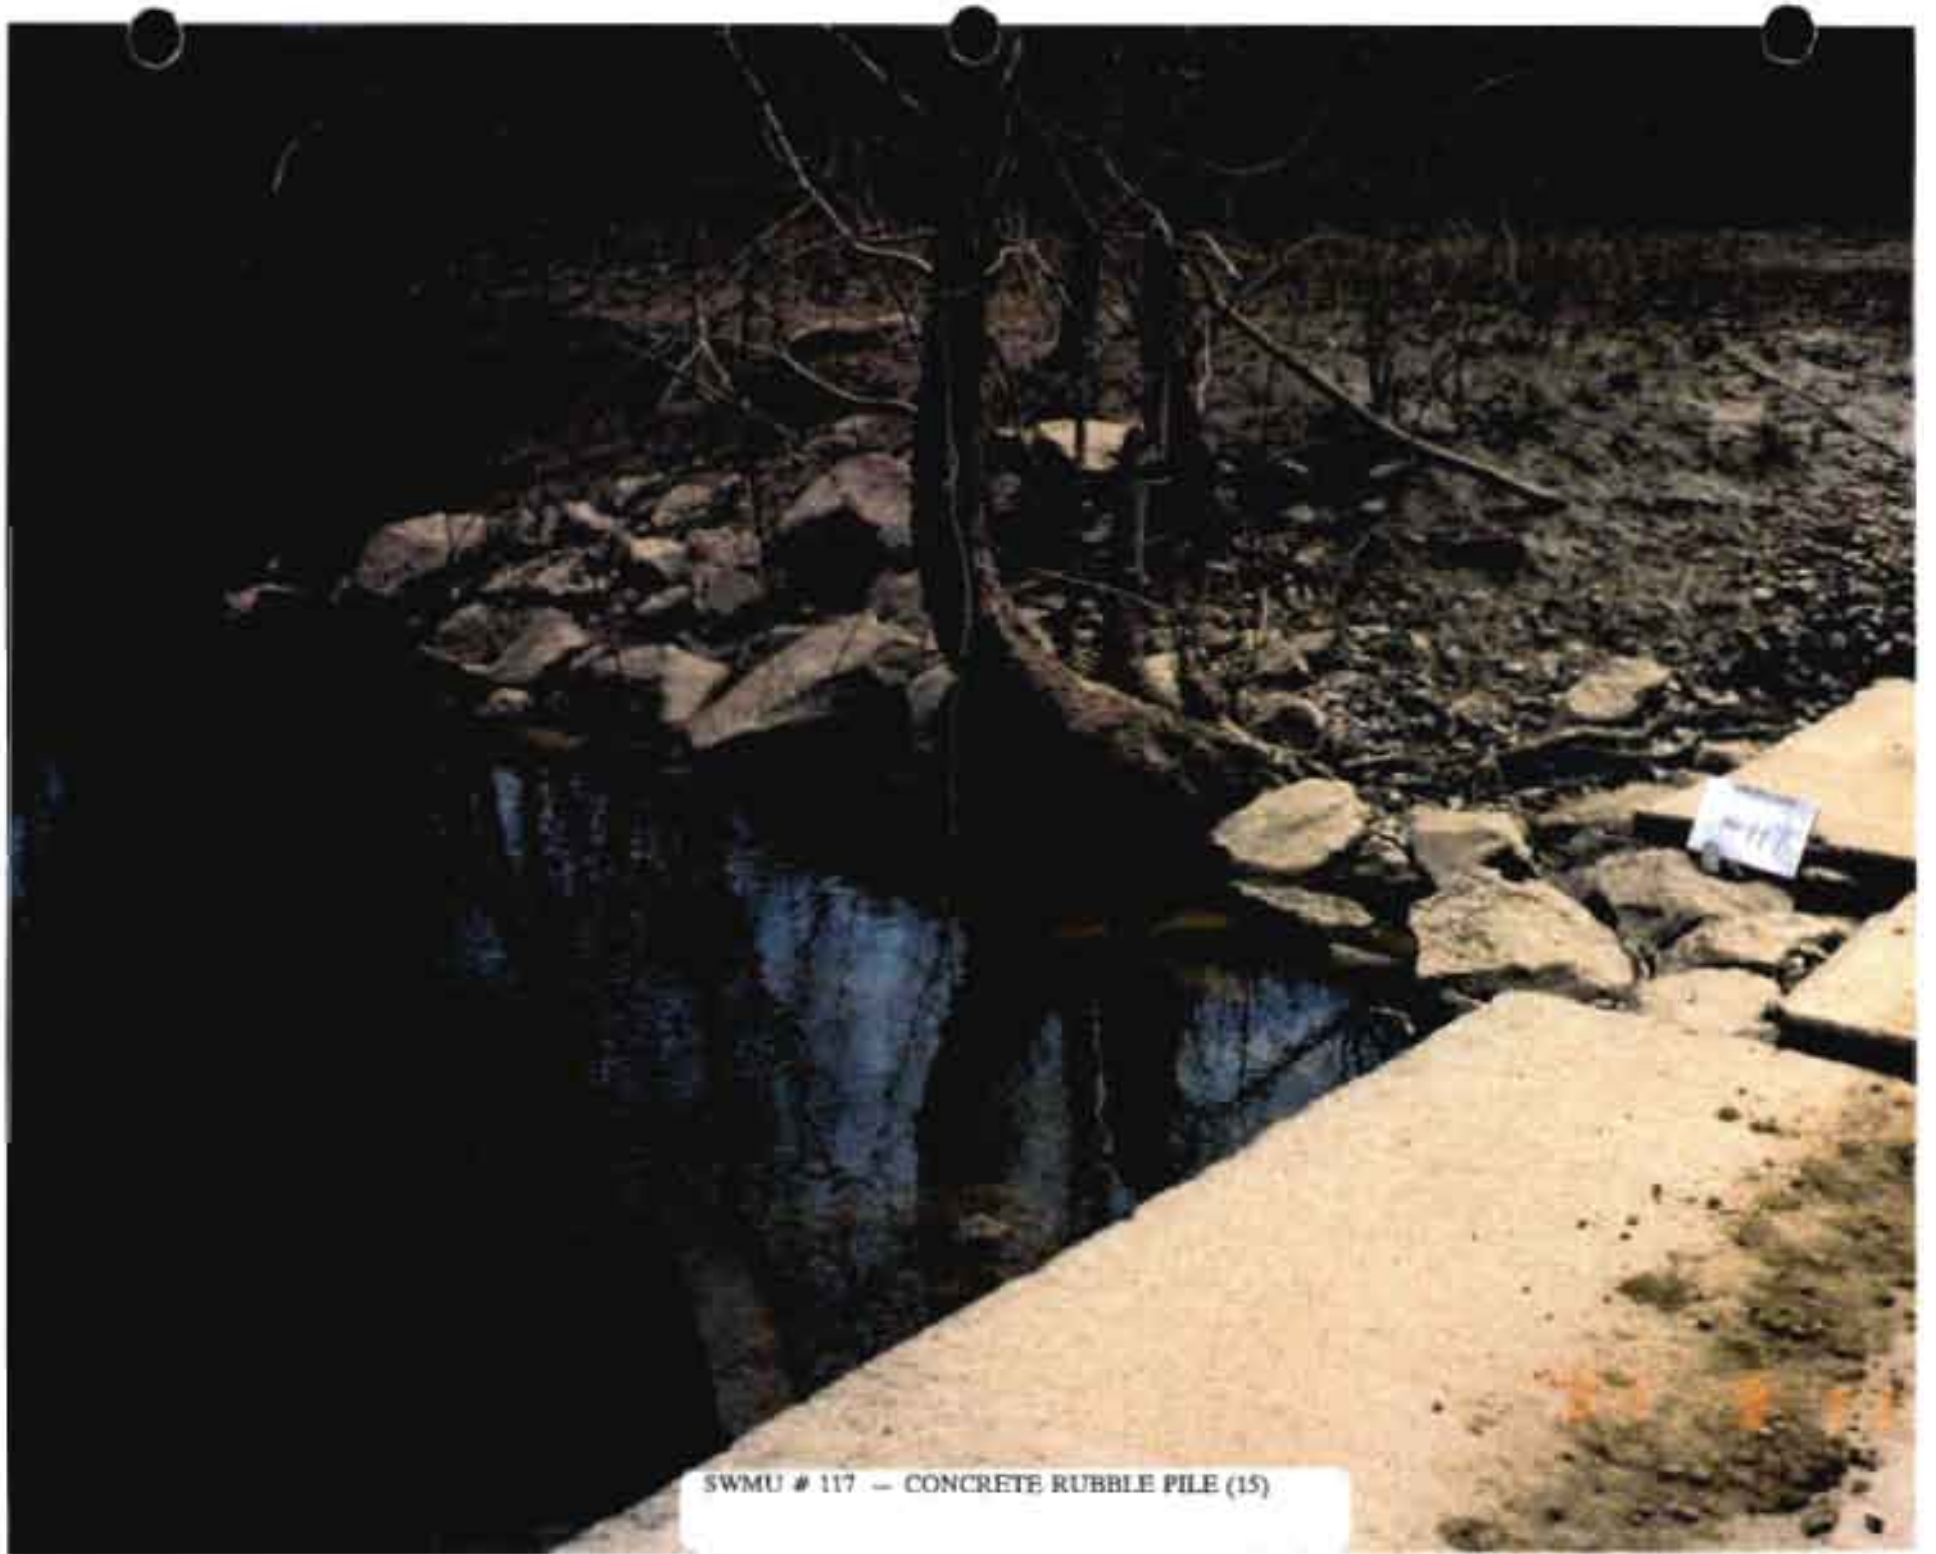
SWMU # 117 -- CONCRETE RUBBLE PILE (15)

DESCRIPTION OF RELEASE: Beta/Gamma scan found one rock approx. 90 cpm over background.
