KY/B-262
Addendum 1
Volume 1
Revision 1

PADUCAH GASEOUS DIFFUSION PLANT

PRELIMINARY ASSESSMENT

PADUCAH GASEOUS DIFFUSION PLANT
SOLID WASTE MANAGEMENT UNITS

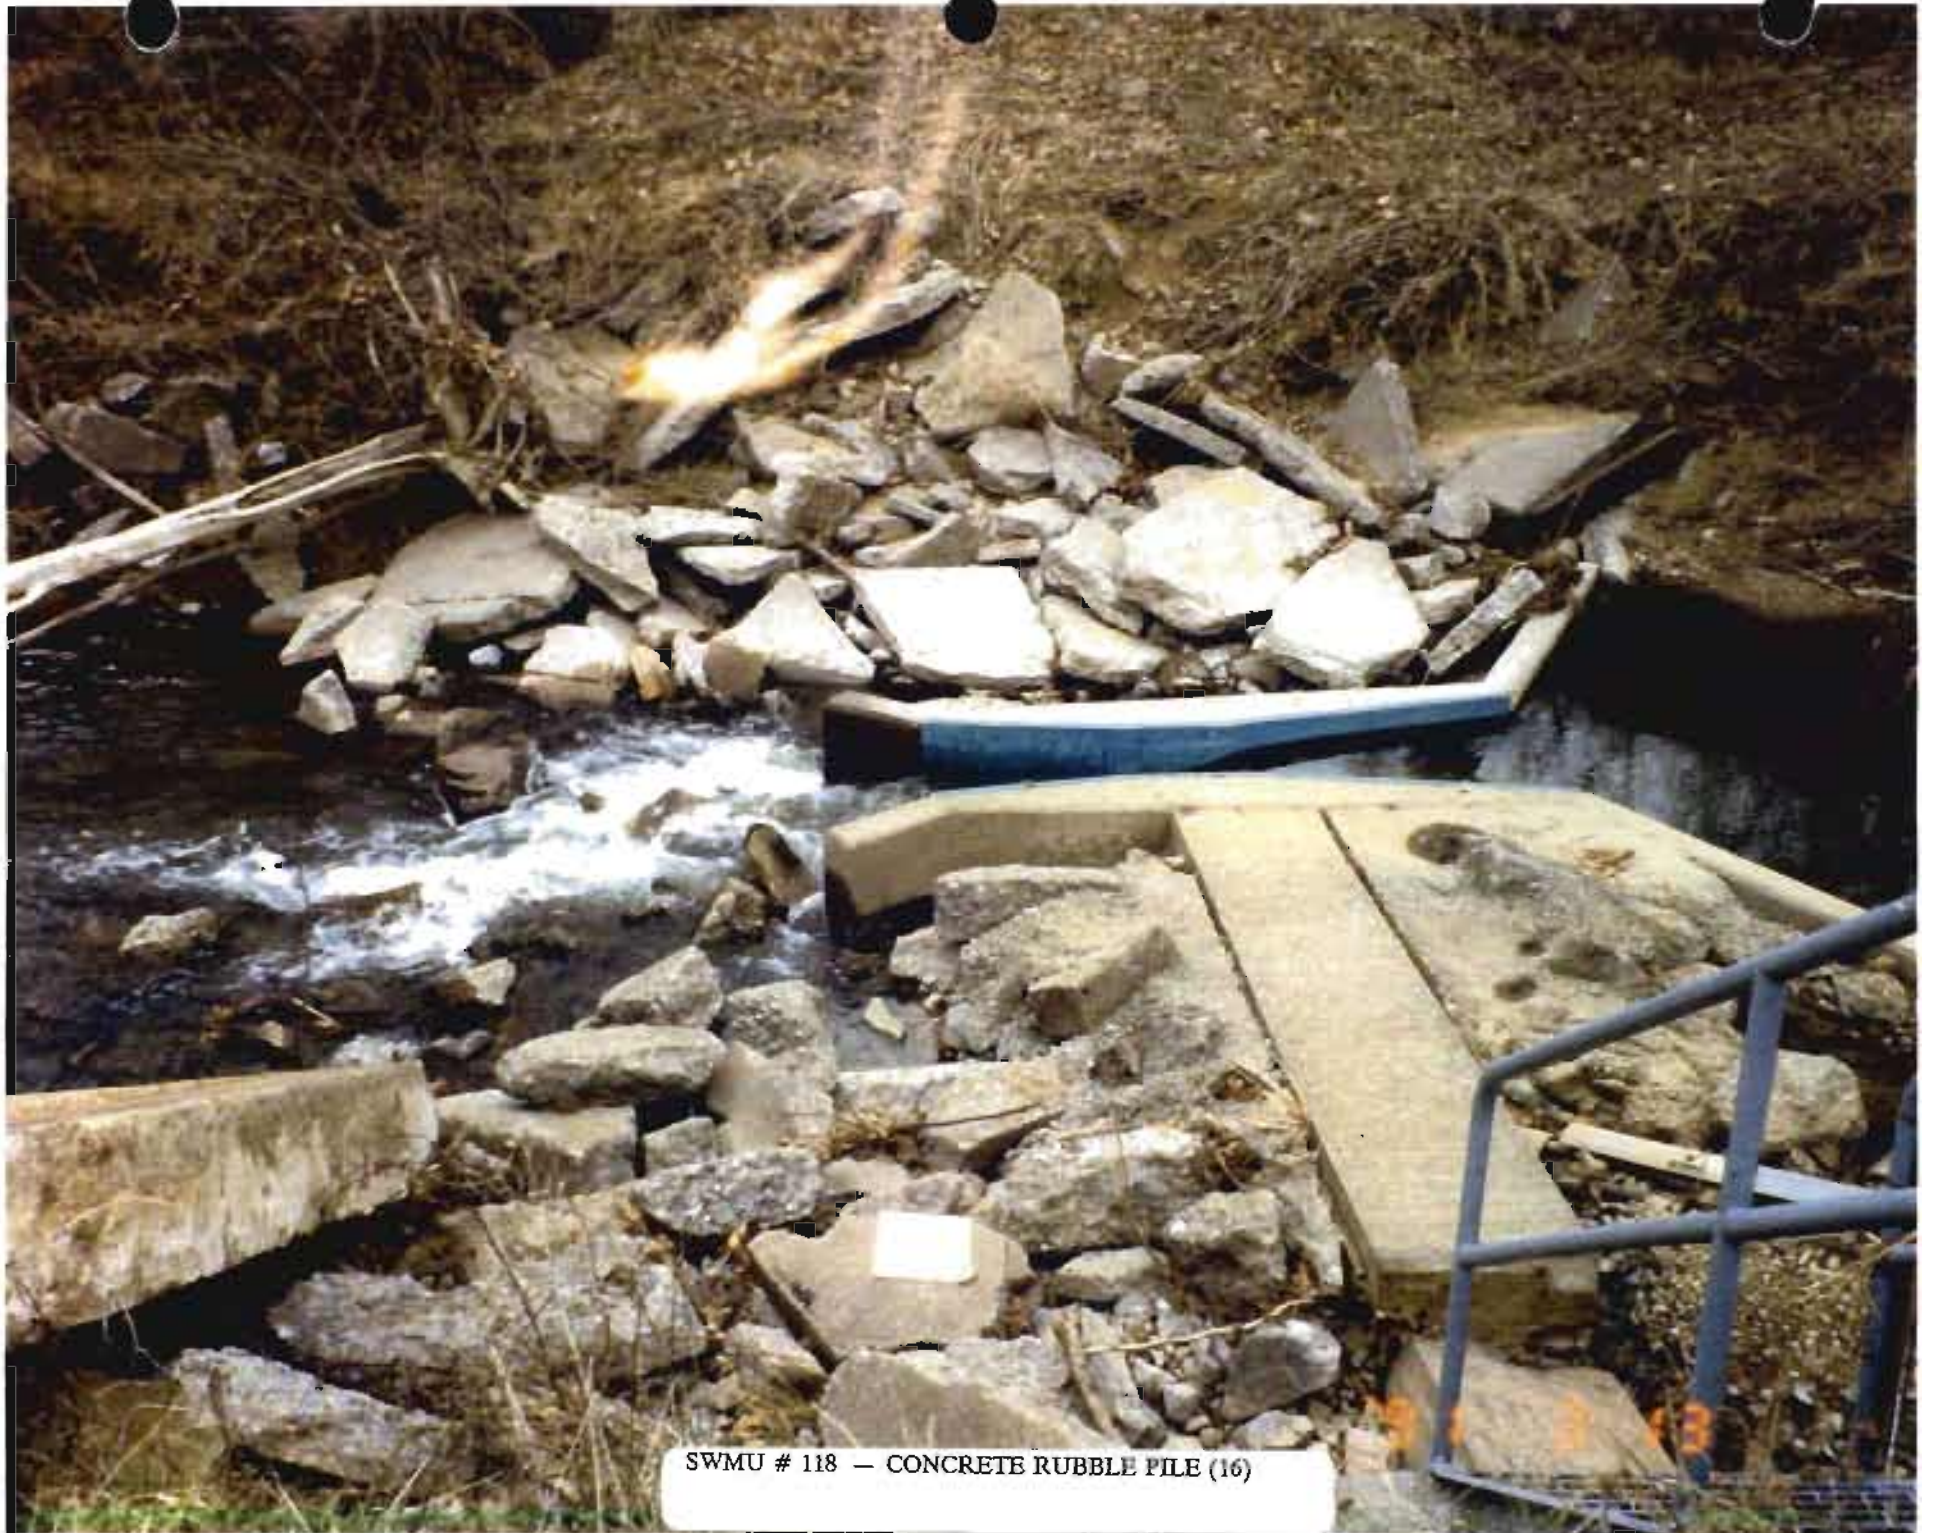
SWMU # 118 — CONCRETE RUBBLE PILE (16)

DESCRIPTION OF RELEASE: Performed Beta/Gamma scan on rubble and found an
average of approx. 80 cpm above background on
4 ft x 8 ft concrete slab

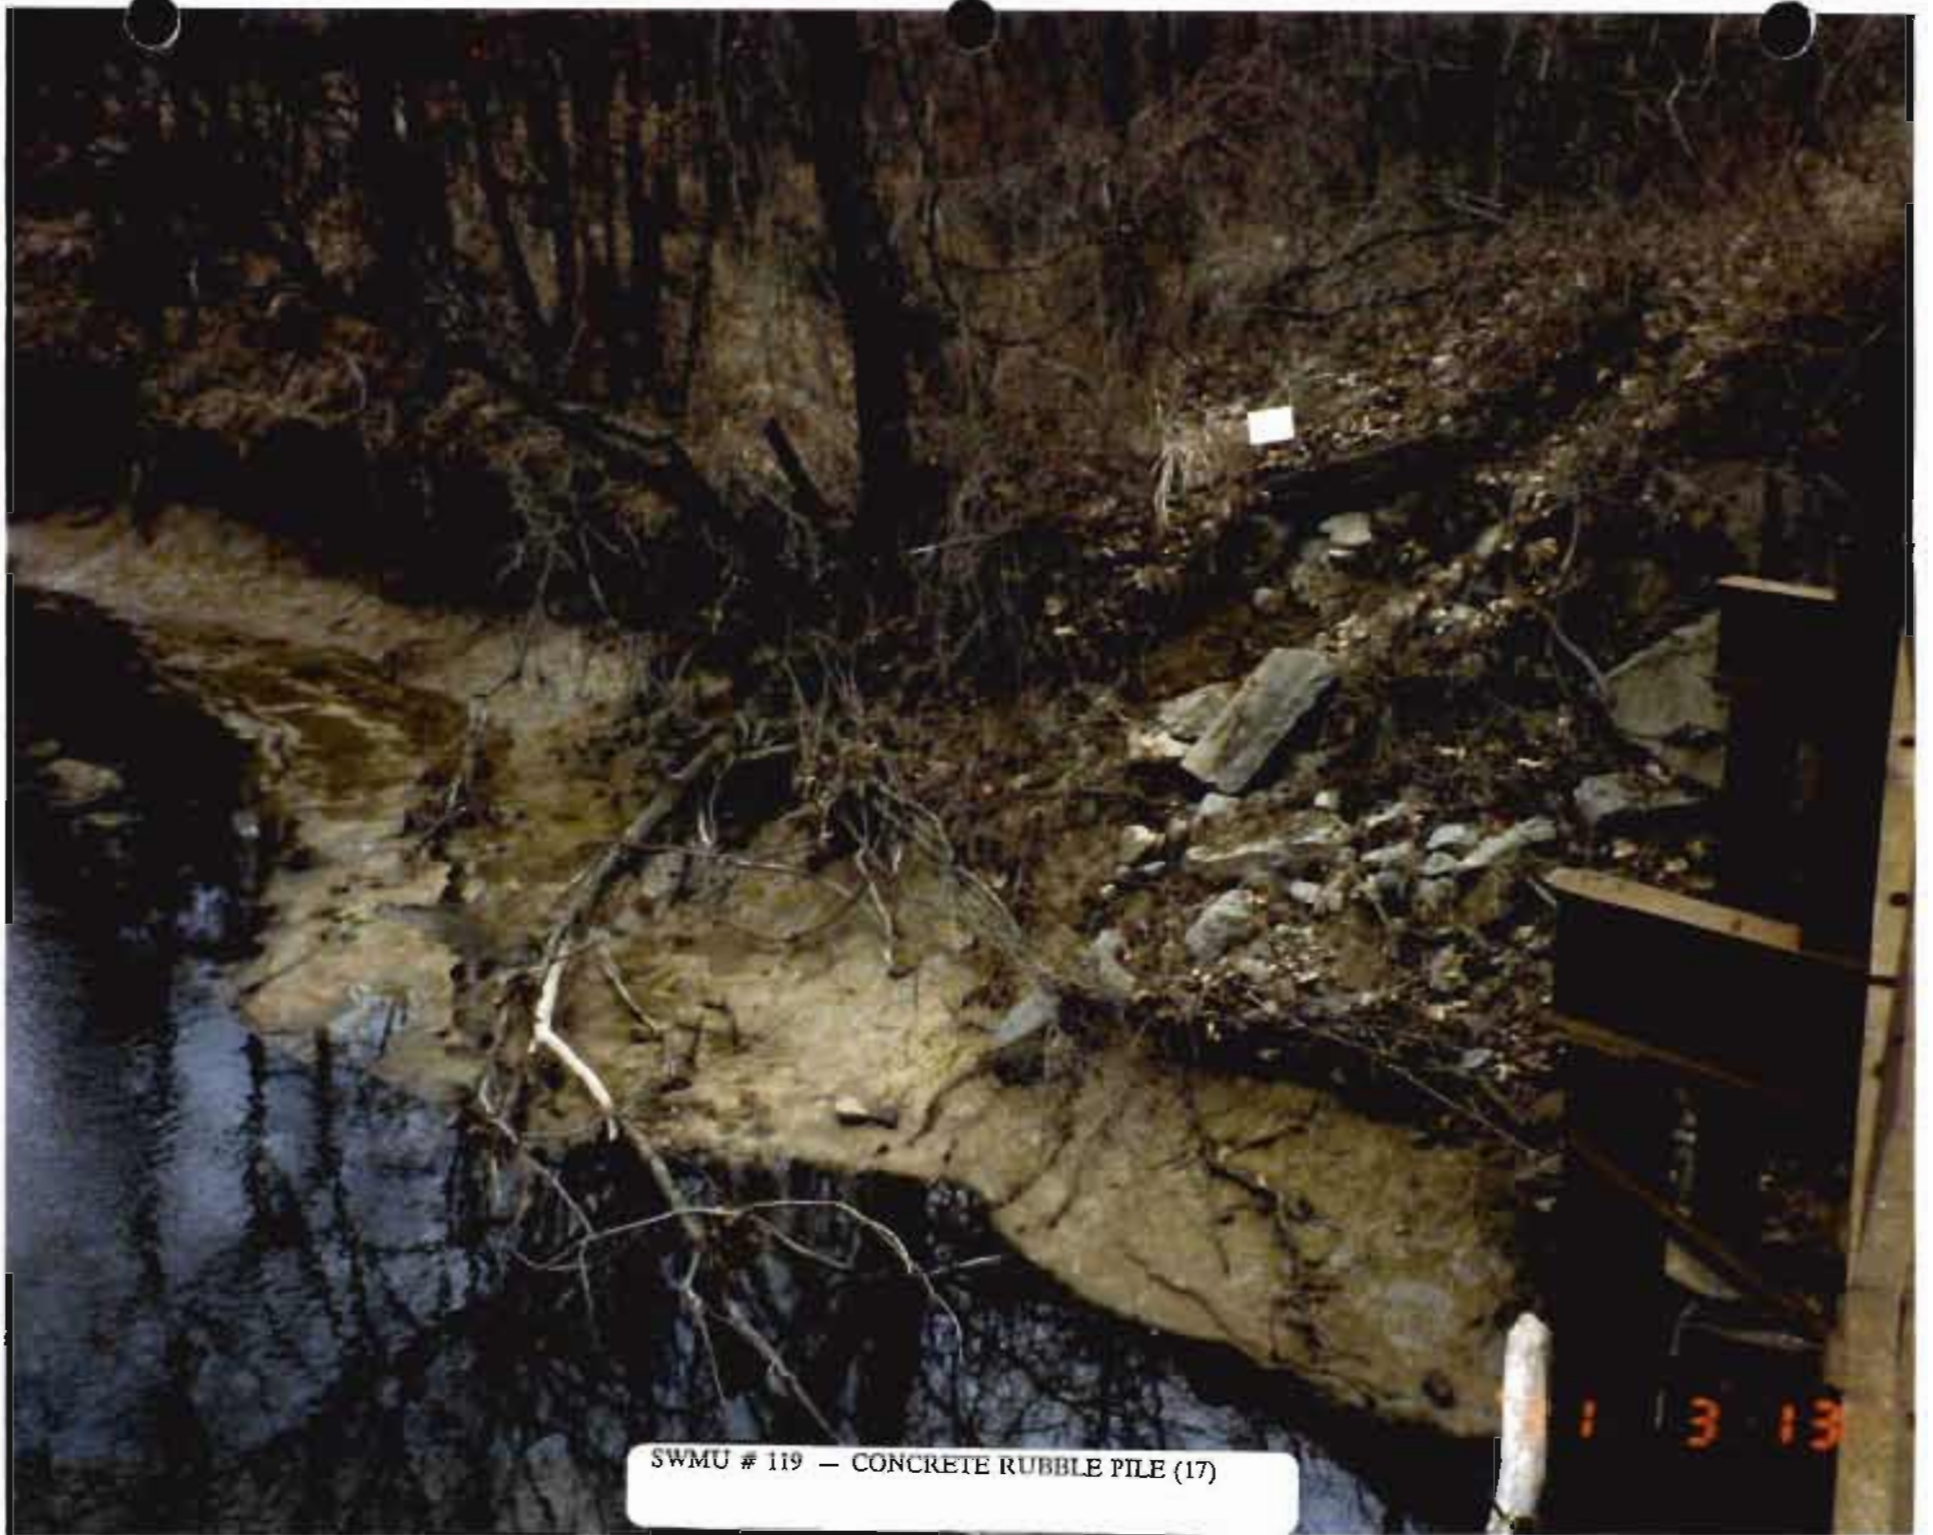
SWMU # 119 - CONCRETE RUBBLE PILE (17)

SITE/PROCESS DESCRIPTION: Iron bridge replaced wooden structure. Slabs of concrete were placed on creek bank - upstream, under, and downstream of the bridge.

DOCUMENTATION OF NO RELEASE: No radiological contamination was found on rubble or soil.

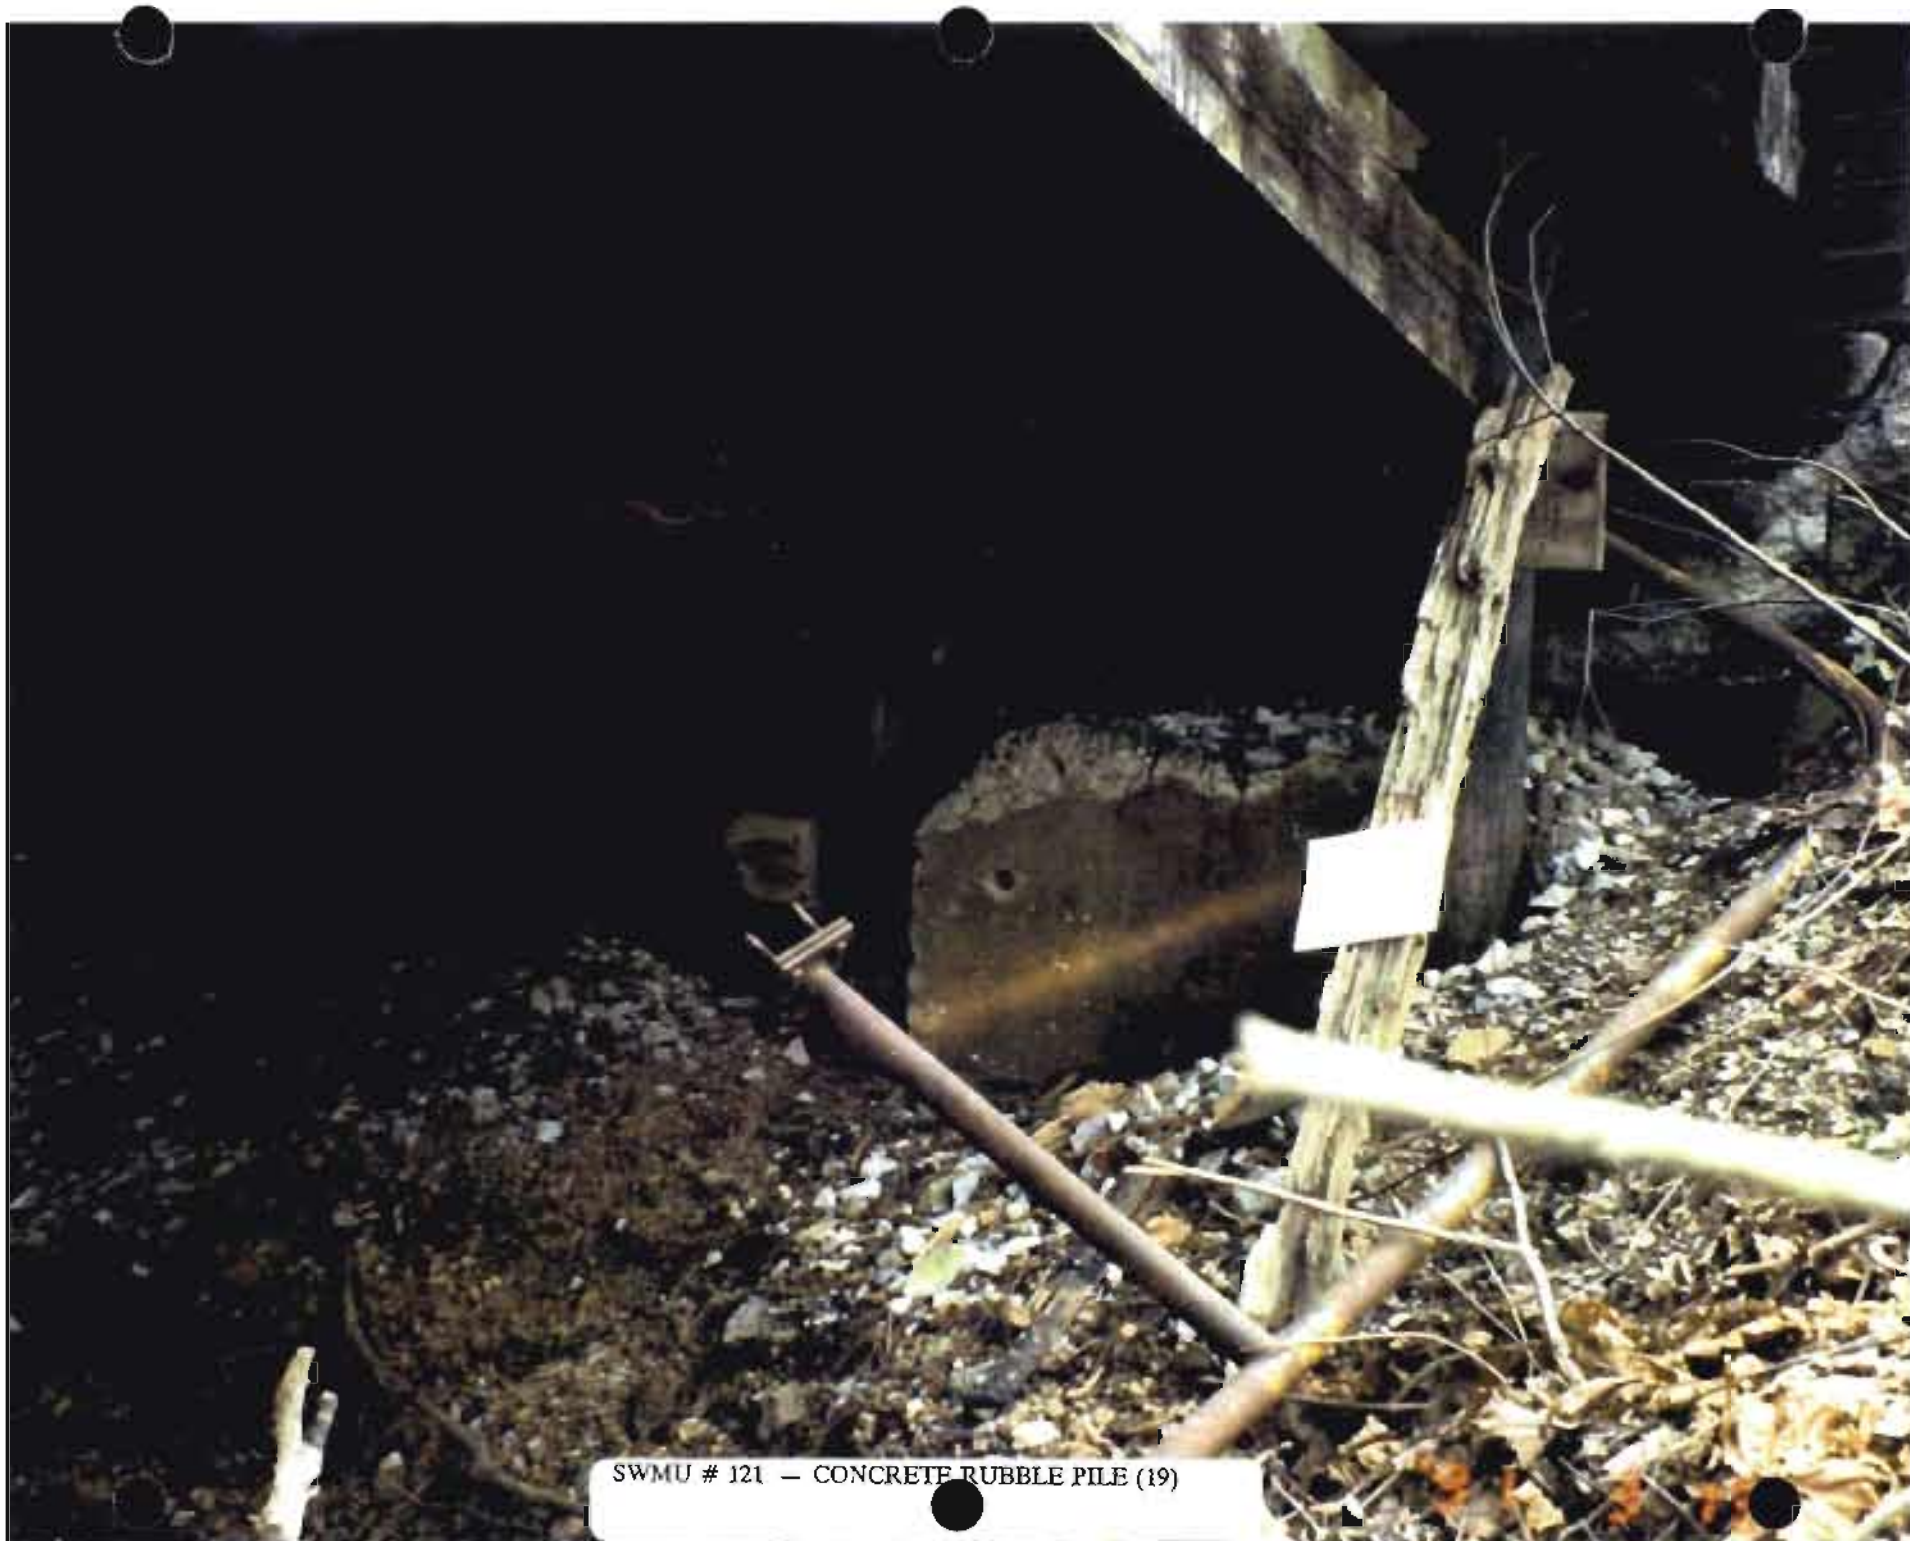
SWMU # 121 - CONCRETE RUBBLE PILE (19)

DESCRIPTION OF RELEASE: The survey found the concrete slabs used for the bridge supports were contaminated. Readings were approx. 150 to 200 cpm.

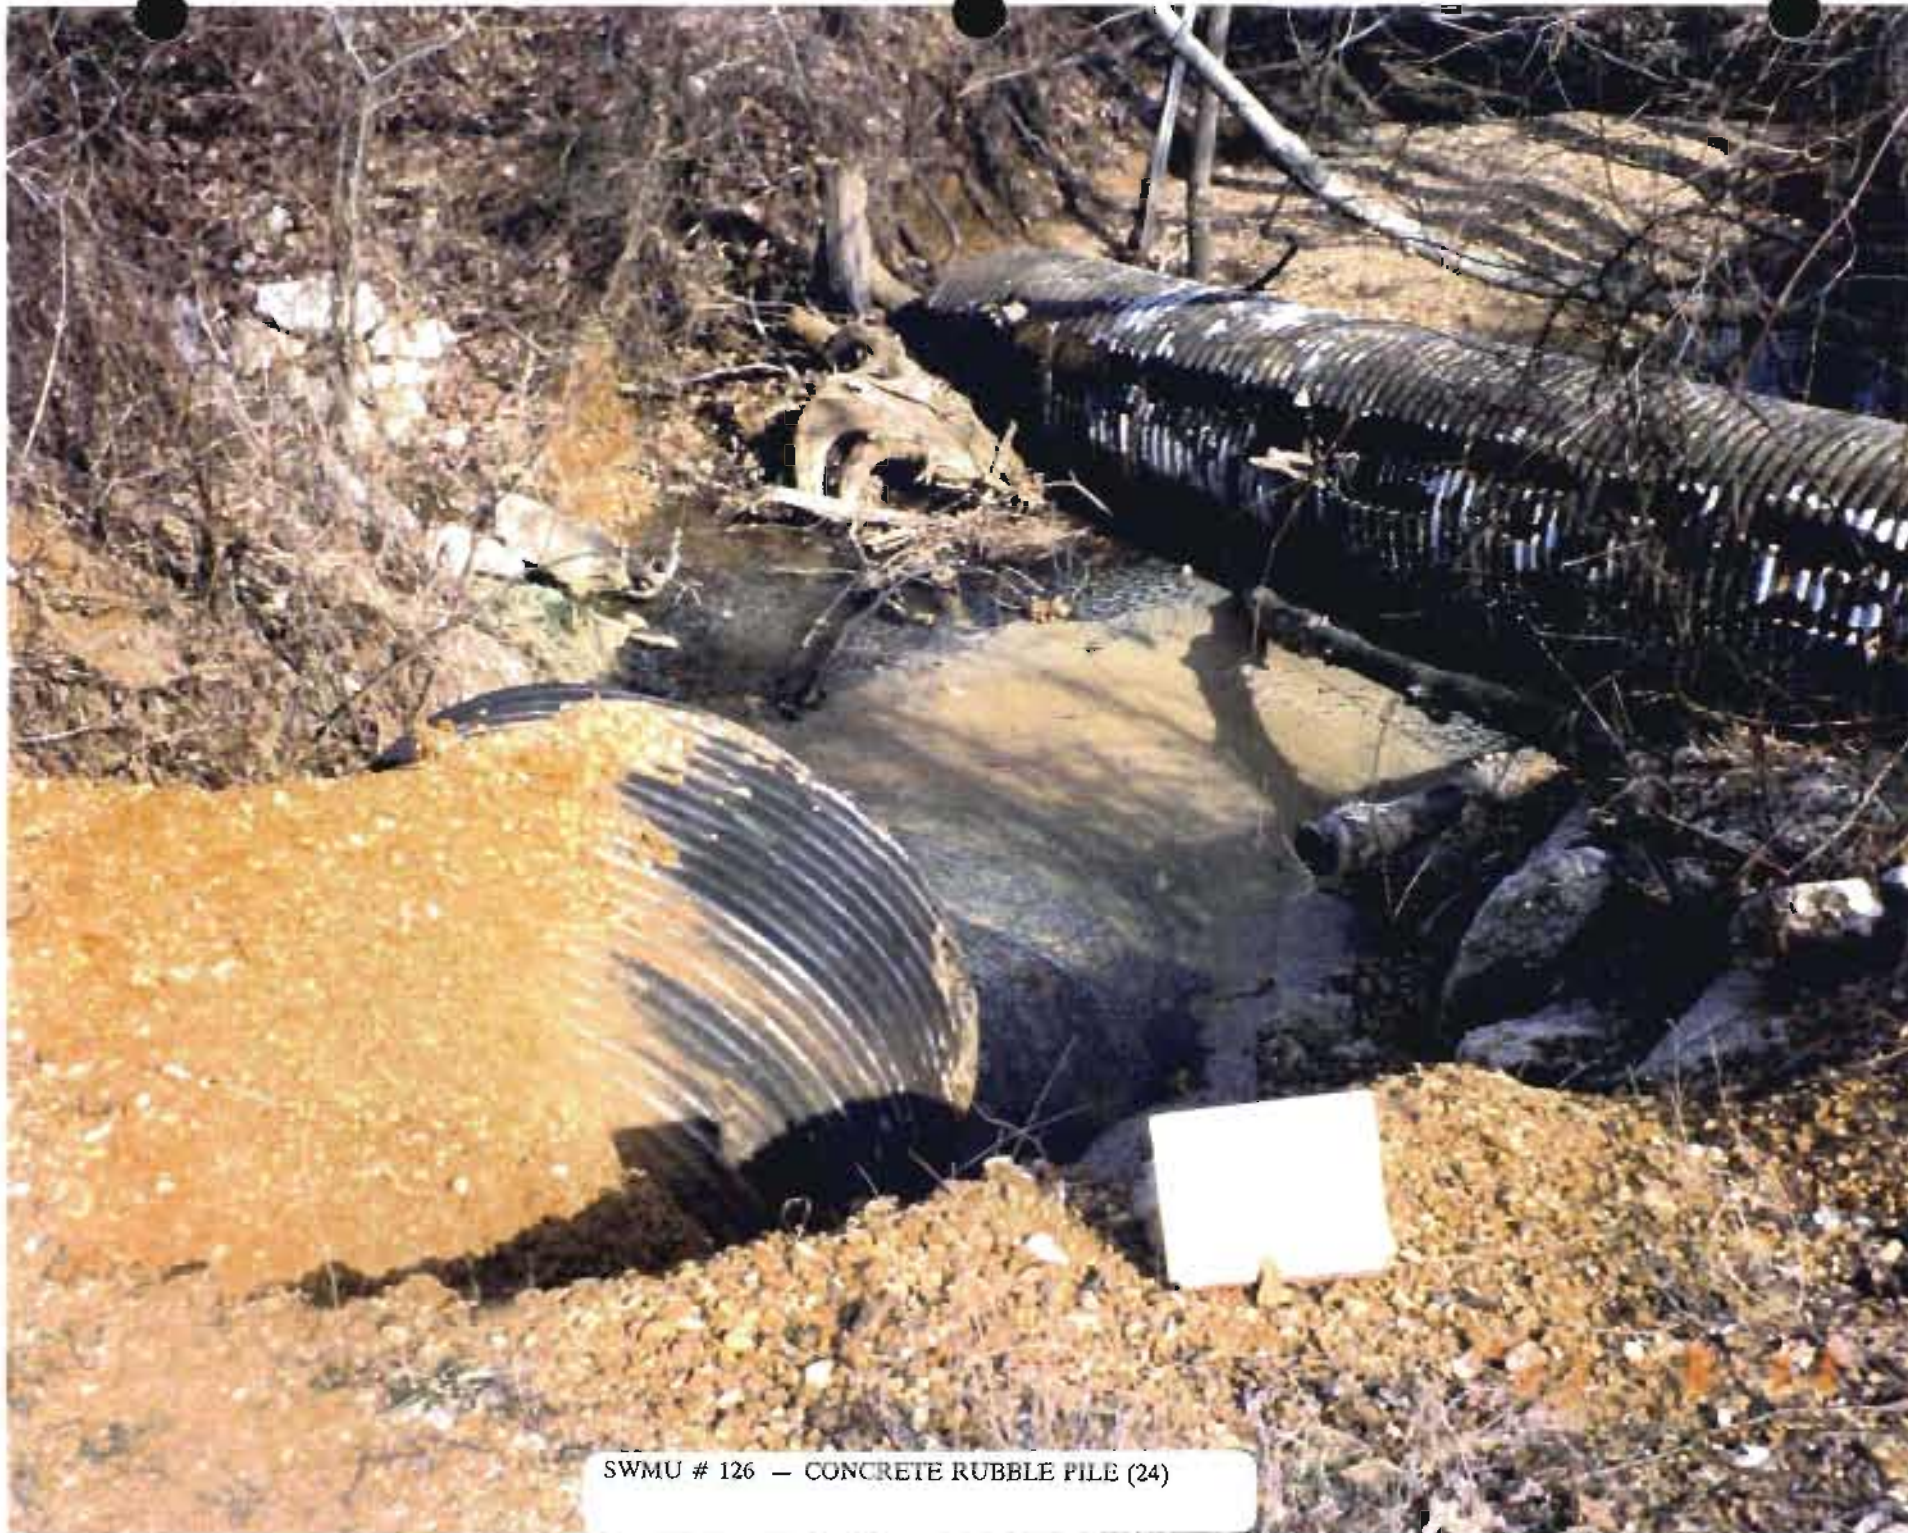
SWMU # 126 - CONCRETE RUBBLE PILE (24)

DOCUMENTATION OF NO RELEASE: No detectable radiation contamination was found

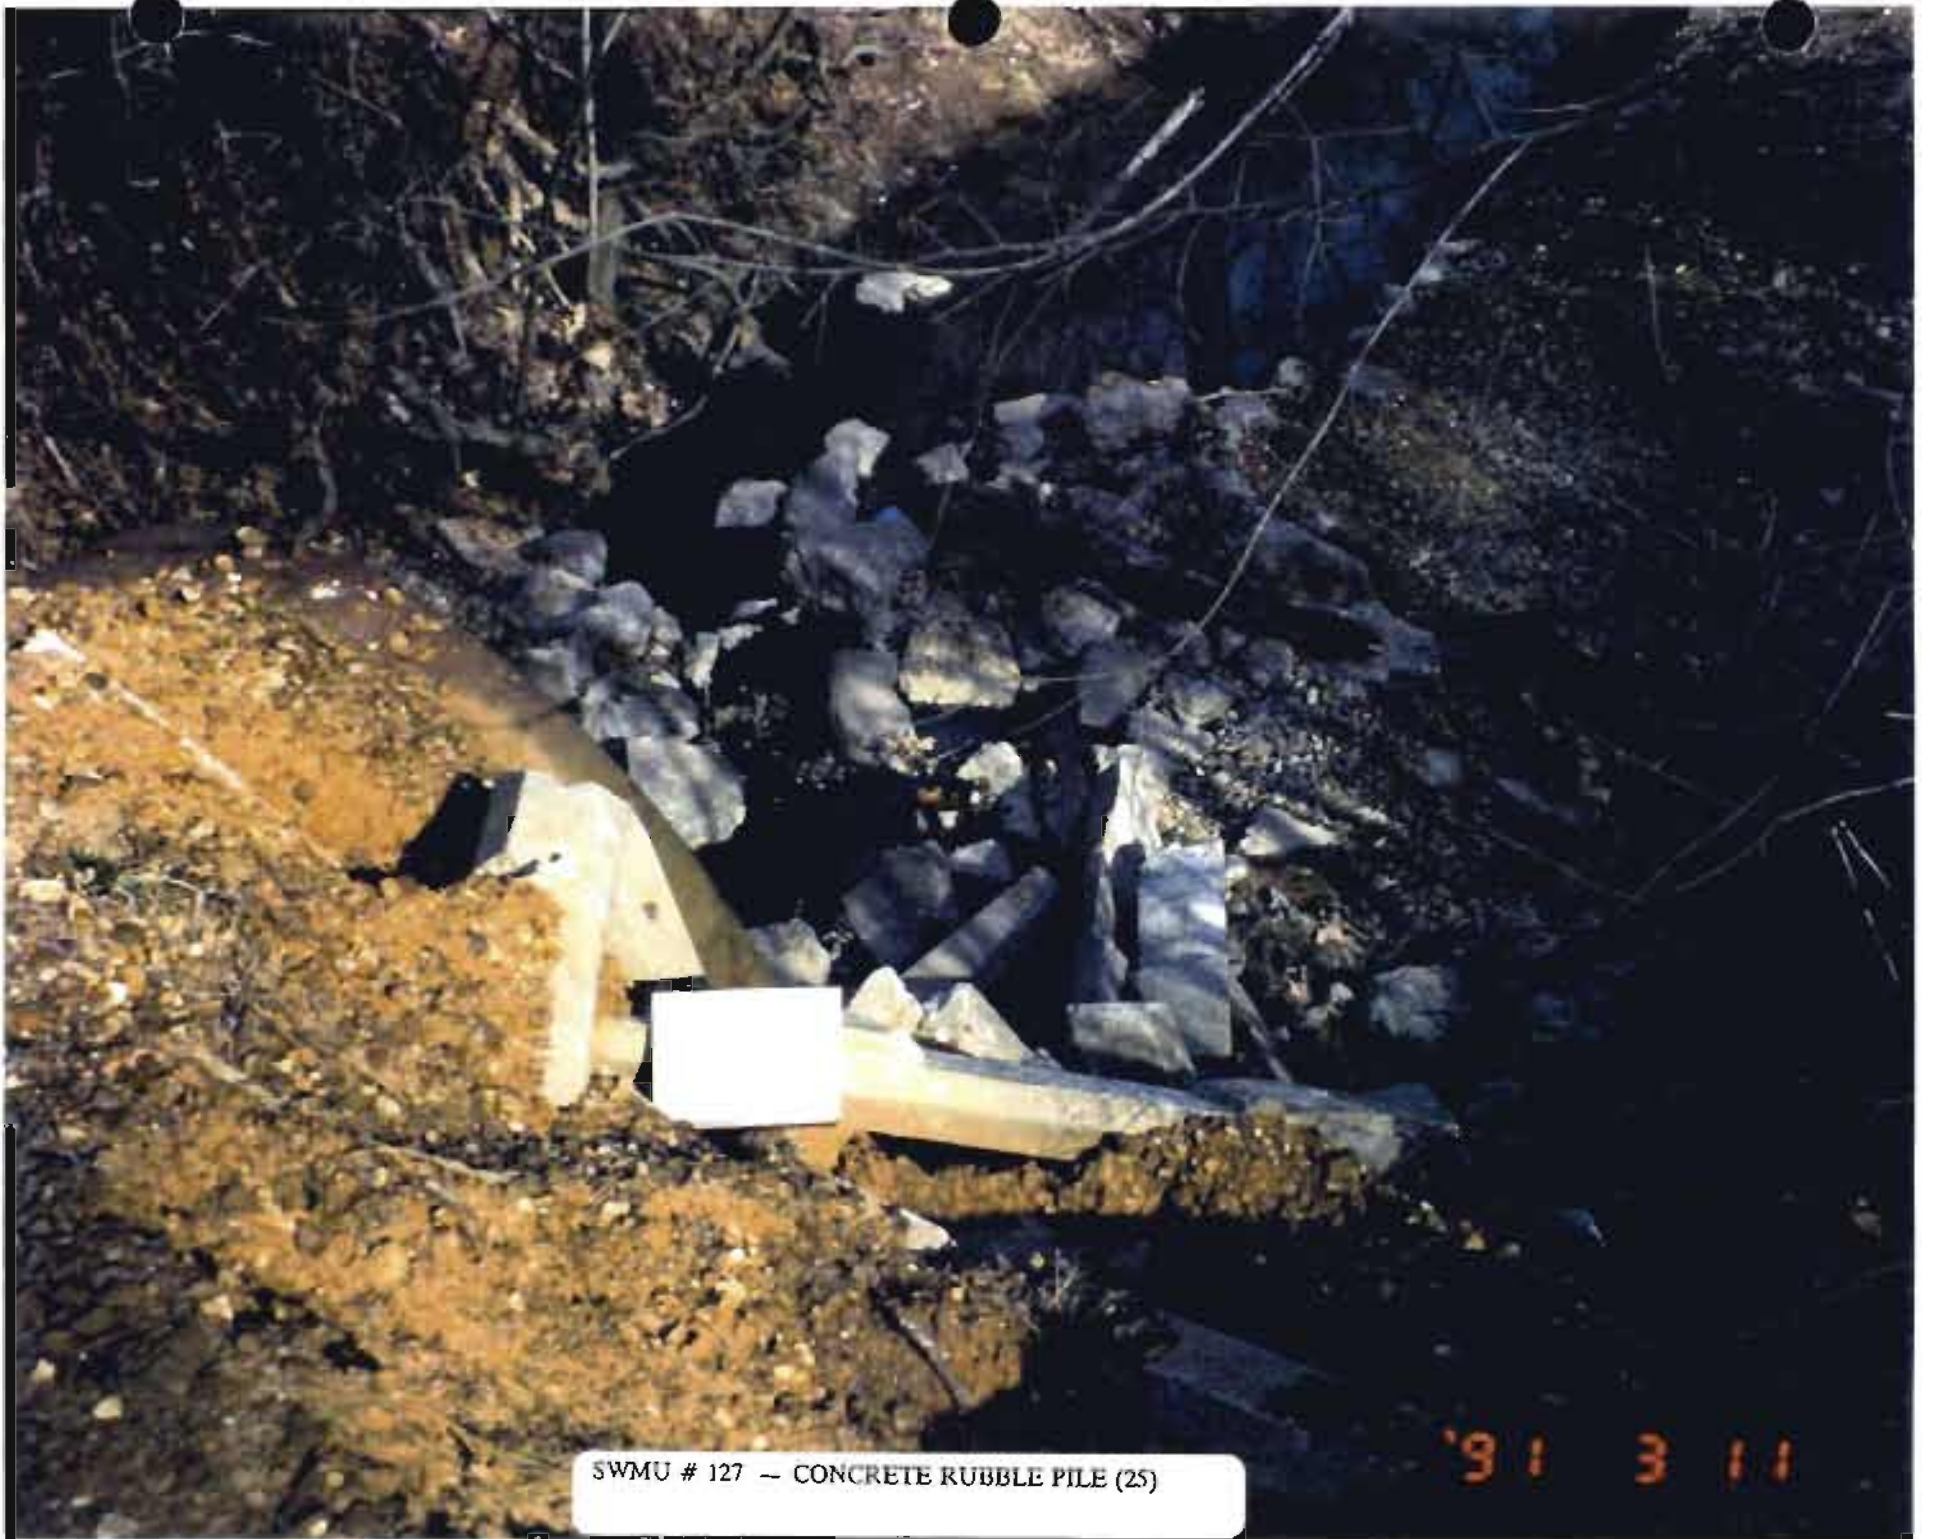
SWMU # 127 -- CONCRETE RUBBLE PILE (25)

DOCUMENTATION OF NO RELEASE: Rubble survey and soil survey found no detectable
radioactive contamination

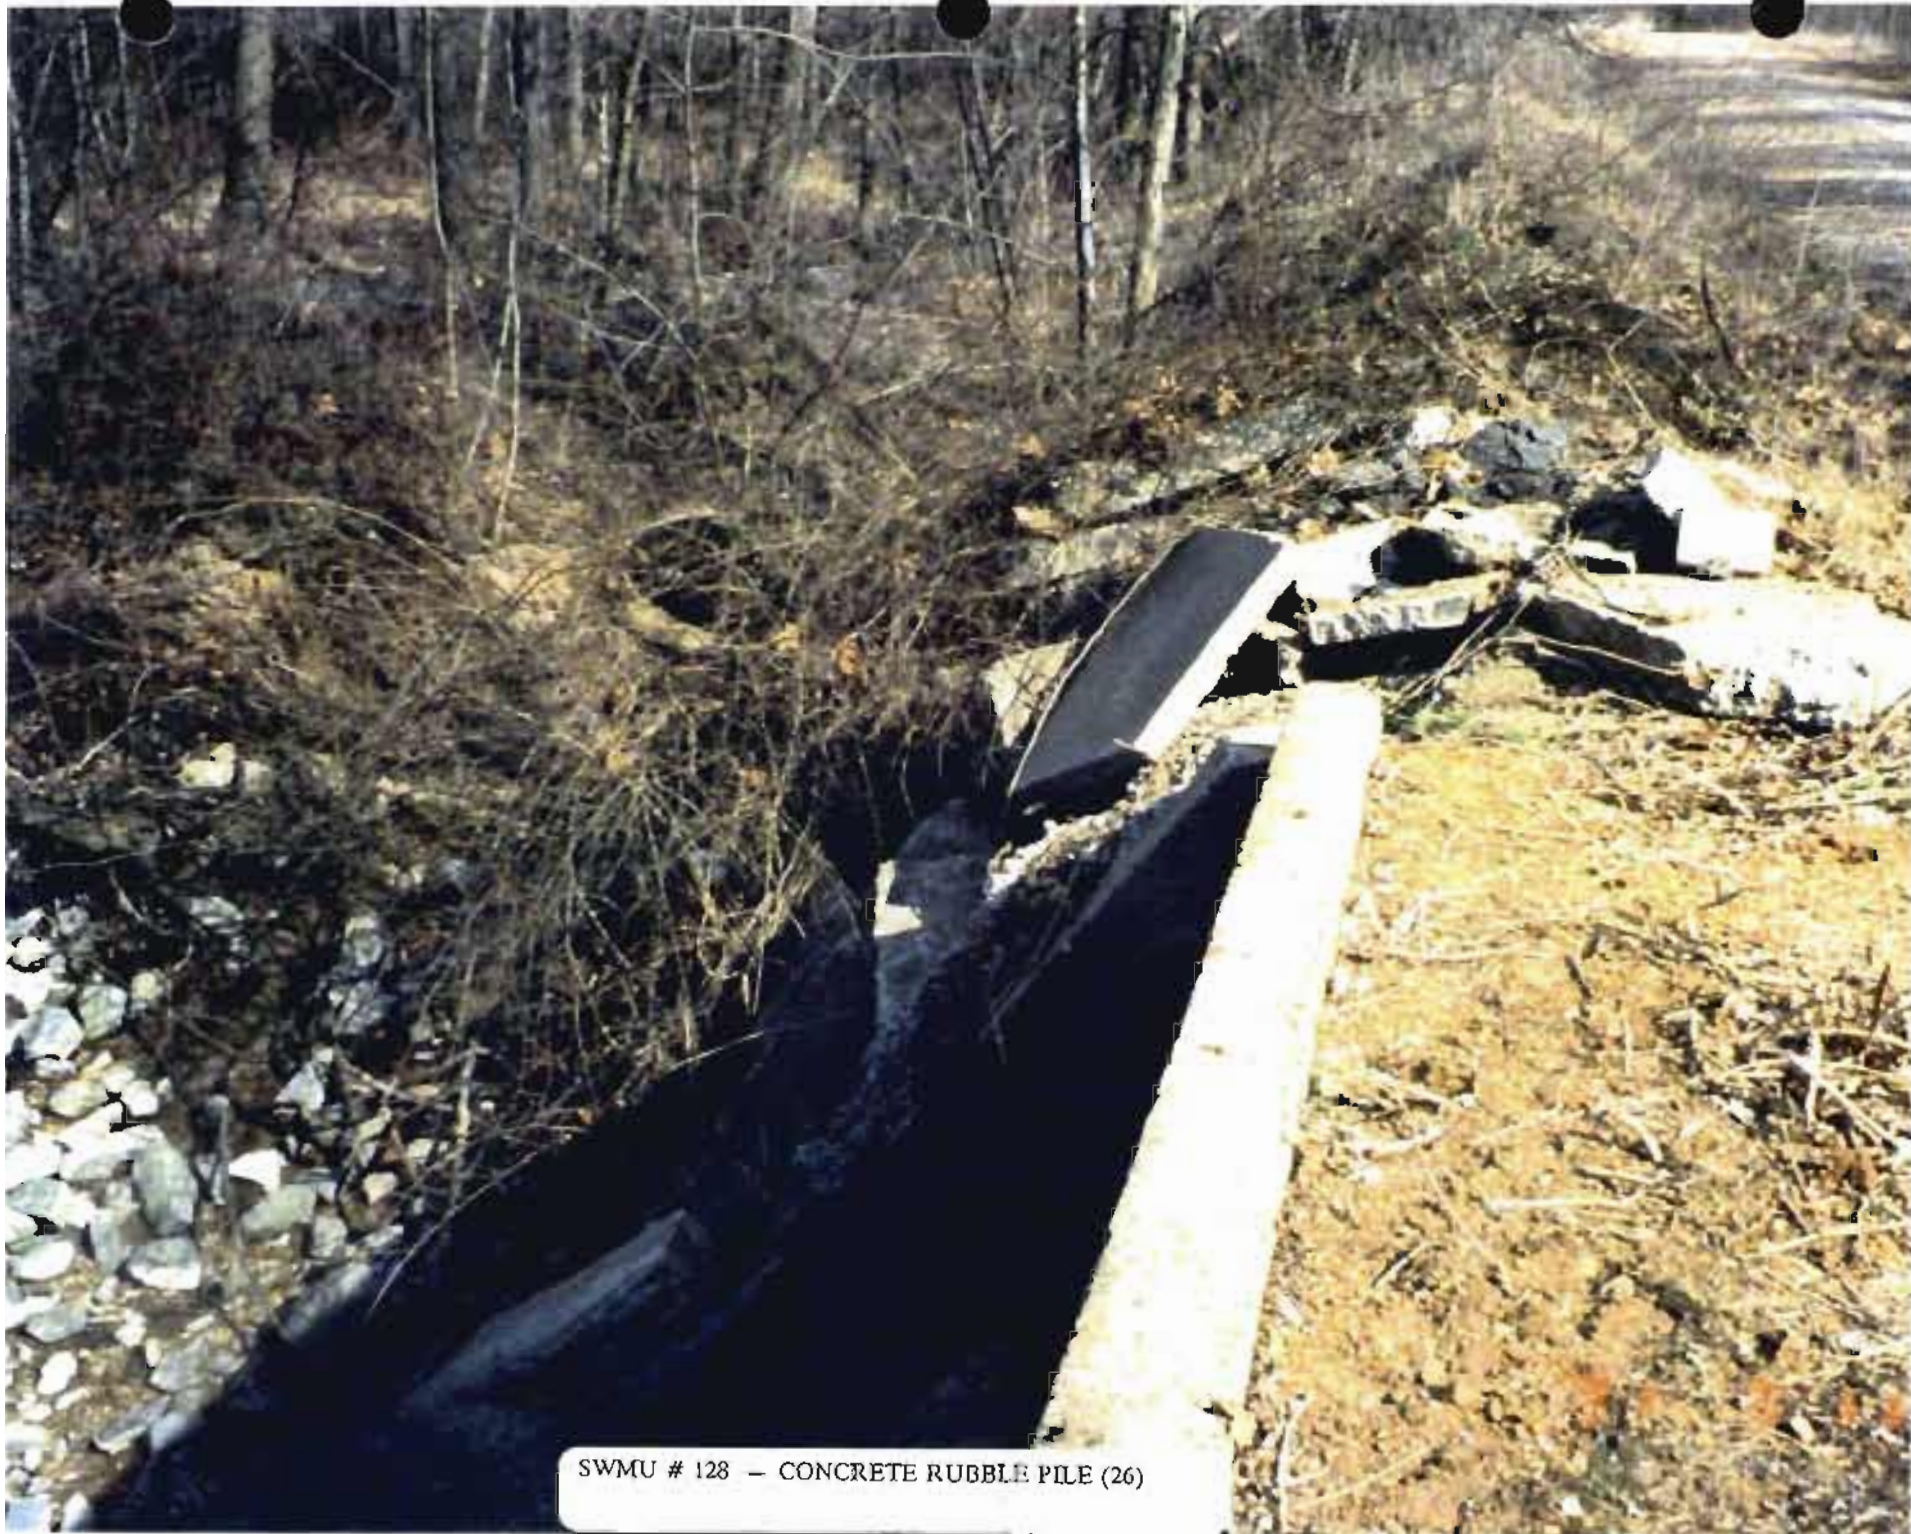
SWMU # 128 - CONCRETE RUBBLE PILE (26)

DOCUMENTATION OF NO RELEASE: Not available at this time

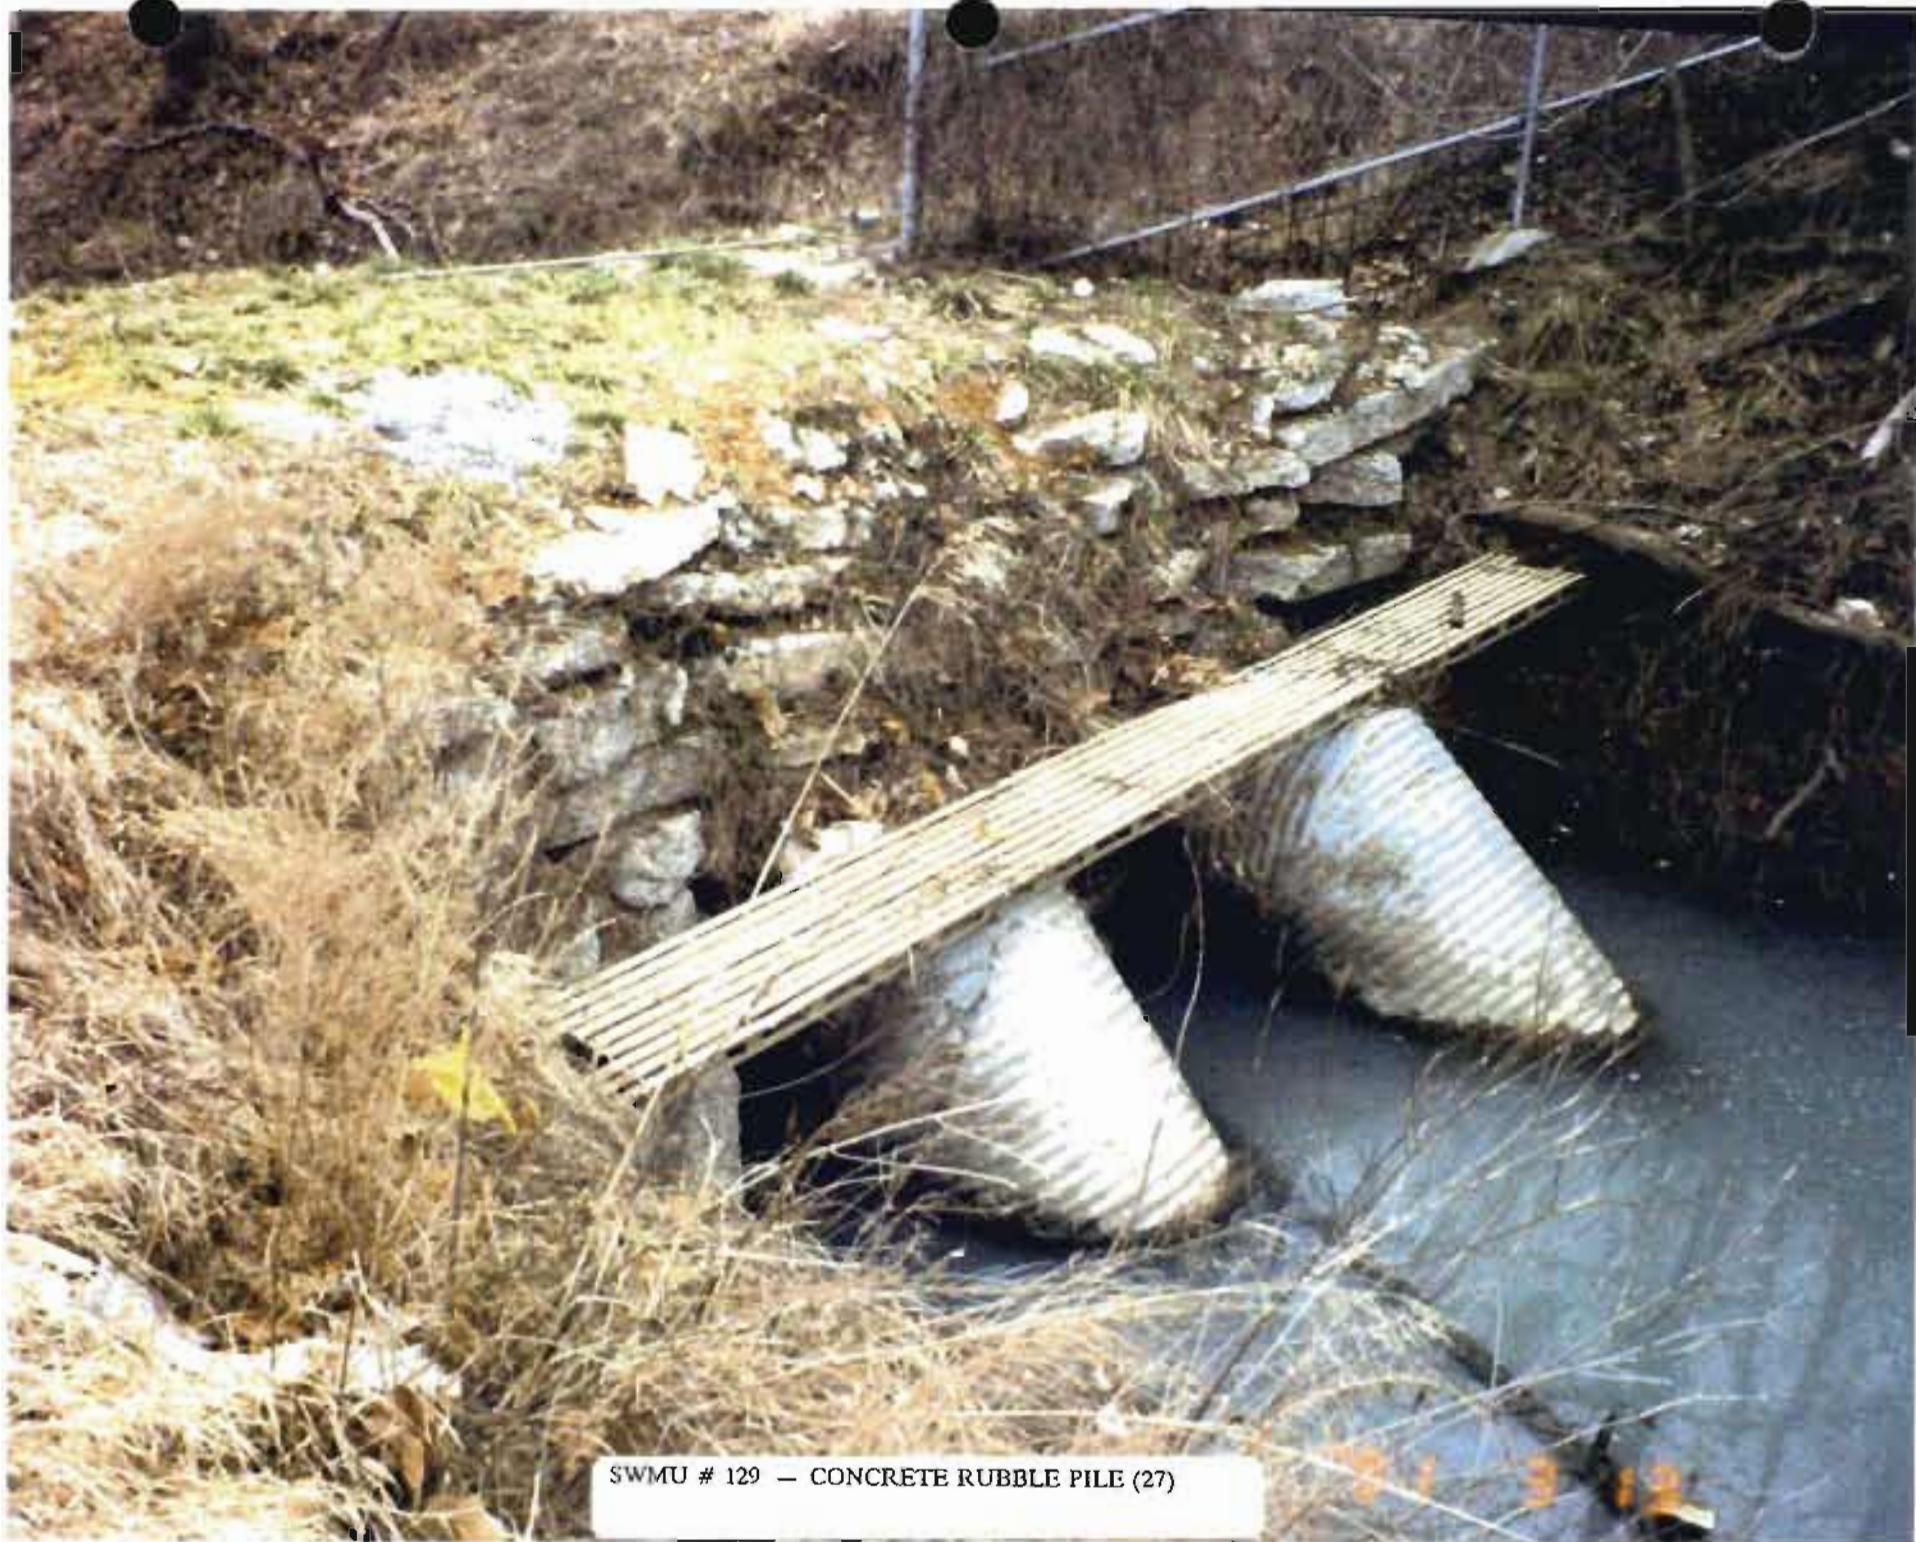
SWMU # 129 - CONCRETE RUBBLE PILE (27)

DOCUMENTATION OF NO RELEASE: Not available at this time
