KY/B-262
Addendum 1
Volume 1
Revision 1

PADUCAH GASEOUS DIFFUSION PLANT

PRELIMINARY ASSESSMENT

PADUCAH GASEOUS DIFFUSION PLANT
SOLID WASTE MANAGEMENT UNITS

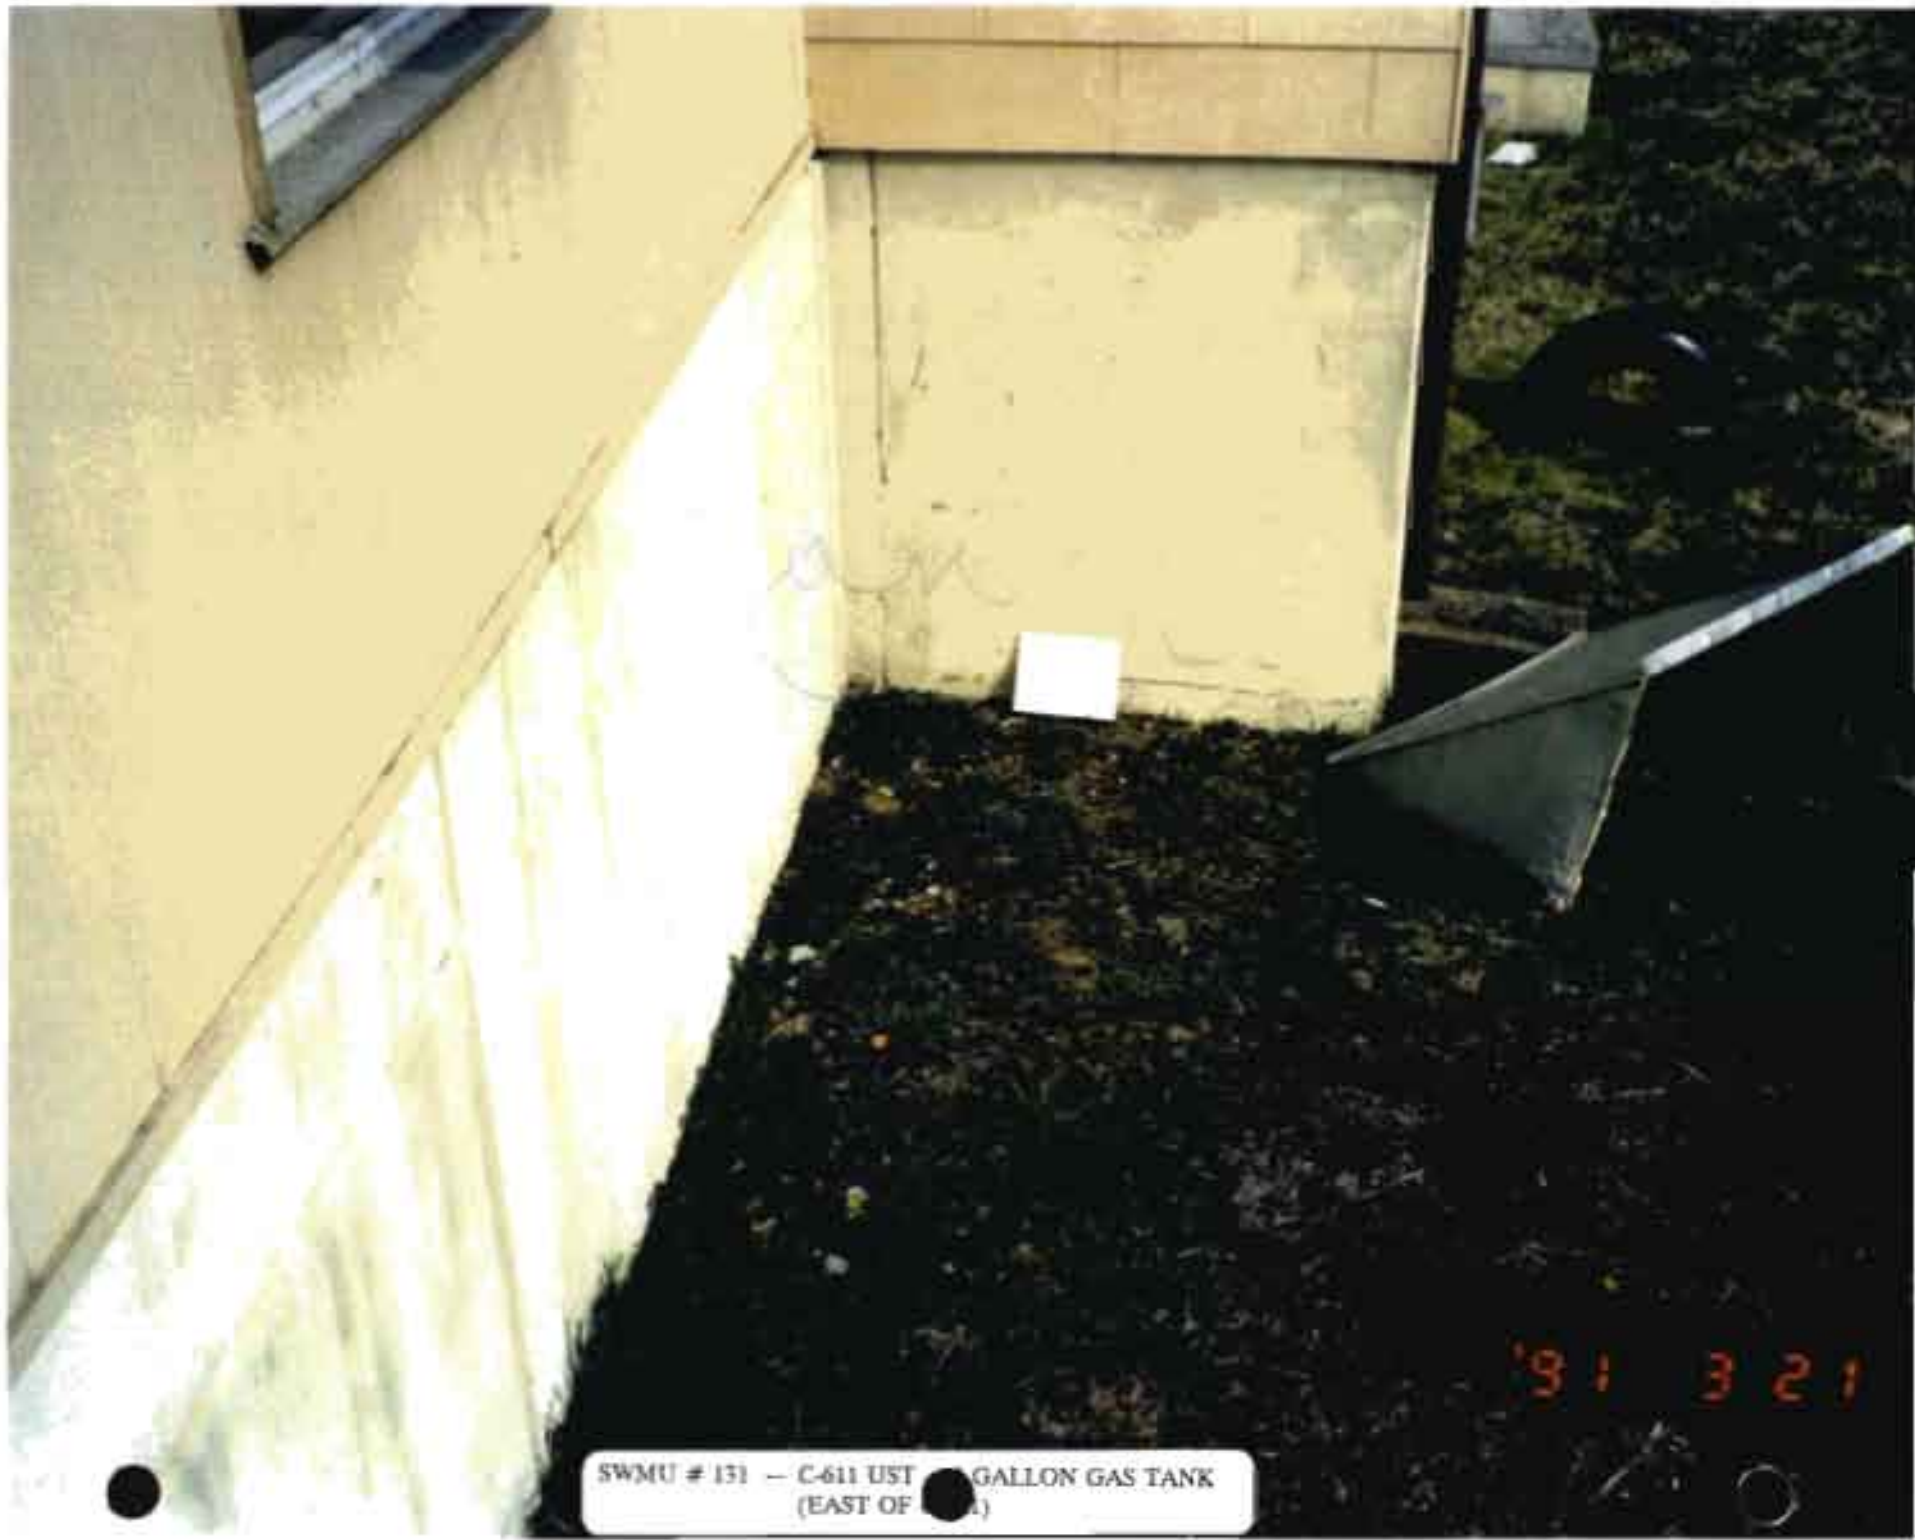
SWMU # 131 - C-611 UST 55 GALLON GAS TANK
(EAST OF [redacted])

DESCRIPTION OF RELEASE: Possible gasoline leakage

This unit has been included in WAG 7 and will receive a RFI pursuant to the schedule outlined in the HSWA permit.

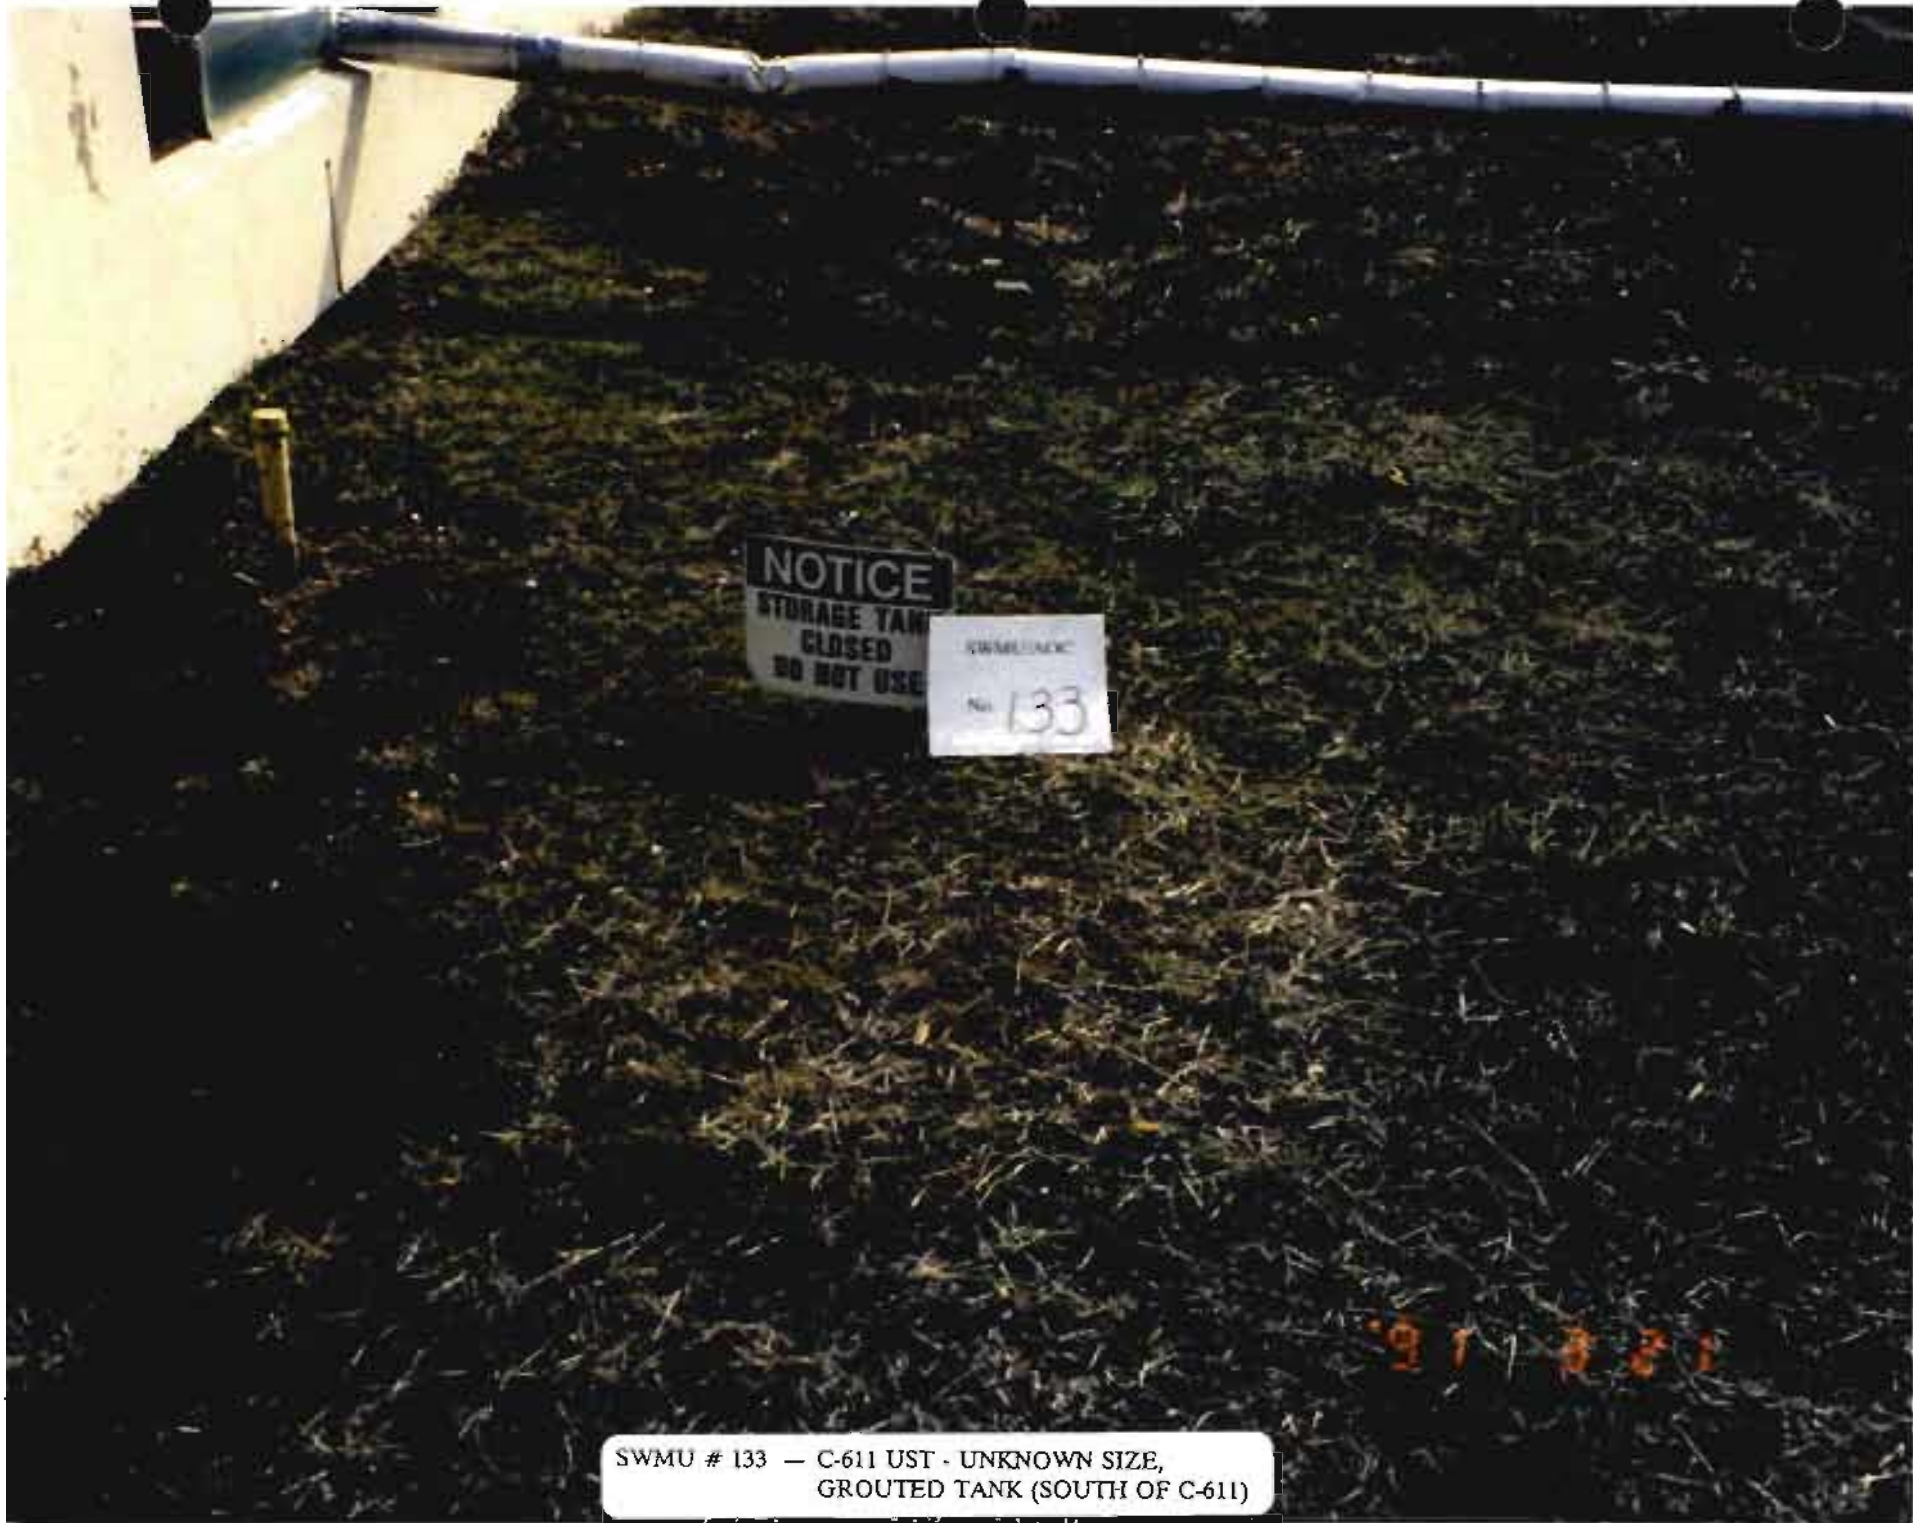
SWMU # 133 — C-611 UST - UNKNOWN SIZE,
GROUTED TANK (SOUTH OF C-611)

DESCRIPTION OF RELEASE: Possible Diesel leakage

This unit has been included in WAG 7 and will receive a RFI pursuant to the schedule outlined in the HSWA permit.

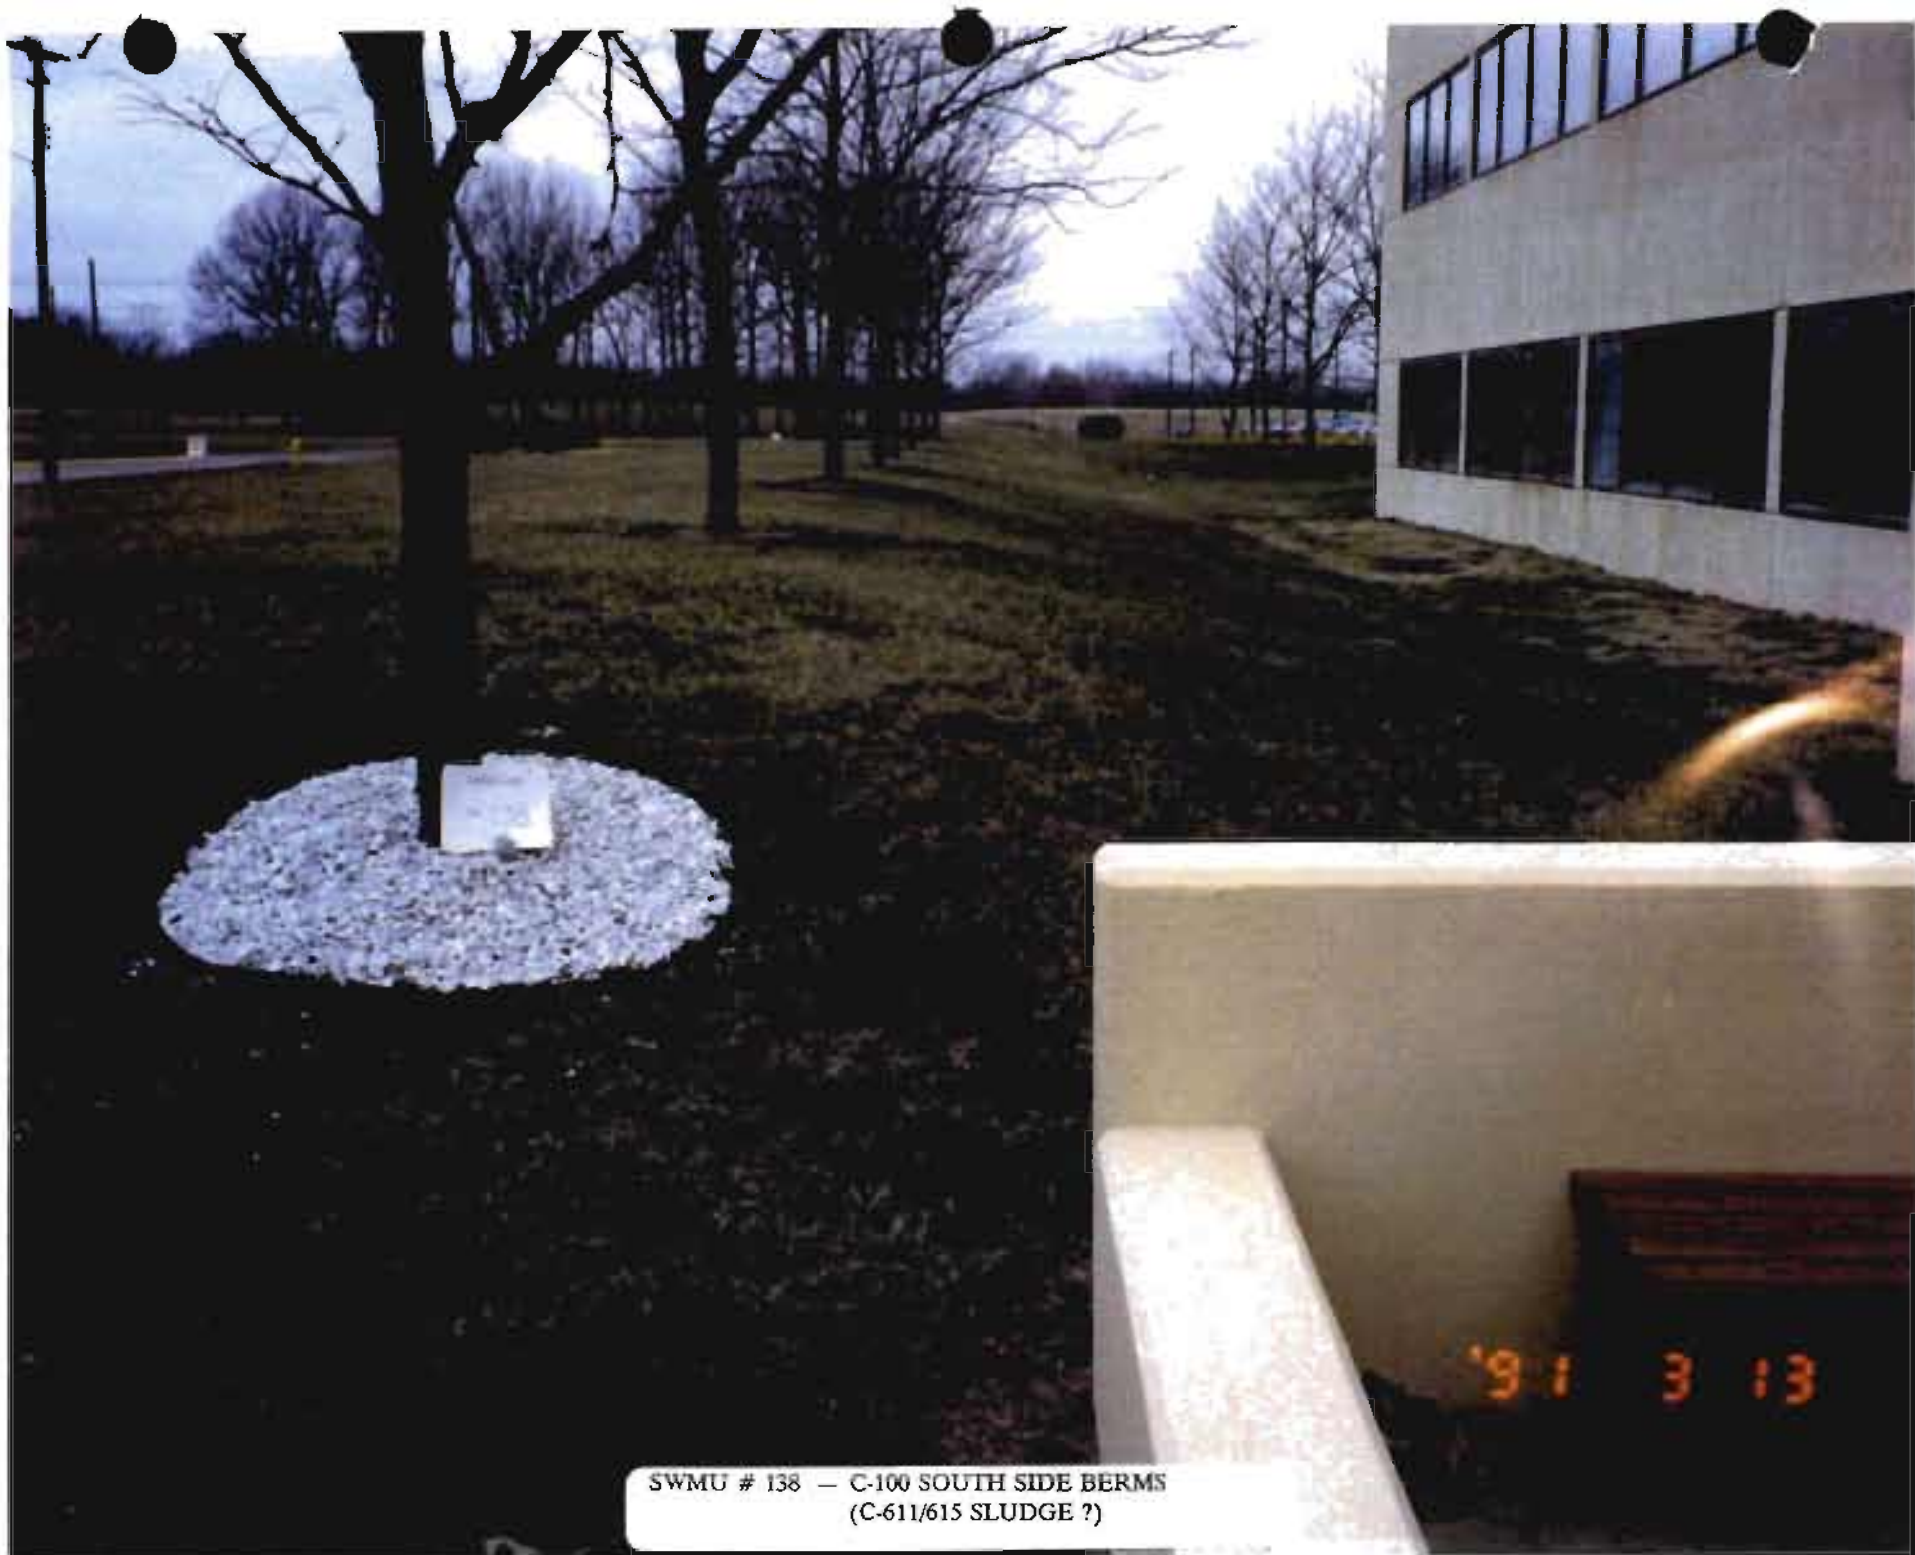
SWMU # 138 — C-100 SOUTH SIDE BERMS
(C-611/615 SLUDGE ?)

RFI NECESSARY: Characterization data indicates mercury (range 2.16 - 34.3 ppm) and lead (range 7.2 - 280.5 ppm) are present in the Berms.

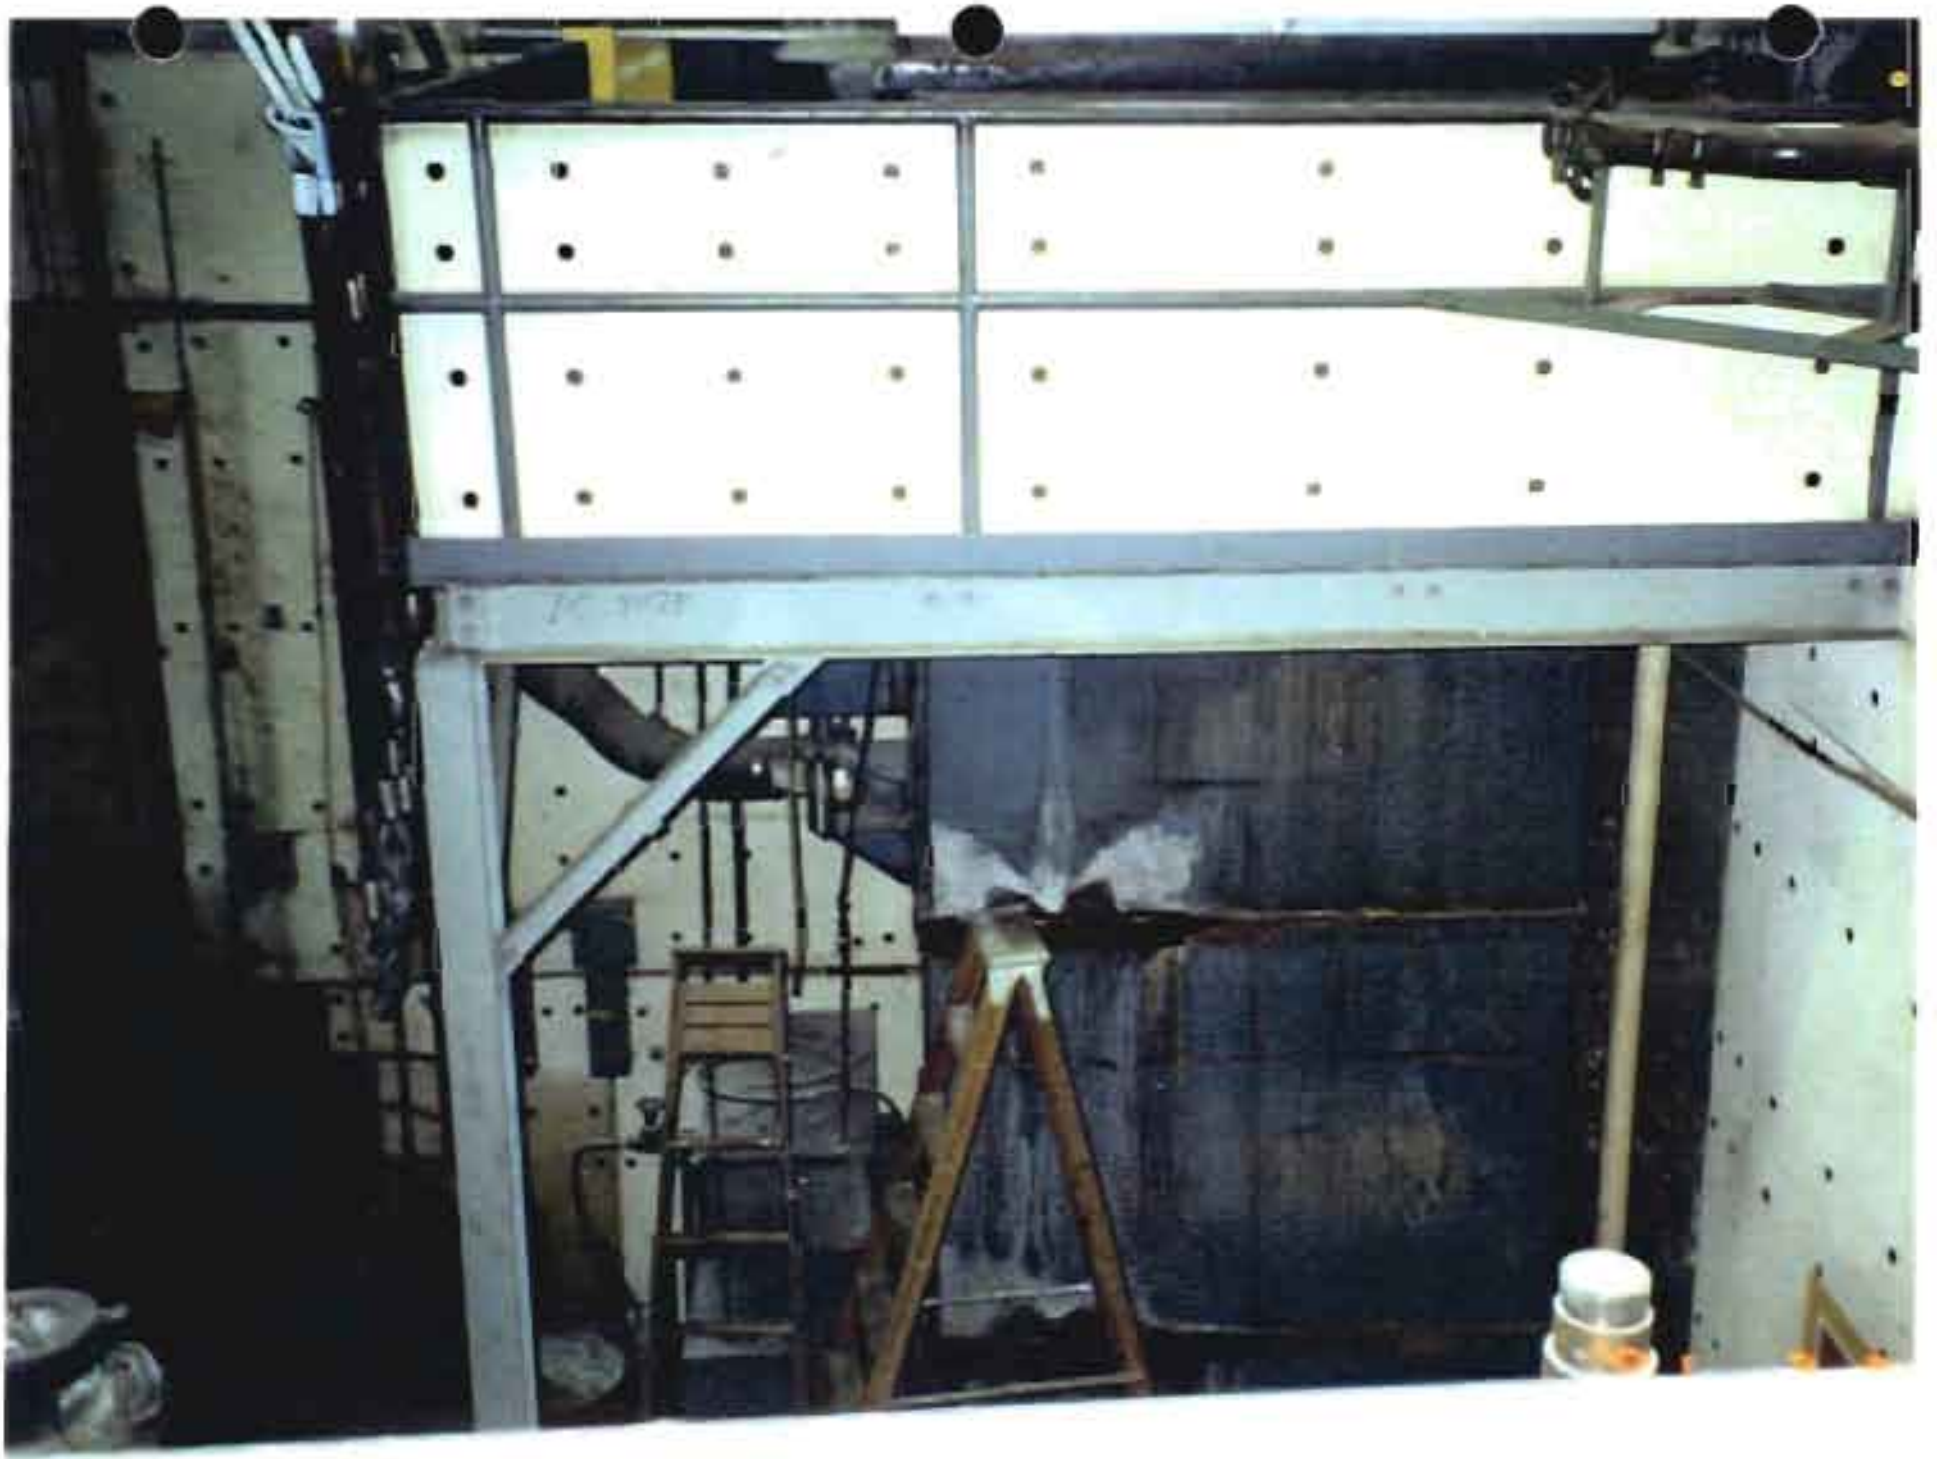
SWMU # 141 - C-720 INACTIVE TCE DEGREASER

DESCRIPTION OF RELEASE: Possible TCE leakage

No releases are known to have occurred at the C-720 Degreaser or from the associated piping. The only release pathway into the environment would be leaks or spills that occurred at the point the aboveground piping associated with the degreaser discharges into the C-720 aboveground tank (swmu #31)). Contamination that was detected in the vicinity of swmu's #31 and 27 is being addressed under the CERCLA ACO.

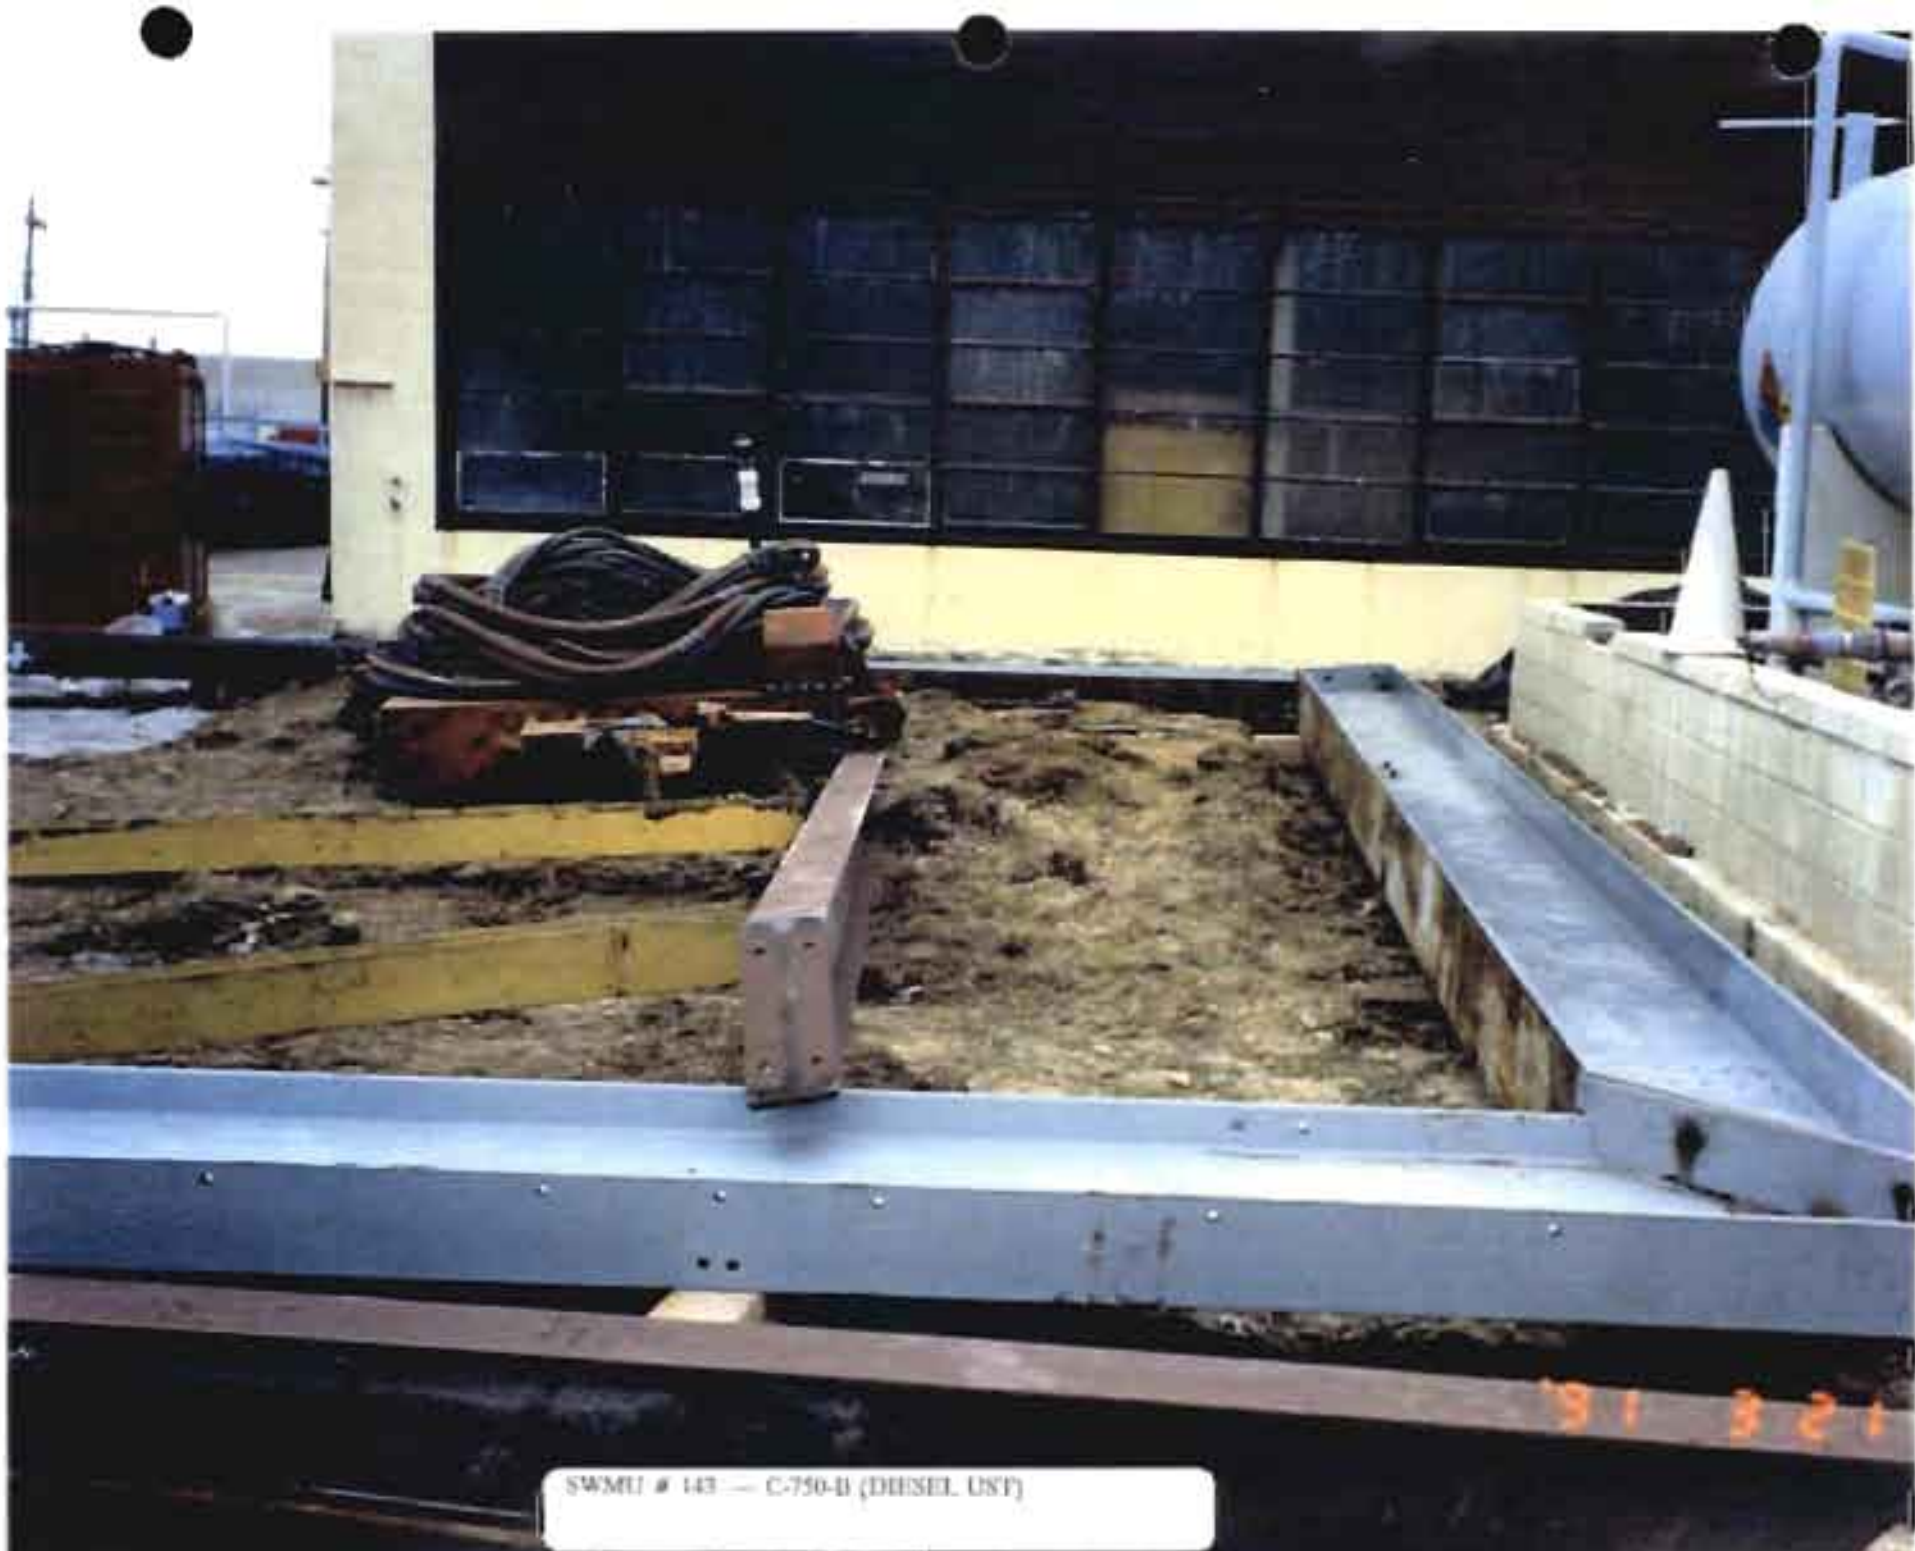
SWMU # 143 — C-750-B (DIESEL UNIT)

DESCRIPTION OF RELEASE: Leakage of diesel

Currently being addressed under the State of Kentucky
Underground Storage Tank Program.

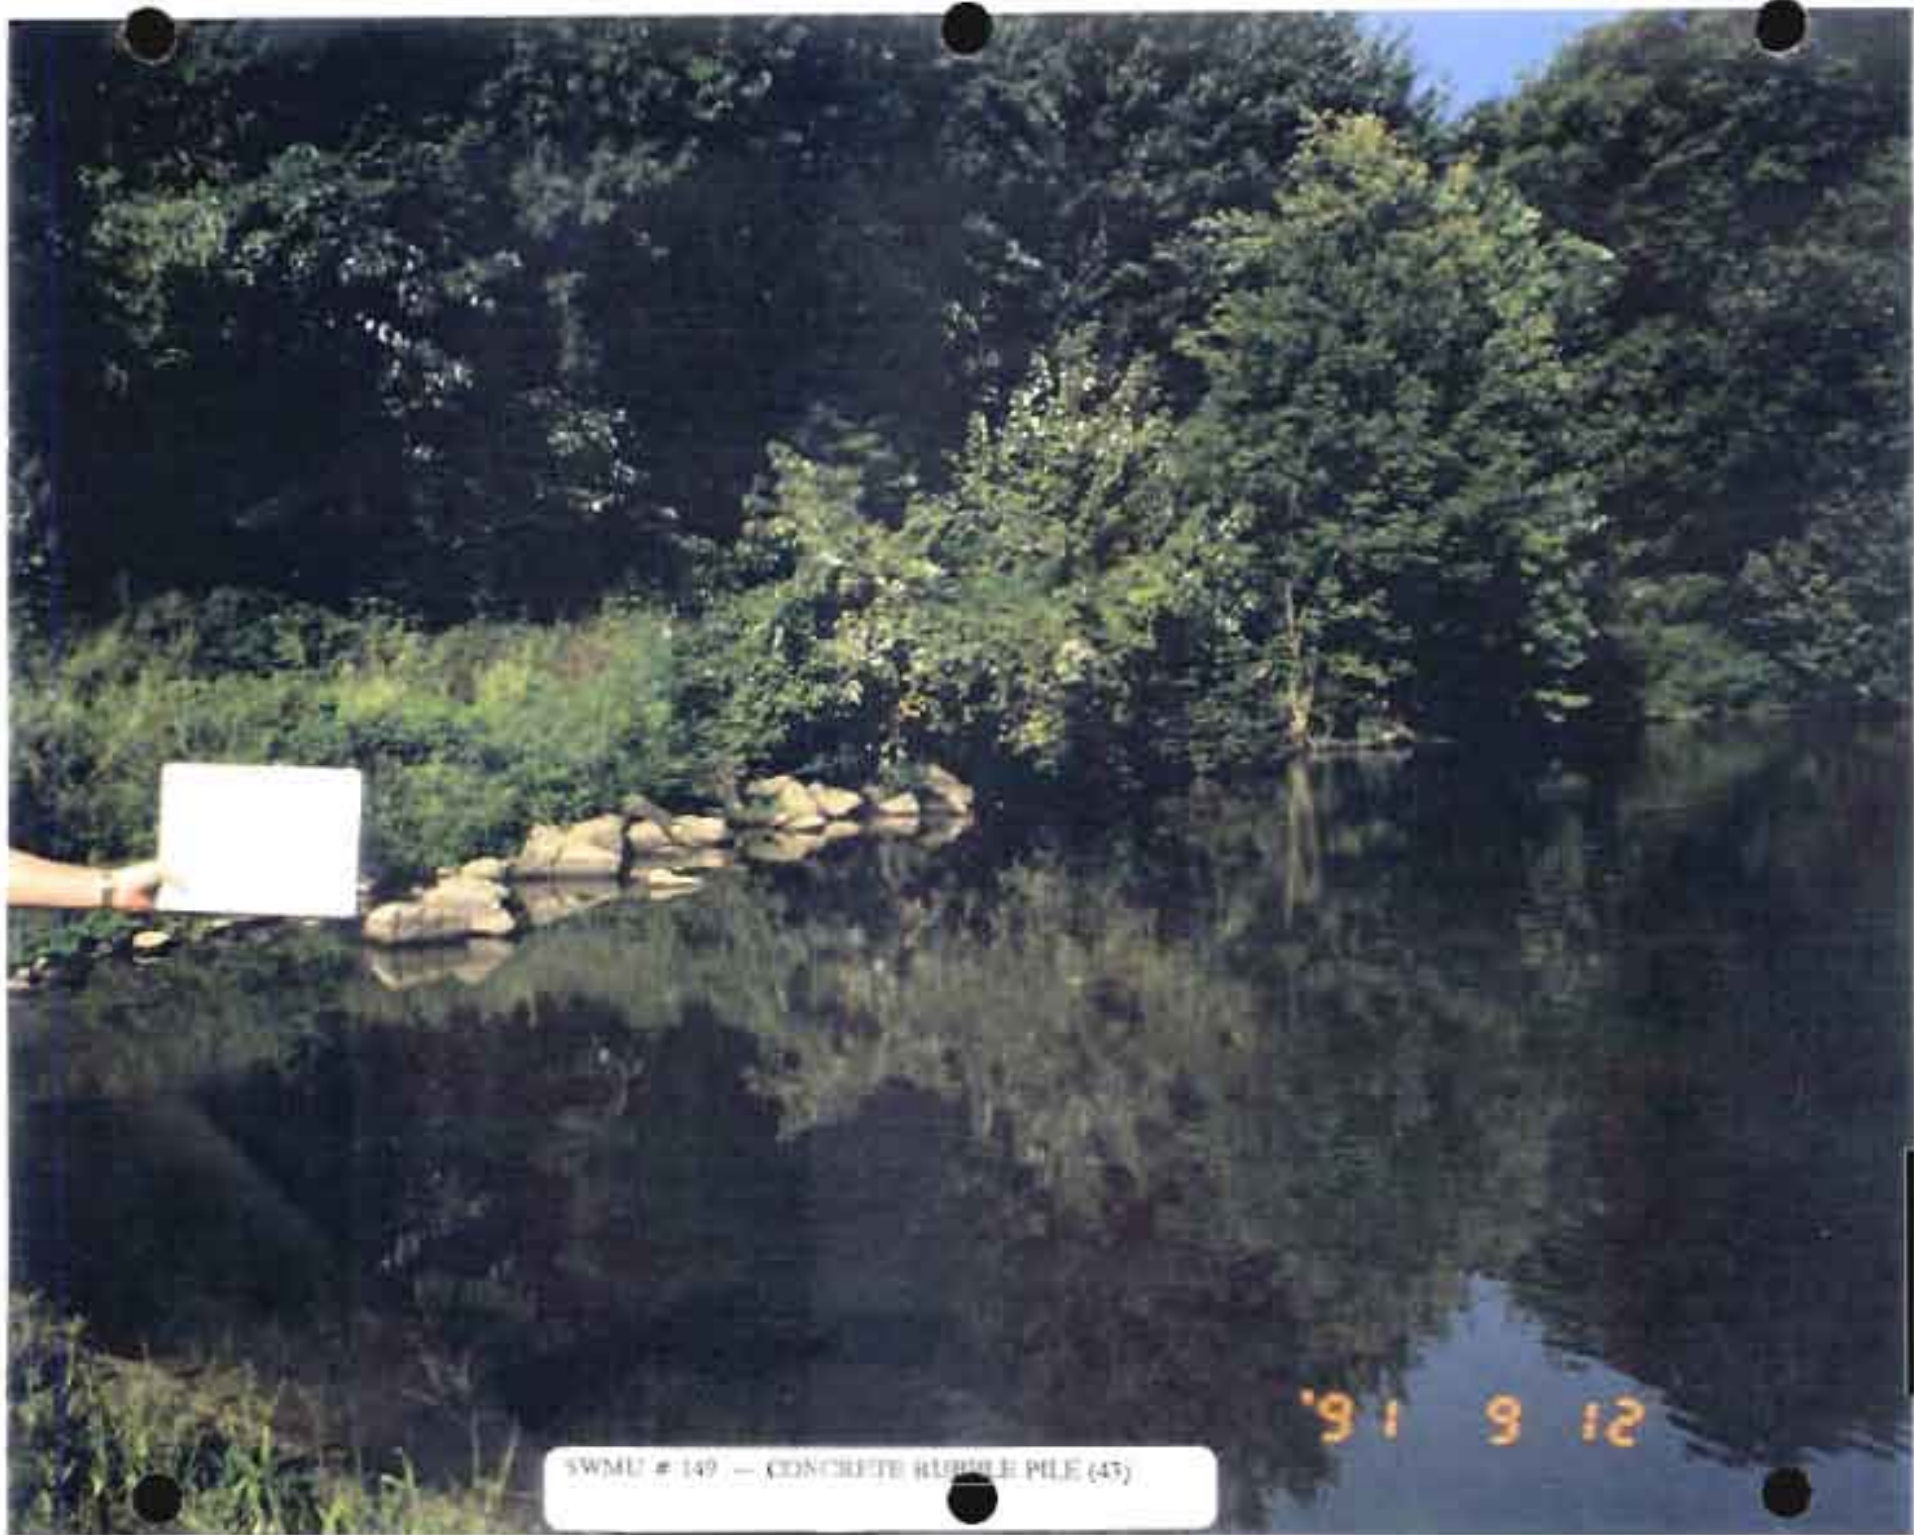
SWMU # 149 - CONCRETE RUBBLE PILE (45)

DOCUMENTATION OF NO RELEASE: Not available at this time

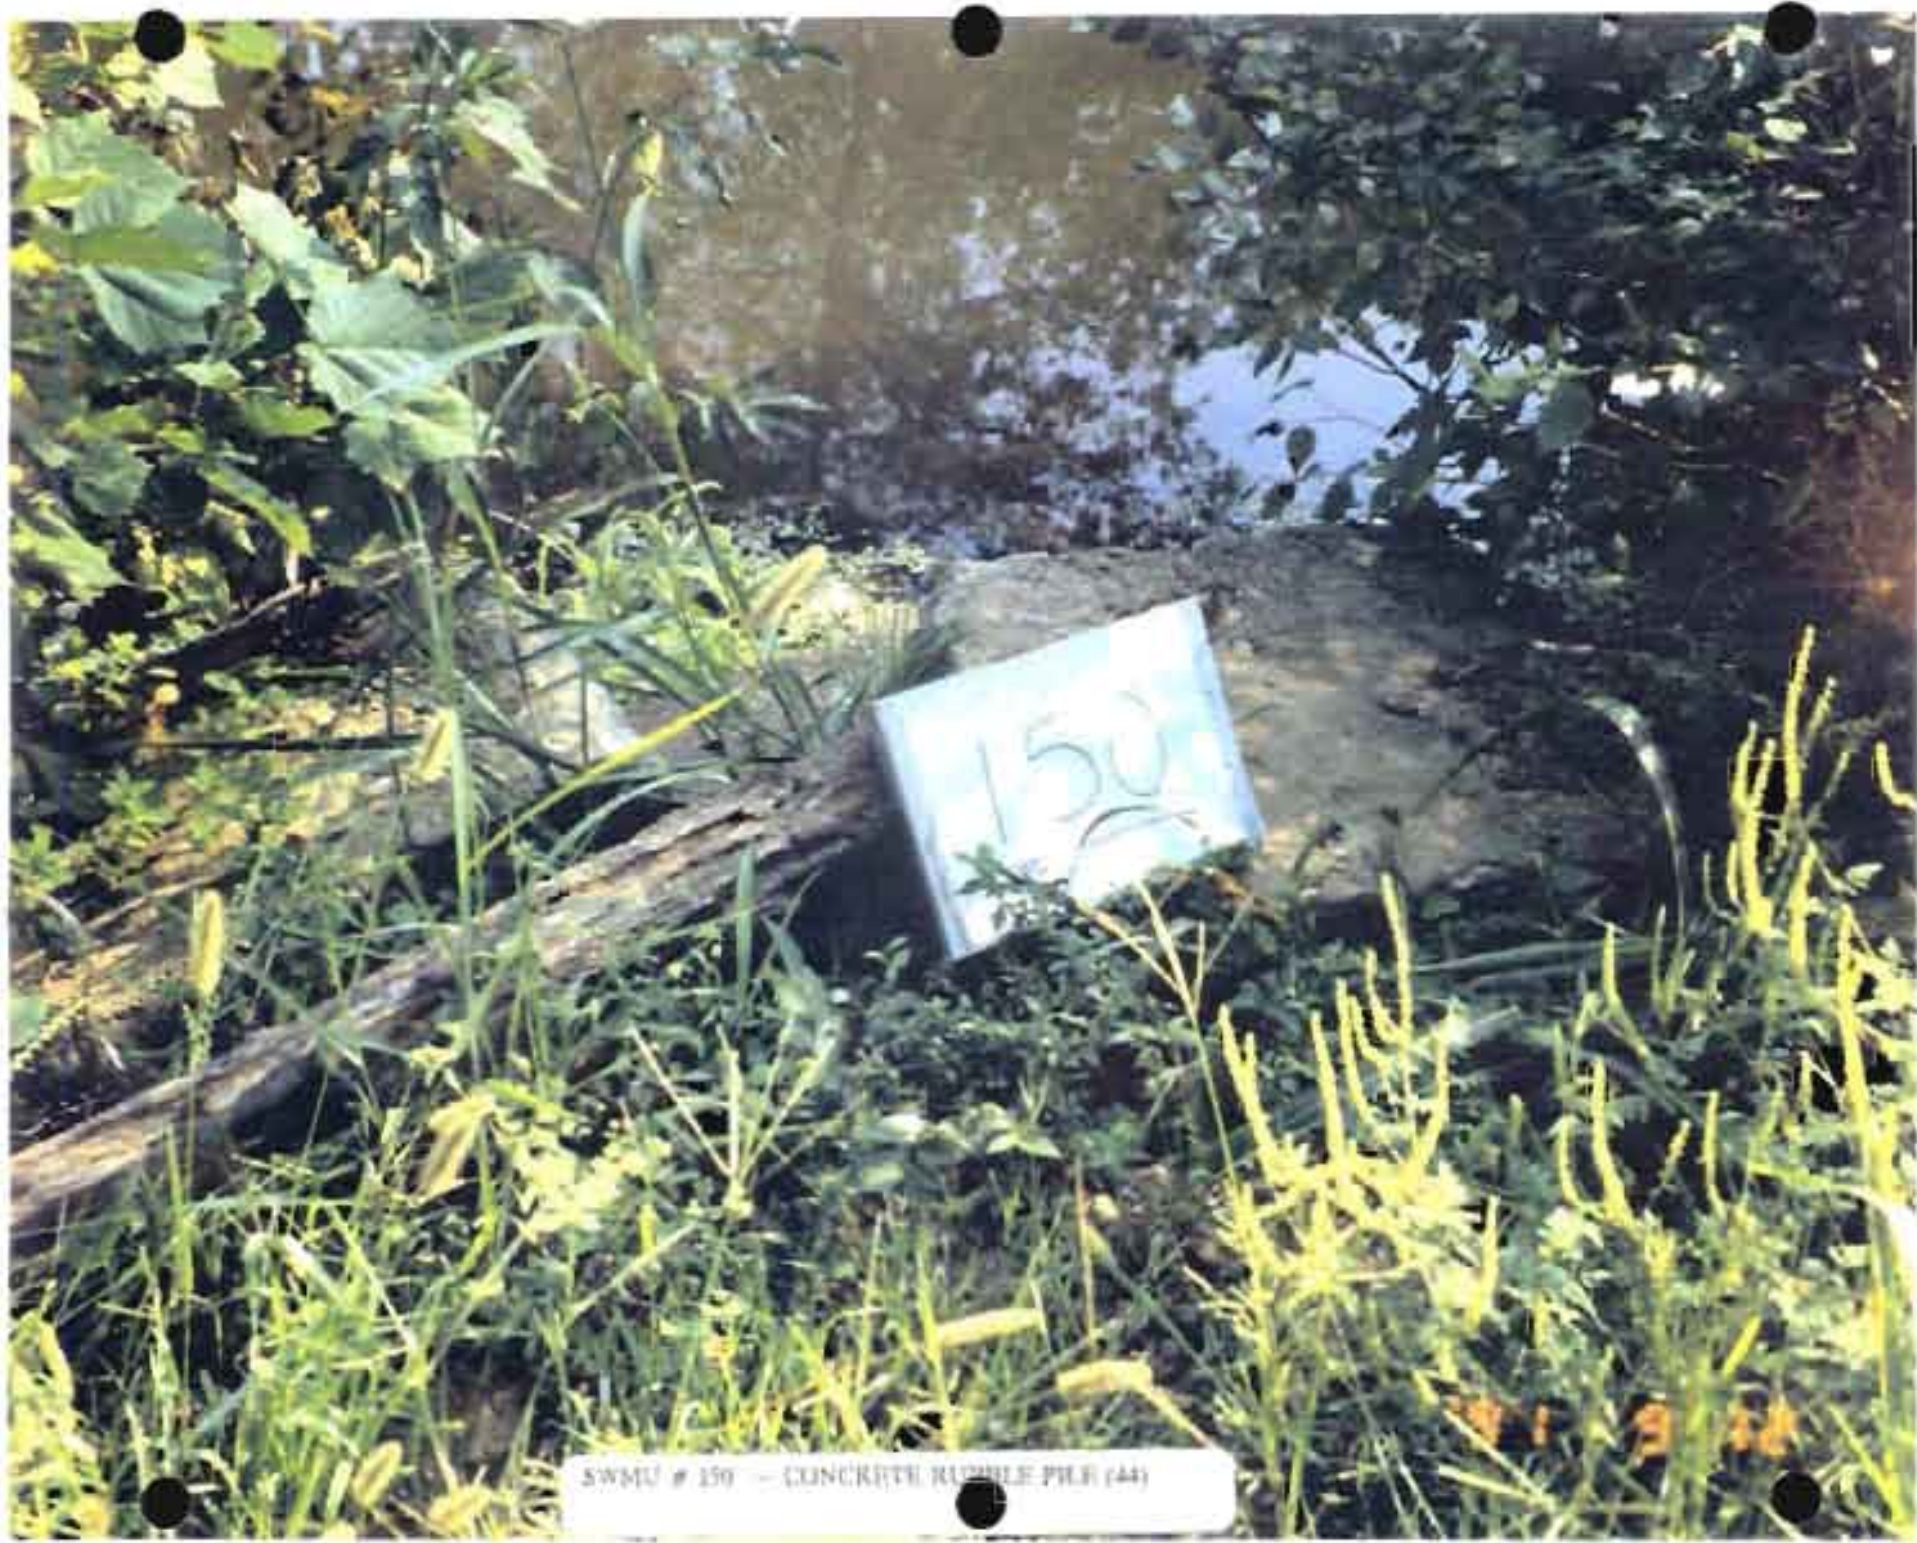
SWMU # 150 - CONCRETE RUBBLE PILE (44)

DOCUMENTATION OF NO RELEASE: Not available at this time
