KY/B-262
Addendum 1
Volume 1
Revision 1

PADUCAH GASEOUS DIFFUSION PLANT

PRELIMINARY ASSESSMENT

PADUCAH GASEOUS DIFFUSION PLANT
SOLID WASTE MANAGEMENT UNITS

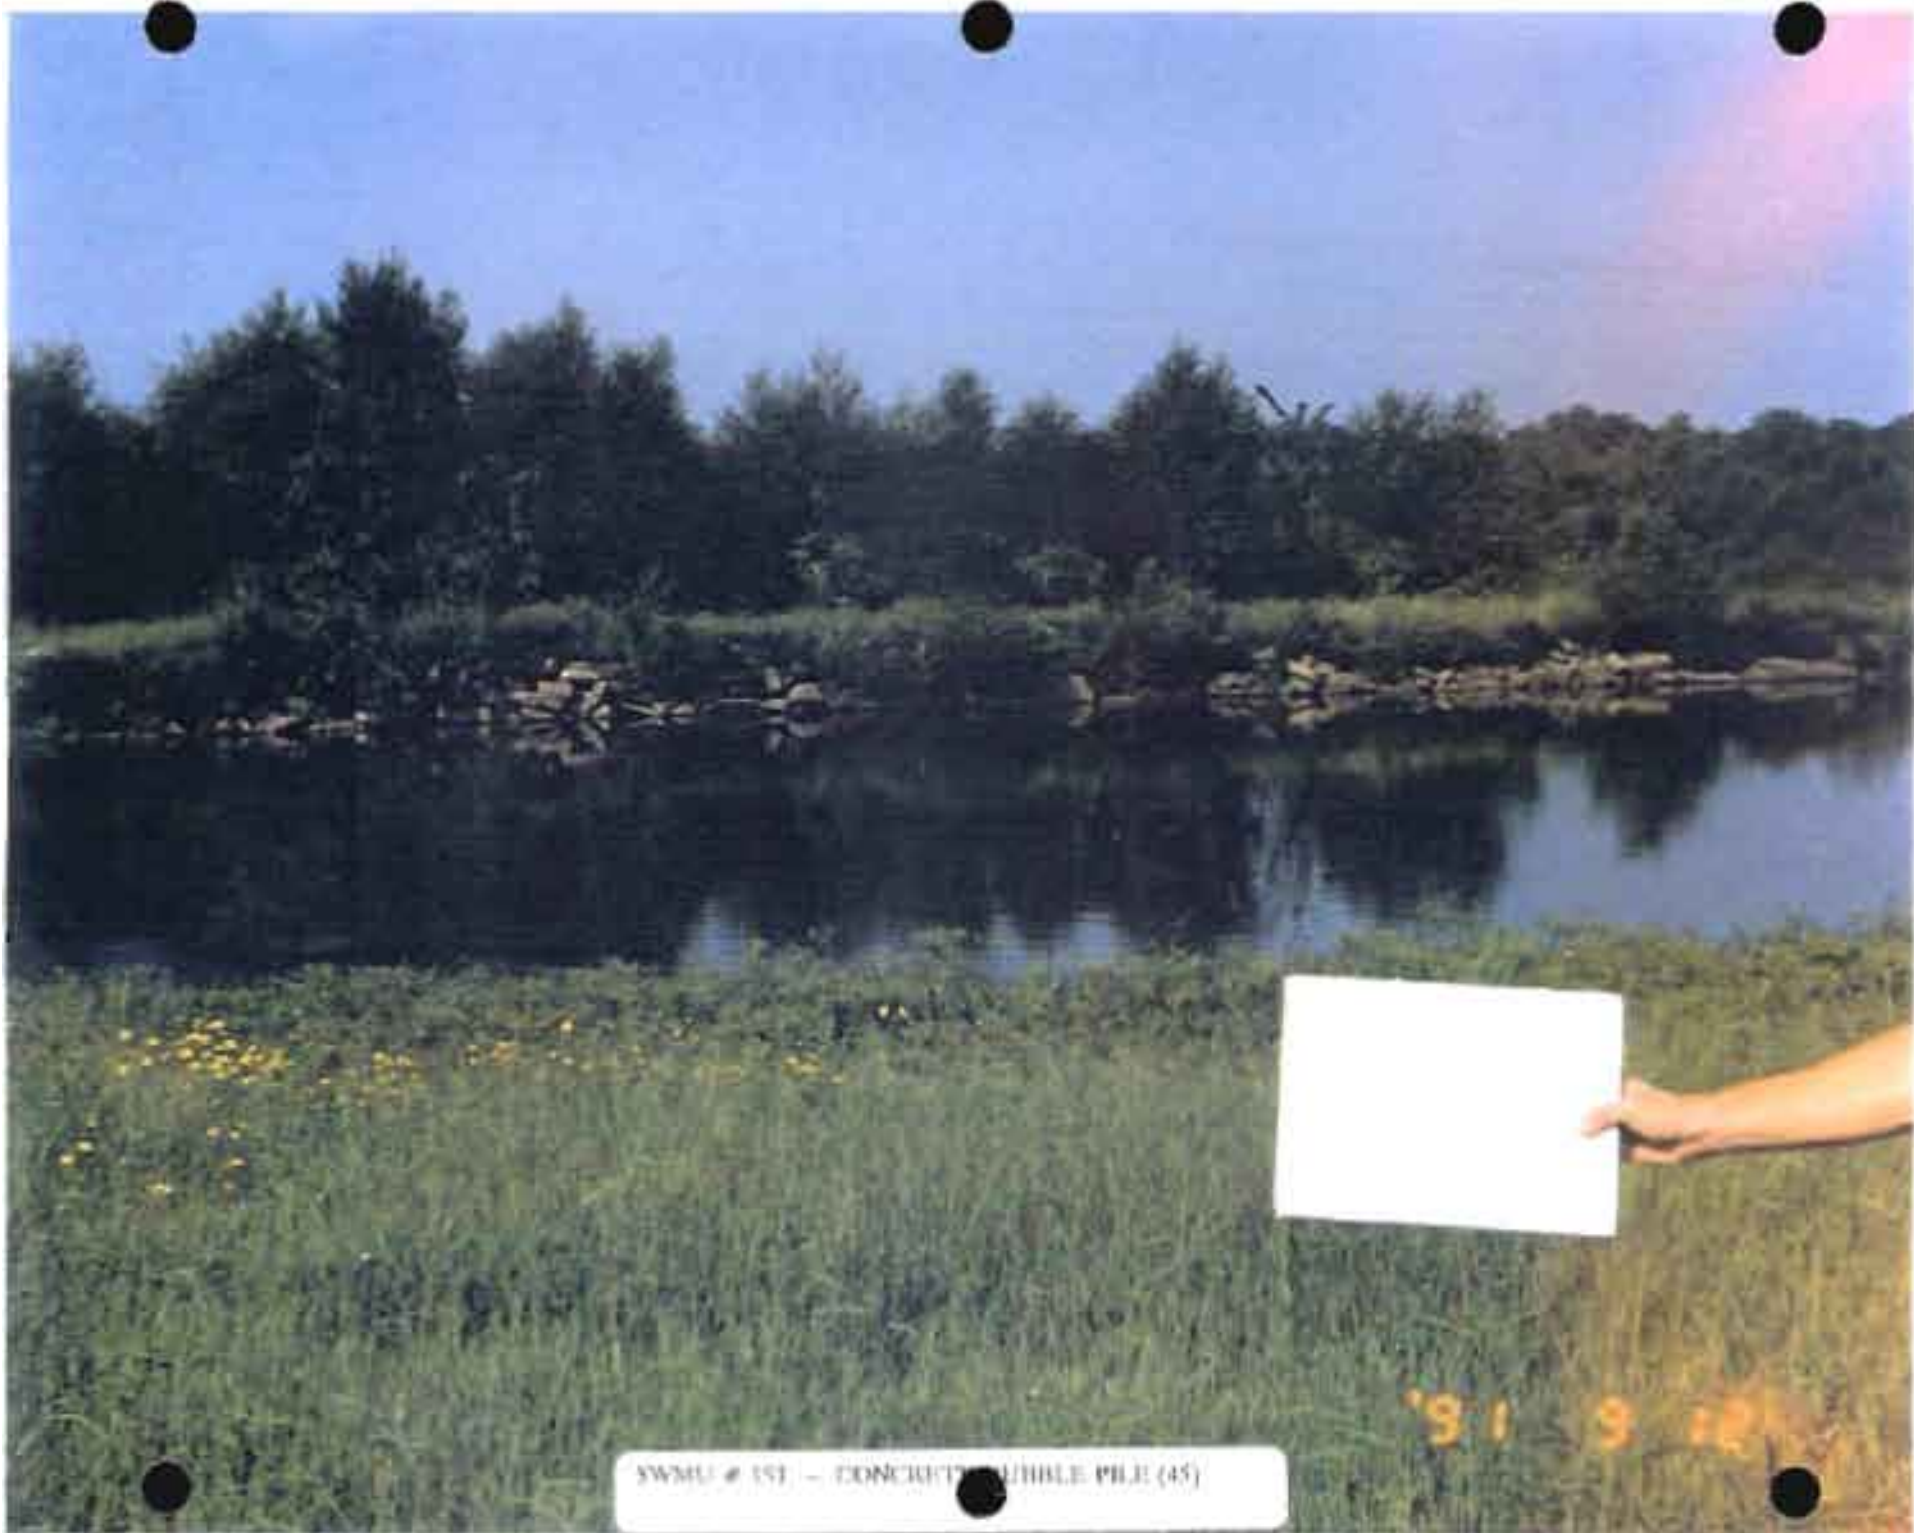
SWMU # 151 - CONCRETE PILE (45)

SITE/PROCESS DESCRIPTION: Ballard Wildlife Management Area utilizes concrete rubble for dam and road stabilization. This concrete rubble originates from many locations, one of which was the PGDP. The causeway across west end of lake has concrete slabs and rubble on lake side.

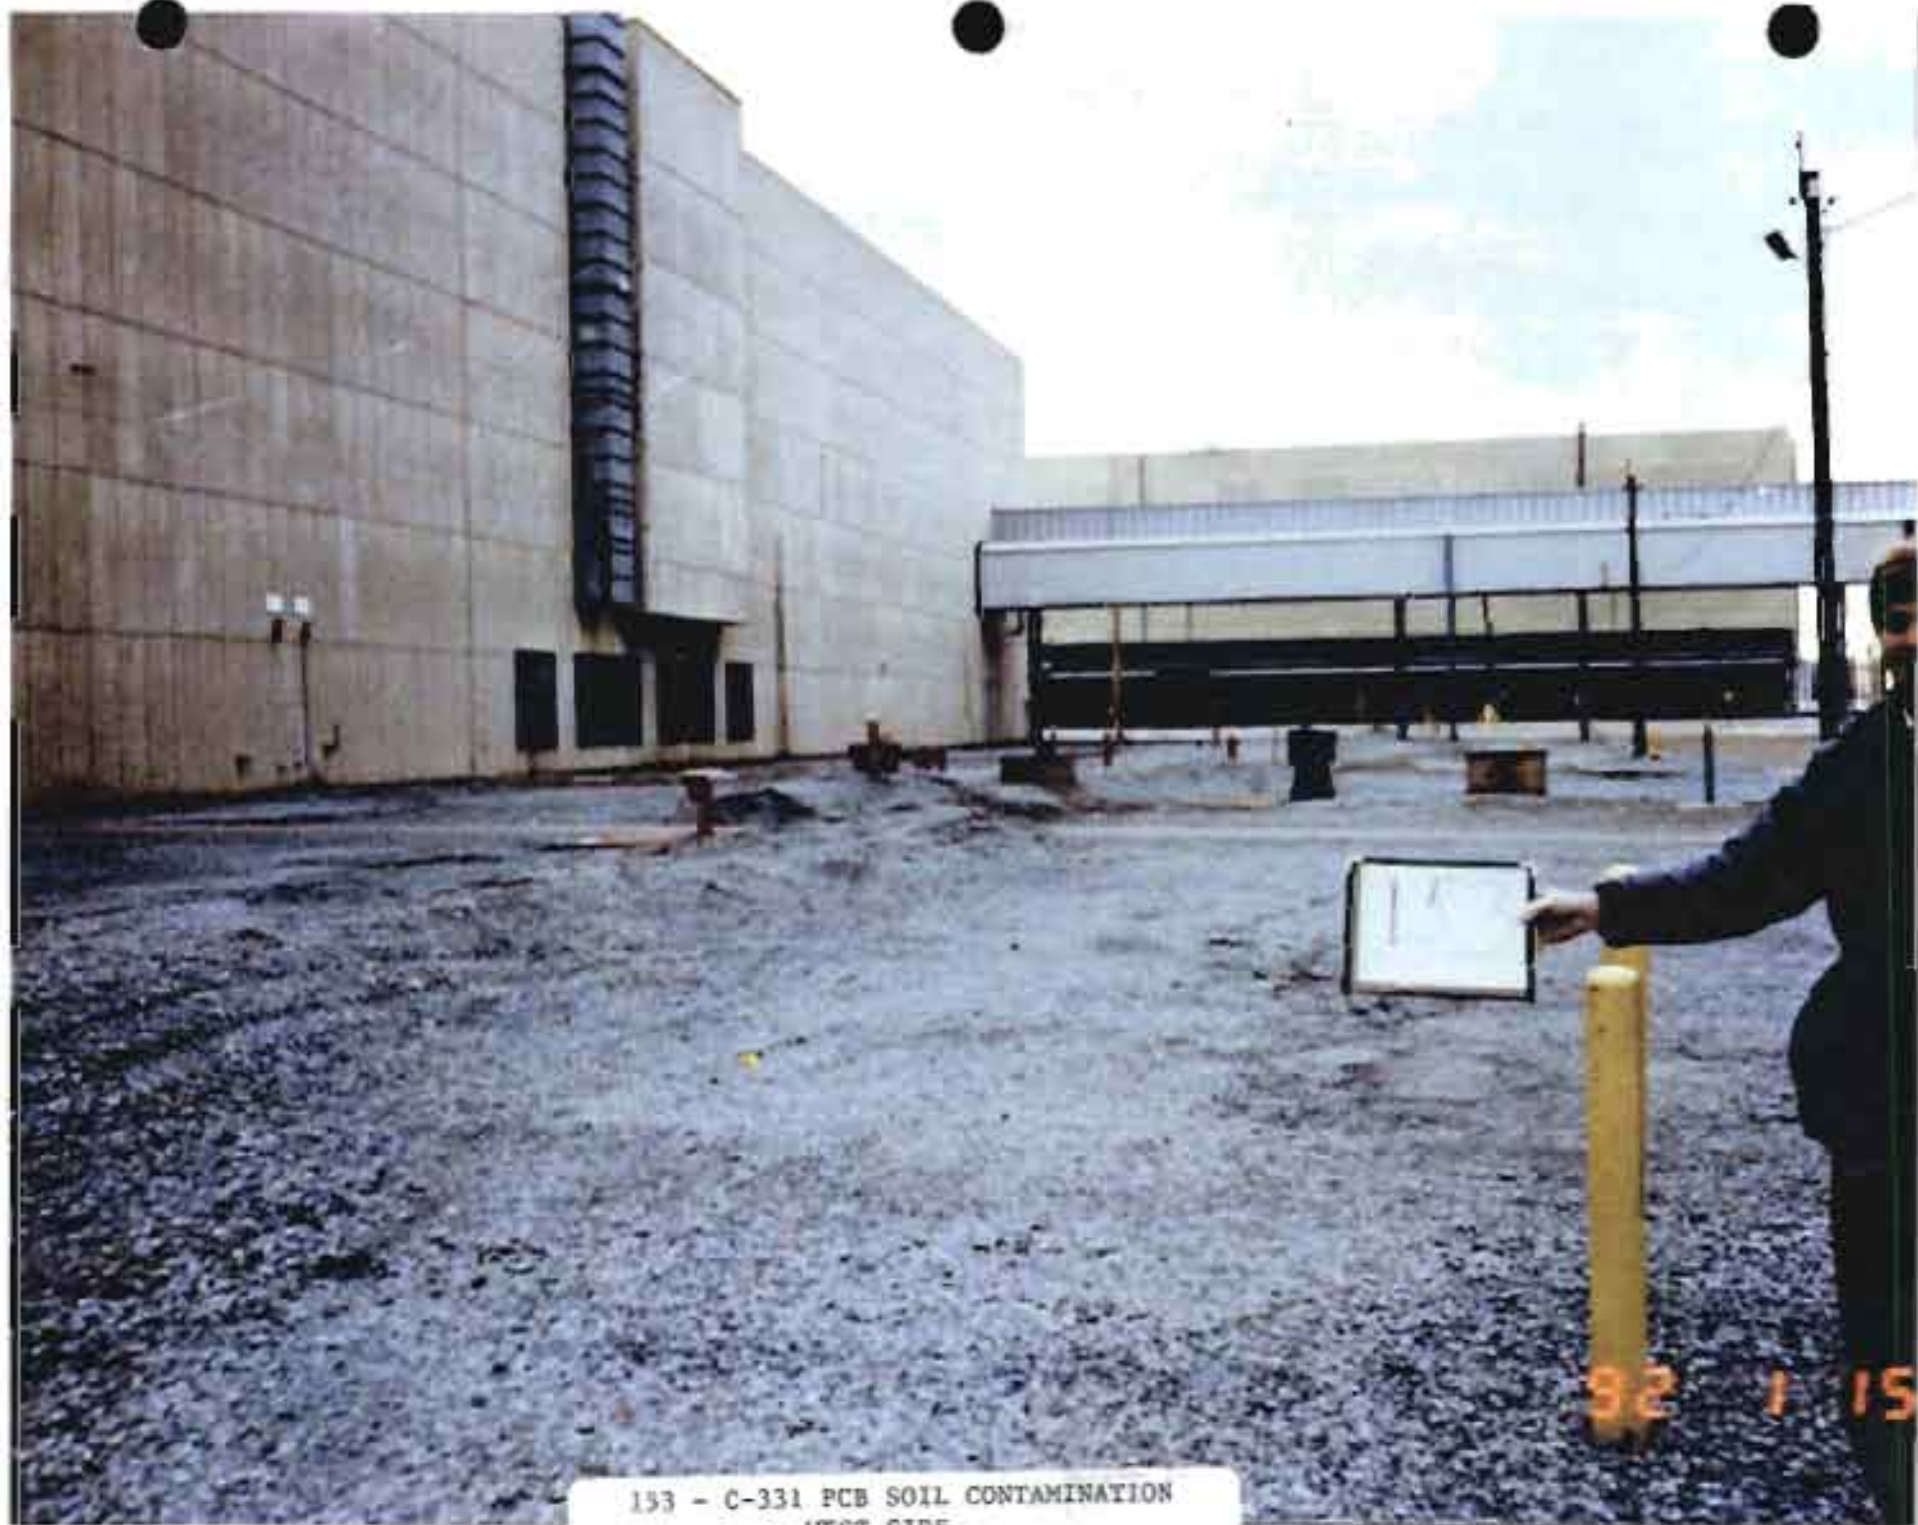
153 - C-331 PCB SOIL CONTAMINATION
WEST SIDE

This area is located inside the Plant Security Fence and is restricted to public access. The TSCA PCB Spill Cleanup Policy establishes a 25 ppm cleanup level for PCB contaminated soils in restricted areas.

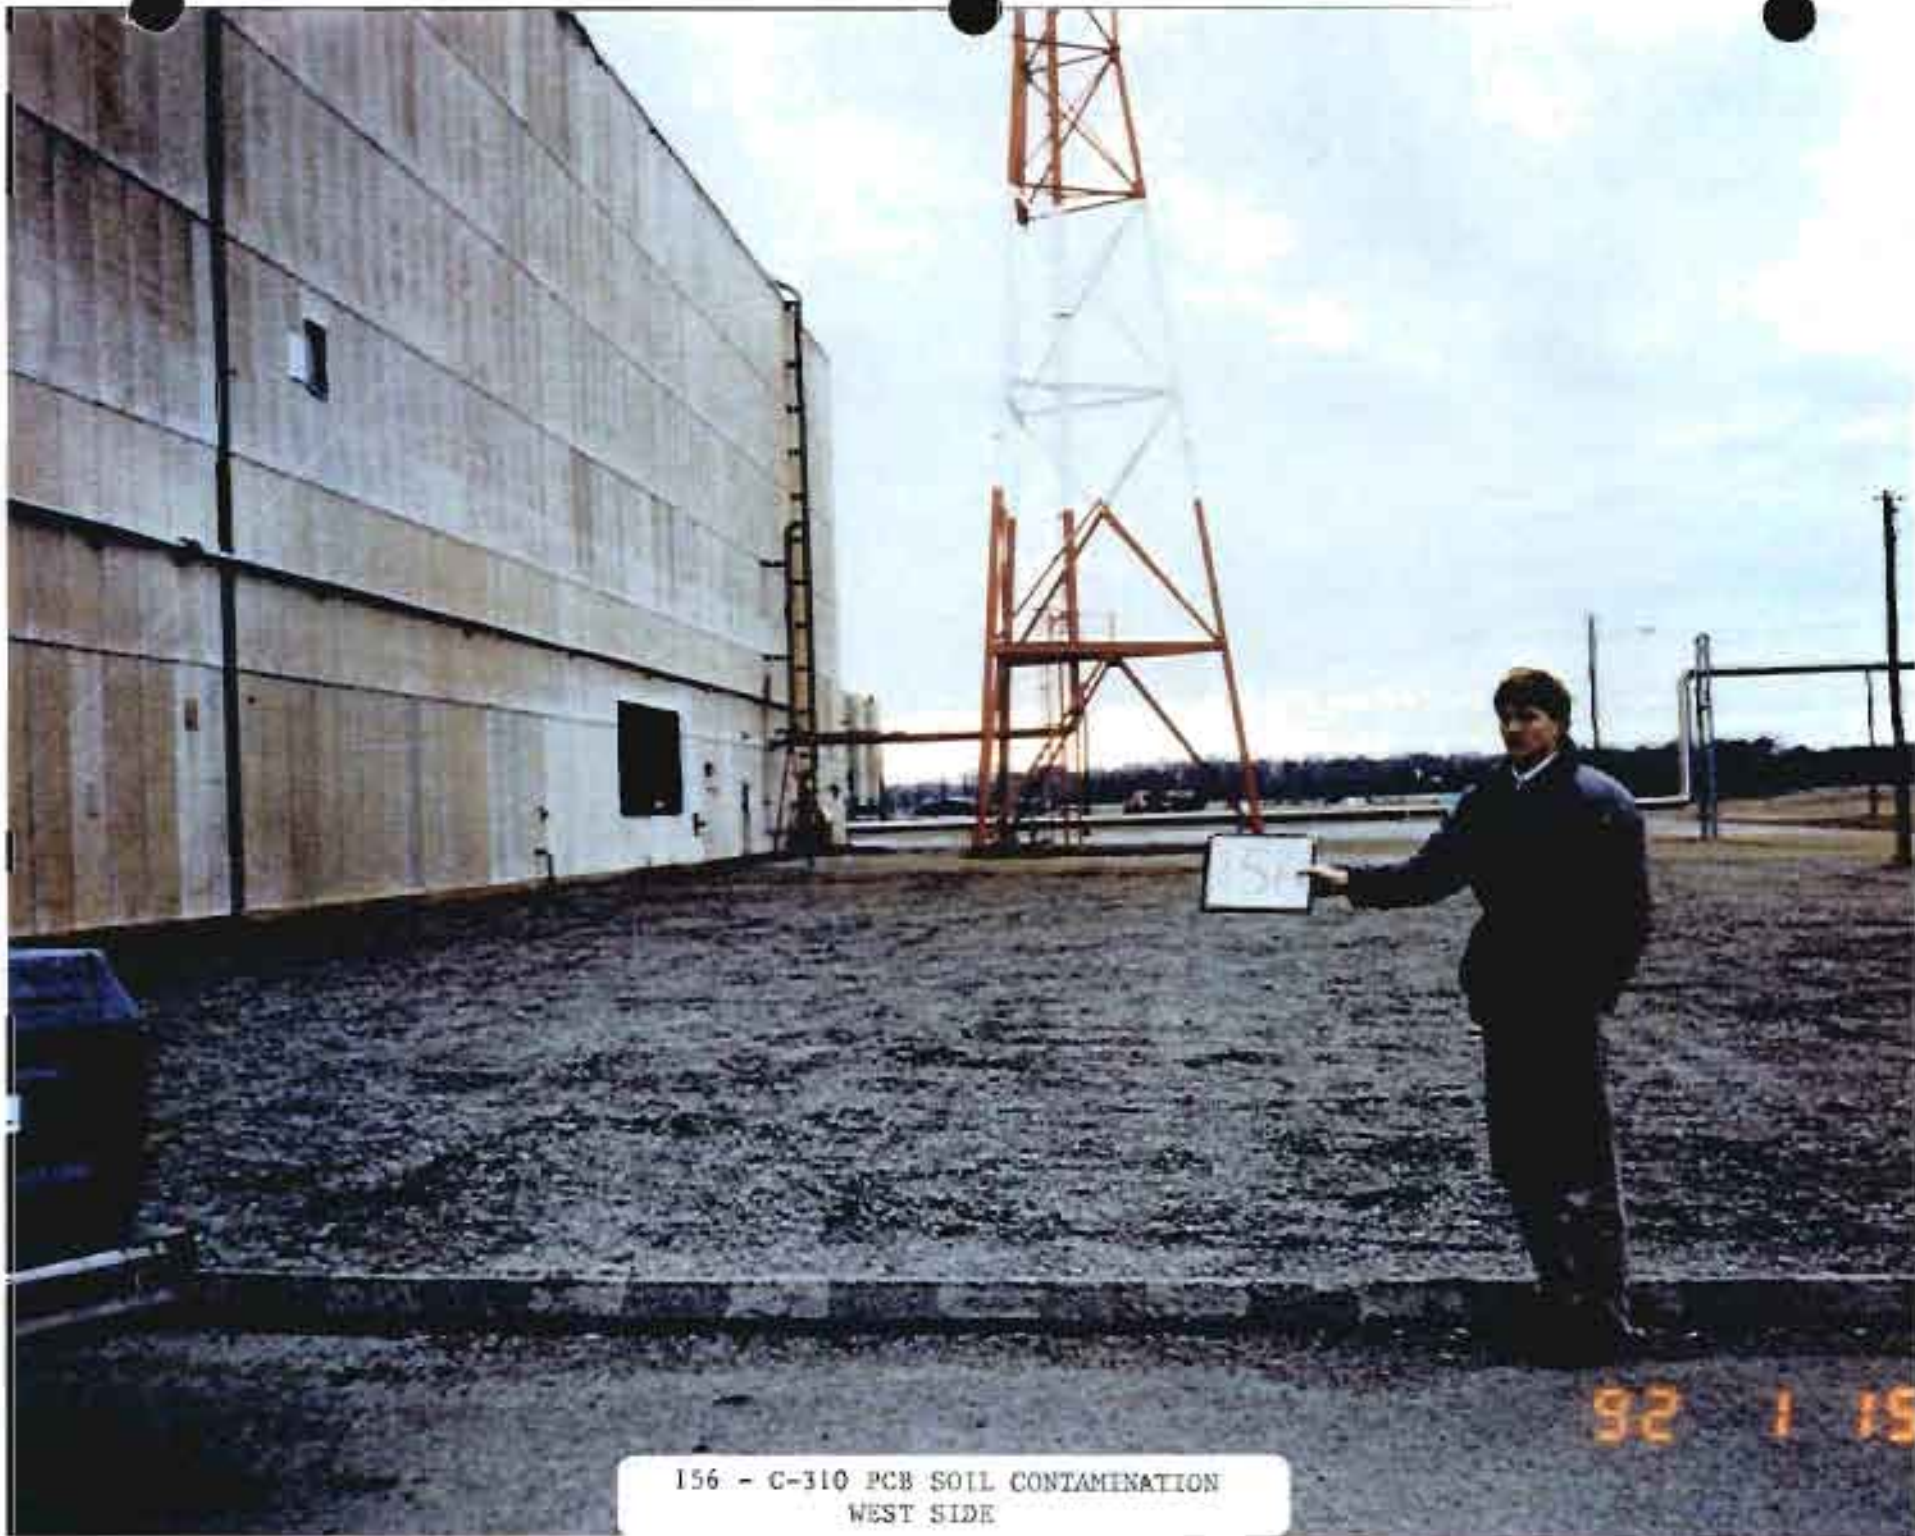
156 - C-310 PCB SOIL CONTAMINATION
WEST SIDE

This area is located inside the Plant Security Fence and is restricted to public access. The TSCA PCB Spill Cleanup Policy establishes a 25 PPM cleanup level for PCB contaminated soils in restricted areas.

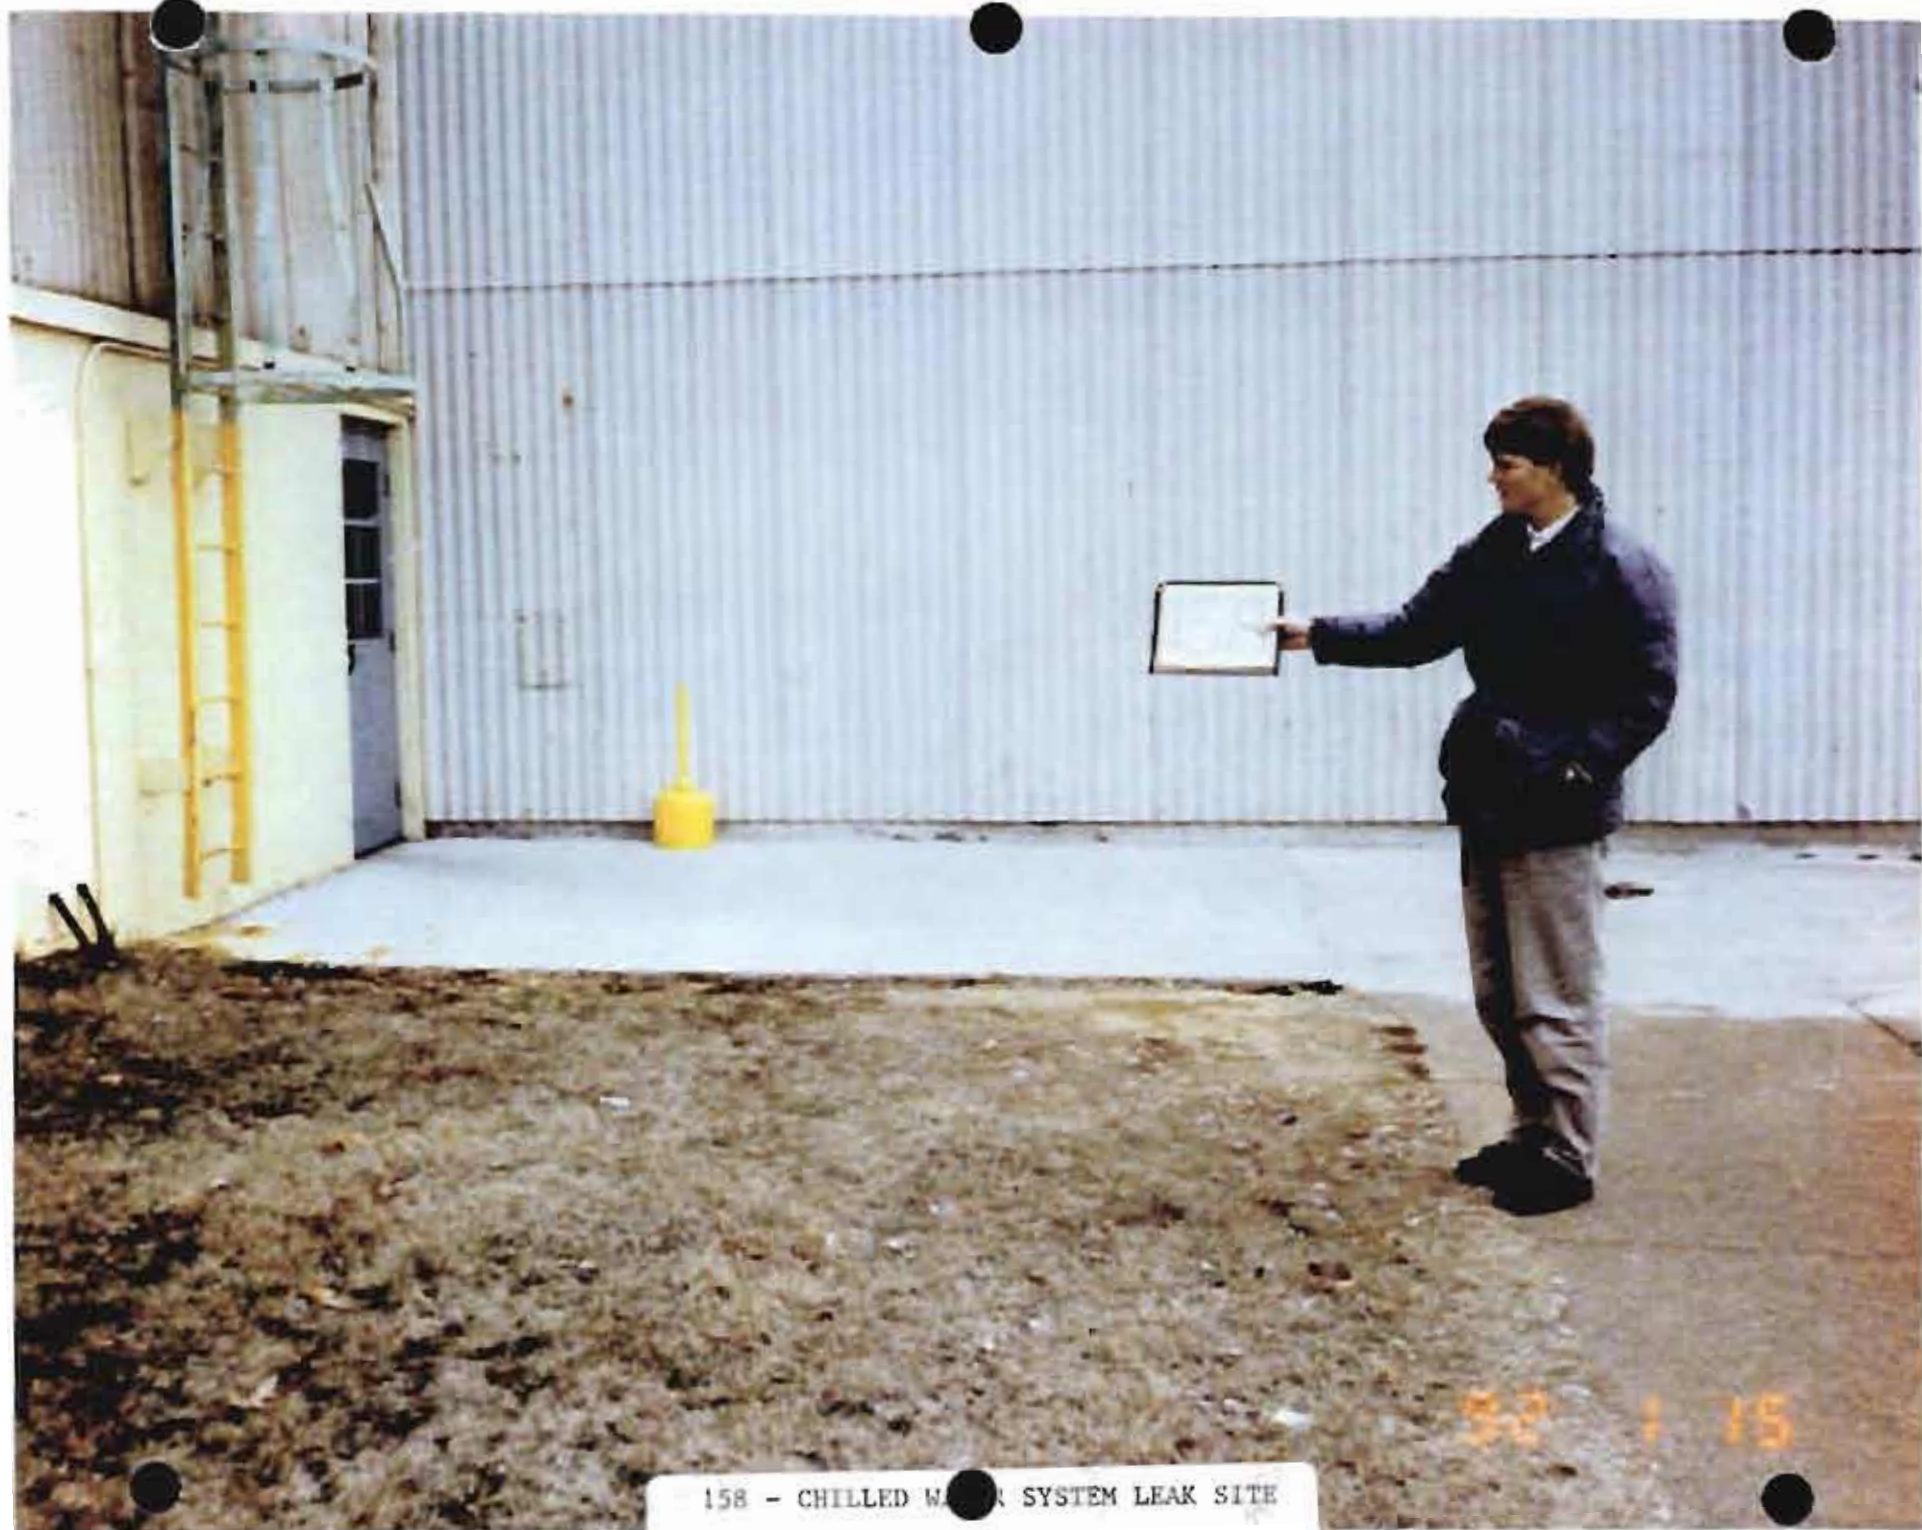
158 - CHILLED WATER SYSTEM LEAK SITE

DESCRIPTION OF RELEASE: The chilled water system lines developed a pinhole leak which flooded an adjacent electrical vault and spilled over to another connected vault. Water sampled in the vault was reported at 100 ppm Cr+6.

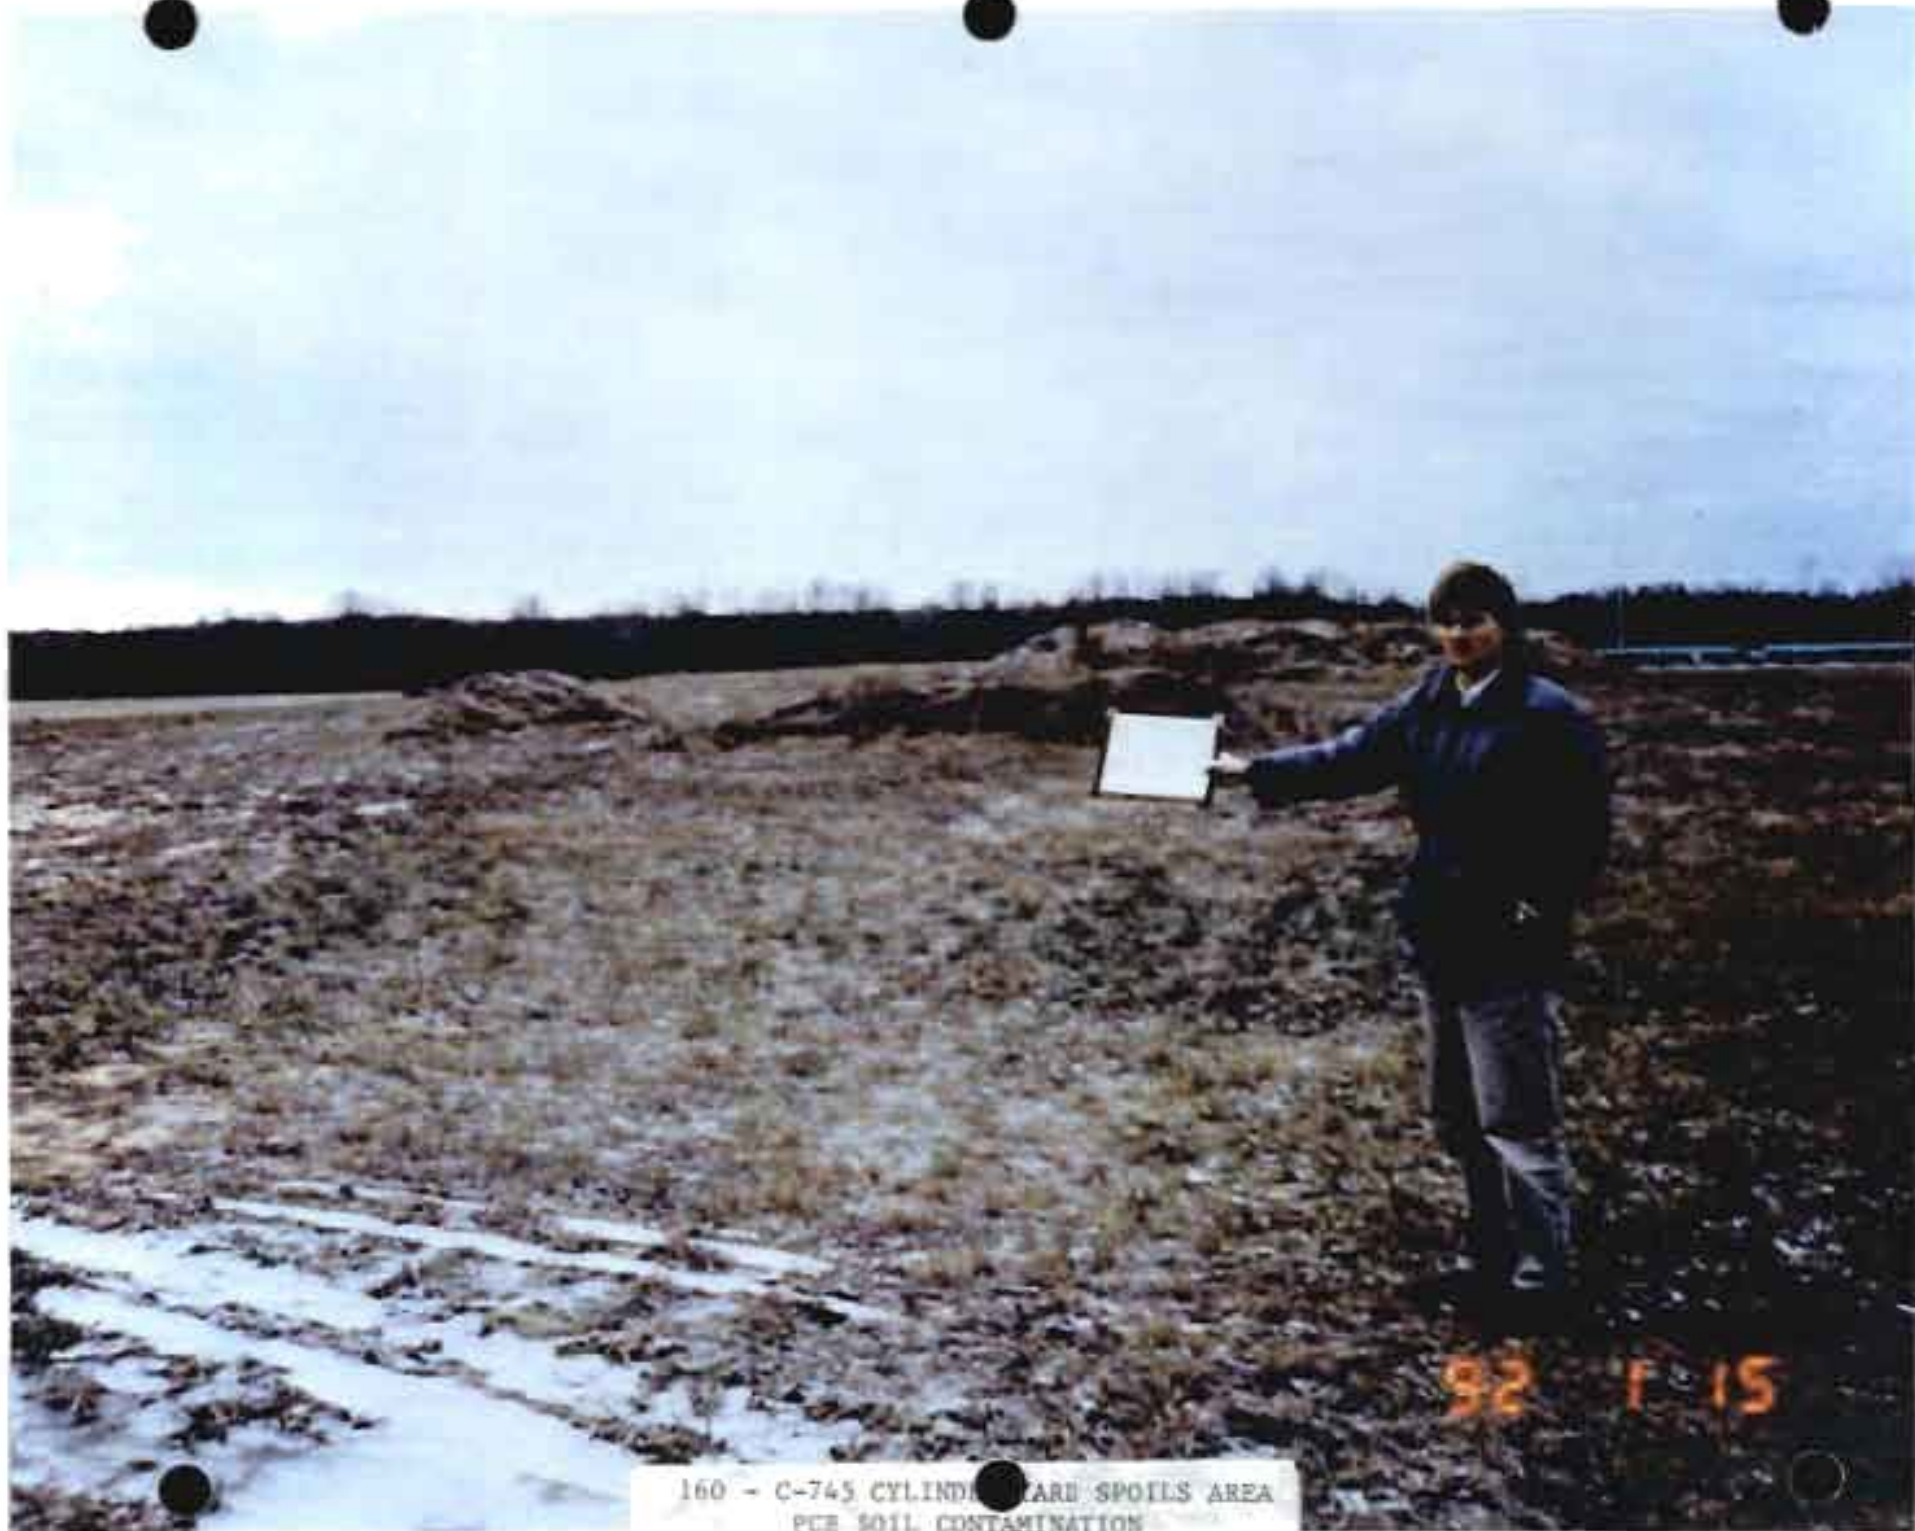
160 - C-745 CYLINDRICAL SPILLS AREA
PCE SOIL CONTAMINATION

This area is located inside the Plant Security Fence and is restricted to public access. The TSCA PCB Spill Cleanup Policy establishes a 25 ppm cleanup level for PCB contaminated soils in restricted areas.

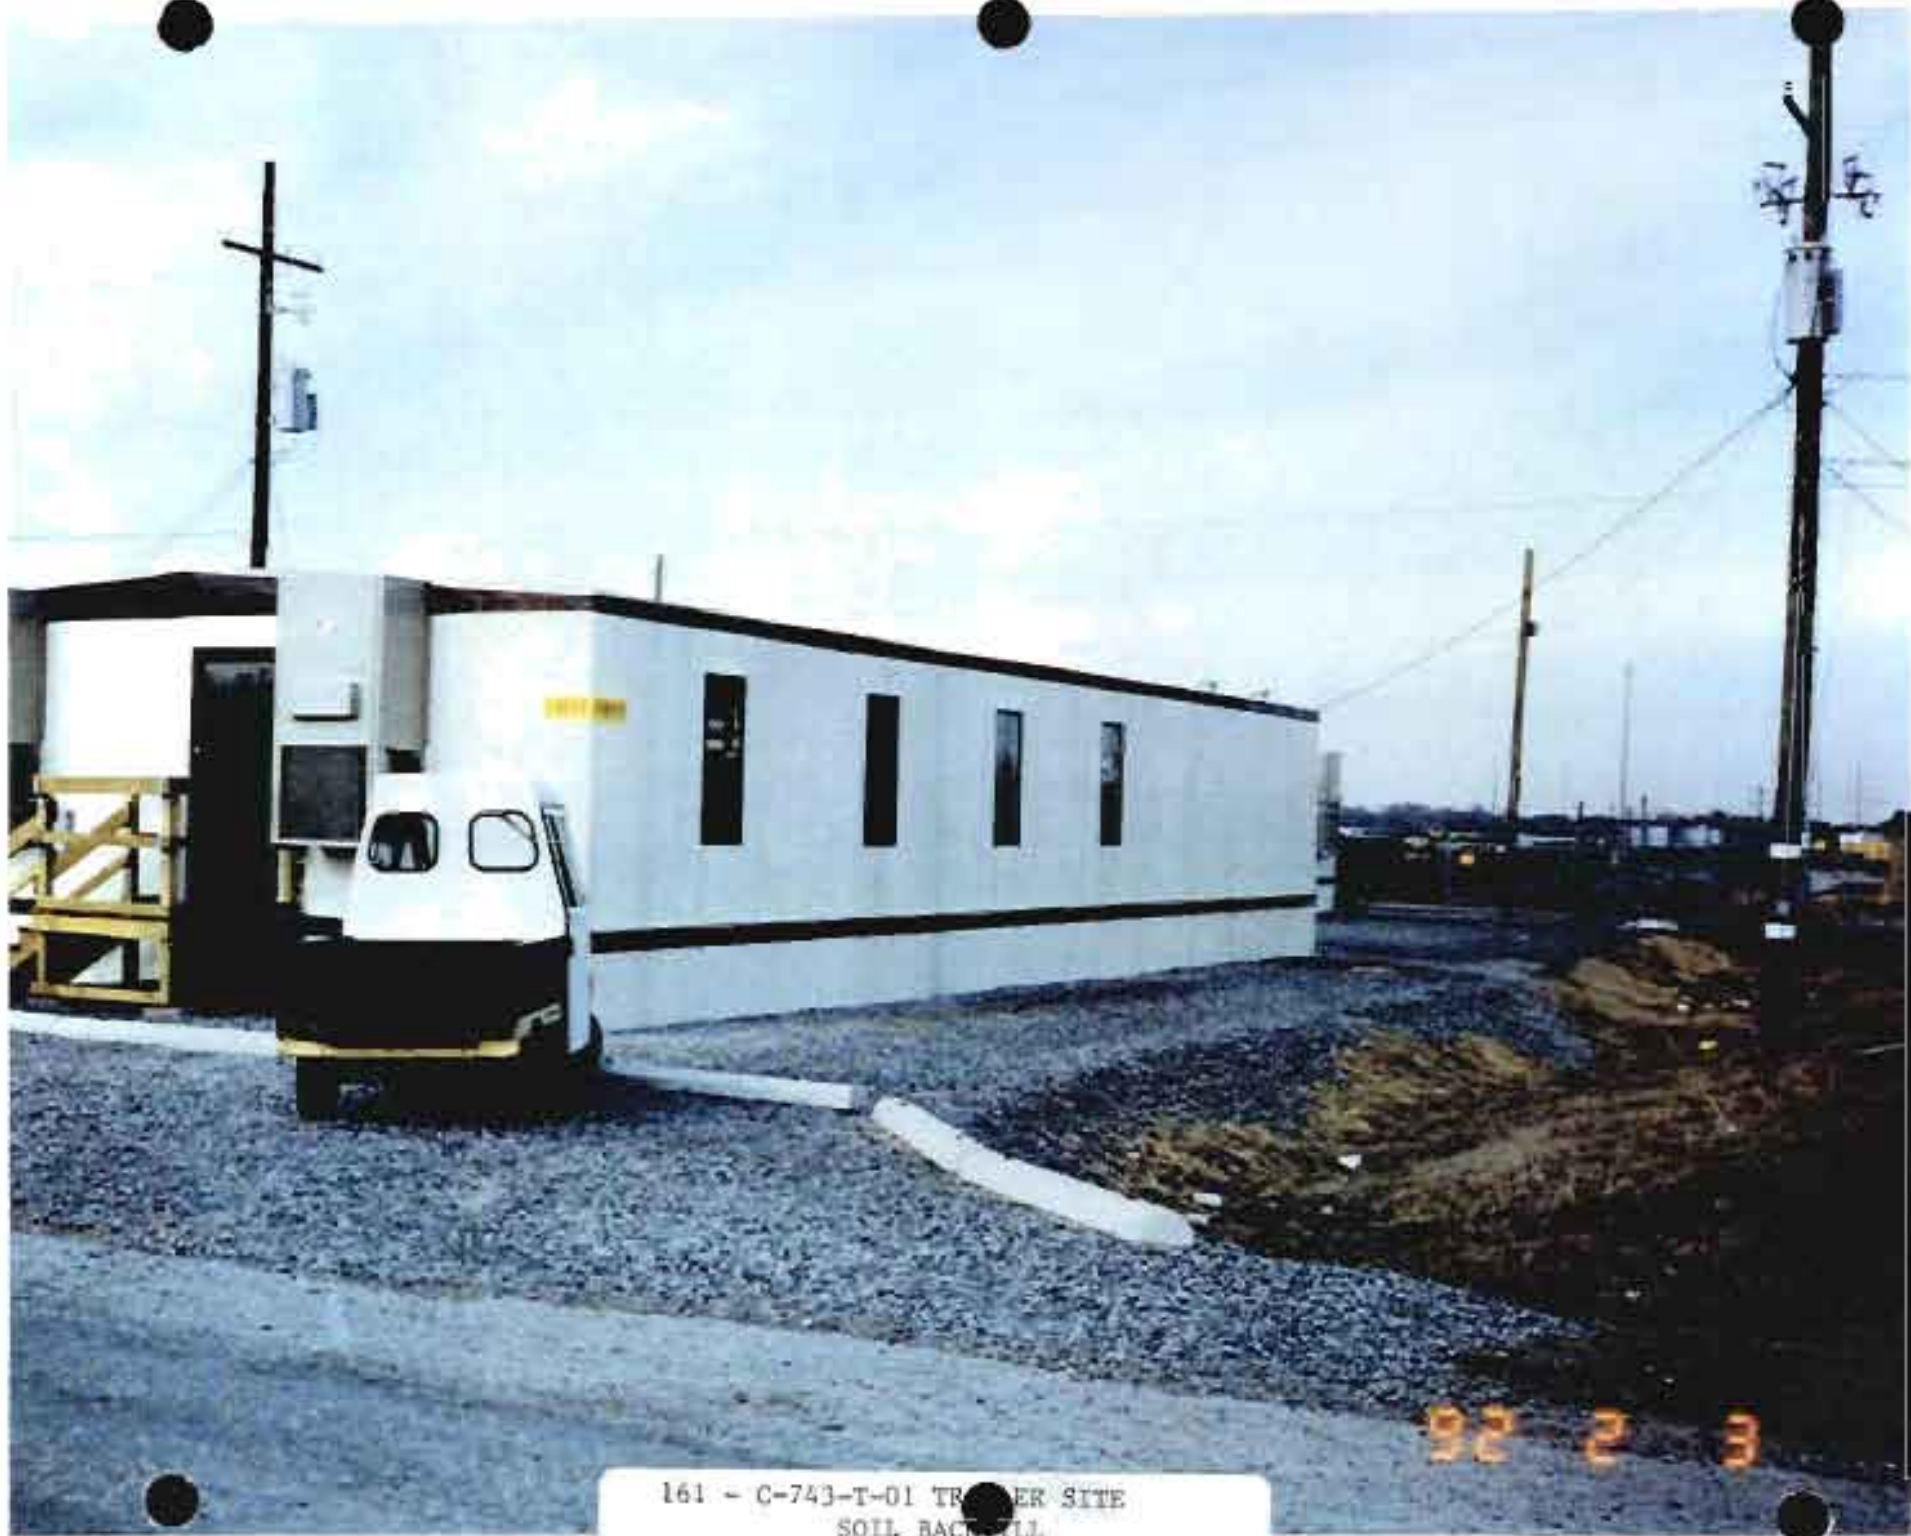
161 - C-743-T-01 TRAILER SITE
SOIL BACKFILL

This area is located inside the Plant Security Fence and is restricted to public access. The TSCA PCB Spill Cleanup Policy establishes a 25 ppm cleanup level for PCB contaminated soils in restricted areas.

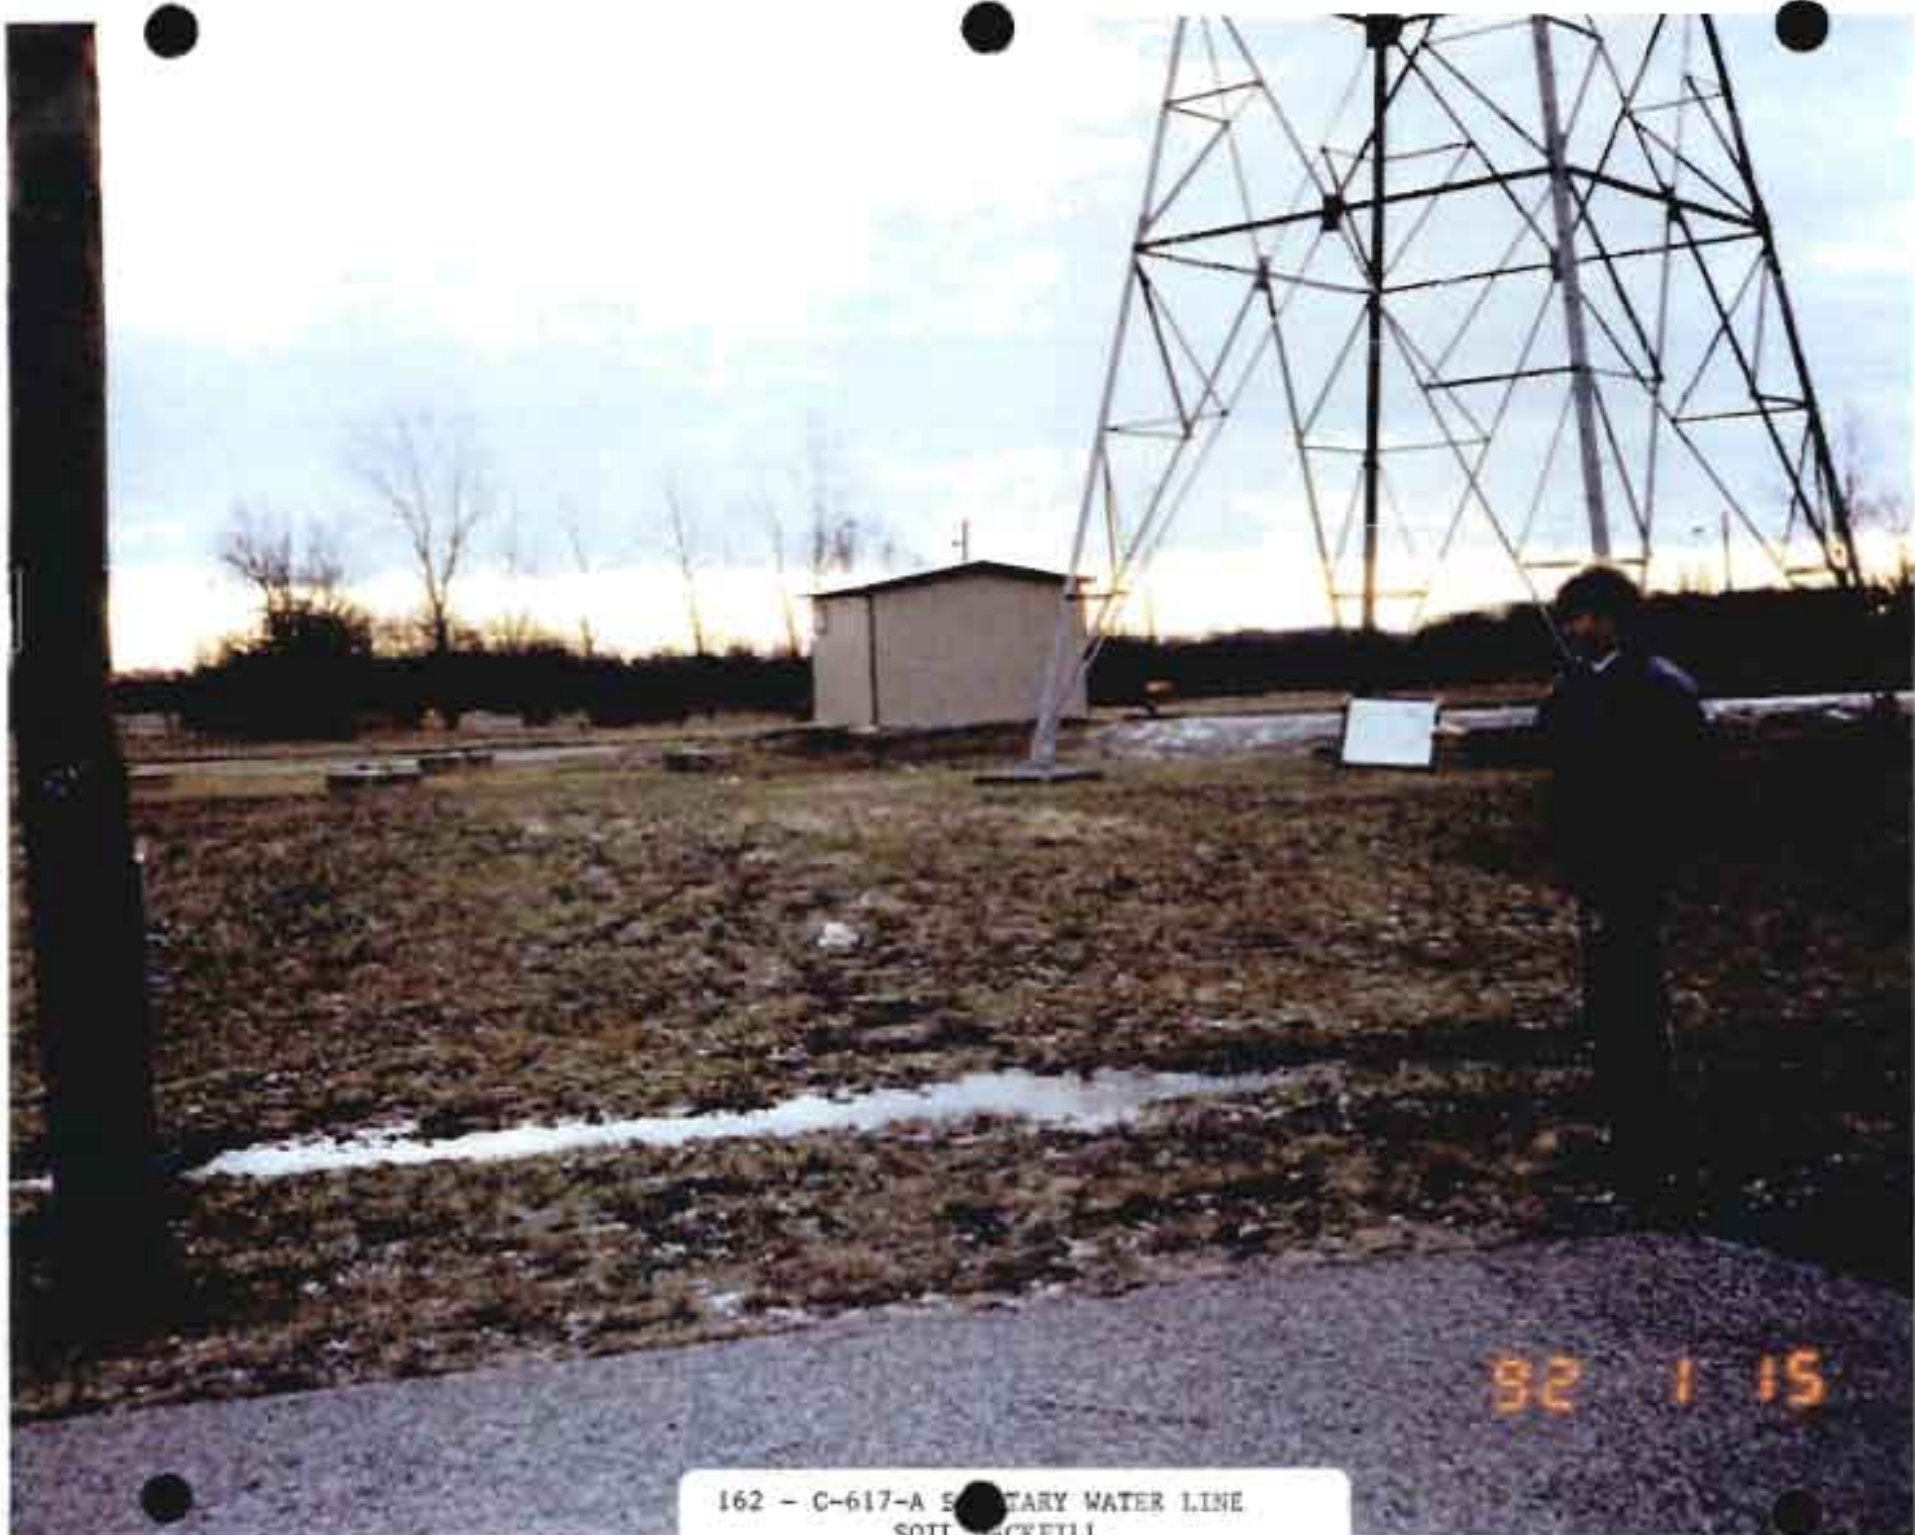
162 - C-617-A SECONDARY WATER LINE
SOIL BACKFILL

This area is located inside the Plant Security Fence and is restricted to public access. The TSCA PCB Spill Cleanup Policy establishes a 25 ppm cleanup level for PCB contaminated soils in restricted areas.
