KY/B-262
Addendum 1
Volume 1
Revision 1

PADUCAH GASEOUS DIFFUSION PLANT

PRELIMINARY ASSESSMENT

PADUCAH GASEOUS DIFFUSION PLANT
SOLID WASTE MANAGEMENT UNITS

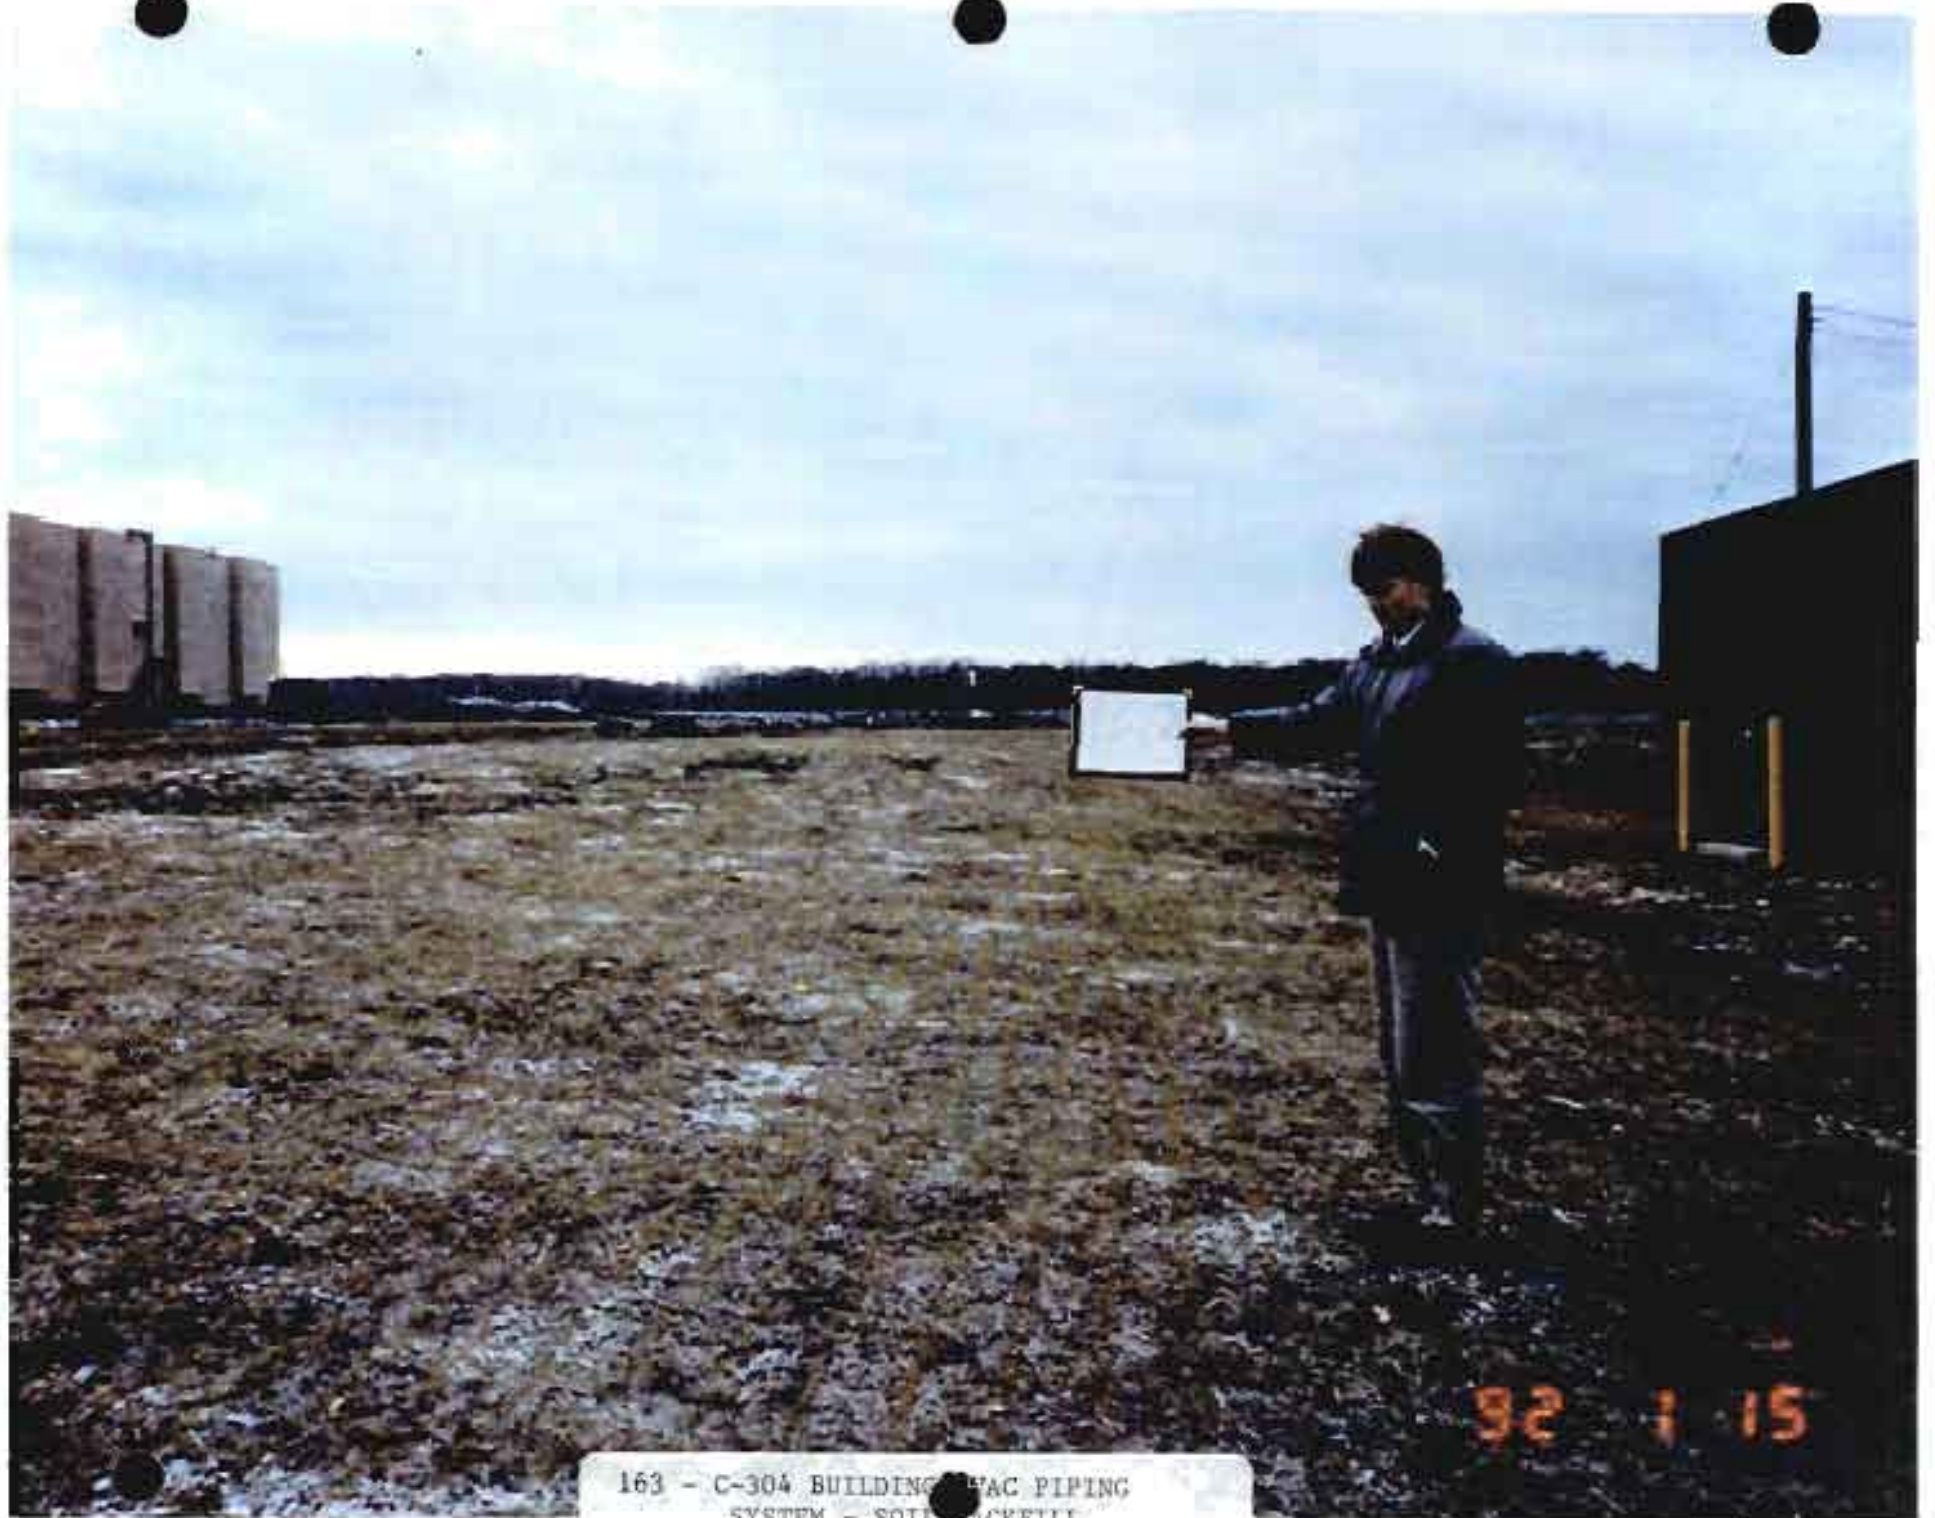
163 - C-304 BUILDING WAC PIPING
SYSTEM - SOIL BACKFILL

This area is located within the Plant Security Fence and is restricted to public access. The TSCA PCB Spill Cleanup Policy establishes a 25 ppm cleanup level for PCB contaminated soils in restricted areas.

The borrow area is currently being characterized, if the results are above the level of concern this SWMU will be assigned to a RFI.

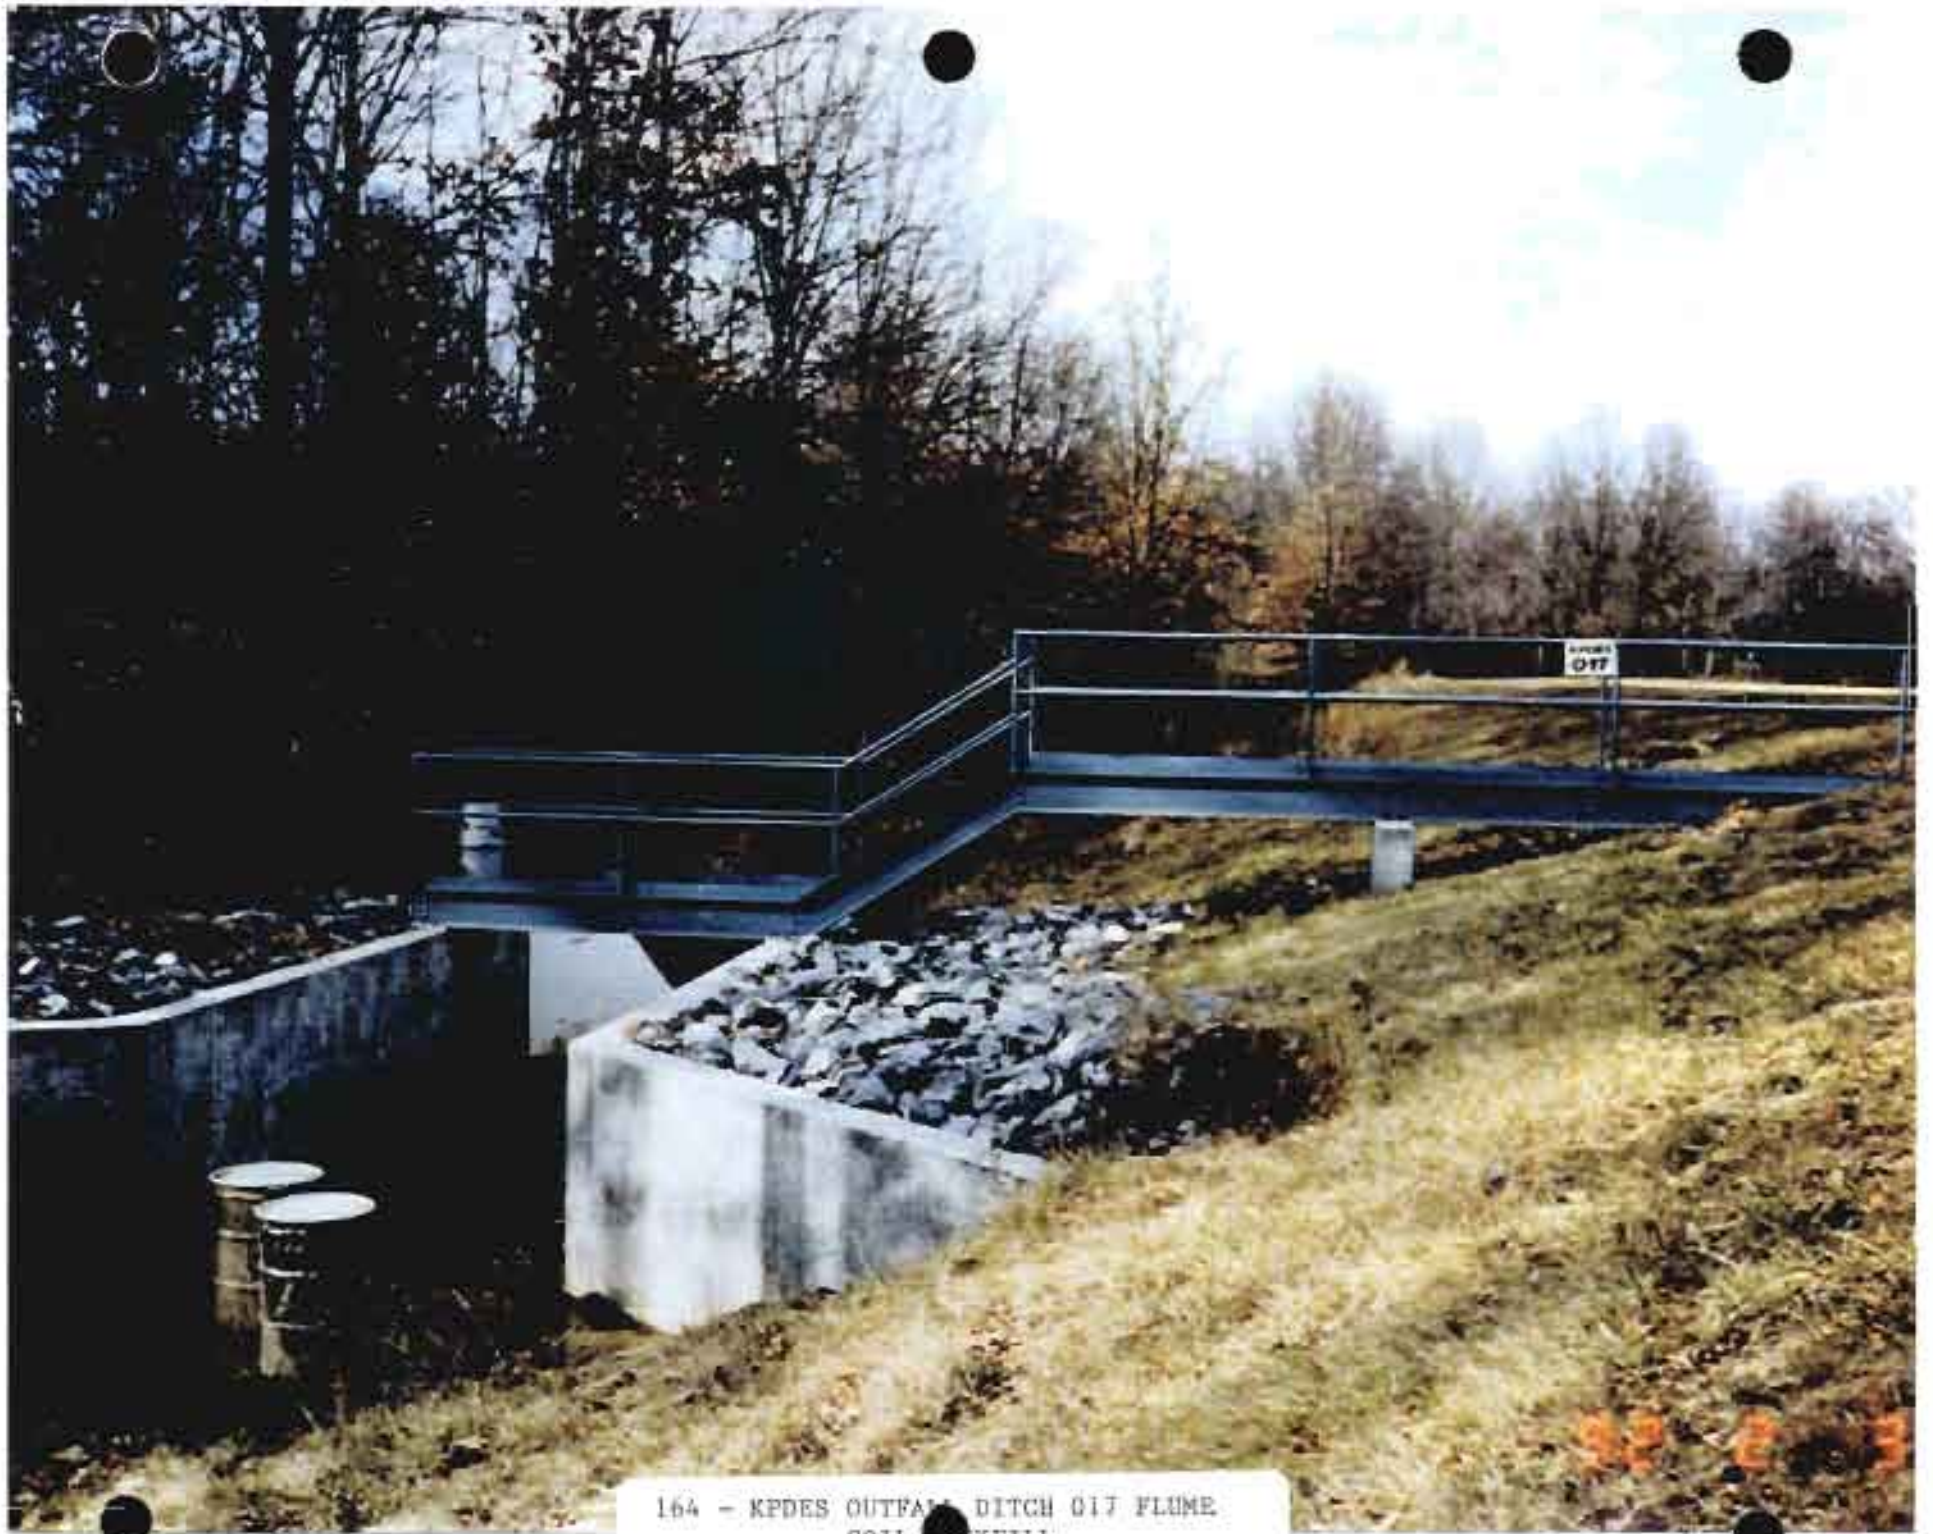
164 - KPDES OUTFALL DITCH 017 FLUME
SOIL BACKFILL.

The soil present at this location was obtained from a borrow area (SWMU 160) that contained 0.3 ppm. The 0.3 ppm was a result of a 5 point composite sample and could be as high as 1.5 ppm. The concentrations are also below the 10 ppm TSCA cleanup levels for unrestricted areas and the material is located under approximately 1 foot of rip-rap.

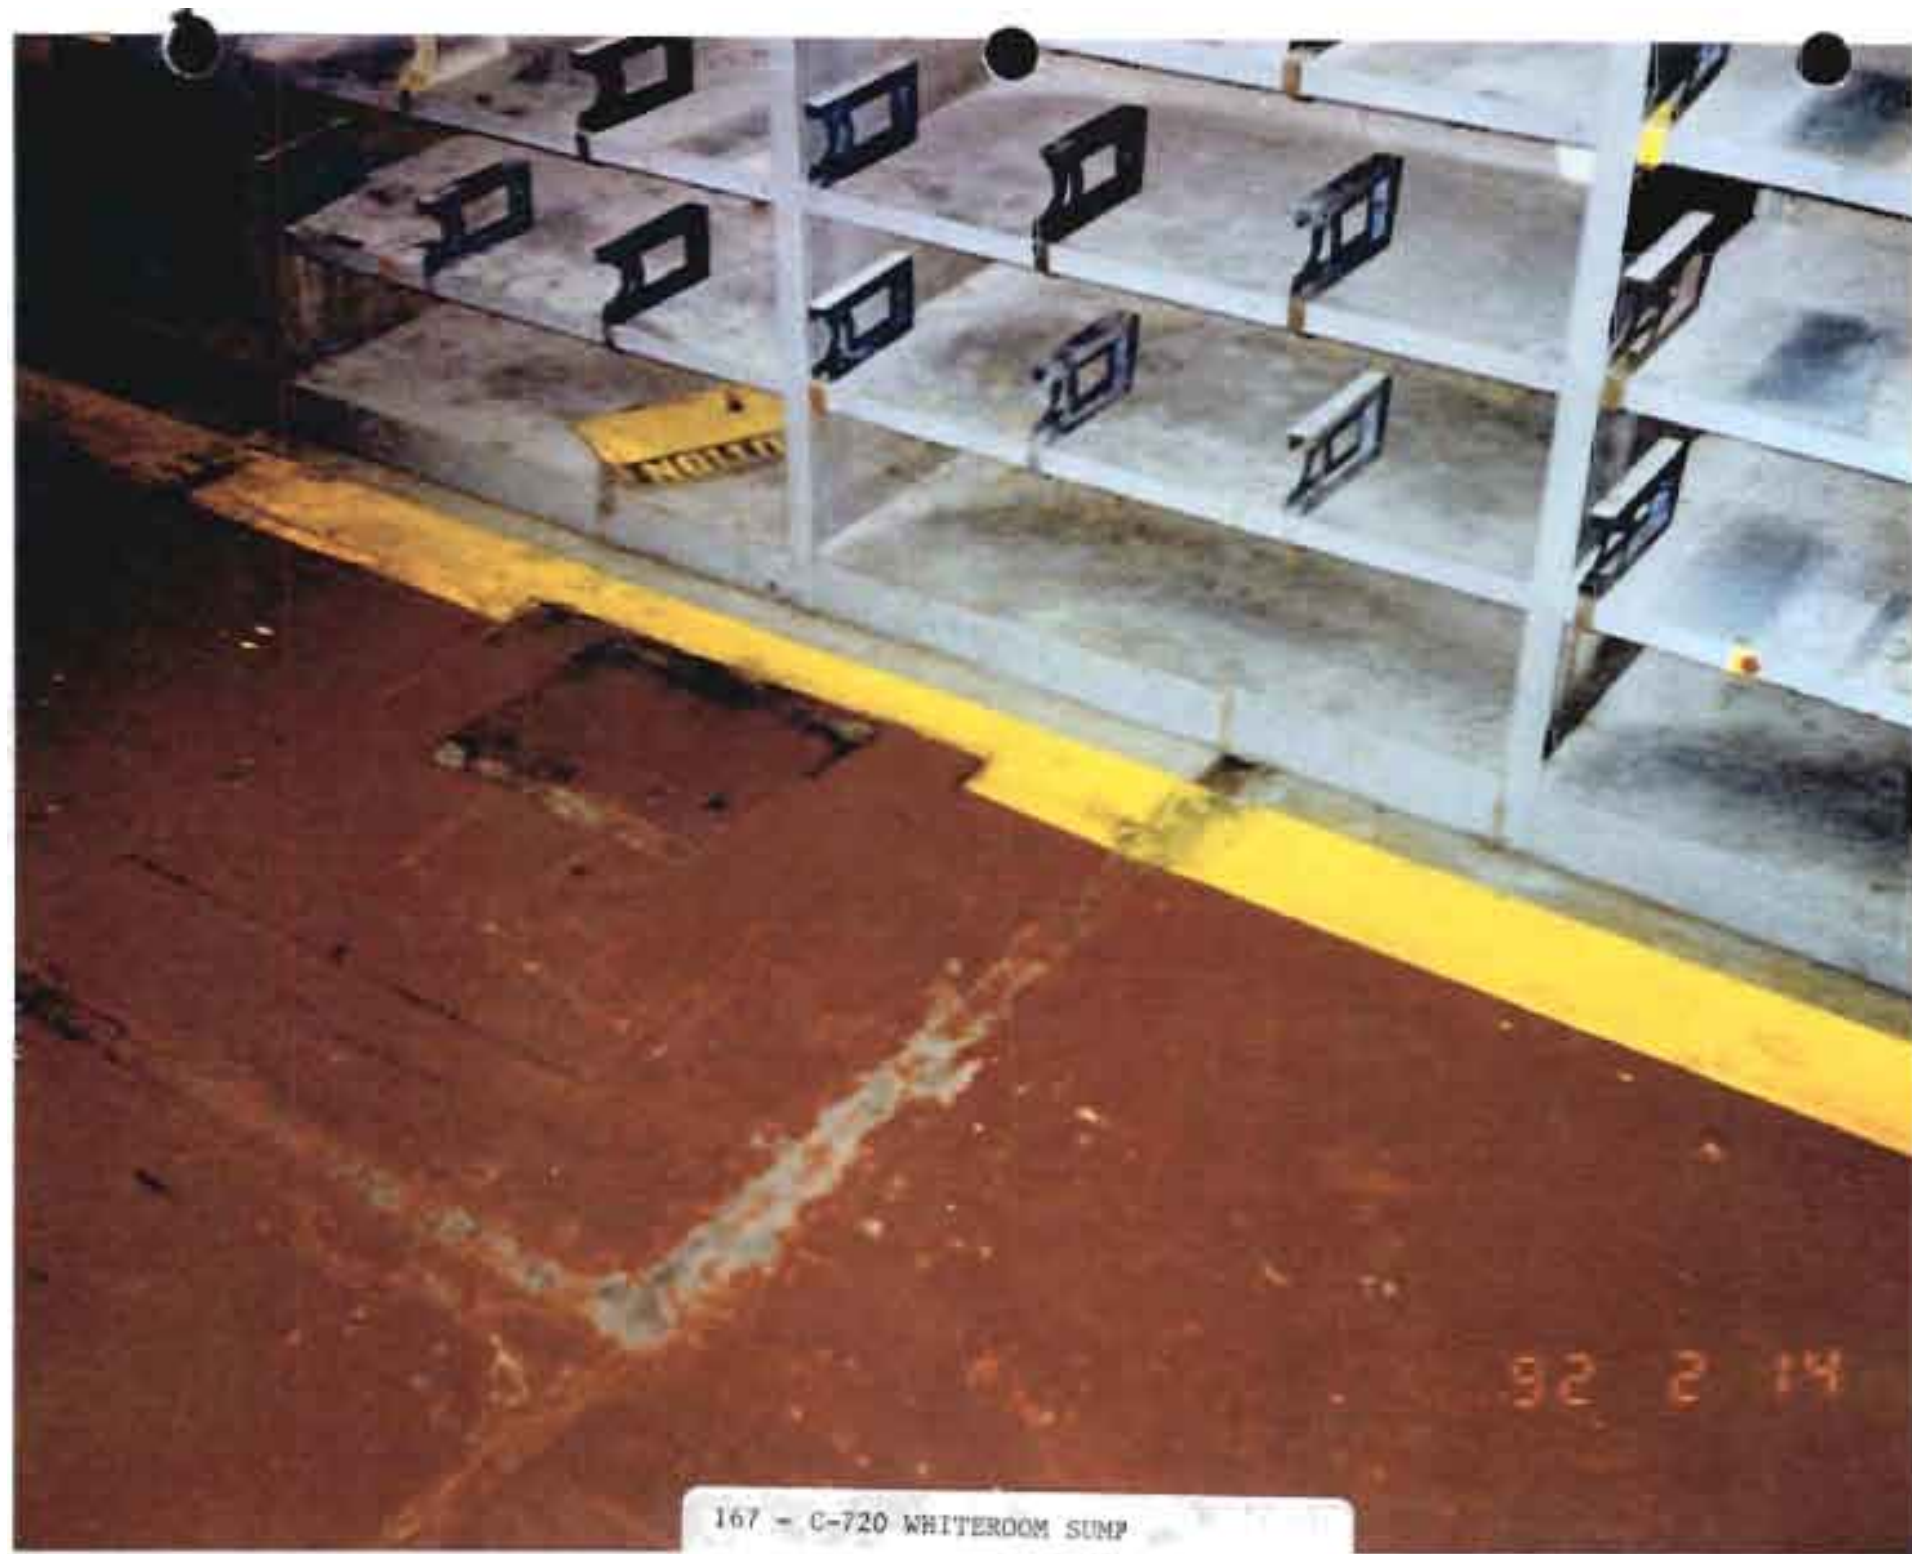
167 - C-720 WHITEROOM SUMP

DESCRIPTION OF RELEASE: The one known pathway for for a release to the environment would be through the storm sewer. The plant storm sewer system is currently addressed under WAG 18. The integrity of the tank has not been established and another pathway for release could be leaks from the tank.

RFI NECESSARY: NO - Disposition of the material in the tank will be made upon completion of characterization. If hazardous materials are identified the material will be removed and the integrity of the tank will be checked. Removal and clean-up of the tank will be handled under the Decontamination and Decommissioning program.

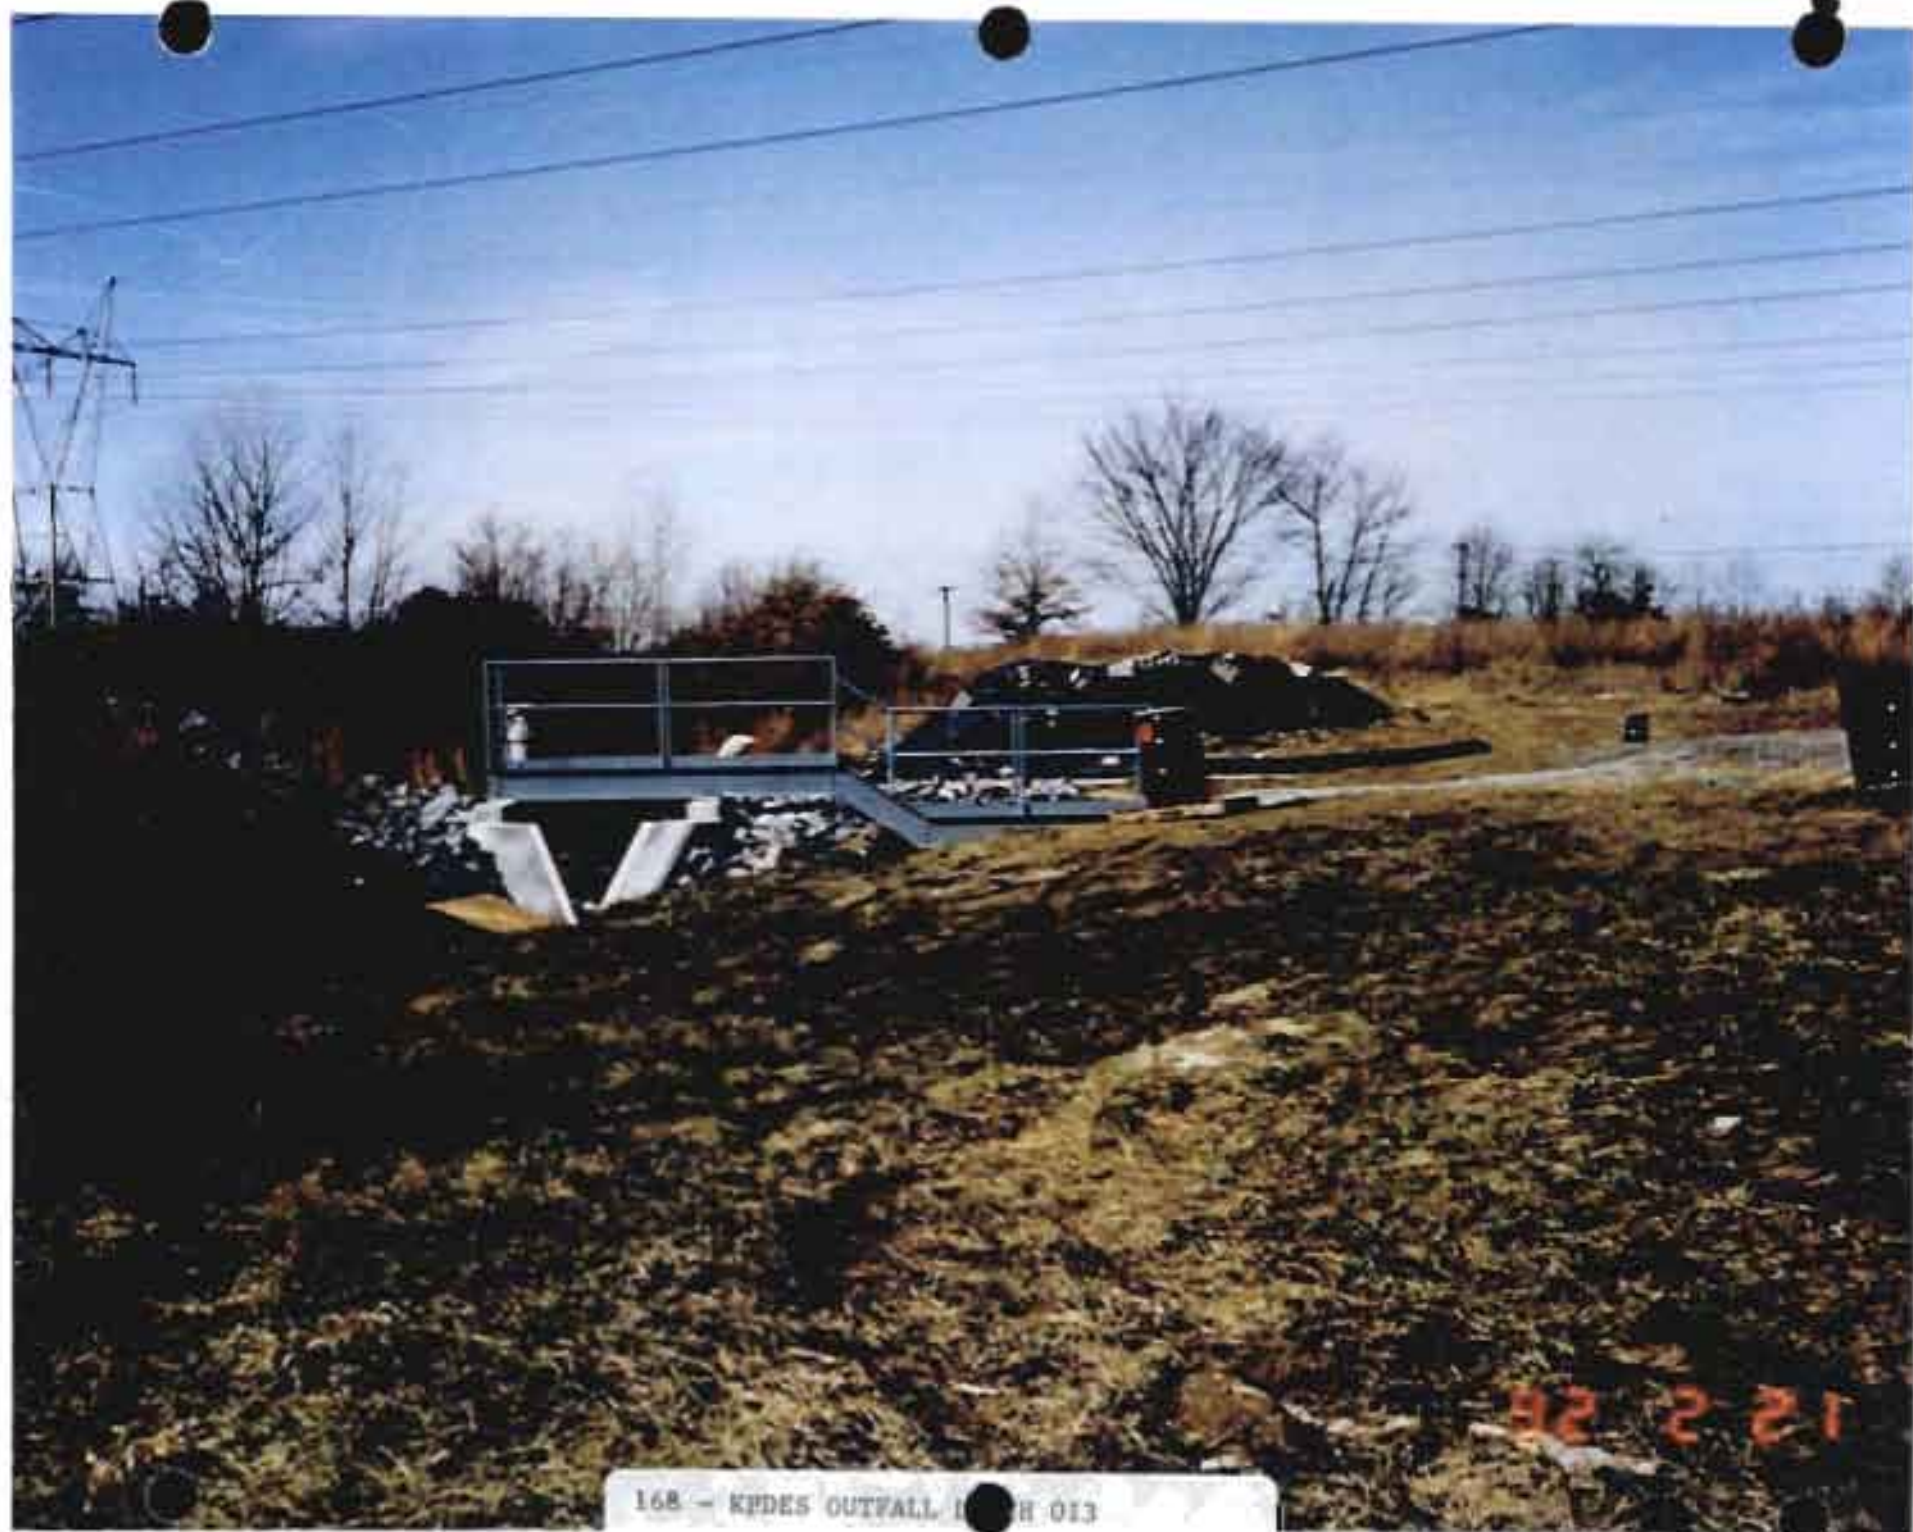
168 - KWDES OUTFALL H 013

DOCUMENTATION OF NO RELEASE: N/A

RFI NECESSARY: YES - This SWMU has been incorporated into the investigation for WAGs 5 and 11.

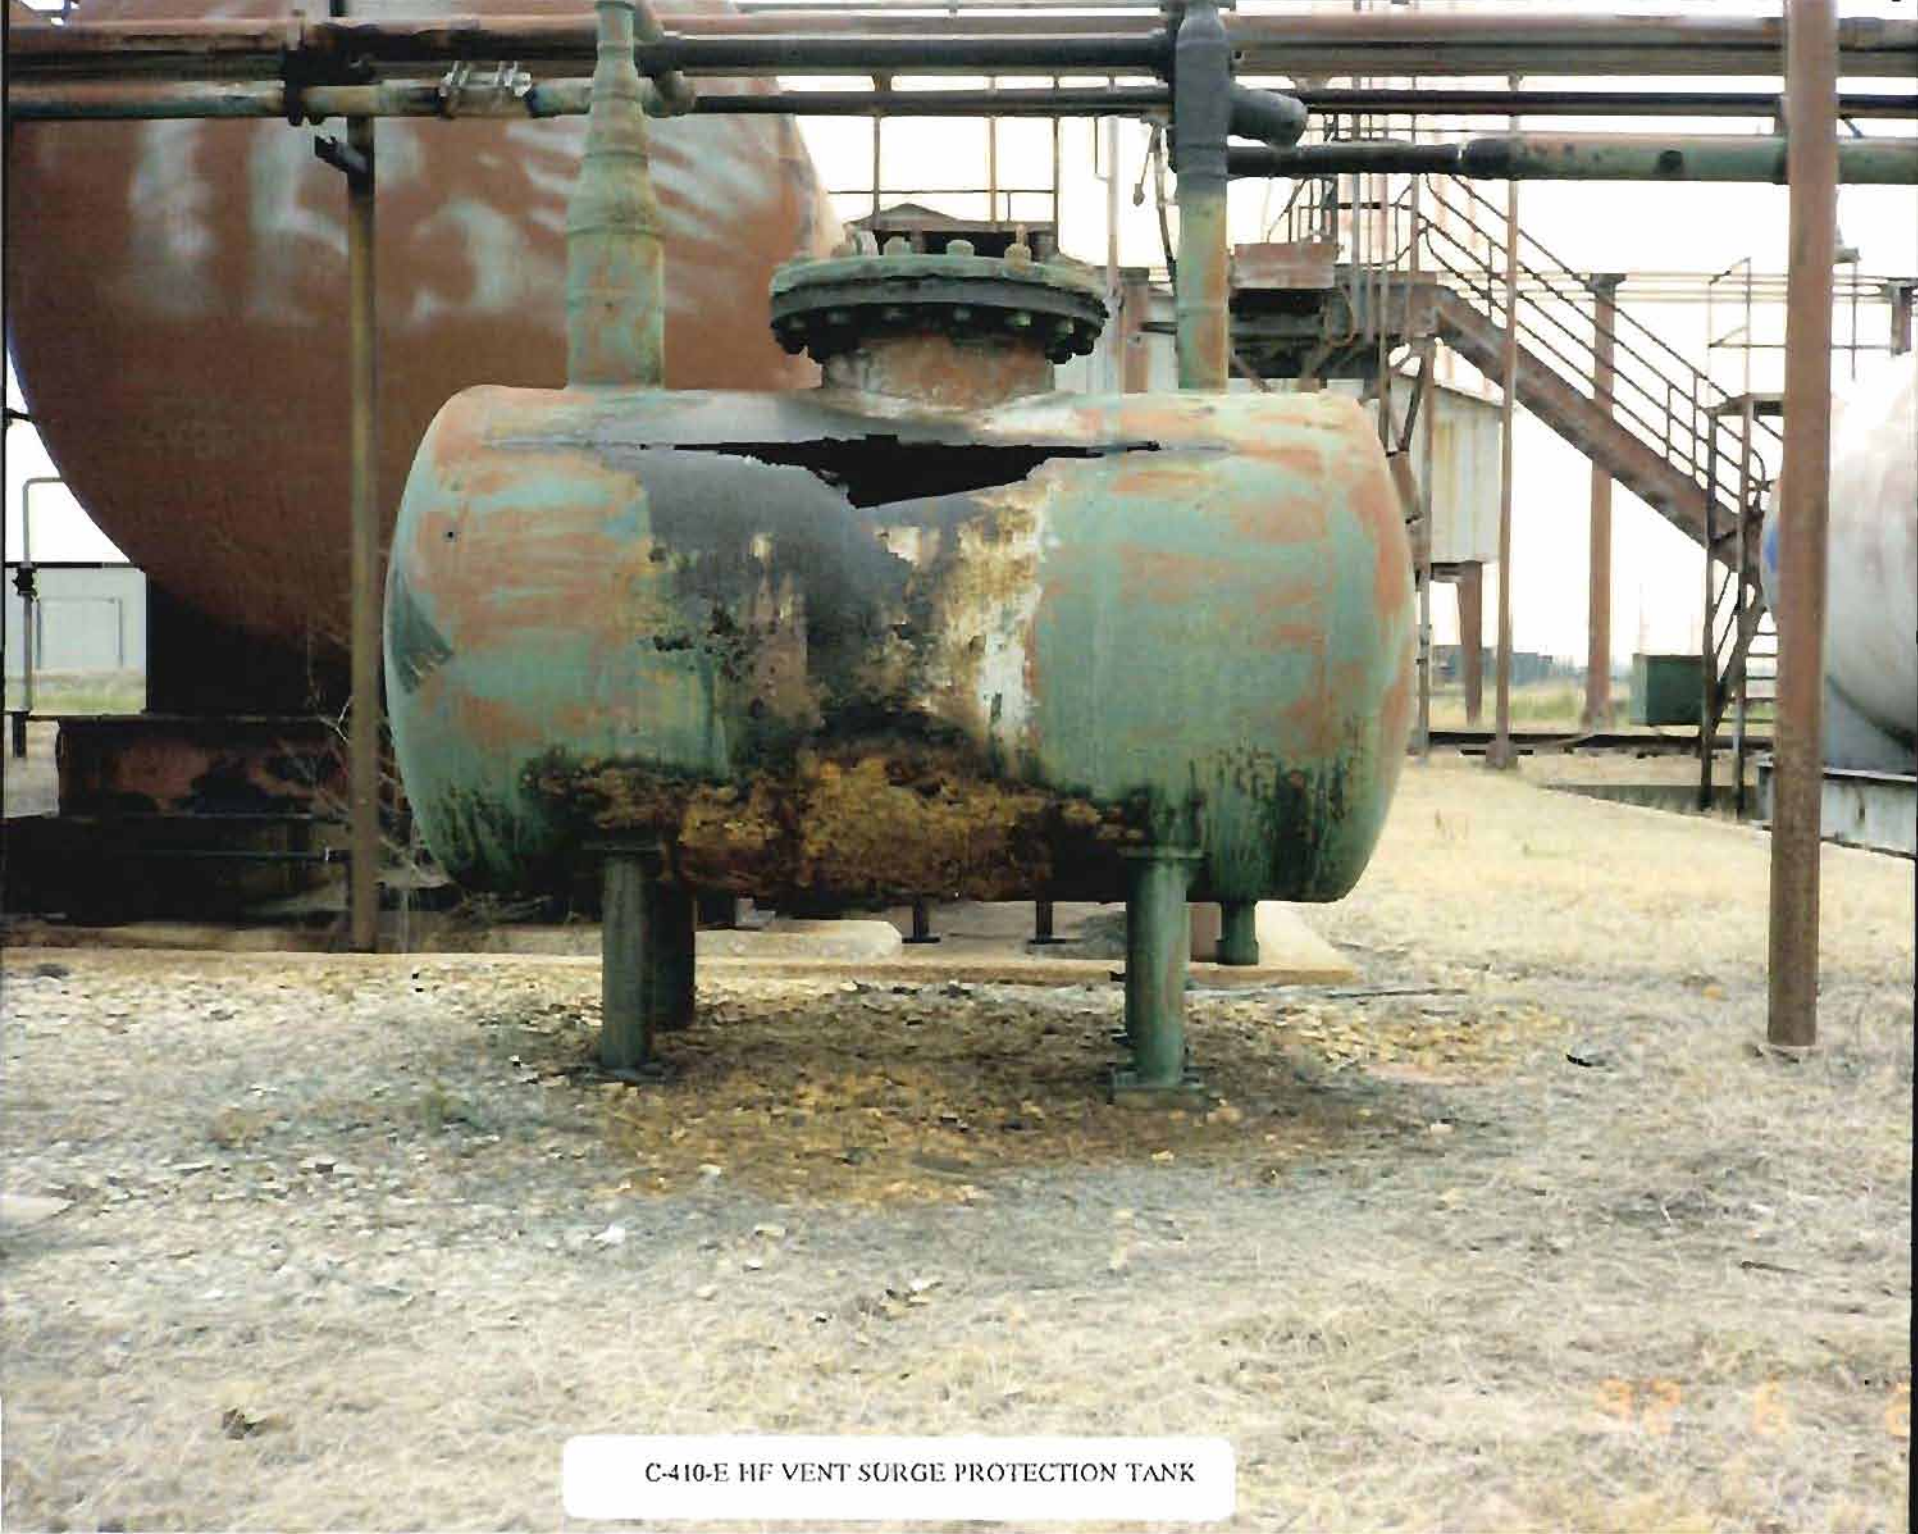
C-410-E HF VENT SURGE PROTECTION TANK

DESCRIPTION OF RELEASE: Stains on the ground under the tank indicate that material from the tank has been released to the ground.

RFI NECESSARY: YES - Initial sampling of material in the tank indicates chromium maybe present. The material is being resampled due to inconsistencies in the results.
