**Removal Action Report
for the C-405 Incinerator at the
Paducah Environmental Remediation Project,
Paducah, Kentucky**

**DOE/LX/07-0106&D2
Secondary Document**

Date Issued—September 2008

PADUCAH REMEDIATION SERVICES, LLC
managing the
Environmental Remediation Activities at the
Paducah Gaseous Diffusion Plant
under contract DE-AC30-06W05001

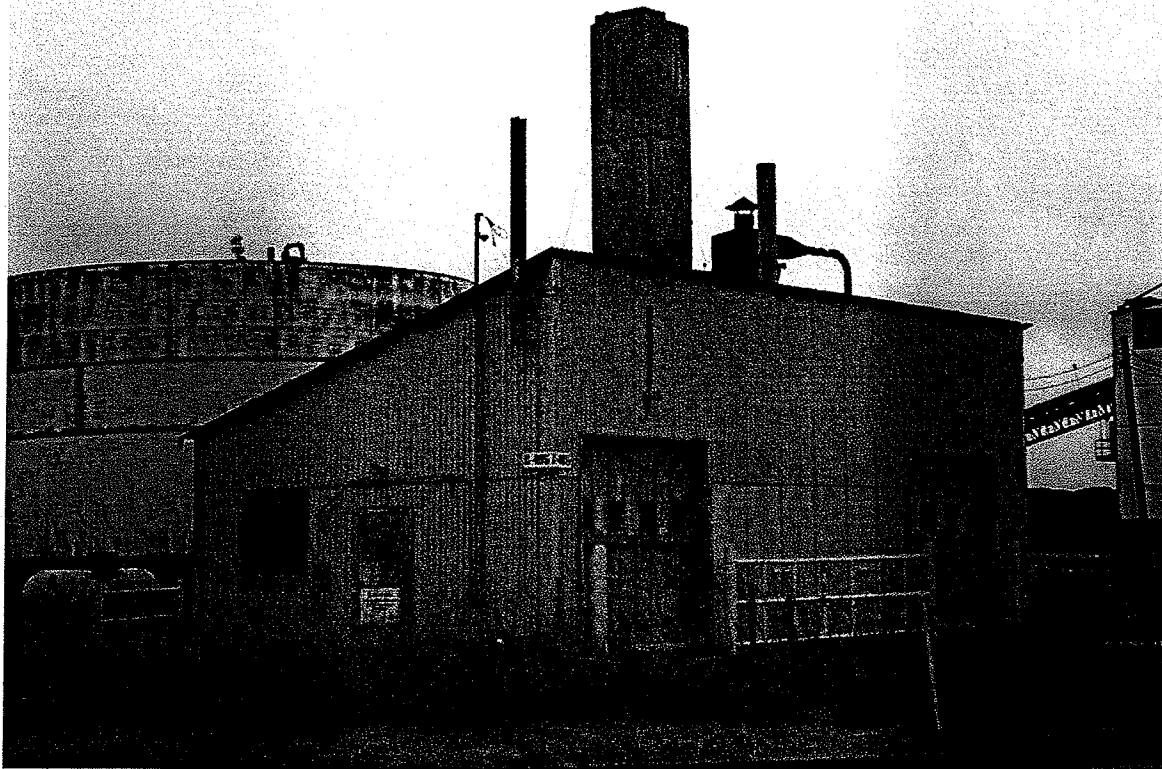
Figure 2. Photograph of Exterior of C-405 Incinerator

The C-405 Incinerator was constructed in the 1950s. The building was a steel frame structure with transite (asbestos) siding and roof. The structure was built on a concrete slab. On the main (north) façade were two steel and glass garage bay doors. A corrugated sheet metal personnel door and a window were located on the east and west sides of the facility. On the south façade were two glass windows with an awning. The building footprint encompassed approximately 1,030 ft² of floor area (22 ft x 46.5 ft).

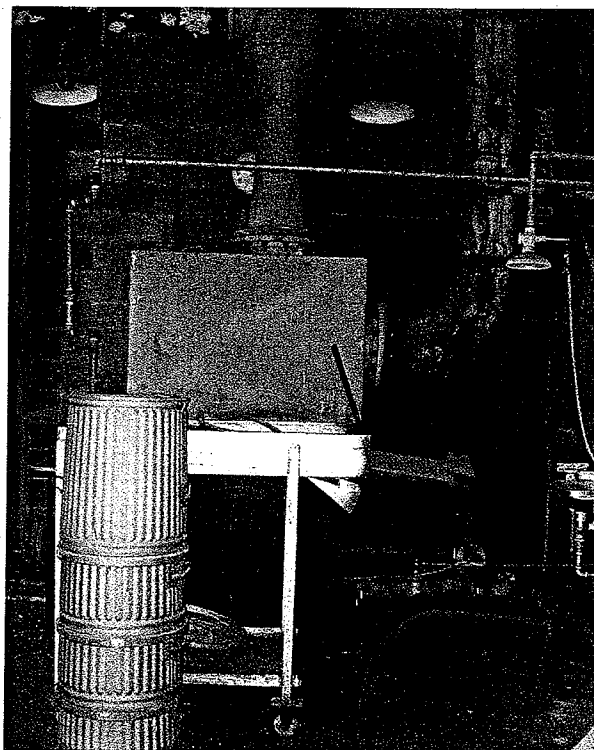
Figure 3. Photograph of Interior (East Side) of C-405

The building housed two inactive incinerators that were utilized to destroy combustible materials generated at the PGDP. There was a cinder block wall that separated the two incinerators. The incinerator on the east side was used to destroy radiologically contaminated items. The incinerator on the west side was used primarily for destroying noncontaminated items including classified documents. Each incinerator had a below-grade ash pit. The east side ash pit contained approximately 700 gallons of rain water. The west side ash pit contained no water. The east side of the building also housed a scrubber, miscellaneous pumps, electrical equipment, hoist, motors, and other debris, such as trash cans and paper. The west side of the building contained loose materials, such as motors, electrical equipment and pumps, a ladder, and spare scrubber parts. The two incinerators shared a common chimney that was located in the center of the building. The chimney was concrete lined with firebrick. The chimney was approximately 35 ft in height with its own foundation separate from the building foundation. A dust collector and stacks for the flue and scrubber were located on the roof of the west side. A 500-gallon liquid propane (LP) tank that provided fuel for the incinerators was located southeast of the building.

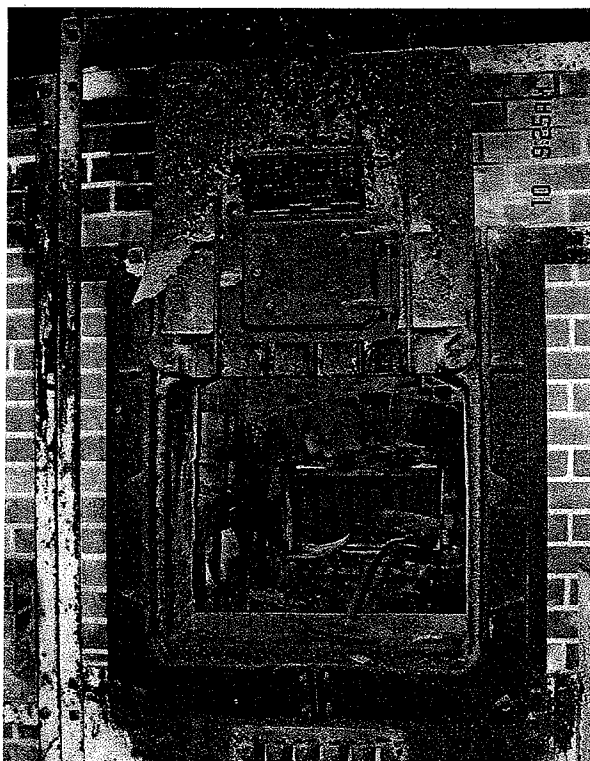
**Figure 4. Photograph of Interior (West Side) of C-405 Incinerator
(Scale for reference—door size is 24 inches x 16 inches)**

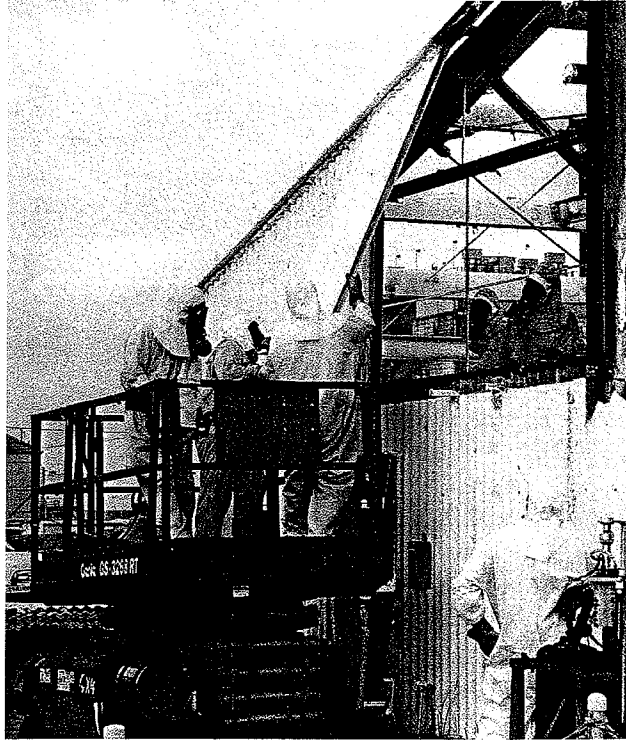
Figure 5. Photograph of Transite Siding Removal at C-405

At this point in the D&D phase, only the building chimney and structure remained. The next work task was the removal of all transite siding and roofing. All glass, window frames, roll up doors, and personnel doors were removed and packaged for disposal. The roof and siding were attached to a steel structure with lead head fasteners. These fasteners were removed and segregated for proper packaging and disposal. The siding and roof were removed and packaged for disposal (see Figure 5). The removal of the transite siding and roof was performed in accordance with all applicable federal and state regulations, as defined in the ARARs. The steel structure was removed with an excavator and shear attachment (see Figure 6). All openings in the concrete floor generated during structure removal were filled with concrete grout flush with the existing concrete floor.

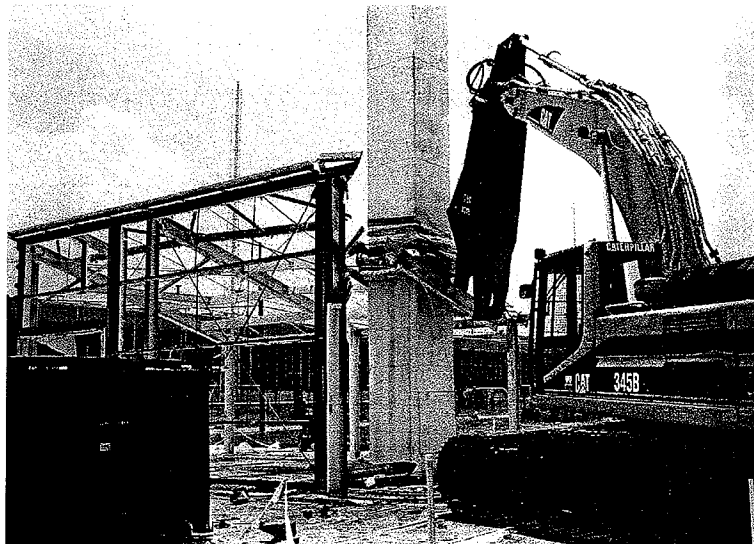
Figure 6. Photograph of Structure Removal at C-405

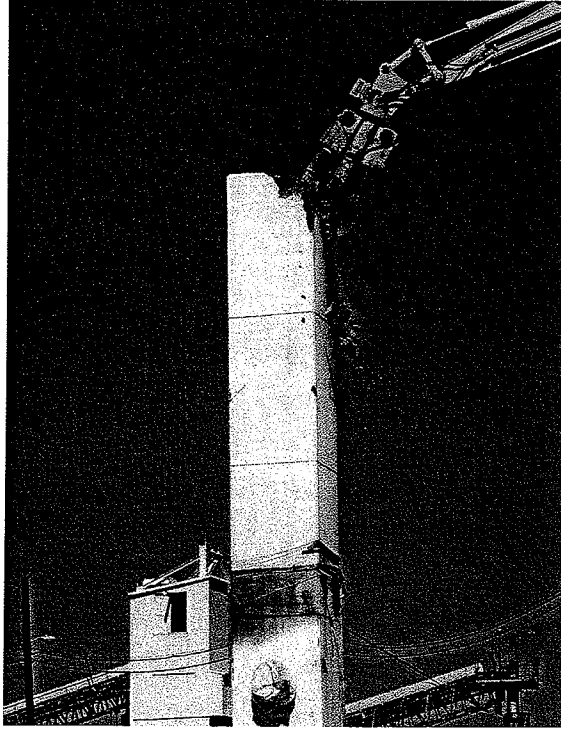
Figure 7. Photograph of Chimney Removal at C-405

A 50-ft construction boundary was established around the perimeter of the chimney to serve as a work area for the chimney removal. Work sedimentation controls were installed to catch any sediment that was generated due to the chimney removal. An excavator with a concrete pulverizer attachment was used in a systematic way to remove the chimney (see Figure 7). A fire hydrant provided the water required to mist the chimney for dust suppression during this demolition activity. As the chimney was removed, all demolition debris was removed from the work area and packaged for disposal. All protruding rebar in the demolition debris was cut to eliminate hazards while packaging the waste for disposal. The chimney was removed to the concrete slab level and all remaining rebar was cut flush with the concrete slab.

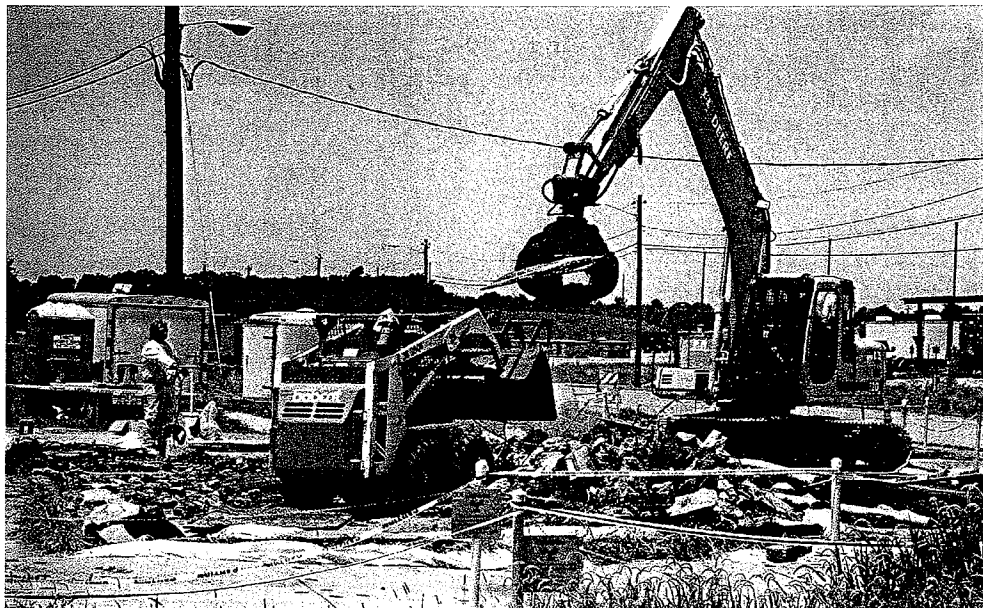
Figure 8. Photograph of Site Cleanup at C-405

After demolition of the building was complete, all equipment and materials were demobilized and site cleanup activities began (see Figure 8). The ground barrier and filter cloth were removed and properly containerized for disposal. General housekeeping activities were performed on the concrete slab and around the building grounds. Radiological surveys of the concrete slab were performed to determine the posting requirements. A fixative was applied to the concrete pad to fix the low-level radiological concerns (1,589,238 dpm/100 cm² total beta/gamma, 702 dpm/100 cm² total Alpha). A perimeter boundary control was installed around the concrete slab to clearly demarcate the area as a fixed CA (see Figure 9).

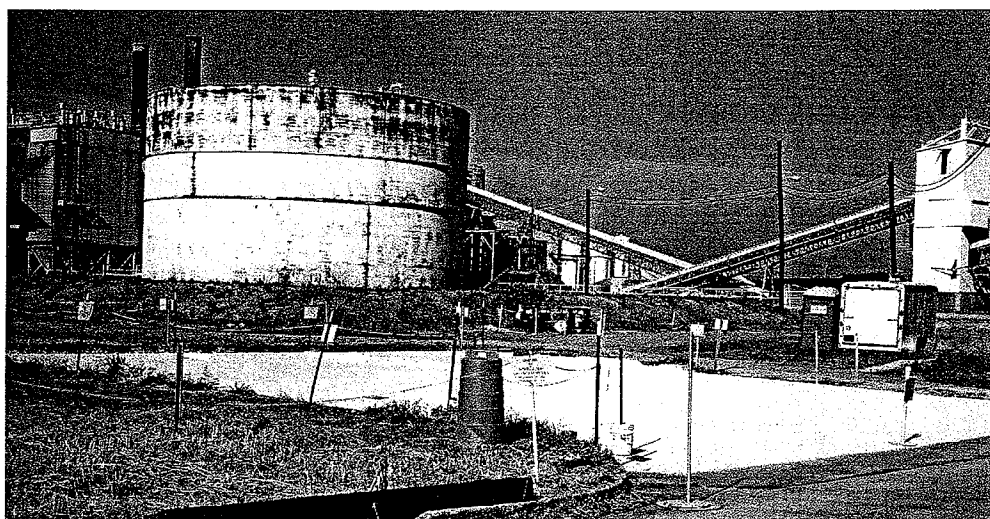
Figure 9. Photograph of C-405 Post D&D
