**TRANSMITTAL OF THE SITE EVALUATION REPORT FOR THE C-606 COAL CRUSHER BUILDING AT THE PADUCAH GASEOUS DIFFUSION PLANT, PADUCAH, KENTUCKY, DOE/LX/07-2454&D1**

**Site Evaluation Report for the  
C-606 Coal Crusher Building at the  
Paducah Gaseous Diffusion Plant,  
Paducah, Kentucky**

C-606

Coal Crusher Building

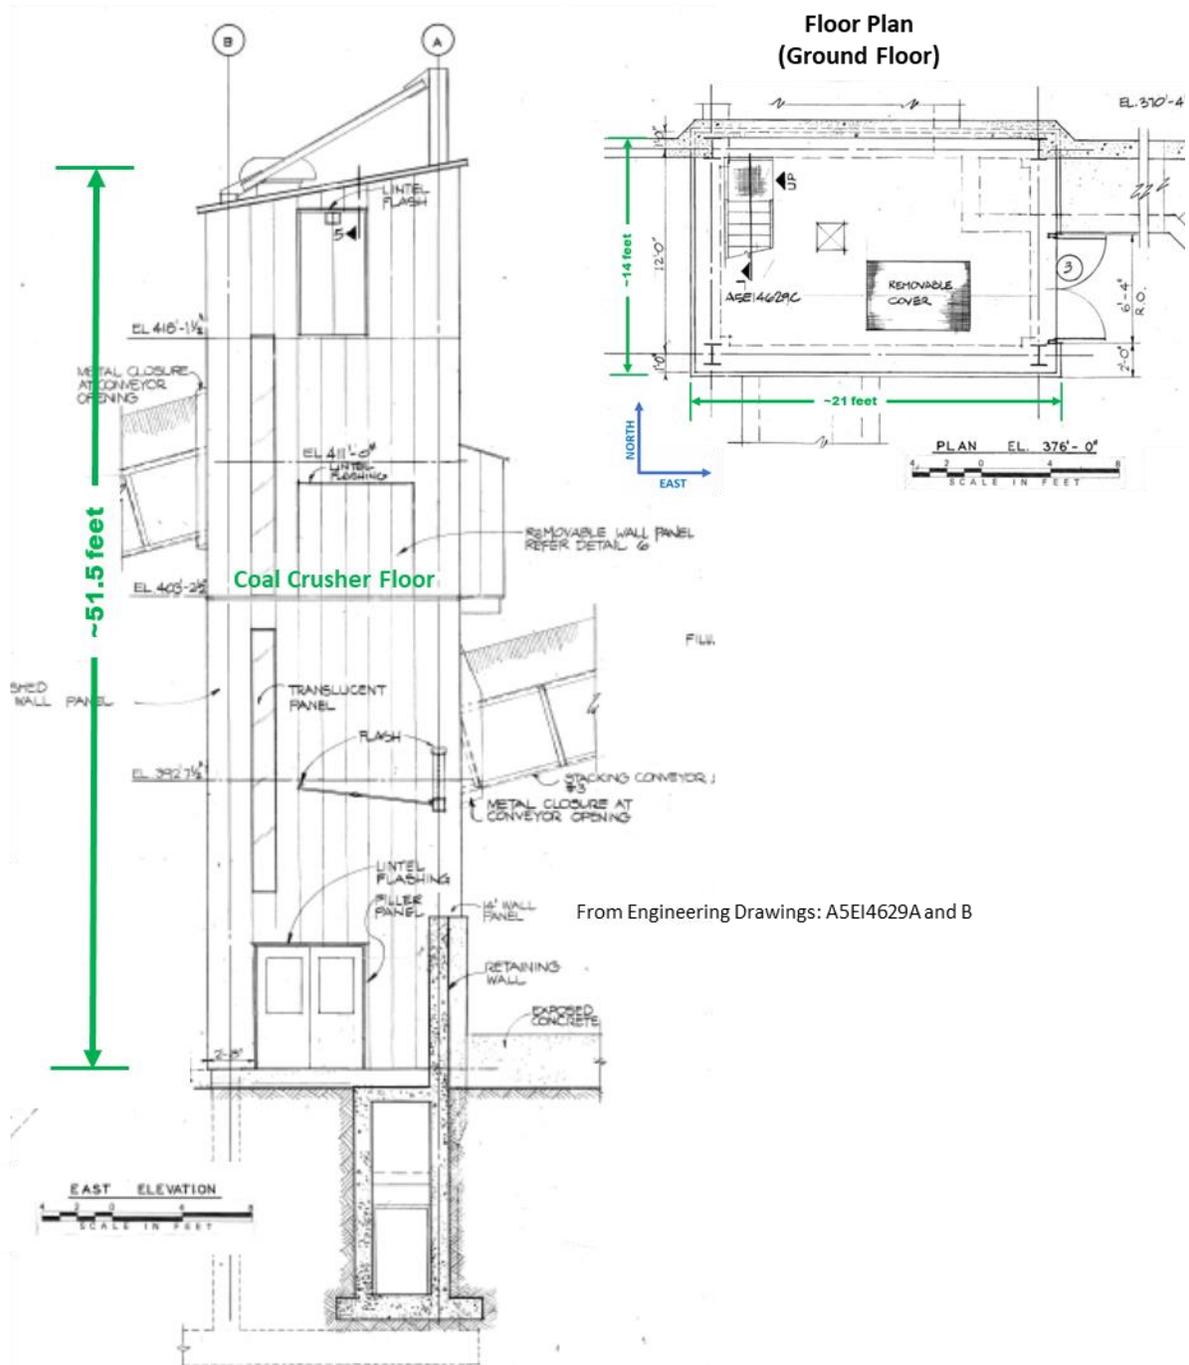
Figure 3. Profile and Floor Plan for C-606

The gross floor space of C-606 is 1,470 ft<sup>2</sup> with an approximately 294 ft<sup>2</sup> footprint. C-606 is an approximately 51.5-ft tall, rectangular-plan building with a concrete foundation and/or basement. The approximate dimensions of C-606 are 21 ft × 14 ft. The building has an approximately 15-ft deep basement with a coal hopper pit. Figure 3 provides a portion of an engineering drawing that shows the building plan and profile, and Figures 4 and 5 are exterior photographs of the facility. Figure 6 shows the entrance to the

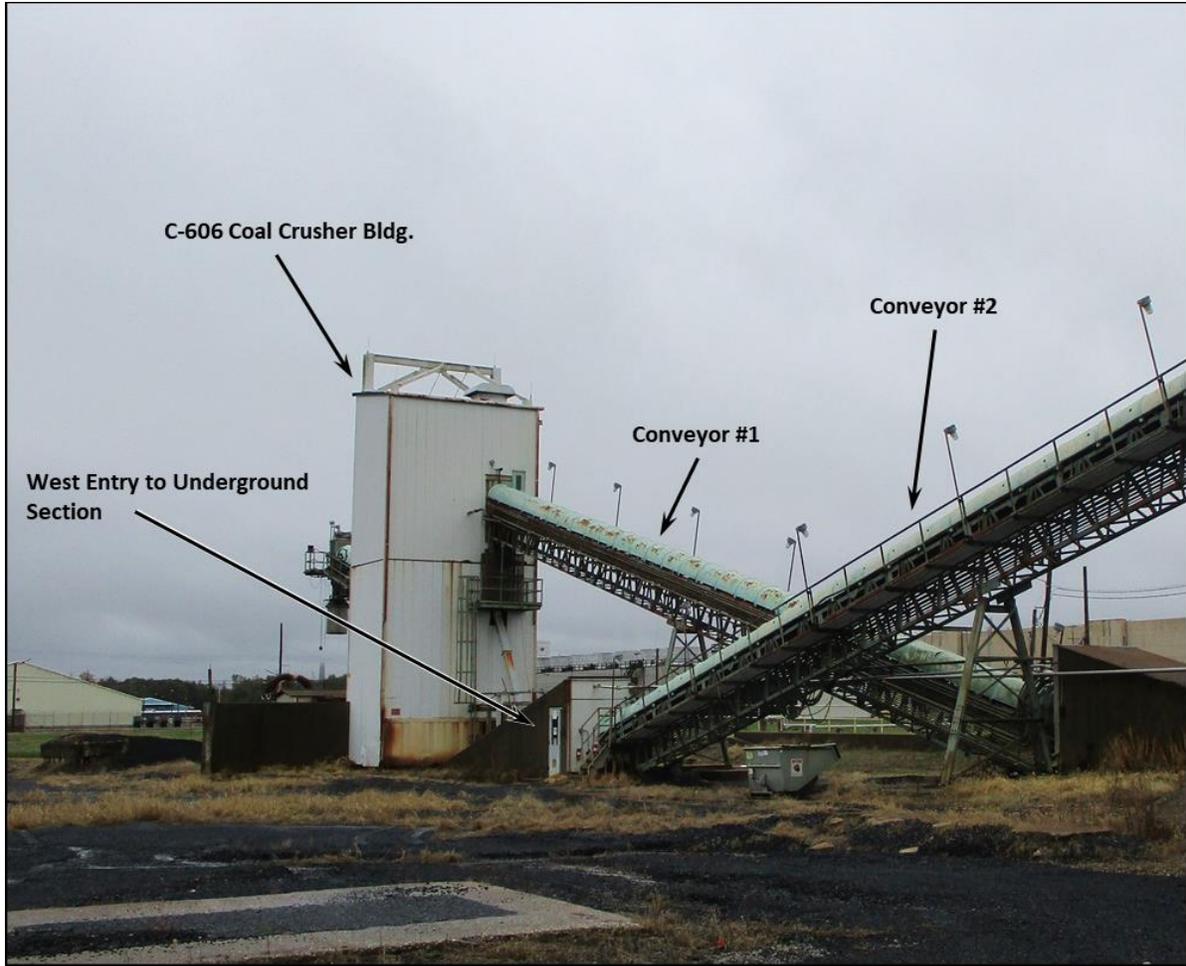
Figure 4. Exterior View of C-606 (Looking Northeast)

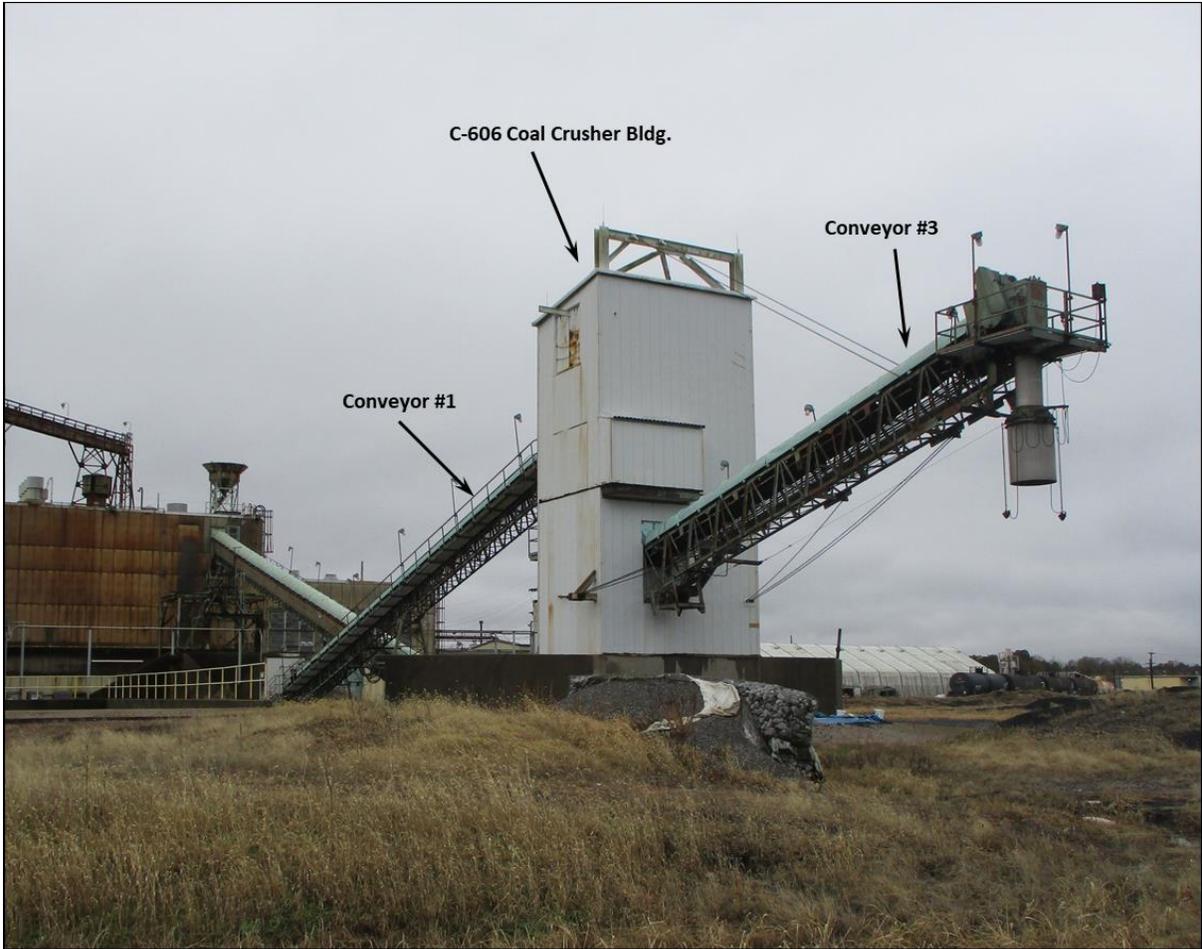
**Figure 5. Exterior View of C-606 (Looking Southwest)**

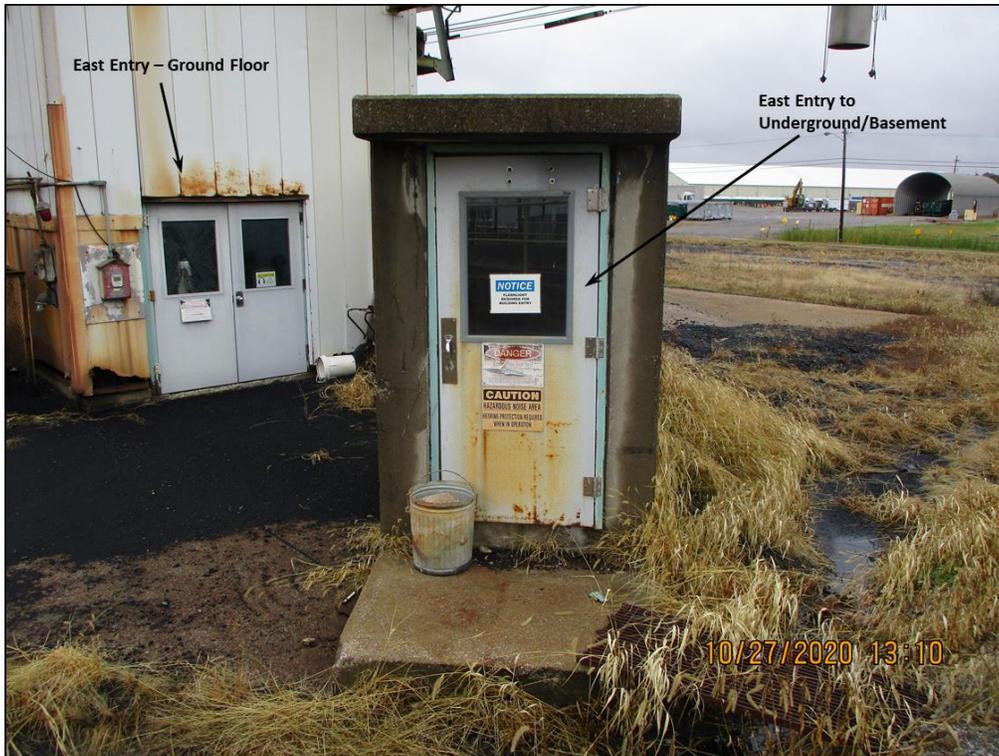
**Figure 6. C-606 Entry for Ground Level and Underground/Basement (Looking West)**

main building and an entrance to the underground portion of C-606. Additional engineering drawings are provided in the appendix to this report.

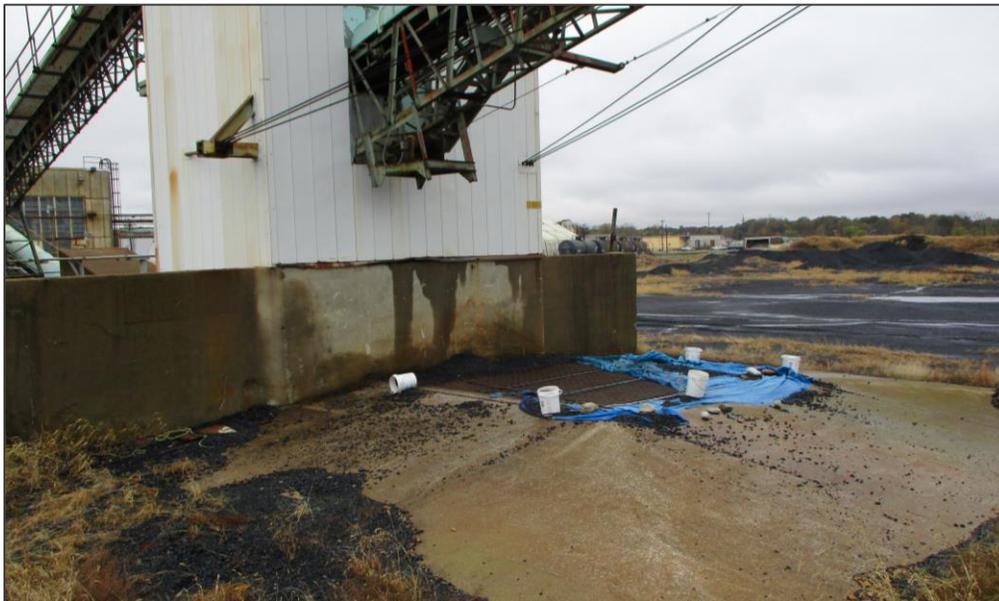
**Figure 7. Coal Feeder Hopper on North Side of C-606 (Looking Southwest)**

C-606 housed the equipment used to crush, or pulverize, coal to a smaller, acceptable size for use at C-600. C-606 operated from construction in 1981 until early 2015. While in operation, coal was received by railcar and unloaded to the building via conveyor #1. There is also a coal feeder hopper on the north side of the building consisting of a metal grate over the hopper pit (Figure 7). Inside the facility the coal was crushed, or pulverized, to a smaller size acceptable for use at C-600. Figures 8 and 9 are interior views of the facility that show the instrumentation and the coal crusher equipment, respectively. From C-606, the pulverized coal either went directly to a coal chute for C-600 via conveyor #2 or to the C-602 Coal Storage Yard via conveyor #3.

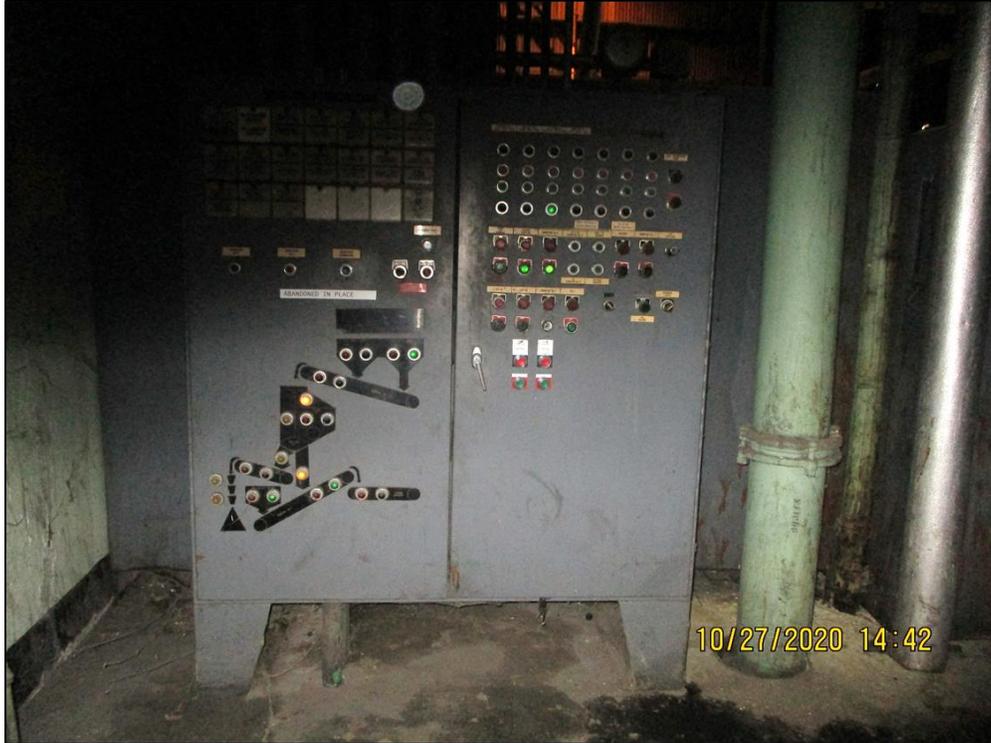
**Figure 8. Interior View of the C-606 Instrumentation Panel**

Limited infrastructure items remain in the facility (e.g., light fixtures, exit lights, instrumentation panels, alarms) that could potentially contain *de minimis* quantities of regulated items [e.g., mercury, lead, polychlorinated biphenyls (PCBs)] which will be removed to the extent practicable during deactivation. The coal crusher motor likely contains lubricants and the associated gear boxes may contain oils. Any oils will be drained and properly disposed during deactivation prior to building demolition. Generation of any residual amounts of regulated items during deactivation and/or demolition will be properly containerized, characterized, and disposed in accordance with applicable regulatory requirements.

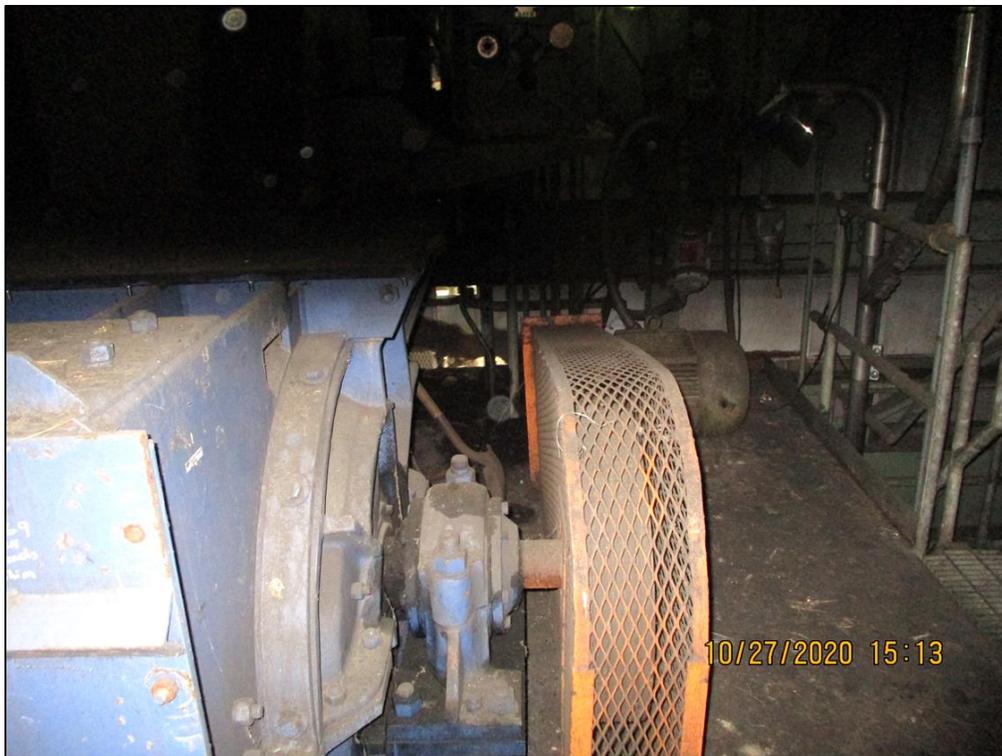
**Figure 9. Interior View of the C-606 Coal Crushing Equipment Drive Assembly**

C-606 was used to crush, or pulverize, coal to a smaller, acceptable size for use at C-600. The general process is described above in Section 7, Function. A facility walkdown occurred in October 2020 and noted that all coal handling and crushing equipment was present in the building. There was standing water in the basement/hopper of the building which is pumped periodically from the facility.

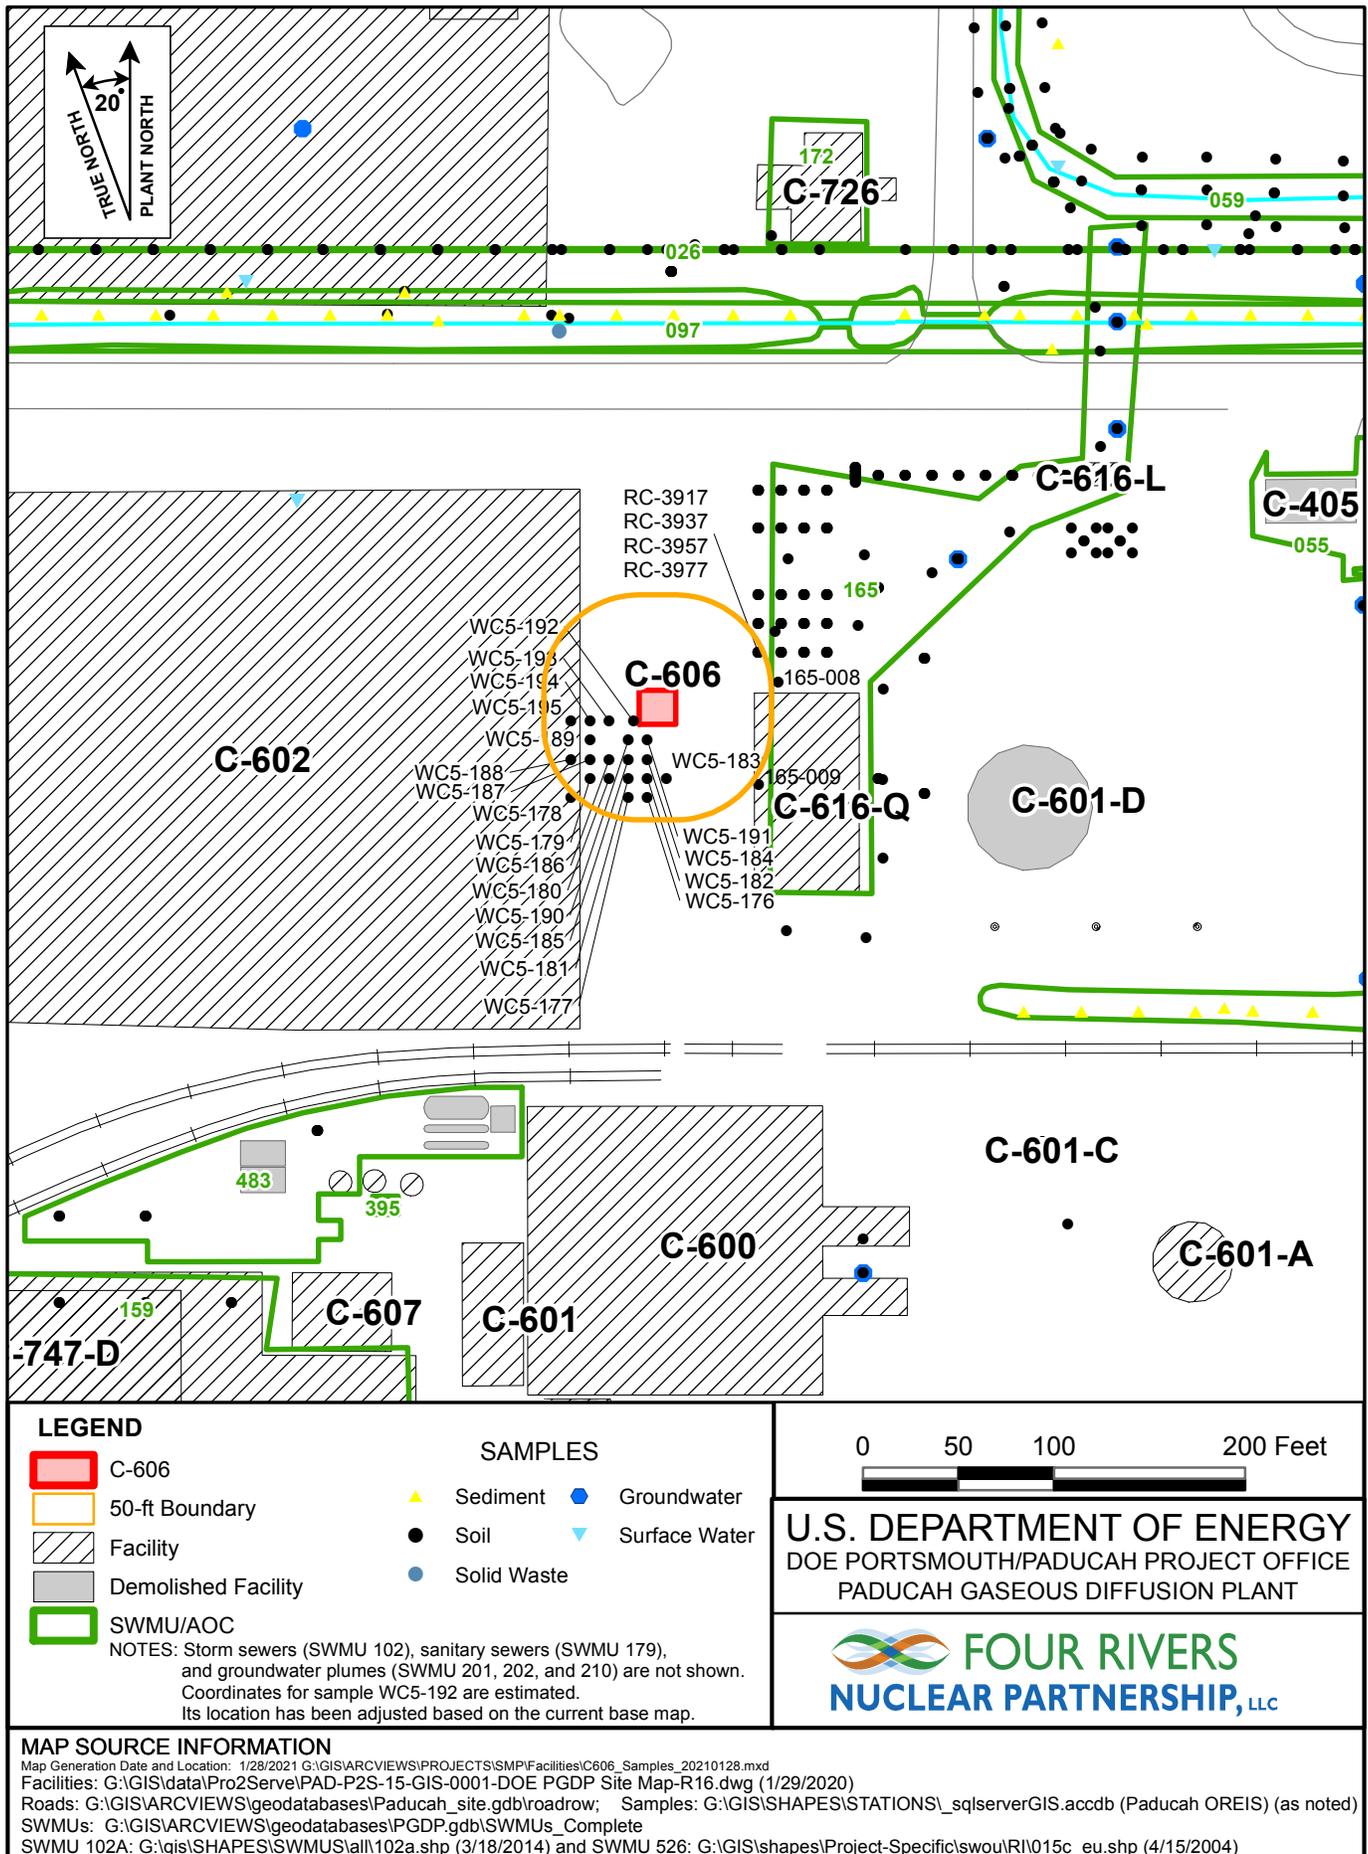
Figure 10. SWMU and Sample Locations near C-606

Limited sampling of environmental media has occurred near C-606. Environmental sampling data were queried and viewed on the DOE's Portsmouth/Paducah Project Office Environmental Geographic Analytical Spatial Information System (PEGASIS). PEGASIS allowed a visual evaluation of environmental data located in proximity to C-606. Environmental data were available from 26 locations within 50 ft of C-606. These data were collected as part of previous environmental studies and investigations conducted at the Paducah Site with all samples associated with the evaluation of the C-616-L Pipeline and Vault soil contamination area (SWMU 165) as part of the Waste Area Groups 9 and 11 site investigation (DOE 1997; DOE 1999). SWMU 165, located east of C-606, was further evaluated as part of the Soils OU (DOE 2013). Soil samples were collected from 26 locations, primarily for PCBs (one location in 1990, 23 locations in 1995, and two locations in 1998). Several samples collected in 1995 included analyses for metals, and the samples collected in 1998 were analyzed for total polycyclic aromatic hydrocarbons also. The sampling locations for these data are shown in Figure 10. Historical data are shown in a table in the appendix to this report.

Based on the data, only arsenic had soil concentrations that exceeded the industrial worker NAL in samples collected within 50 ft of C-606 (at locations WC5-182, WC5-184, WC5-188, WC5-192, and WC5-194). The maximum detected concentration of arsenic (4.6 mg/kg) in those samples is less than the Paducah Site provisional surface soil background concentration (12 mg/kg).

The only analytes in soil in the samples collected within 50 ft of C-606 that exceeded both the provisional background concentrations and the groundwater protection screening values were barium and cadmium. Both barium and cadmium exceeded the screening values at locations WC5-182 and WC5-194 while cadmium exceeded the screening values at locations WC5-184, WC5-188, and WC5-192. Metals such as arsenic, barium, and cadmium are typically found in coal.
