**Site Evaluation Report for the
C-725 Paint Shop at the
Paducah Gaseous Diffusion Plant,
Paducah, Kentucky**

C-725

Paint Shop

July 13, 2021

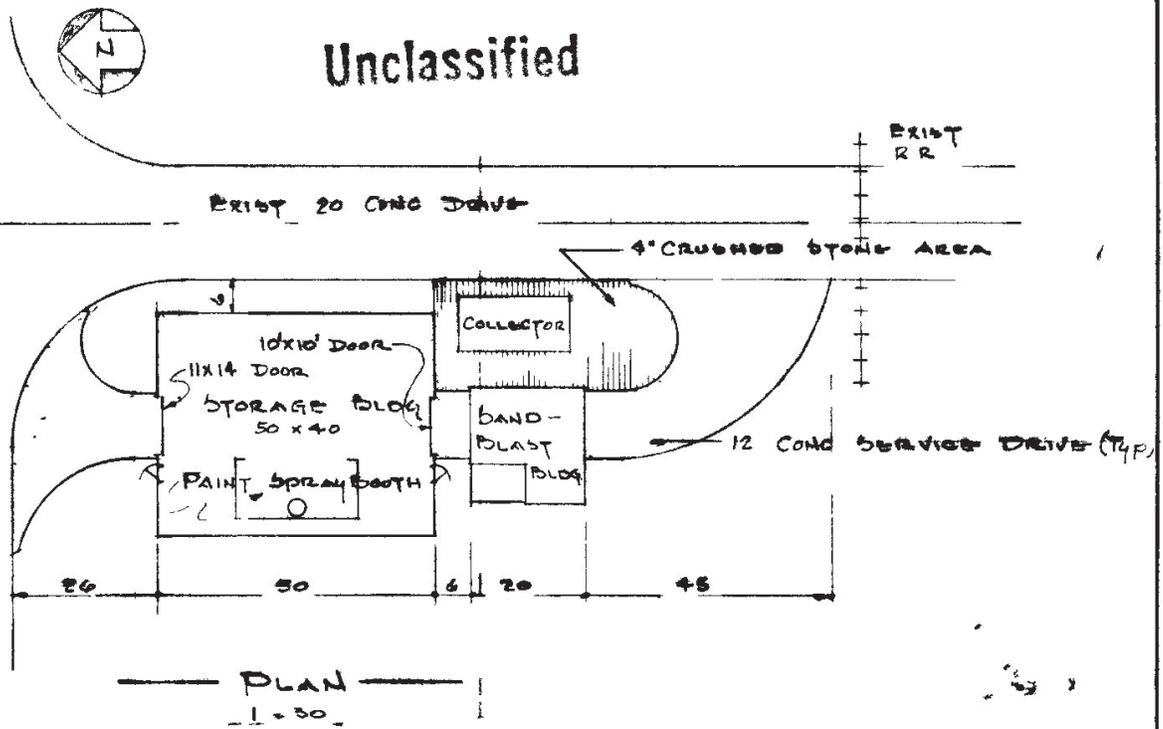
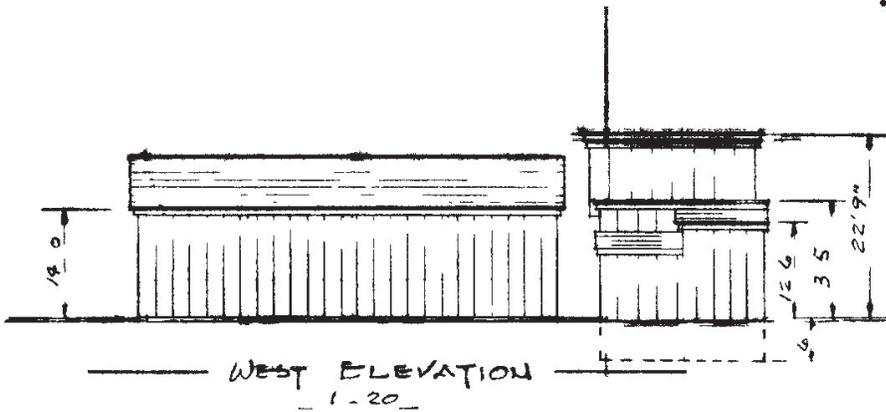
Figure 3. Engineering Drawing A-A-10711-B

The existing configuration of the facility does not match what is shown on the engineering drawings. Based on Figure 3, Engineering Drawing A-A-10711-B, the facility was originally comprised of three main components (40 ft × 50 ft storage building, sandblast building, and dust collector system); a paint spray booth is located on the west side of the structure in the drawing. Figure 3 is the only engineering drawing that shows a paint spray booth at this location. Figure 4, Engineering Drawing E-E-10711E, shows a paint spray booth inside the storage building in the southeast corner. A paint spray booth at this location is reflected in other engineering drawings. Figure 5, Engineering Drawing E-M-10711-X, shows the sandblast room, equipment shed, and dust collector. Section C-C on drawing E-M-10711-X is a south elevation view looking north. Sometime prior to 1984, the dust collector was removed and paneling was installed to create a covered structure on the southeastern portion of the facility.

Note: While the drawing legend identifies this building as C-724-C, an engineer has verified that the drawing represents C-725.

C-725 was originally comprised of three main components—40 ft × 50 ft storage building, sandblast building, and dust collector system. A paint spray booth was located in the southeast corner. Two conveyor belts were located in the sandblast building. A sump was located in the equipment shed located next to the sandblast building. Hoppers were located beneath the sandblast building. Sometime prior to 1984, the dust collector was removed and paneling was installed to create a covered structure on the southeastern portion of the facility.

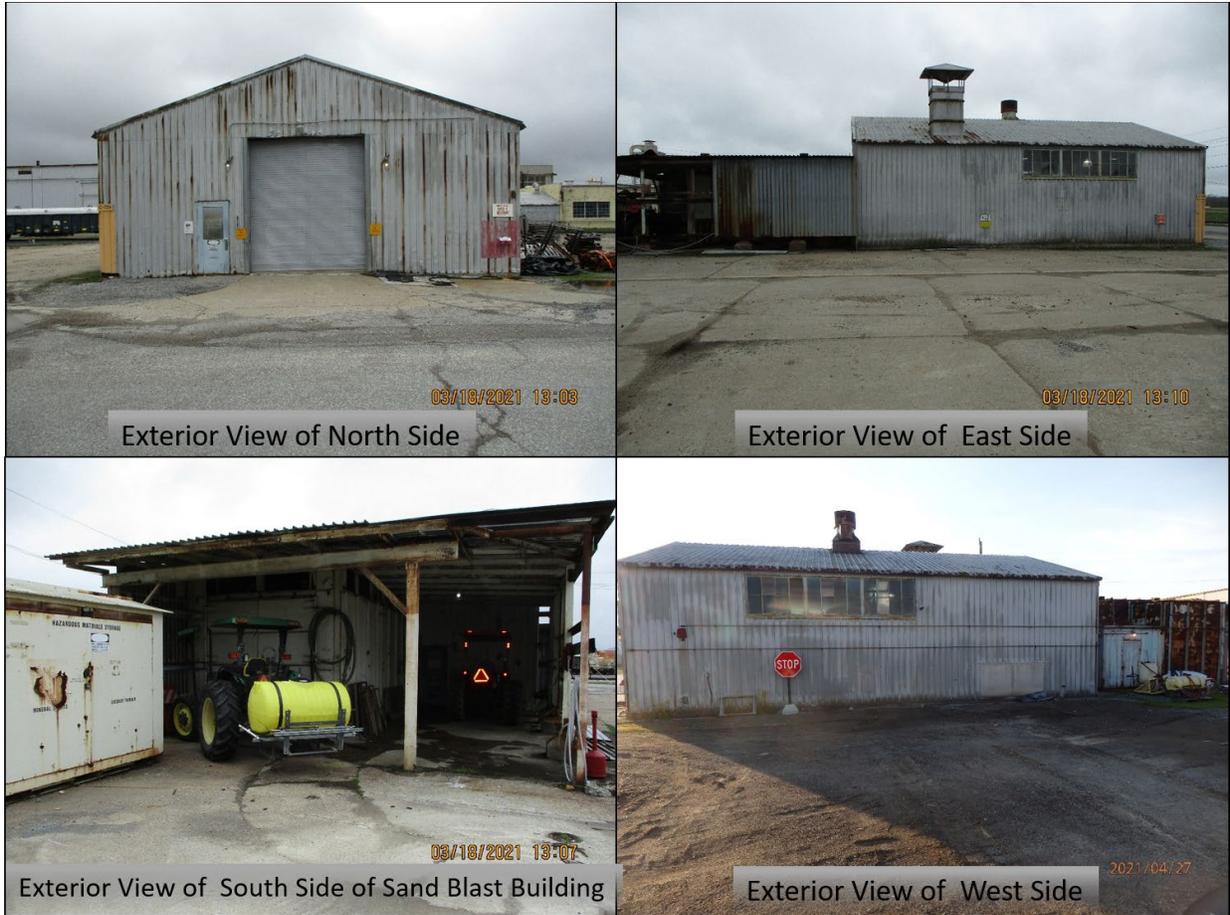
Figure 6. Exterior Views of C-725

C-725 was constructed in 1961 for use as a paint shop. Figure 6 shows exterior views of C-725.

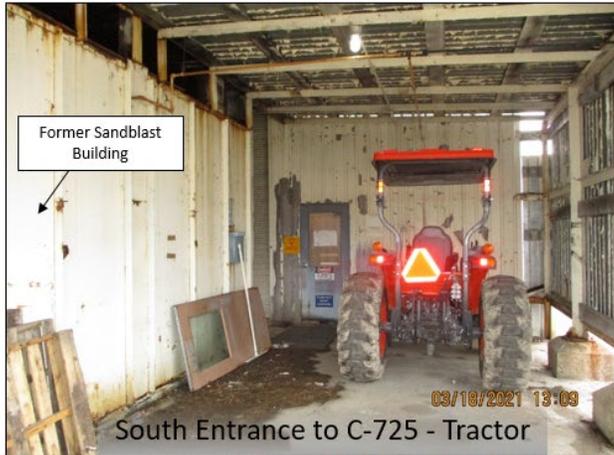
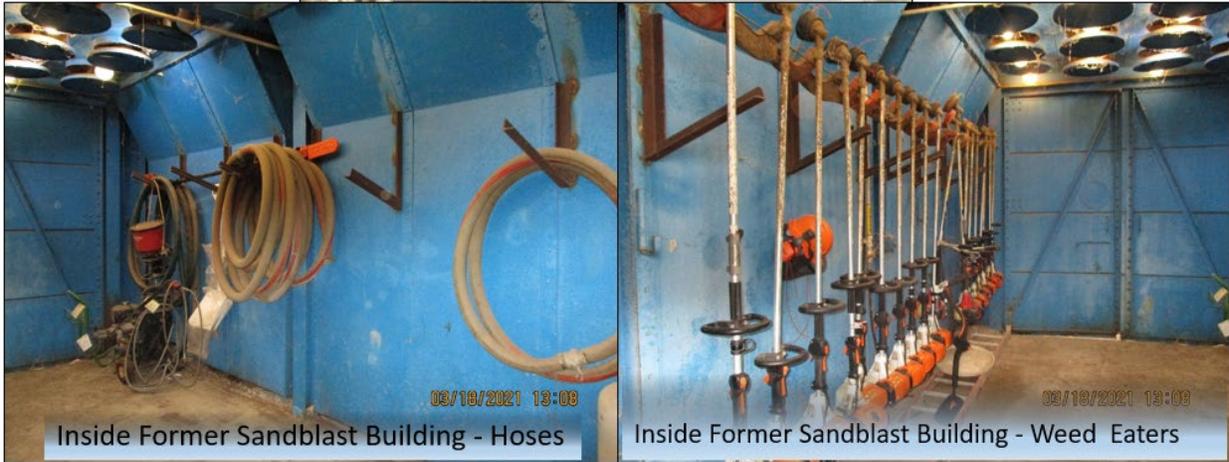
Figure 7. Various Maintenance Equipment

C-725 currently is utilized as a storage facility for various maintenance equipment (e.g., tractors, mowers, weed eaters) and janitorial supplies. Figure 7 shows various maintenance equipment and Figure 8 shows janitorial supplies and various maintenance equipment used by the infrastructure maintenance organization. A mobile storage container is located outside of C-725. The storage container is used during the mowing season to store materials (e.g., gasoline, oil, wasp/hornet spray).

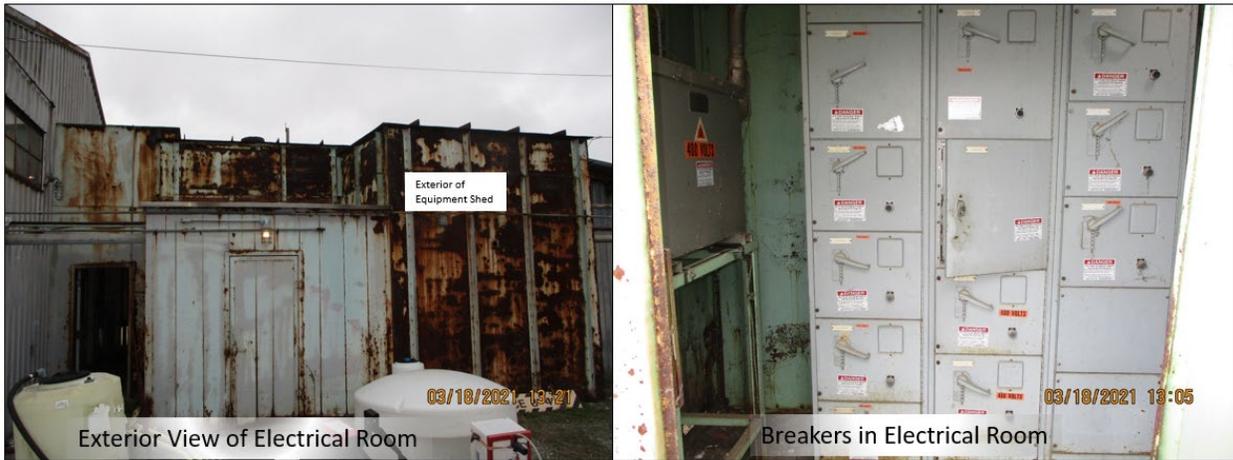
Figure 9. Electrical Room

An electrical room is located between the storage building and the equipment shed as shown in Figure 9.

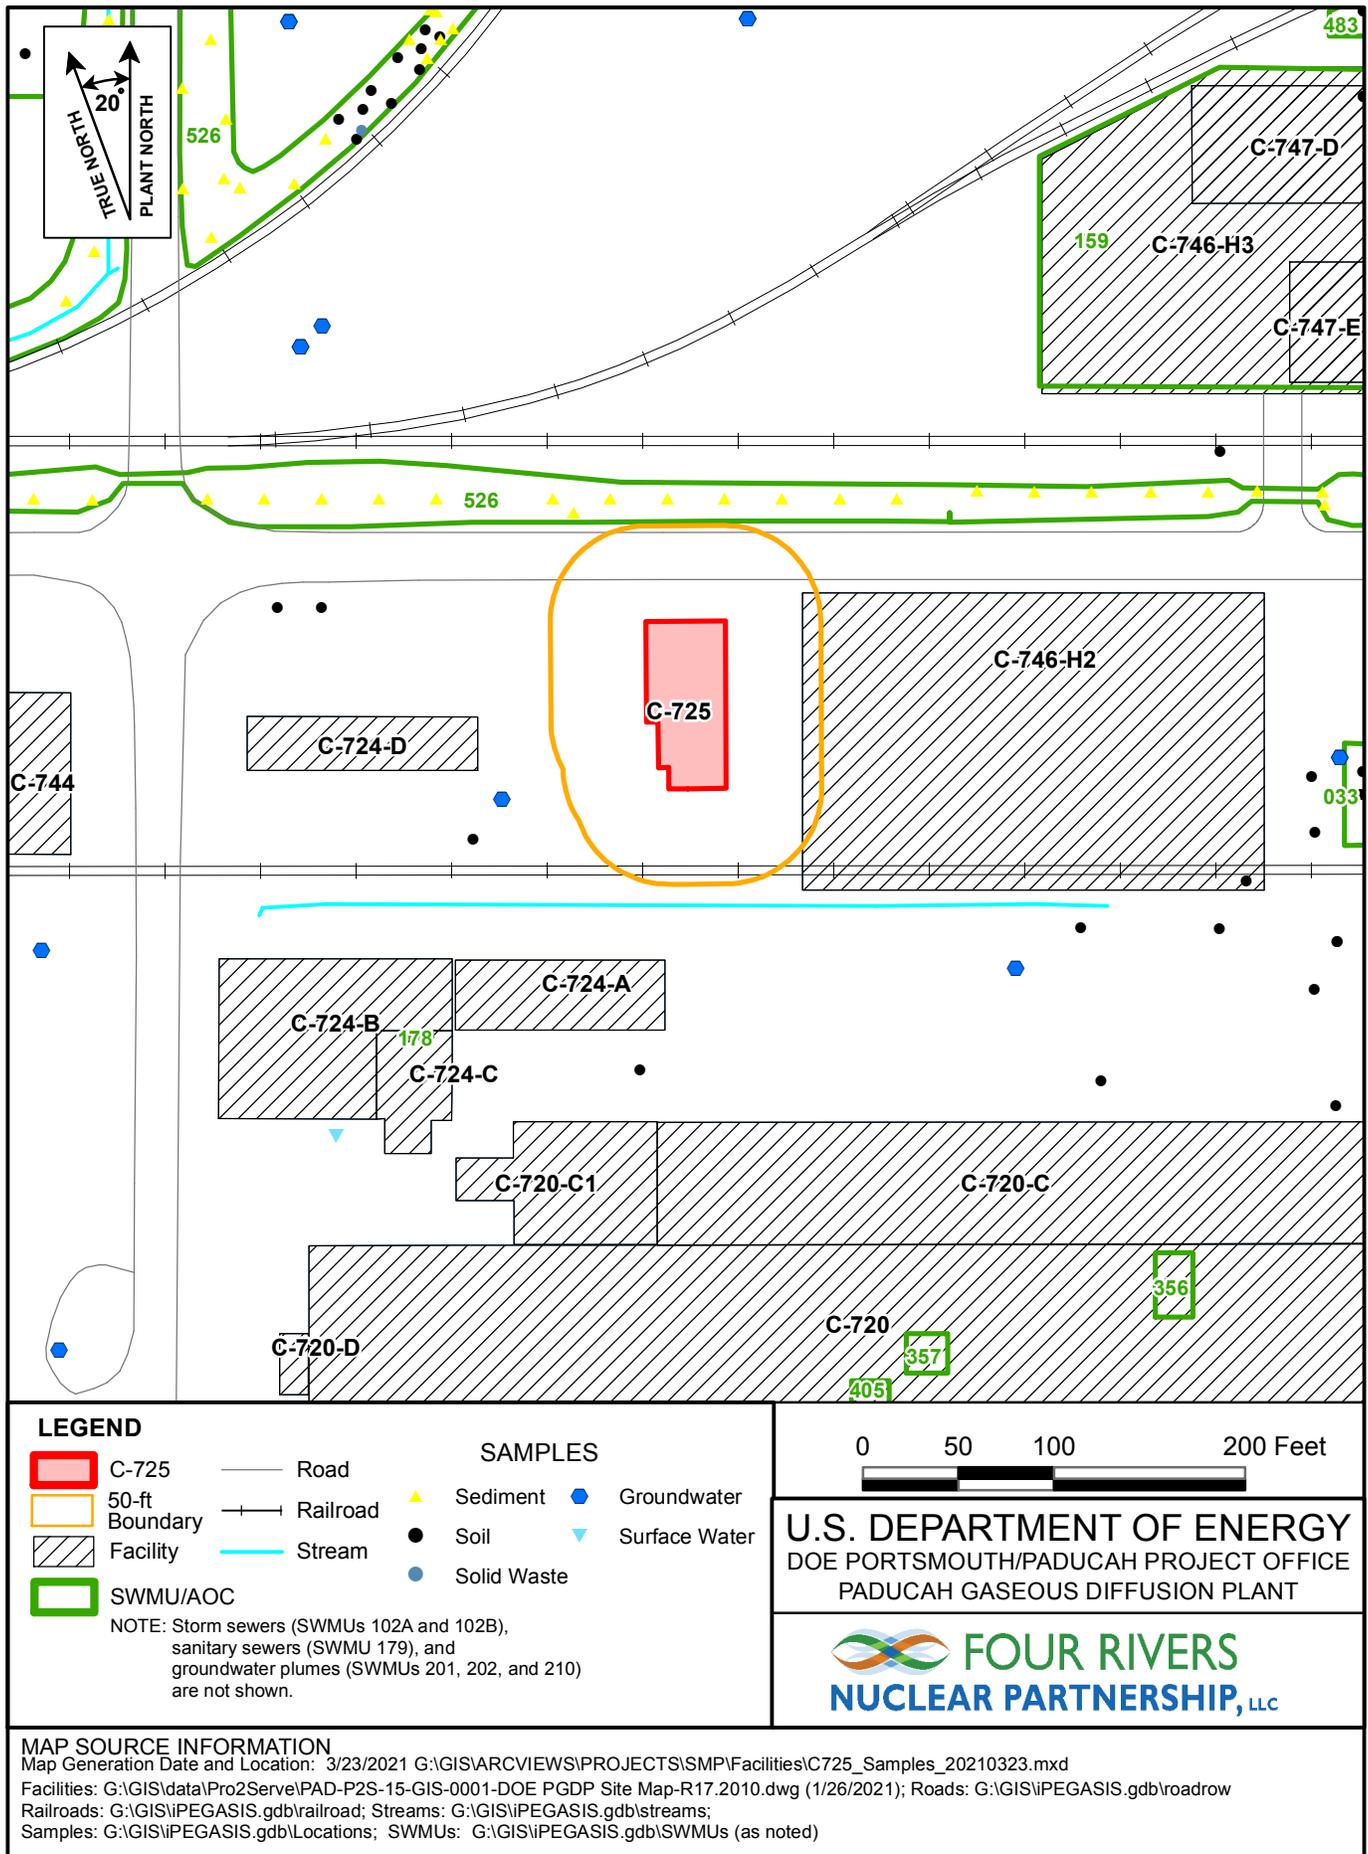
Figure 10. SWMUs and Sample Locations near C-725

Figure 10, SWMUs and Sampling Locations near C-725, shows no sample locations within a 50-ft boundary of C-725.

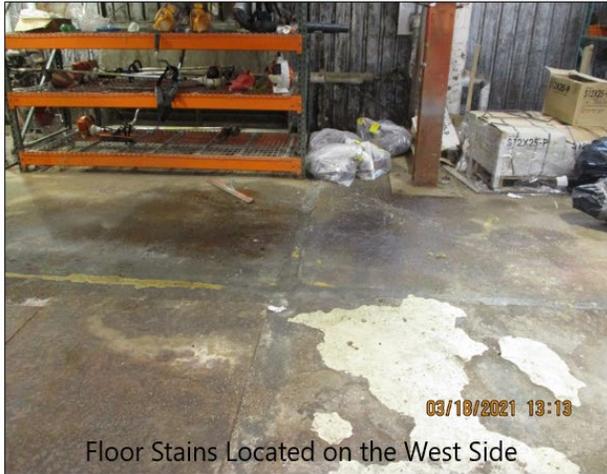
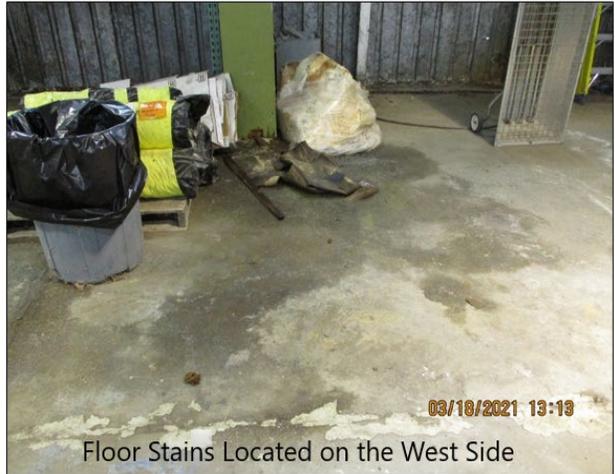
Figure 11. Floor Stains

Figure 11 shows two separate floor stains located in front of the interior west wall. There are no cracks in the floor and the concrete joints located within the stained areas are sealed. The stains appear to be contained within the building; there is no visible evidence that spills or releases associated with the floor stain were released to the environment. No other areas were visually observed to have had a spill or release during walkdowns conducted in March 2021.

Floor Stains Located on the West Side

While there is no evidence of a known release, or threat of any release, to the environment from the facility, an RFI is recommended for the C-725 slab and underlying soils based on the uncertainty of potential releases that may have occurred during historical operations and consistent with similar operations and the recommendation for the C-724 paint spray booth. Further investigation of the C-725 slab and underlying soils is recommended to verify whether any environmental releases may exist. Based on the results of the RFI sampling data, a future decision will be made as to whether to designate any or portions of the C-725 slab or underlying soils as a new AOC.

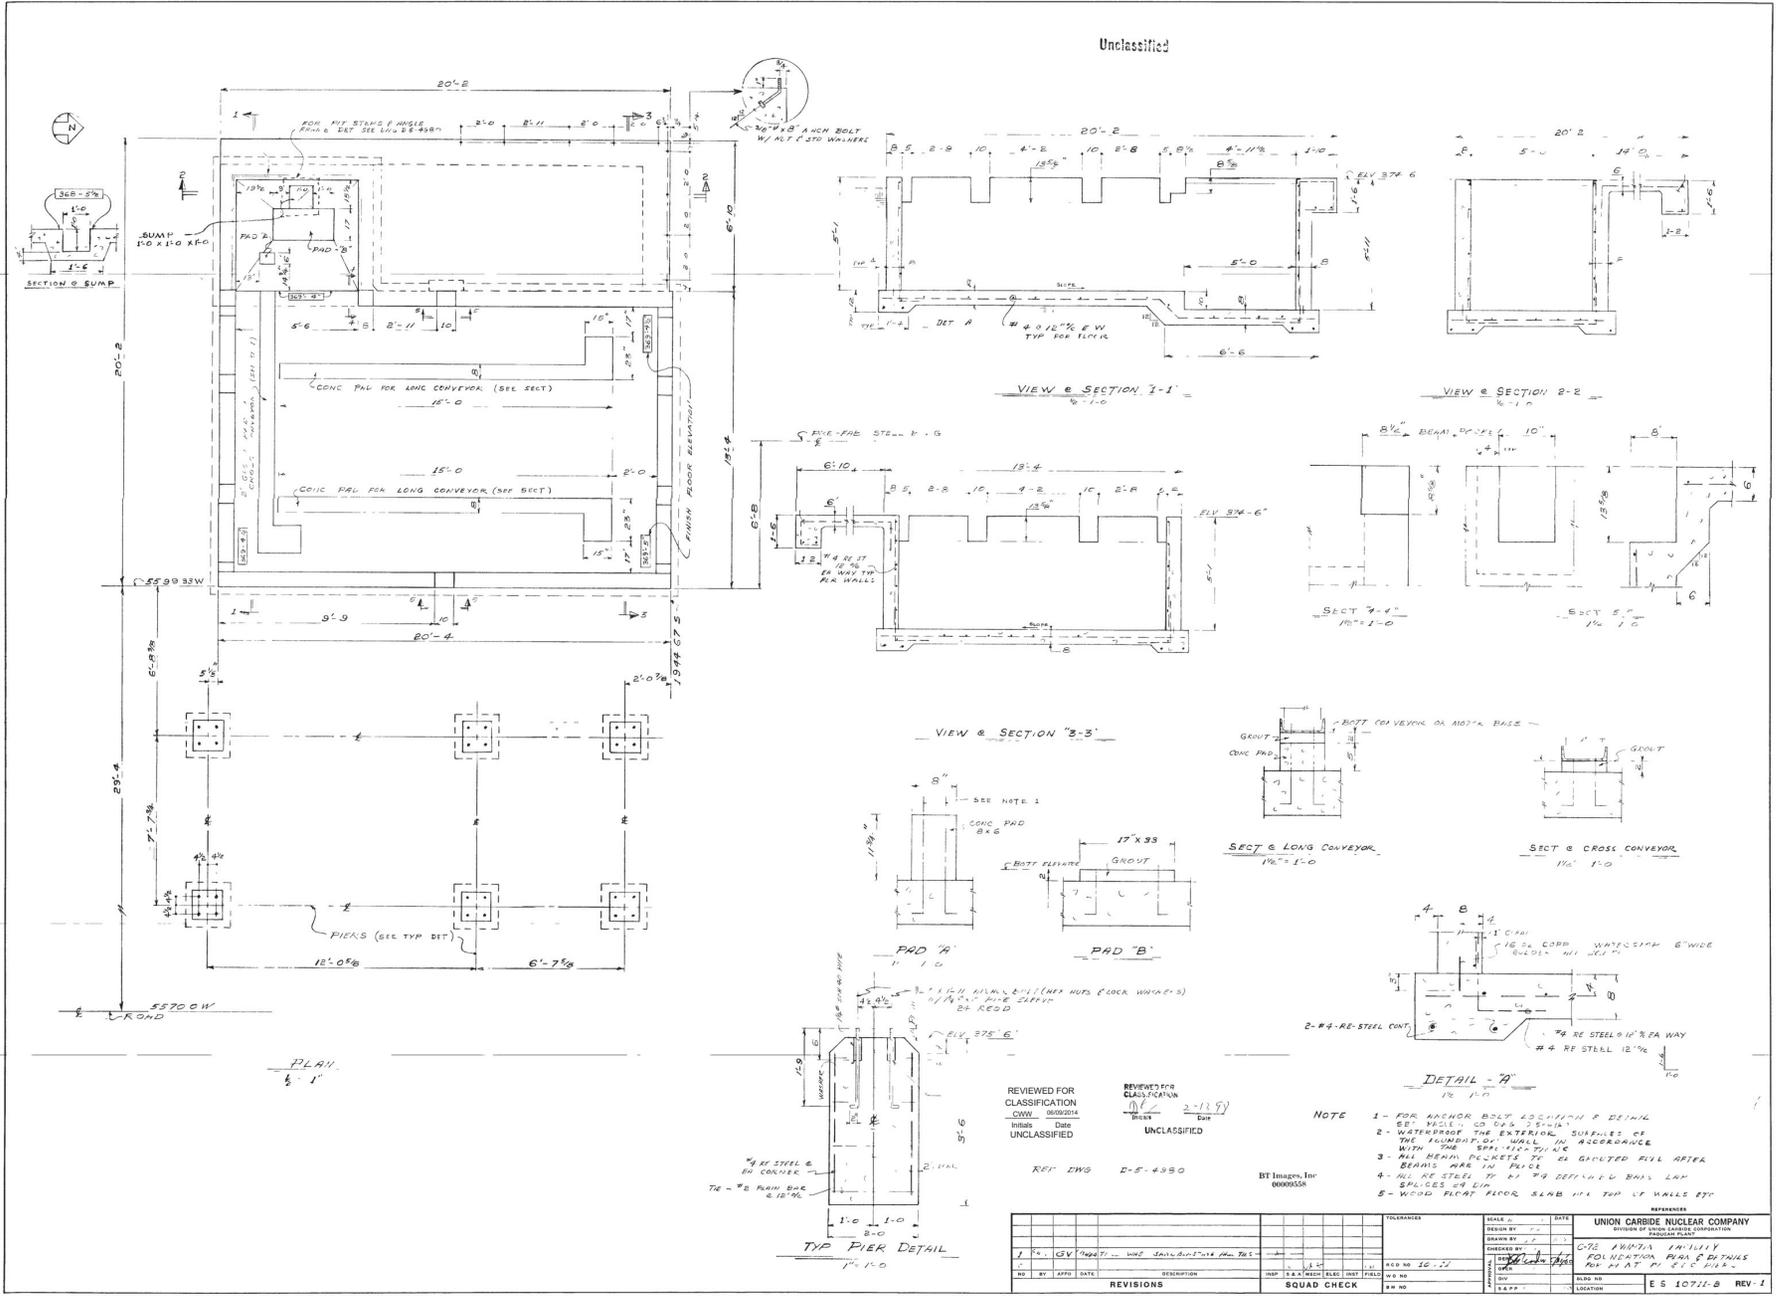
Figure A.1. Engineering Drawing E-S-10711-B

Additional engineering drawings are provided in an appendix to this report. Figure A.1, Engineering Drawing E-S-10711-B, shows the foundation plan for the sandblast room, equipment shed, electrical room, and the dust collector piers. Figure A.2, Engineering Drawing E-S-10711-C, shows the foundation plan for the storage building.
