TRANSMITTAL OF THE SITE EVALUATION REPORT FOR THE C-750 GARAGE, C-750 GARAGE SLAB AND UNDERLYING SOILS, AND ASSOCIATED OUTSIDE AREAS (AREA OF CONCERN 573) AT THE PADUCAH GASEOUS DIFFUSION PLANT, PADUCAH, KENTUCKY, DOE/LX/07-2466&D1

**Site Evaluation Report for the
C-750 Garage, C-750 Garage Slab and Underlying Soils, and
Associated Outside Areas (Area of Concern 573)
at the Paducah Gaseous Diffusion Plant,
Paducah, Kentucky**

C-750 Garage

AOC 573—C-750 Garage Slab and Underlying Soils and Associated Outside Areas

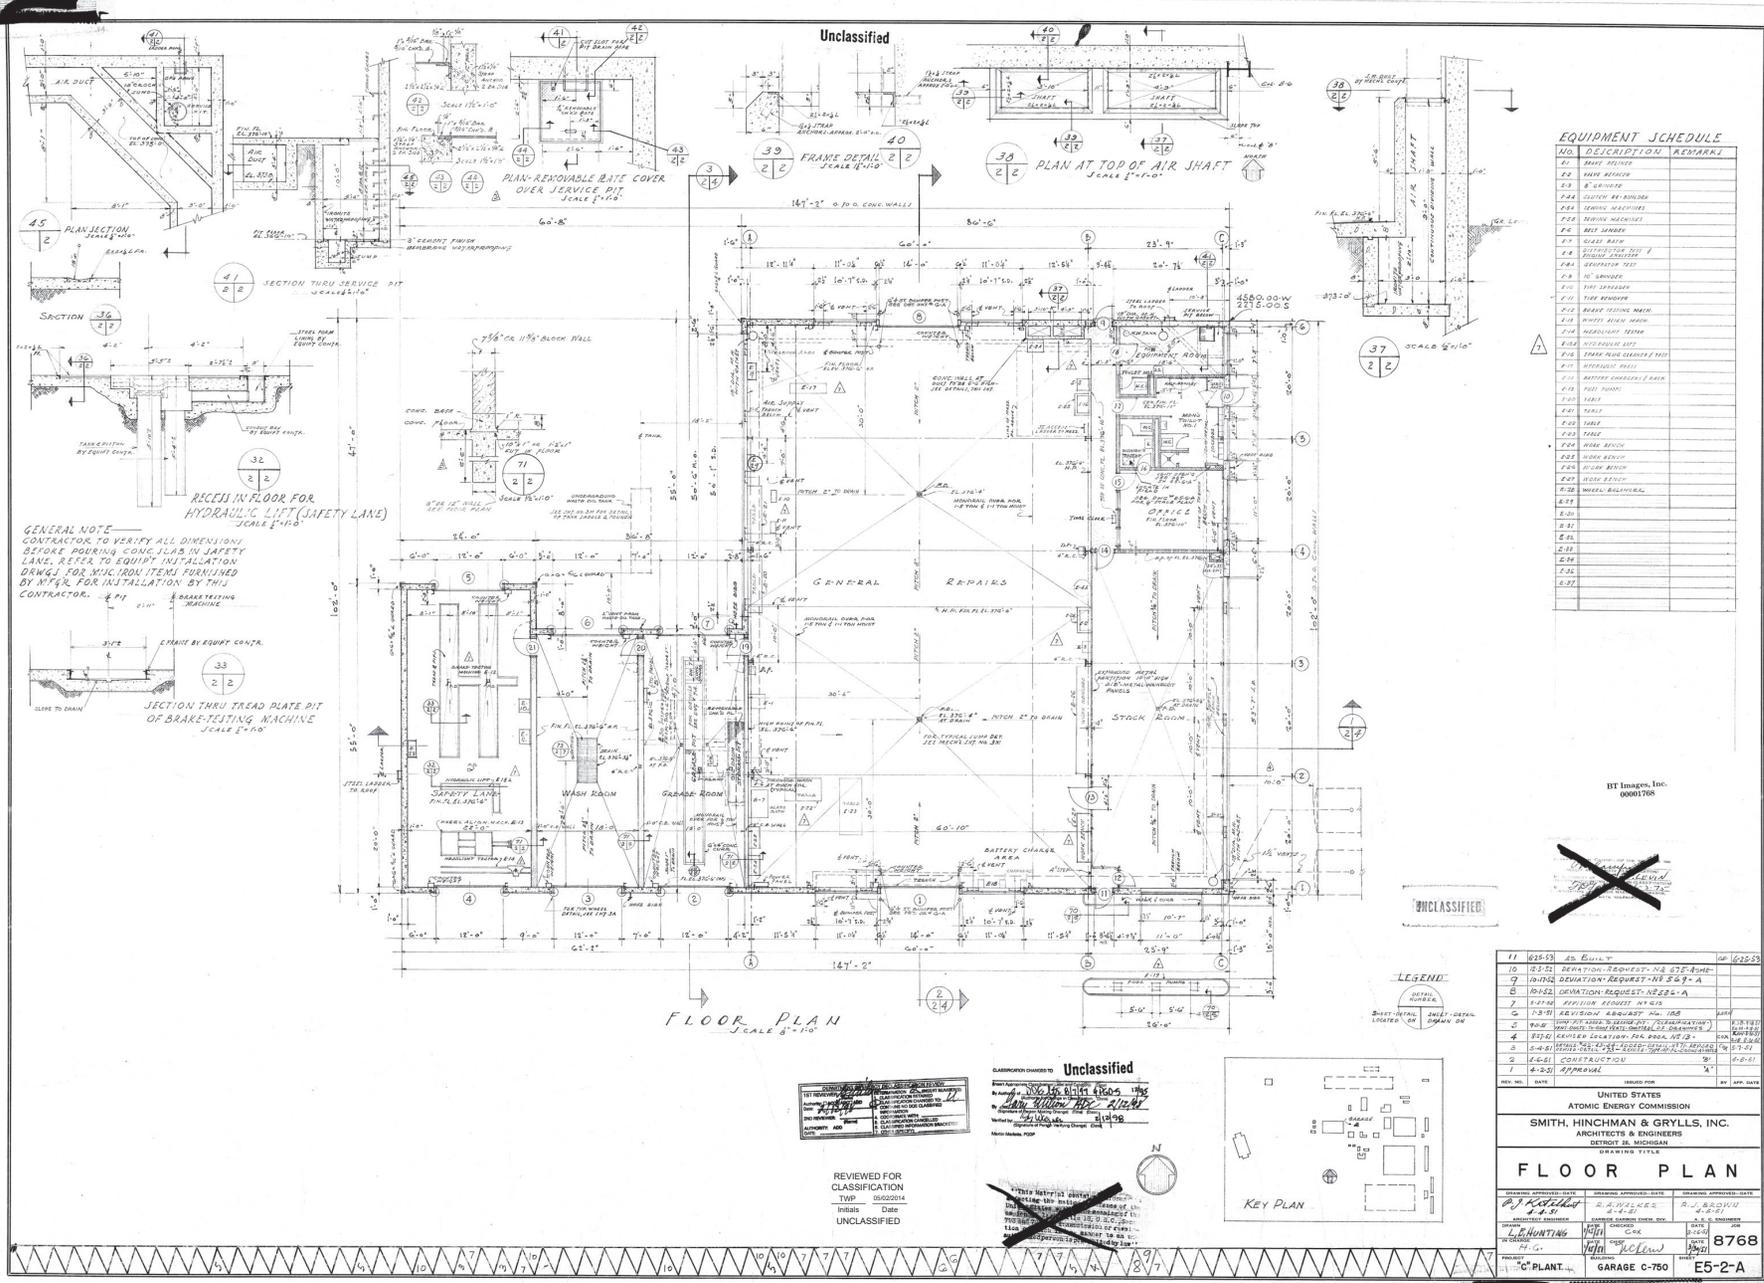
Figure 3. Engineering Drawing E5-2-A_0001_U-017124

C-750 is a one-story building made of cast-in-place concrete walls and structural steel/corrugated siding built in 1952. The total square footage of C-750 is approximately 11,866 ft² (see Figure 3, Engineering Drawing E5-2-A_0001_U-017124).

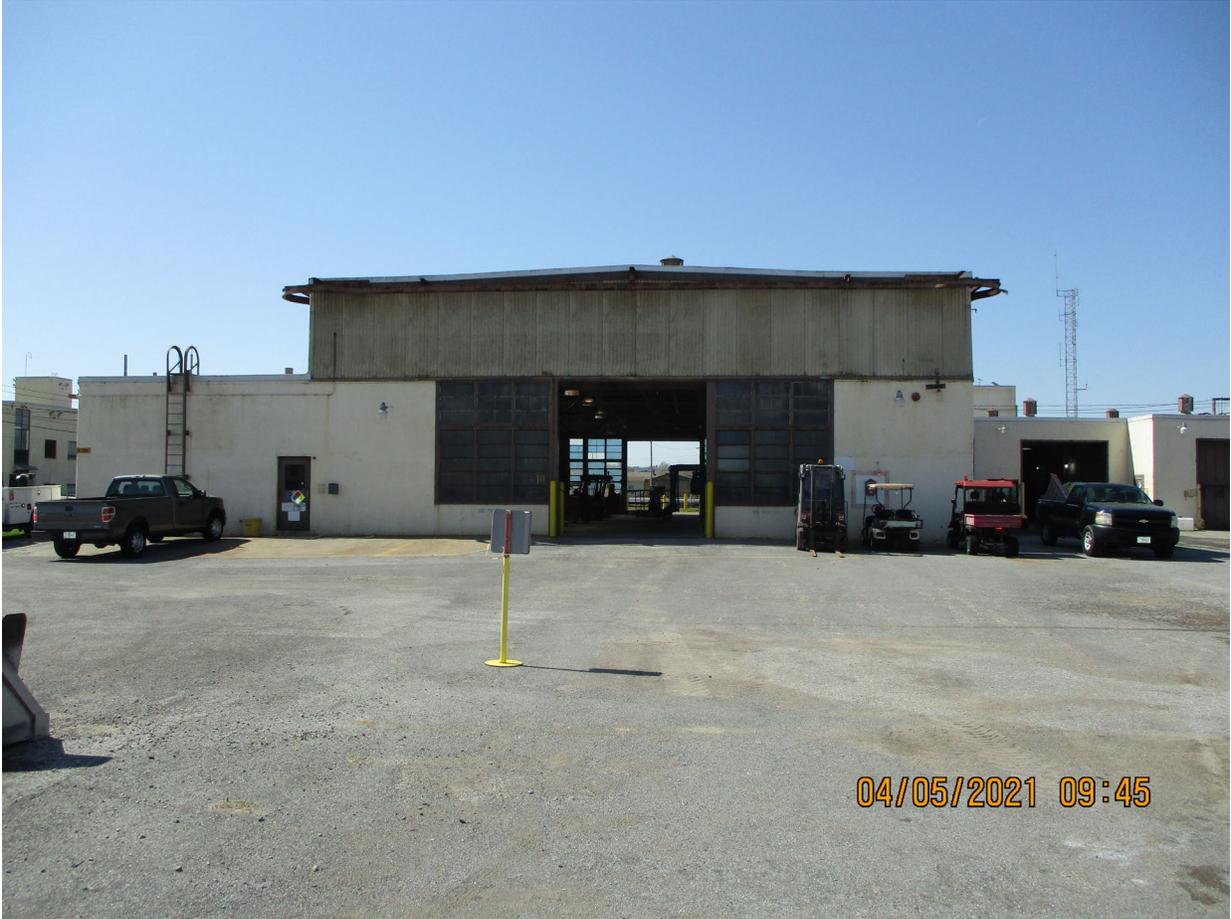
Figure 4. North Side of C-750

Figures 4 through 7 show the exterior of C-750. Automotive spare parts are stored in C-750 as shown in Figures 8 through 10. Work and storage areas are shown in Figures 11 through 21.

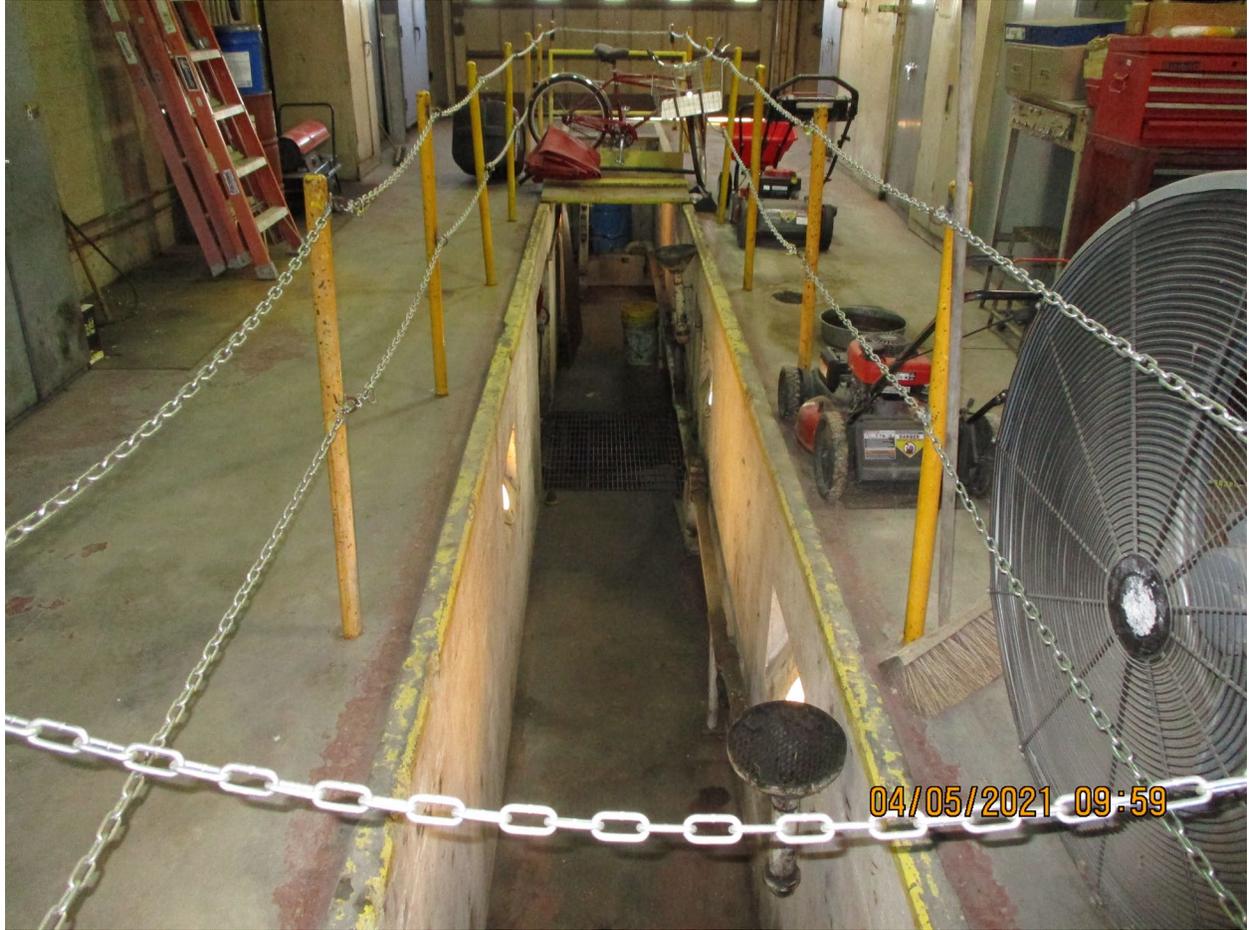
Figure 17. Lubrication Bay Trench

The garage consists of one main building and three bays. The bays are used as a tire and waste storage area; a wash room; and a grease/lubrication room with a 4 ft 9-inch deep trench. The grease/lubrication room contained a 6 ft 3-inch waste oil storage pit. A small degreaser, historically used to clean small parts, was located in the garage and stored in the wash room or west bay. The degreaser was removed from service in approximately 2018. Figure 3 shows a “glass bath” in the grease/lubrication room. The glass bath, as described in the engineering drawing, is no longer located at C-750. While employee interviews confirmed that a glass bath has not been in the facility since at least 1995, interviewees were not able to provide any detailed information concerning the purpose or use of the glass bath.

facility is recommended to be conducted outside of the FFA and/or CERCLA process. While measures to be implemented during D&D are not a part of this SE, the demolition of the C-750 facility would identify any necessary best management practices to prevent and/or minimize contaminated storm-water runoff and to prevent any debris from pooling and collecting in the below-grade trench and associated pit and any additional subgrade areas.

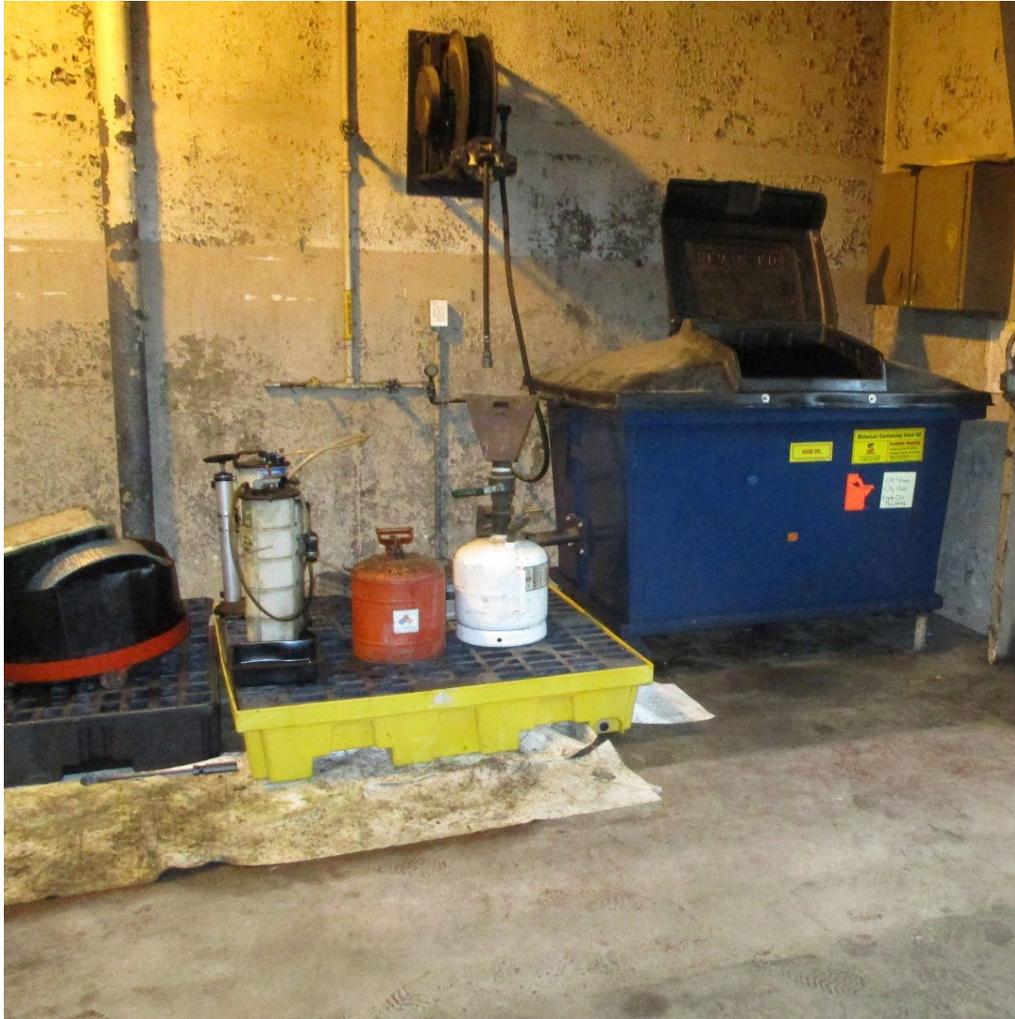
Figure 20. Oil Storage Area (GSA G-750-01)

Currently, oil, antifreeze (i.e., ethylene glycol), hydraulic fluid, transmission oil, and lead-acid batteries are stored and routinely used to support daily operations at the facility. Nitrogen was historically used to charge hydraulic accumulators; however, nitrogen is no longer used in the facility. An oxygen-acetylene torch is used for heating or cutting parts. Small amounts of automotive brake cleaner are disposed of with waste oil. Stains are visible on the garage shop floor, on the parking area surface, and on the outside storage area.

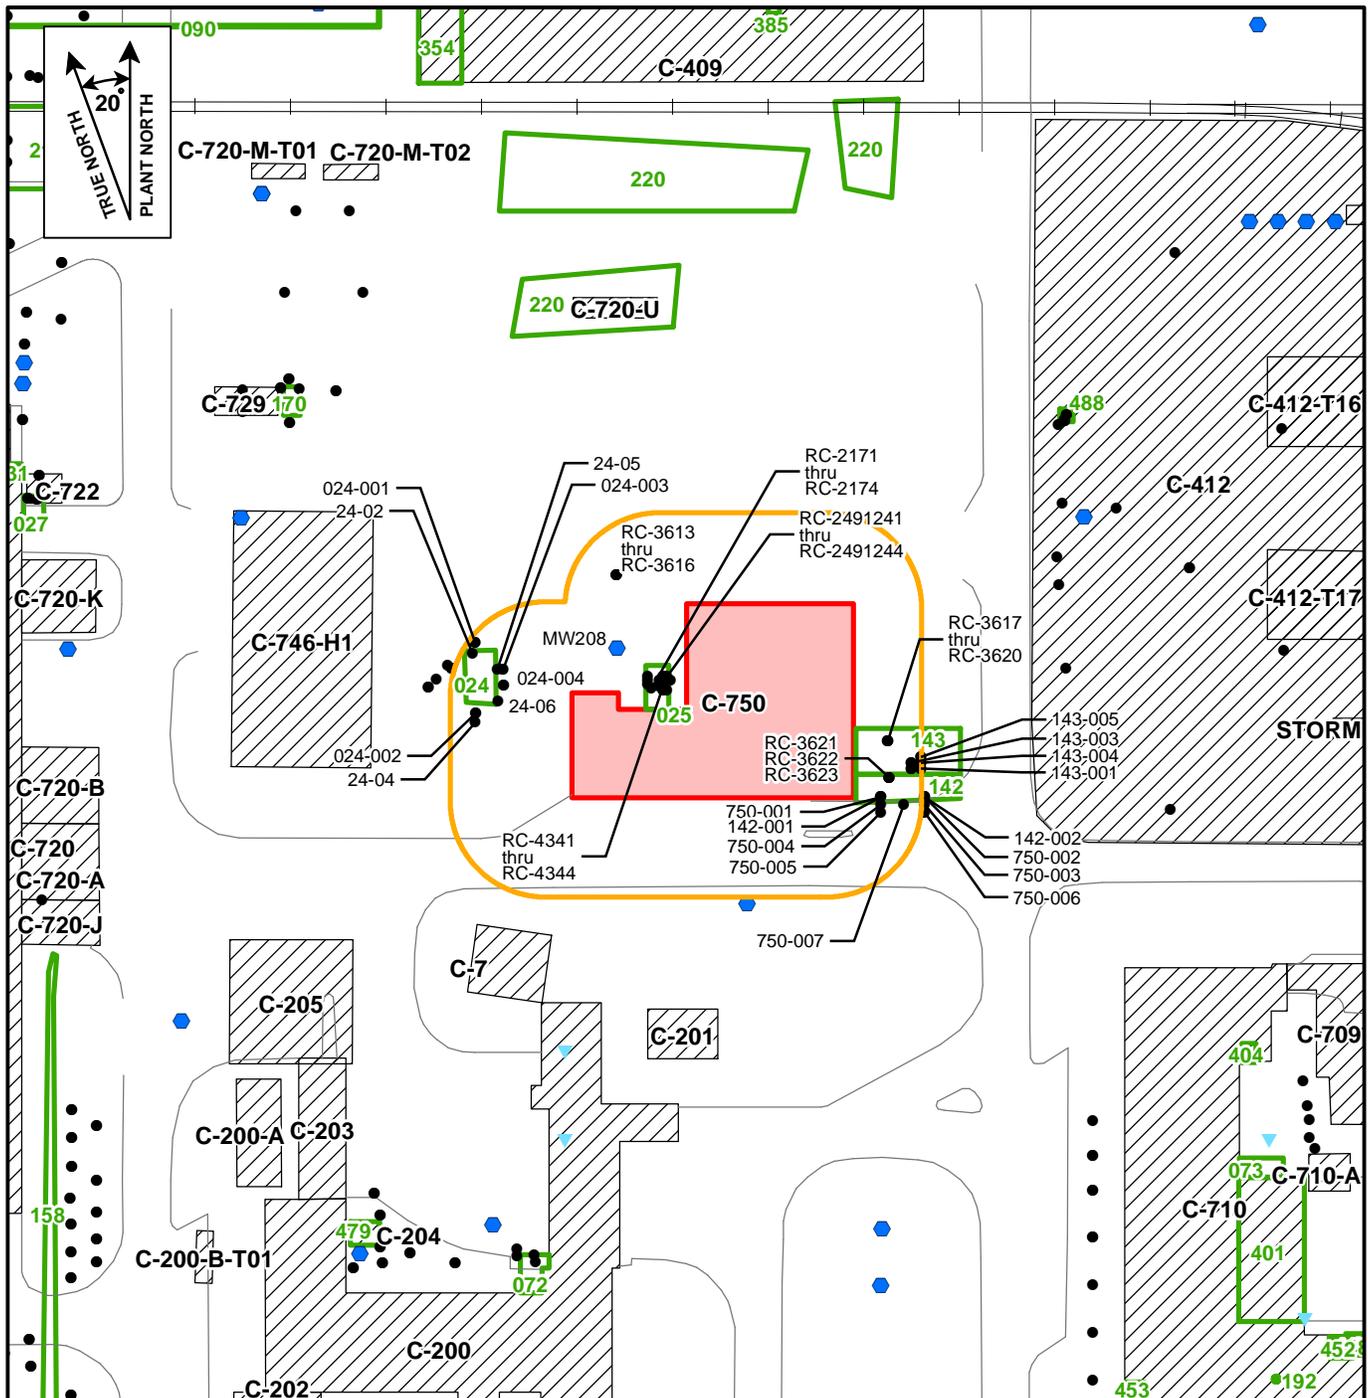
Figure 22. SWMUs and Sampling Locations near C-750

SWMU and sampling locations within a 50-foot boundary of C-750 are shown in Figure 22.

Soil samples were collected from locations RC-3613 through RC-3616 (shown on the west side of C-750 on Figure 22) from the C-750 Fuel Tank Soil Cover. Samples were collected on January 31, 1990 (MMES 1990). The sample results describe the material as soil from east of C-750, gas tanks, which is consistent with sample locations RC-3617 through RC-3623.

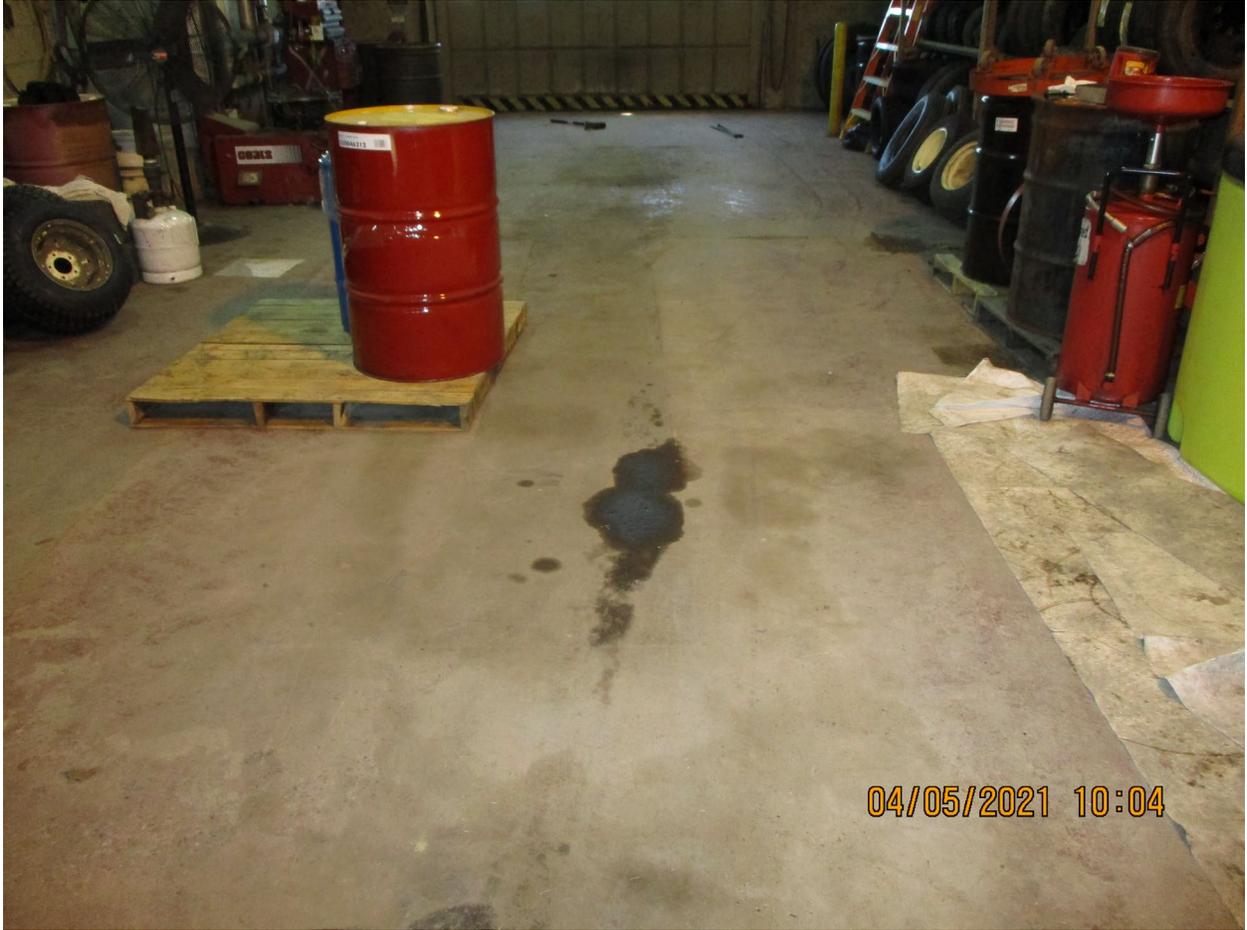
Figure 23. Floor Stain

During walkdowns in April/May 2021, areas inside the garage were visually observed to have had a spill or release, and stains were identified on the floors (see Figure 23) and the waste oil storage pit; however, it is not known whether these spills have reached the environment.

A RCRA Facility Investigation is recommended for the C-750 slab and underlying soils, the outside storage area on the west side of the building, and the former fuel service island that was located on the south side of the garage due to possible historical leaks or spills of lube oil, ethylene glycol, solvents/degreasers, waste oil, hydraulic oil, or fuel (i.e., gasoline, diesel).

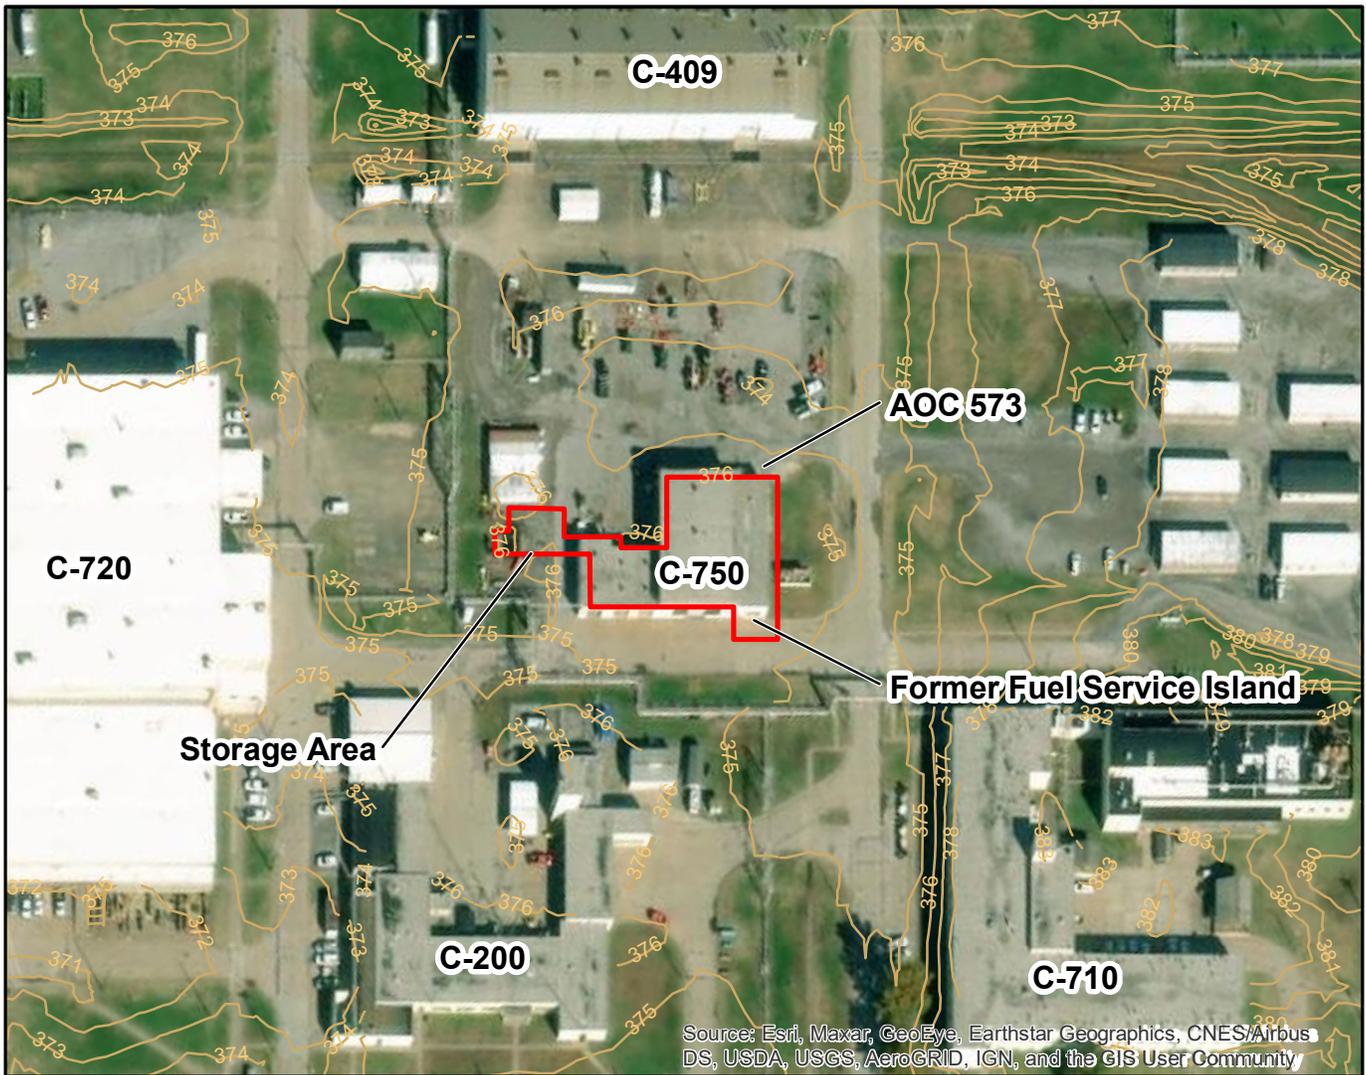
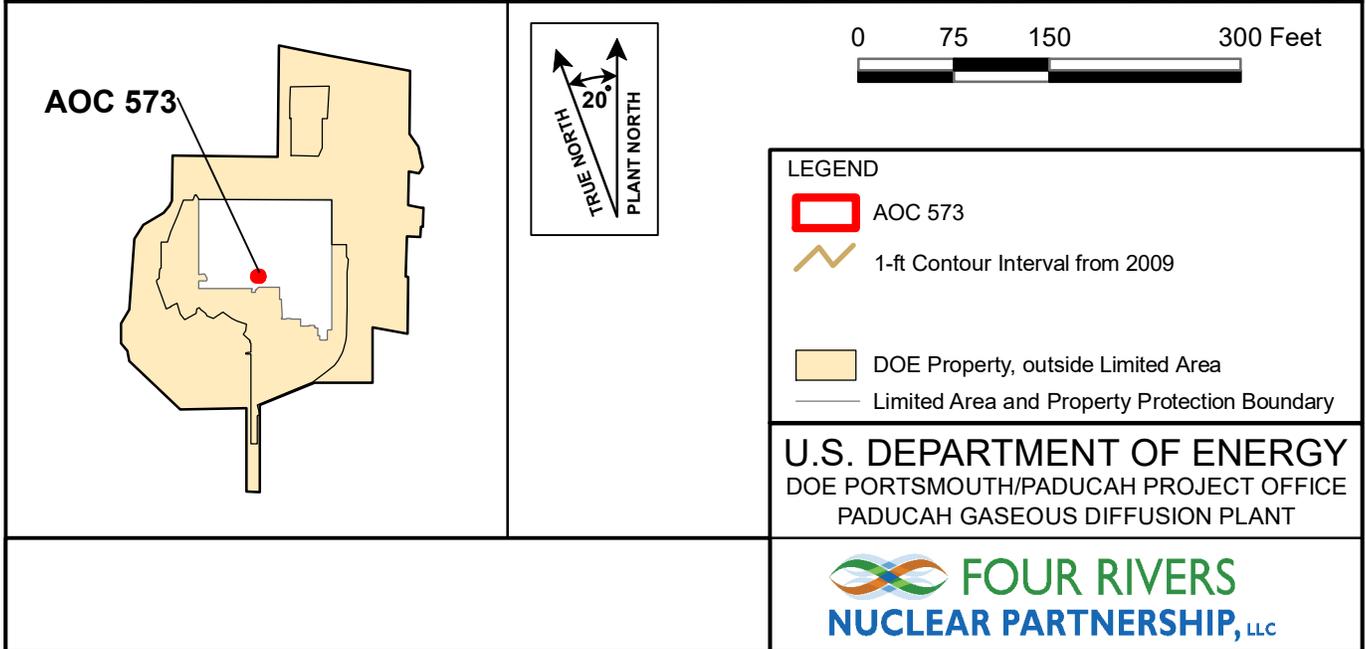
Figure 24. C-750 Slab and Underlying Soils and Associated Outside Areas (AOC 573)

Based on historical information associated with past operations at the garage, including potential leaks and spills within the building, the leak at the former fuel service island that was located on the south side of the garage, and the condition of containers stored on a storage area on the west side of C-750, it is recommended that the soils and slab beneath C-750, the soils and slab associated with the former fuel service island located on the south side of C-750, and the soils and slab associated with the storage area on the west side of C-750 be designated as an AOC [AOC 573—C-750 Garage Slab and Underlying Soils and Associated Outside Areas (see Figure 24)]. It should be noted that the storage area on the west side of C-750 directly overlies the C-750-D UST that was formerly designated as SWMU 24 and granted an NFA determination by KDWM (UST Branch) on November 23, 1999. The portion of the boundary for AOC 573 that overlies the C-750-D UST is not intended to include the UST tank nor affect or serve to reopen the previous NFA determination granted for SWMU 24.

The RCRA Facility Investigation will define the nature and extent of contamination associated with AOC 573.

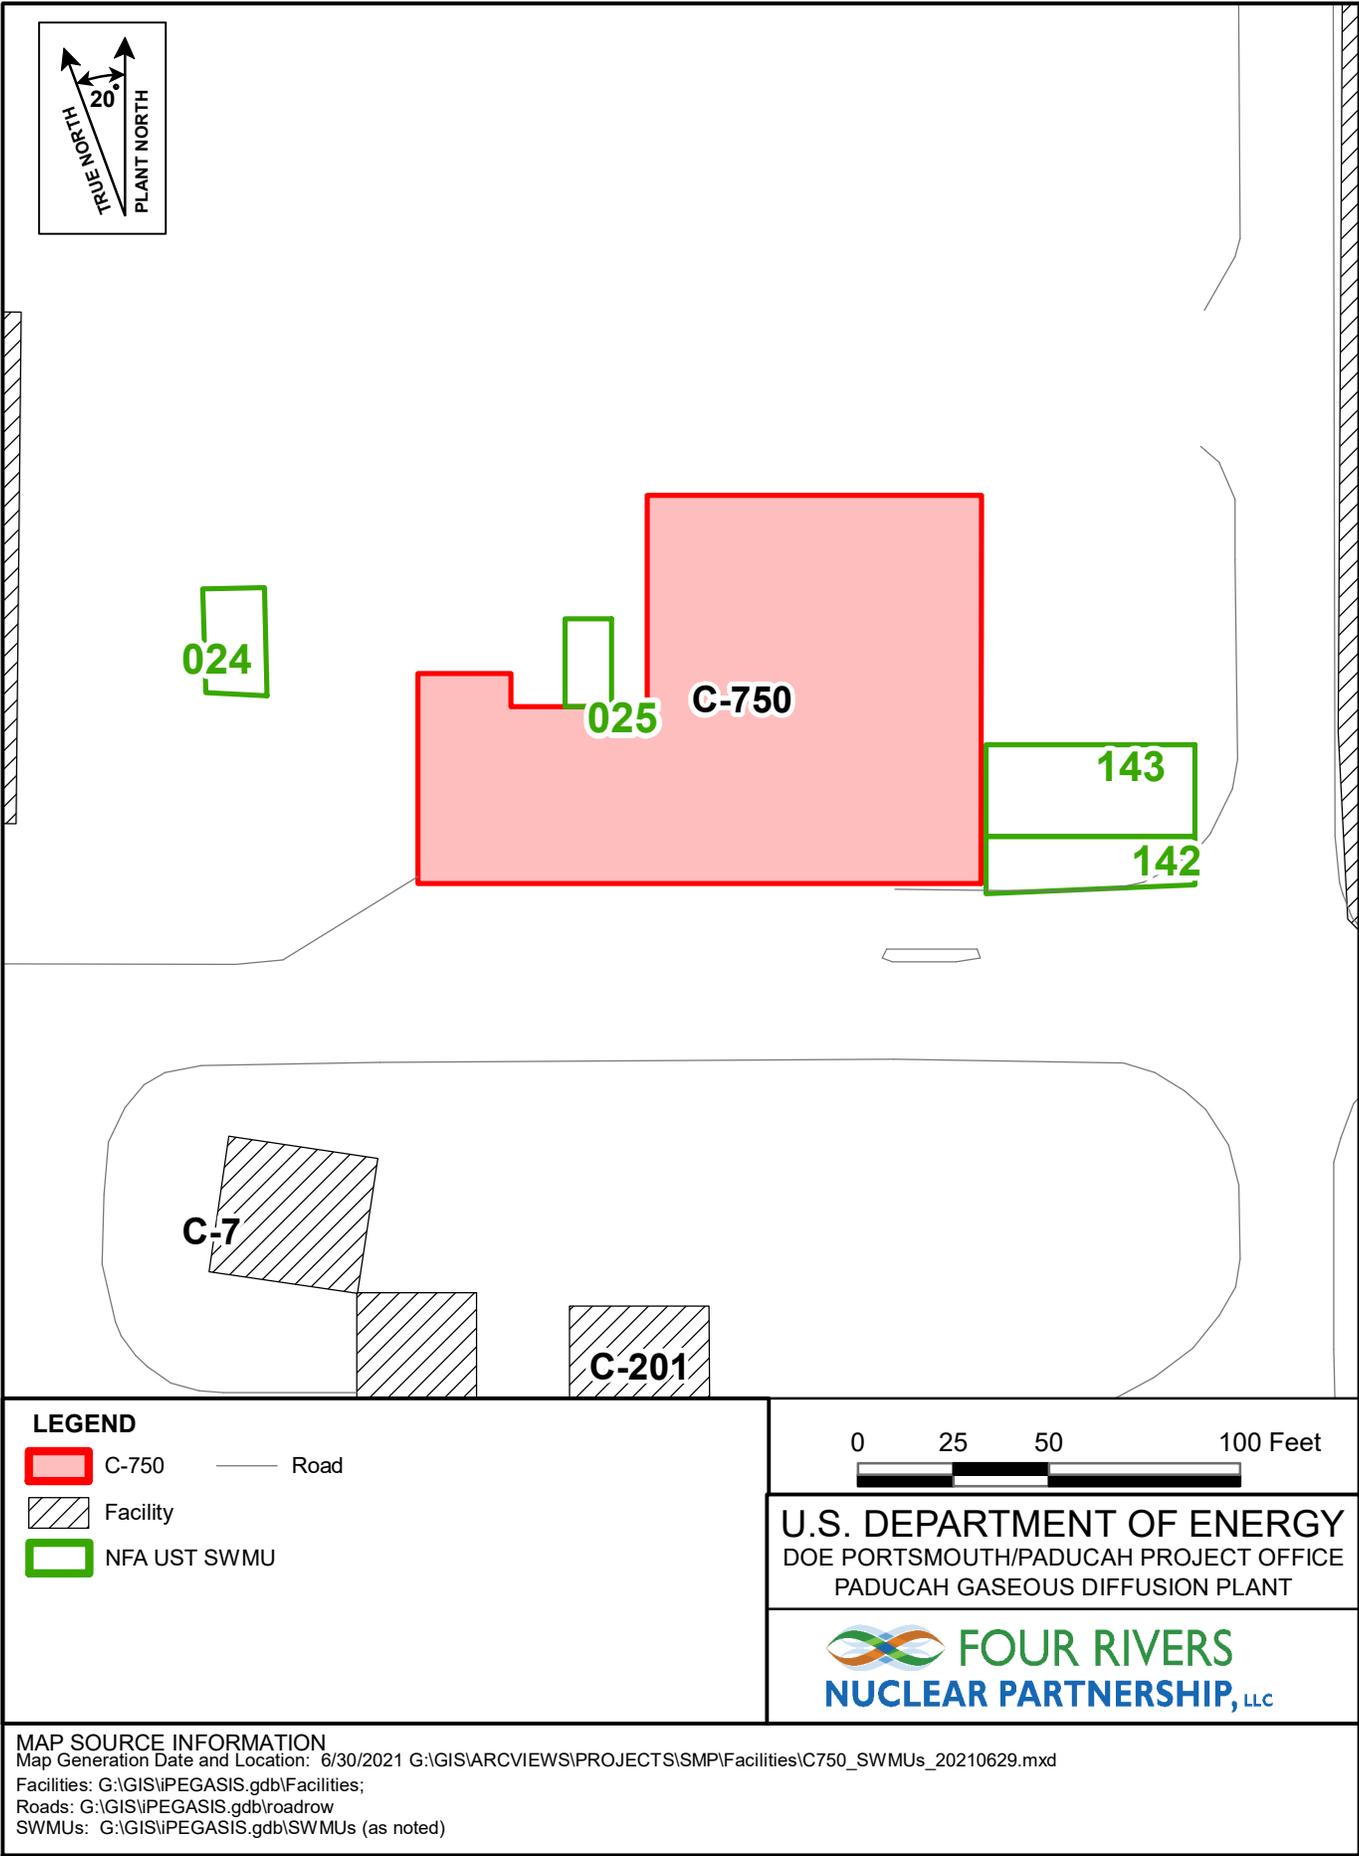
Four SWMUs that have been granted an NFA determination by KDWM (UST Branch) are located within a 50-ft boundary of C-750 and are shown on Figure 25.

SWMU 24 was the C-750-D 8,000-gal UST. The tank was used from 1953 to 1982 to accumulate waste oils that were then sold to reclaimers. Potential releases associated with this tank were previously addressed. KDWM (UST Branch) granted an NFA determination on November 23, 1999.

SWMU 25 was the C-750 1,000-gal waste oil tank. The tank was used since 1952 for the storage of waste motor oil from vehicle maintenance activities prior to the oil's resale to reclaimers. The date that the tank was removed from service is unknown; its removal is assumed to have occurred in the mid- to late 1980s—similar to when other tanks located at C-750 were removed. Potential releases associated with this tank were previously addressed. KDWM (UST Branch) granted an NFA determination on June 20, 1994.

SWMU 142 was the C-750-A 10,000-gal gasoline tank. The tank was used from the 1950's to 1989; it was found to be leaking in 1989 and removed in early 1991. Contamination from this UST was previously addressed. KDWM (UST Branch) granted an NFA determination on March 25, 1999.

SWMU 143 was the C-750-B 10,000-gal diesel tank. The tank was used from the 1950's to 1989; it was found to be leaking in 1989 and removed in 1991. Contamination from this UST was previously addressed. KDWM (UST Branch) granted an NFA determination on March 25, 1999.
