**TRANSMITTAL OF THE ADDENDUM TO THE FIVE-YEAR REVIEW FOR
REMEDIAL ACTIONS AT THE PADUCAH GASEOUS DIFFUSION PLANT,
PADUCAH, KENTUCKY, (DOE/LX/07-1289&D2/R1/A2)**

**Five-Year Review for
Remedial Actions
at the Paducah Gaseous Diffusion Plant,
Paducah, Kentucky**

**Water Policy Area Vapor Intrusion
Screening Study Report for the
Five-Year Review of Remedial Actions
Paducah, Kentucky**

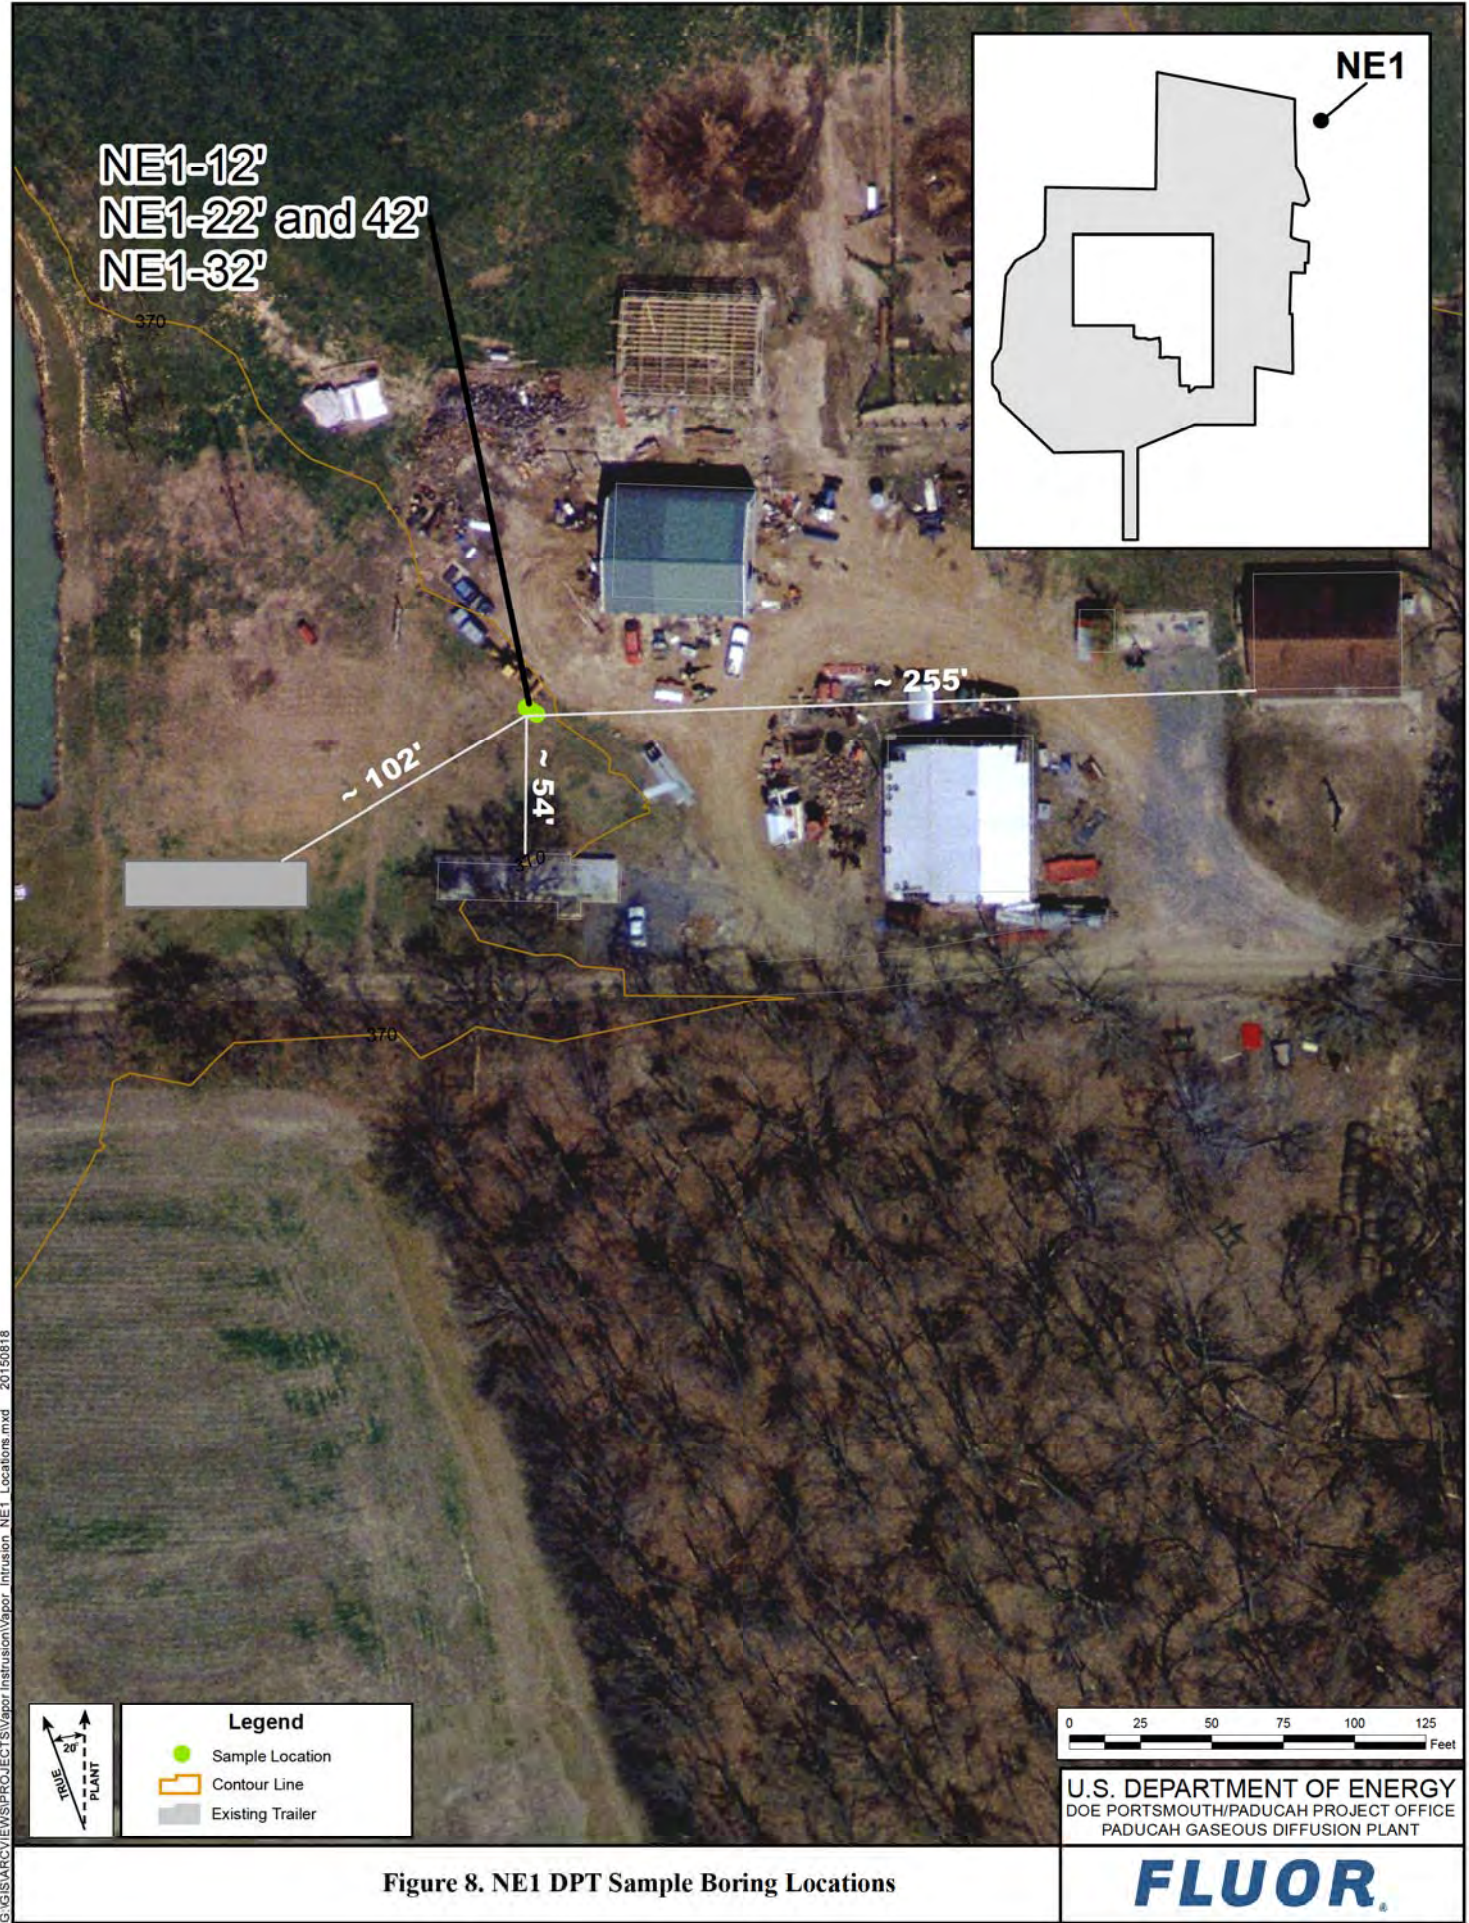
Figure 8. NE1 DPT Sample Boring Locations

^b NE1 22 ft boring extended to 42 ft in attempt to secure UCRS groundwater sample.

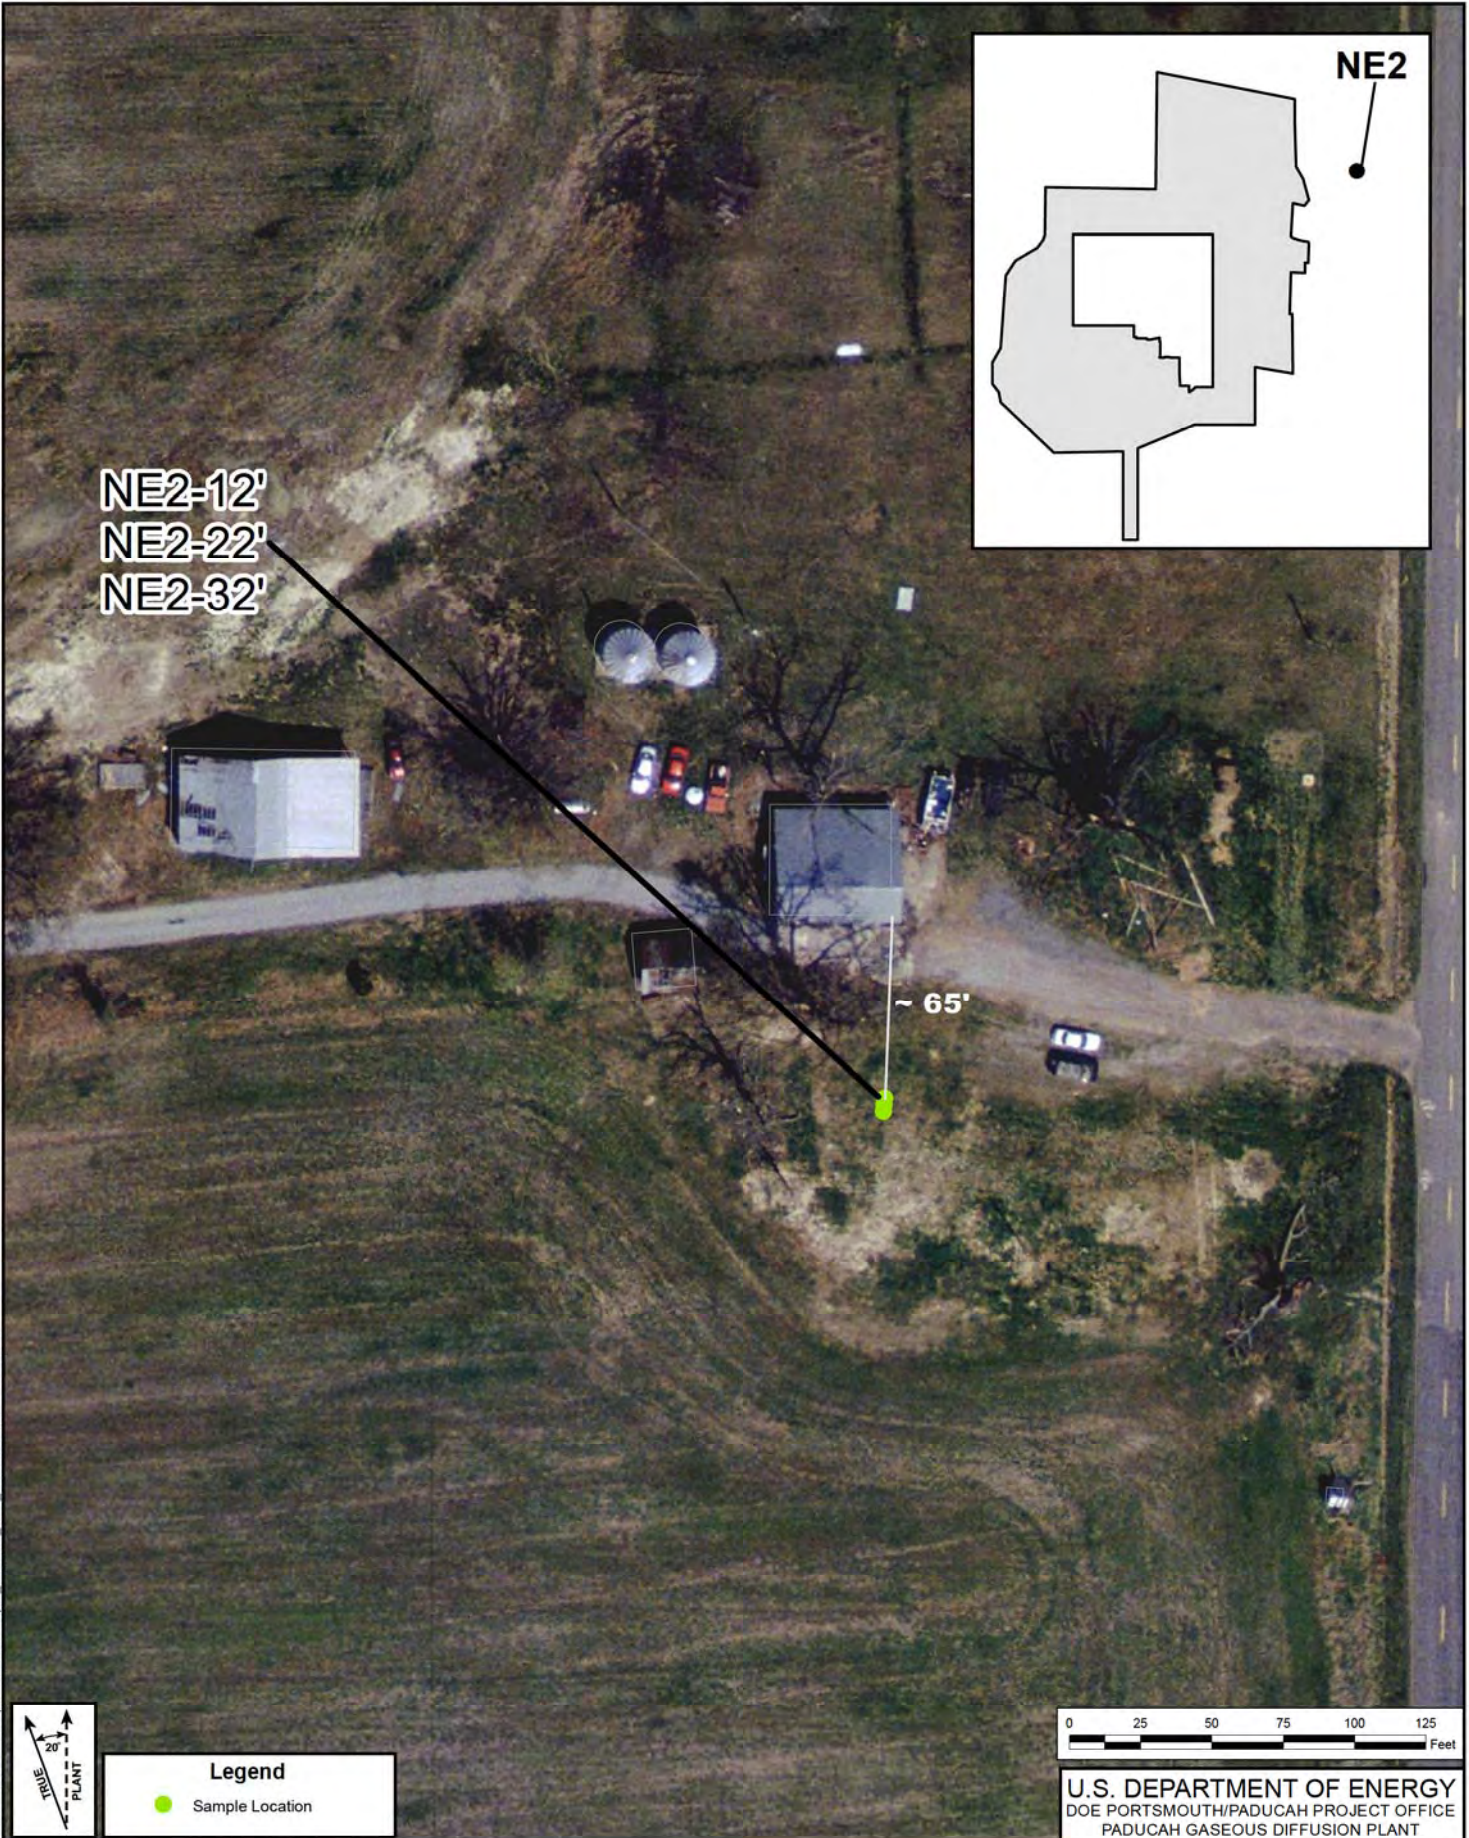
Figure 9. NE2 DPT Sample Boring Locations

If a groundwater sample cannot be obtained from the DPT borings at NE2, then the sample collected at NE1 will be used to extrapolate the conditions at NE2. On June 29, 2015, the FFA parties met and discussed the results of NW1 and NW2 borings having insufficient water to sample. For the NW locations, the FFA parties agreed to the following, which is documented in a record of conversation (DOE 2015c):
