**Five-Year Review for
Remedial Actions
at the Paducah Gaseous Diffusion Plant,
Paducah, Kentucky**

Date Issued—July 2018

U.S. DEPARTMENT OF ENERGY
Office of Environmental Management

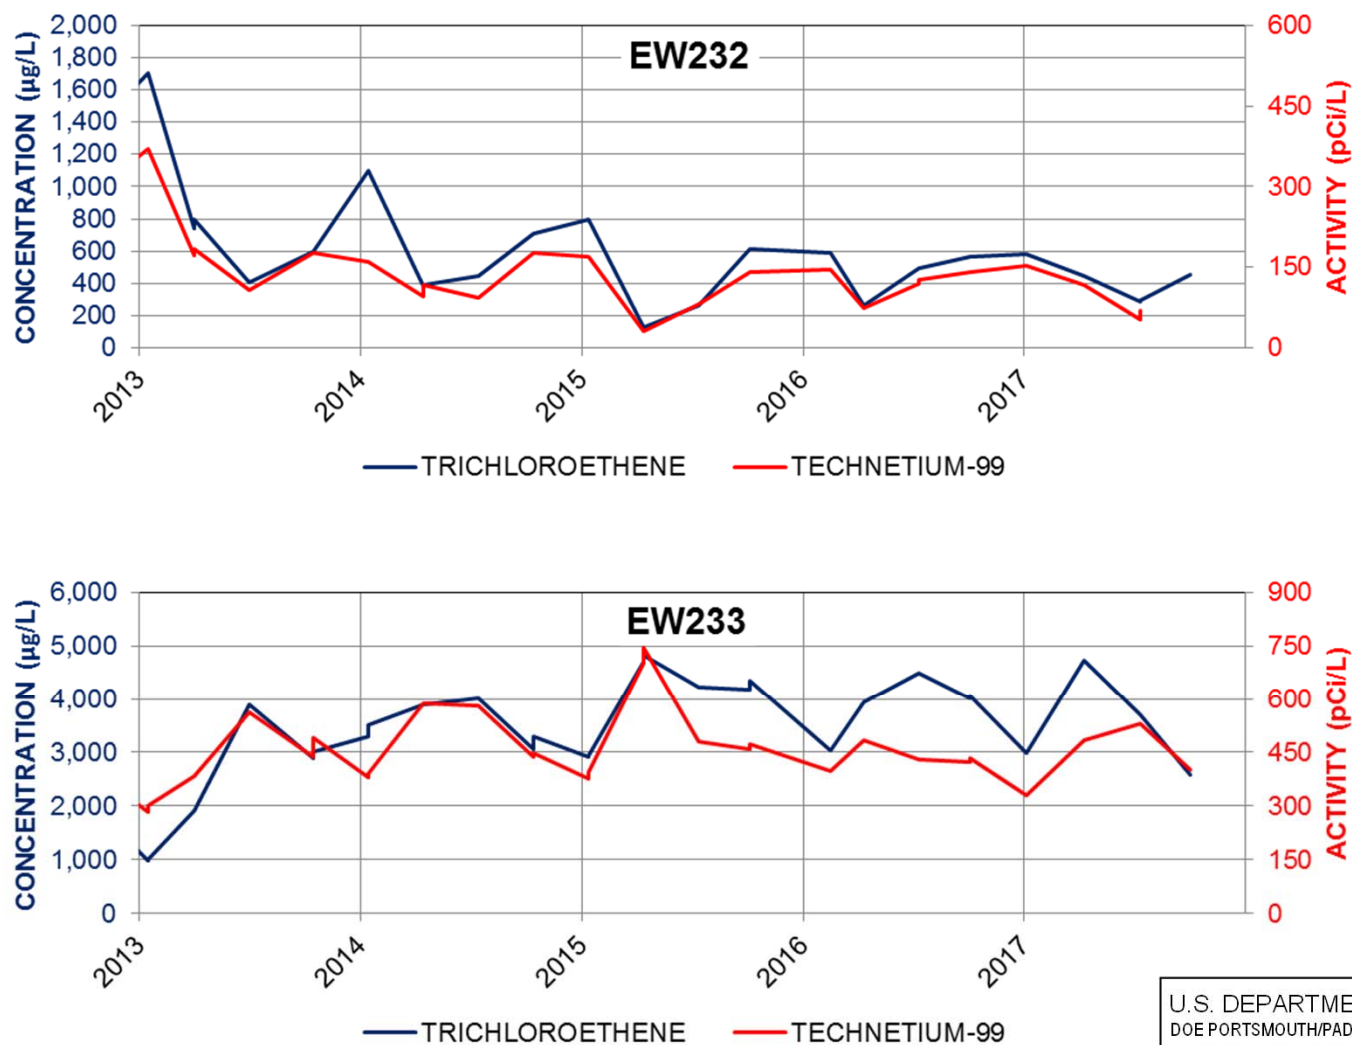
Figure 5.3. Contaminant Trends in the Optimization Wellfield EWs (EW232 and EW233)

Figure 5.3 shows contaminant level trends in each of the optimization EWs. Targets for the average levels of TCE and Tc-99 in effluent continue to be met (Table 5.1), as indicated from the latest semiannual reporting period of January 1, 2017, to June 30, 2017 (DOE 2017b). The target concentrations for these contaminants are 5 µg/L TCE and 900 pCi/L Tc-99.

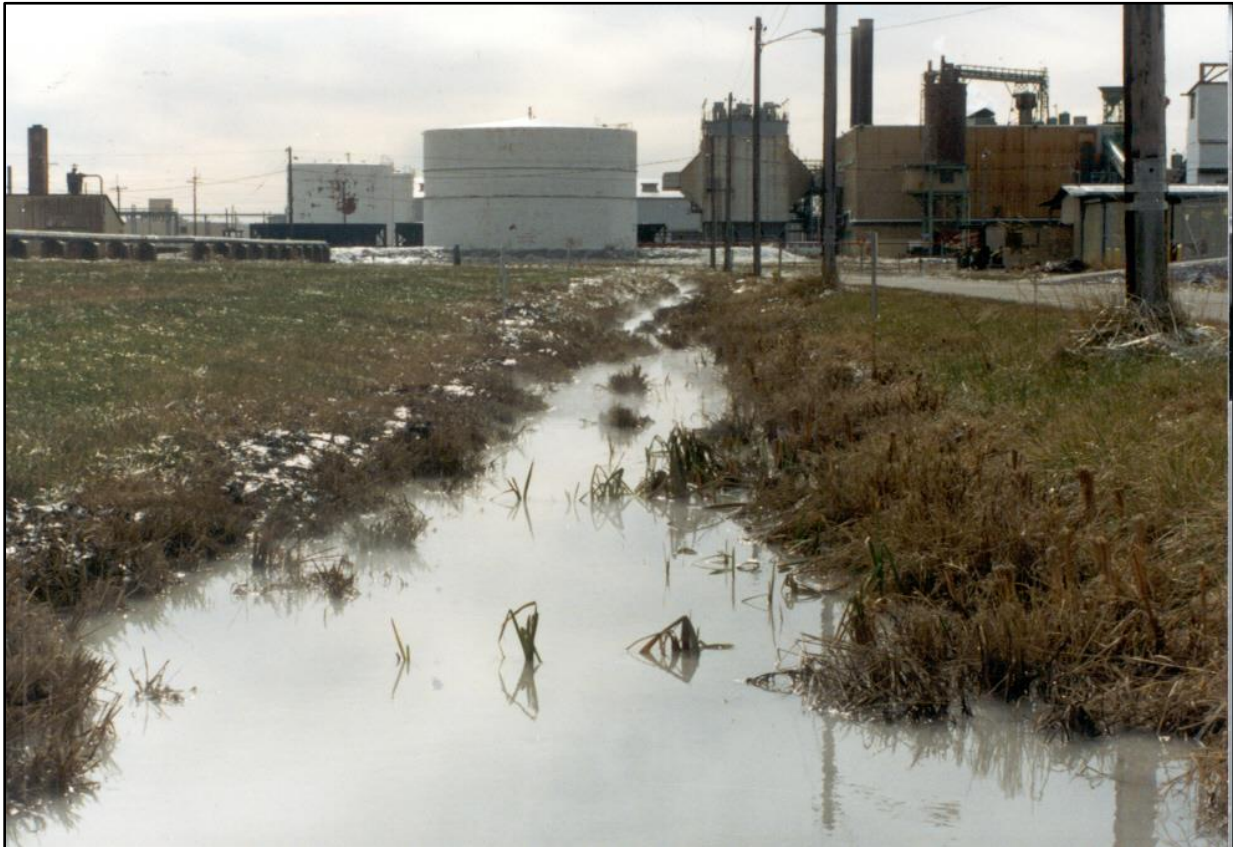
Figure 12.2. NSDD Sections 1 and 2 before Remedial Action

Figures 12.2 and 12.3 show “before and after” views of the NSDD Sections 1 and 2. The total cost of excavation of Sections 1 and 2, construction of the detention basin, and disposal of approximately 3,200 yd³ of soil in the C-746-U Landfill was \$12.2M, according to the *Remedial Action Completion Report for the North-South Diversion Ditch Sections 1 and 2 at the Paducah Gaseous Diffusion Plant, Paducah Kentucky*, DOE/OR/07-2195&D2 (DOE 2005d).
