### **TRANSMITTAL OF THE CY 2023 FIVE-YEAR REVIEW FOR REMEDIAL ACTIONS AT THE PADUCAH GASEOUS DIFFUSION PLANT, PADUCAH, KENTUCKY (FIFTH SYNCHRONIZED FIVE-YEAR REVIEW), (DOE/LX/07-2492&D2)**

Please find enclosed the *CY 2023 Five-Year Review for Remedial Actions at the Paducah Gaseous Diffusion Plant, Paducah, Kentucky (Fifth Synchronized Five-Year Review)*, DOE/LX/07-2492&D2. This Five-Year Review encompasses activities associated with response actions from January 2018 through December 2022. Section XXX of the Federal Facility

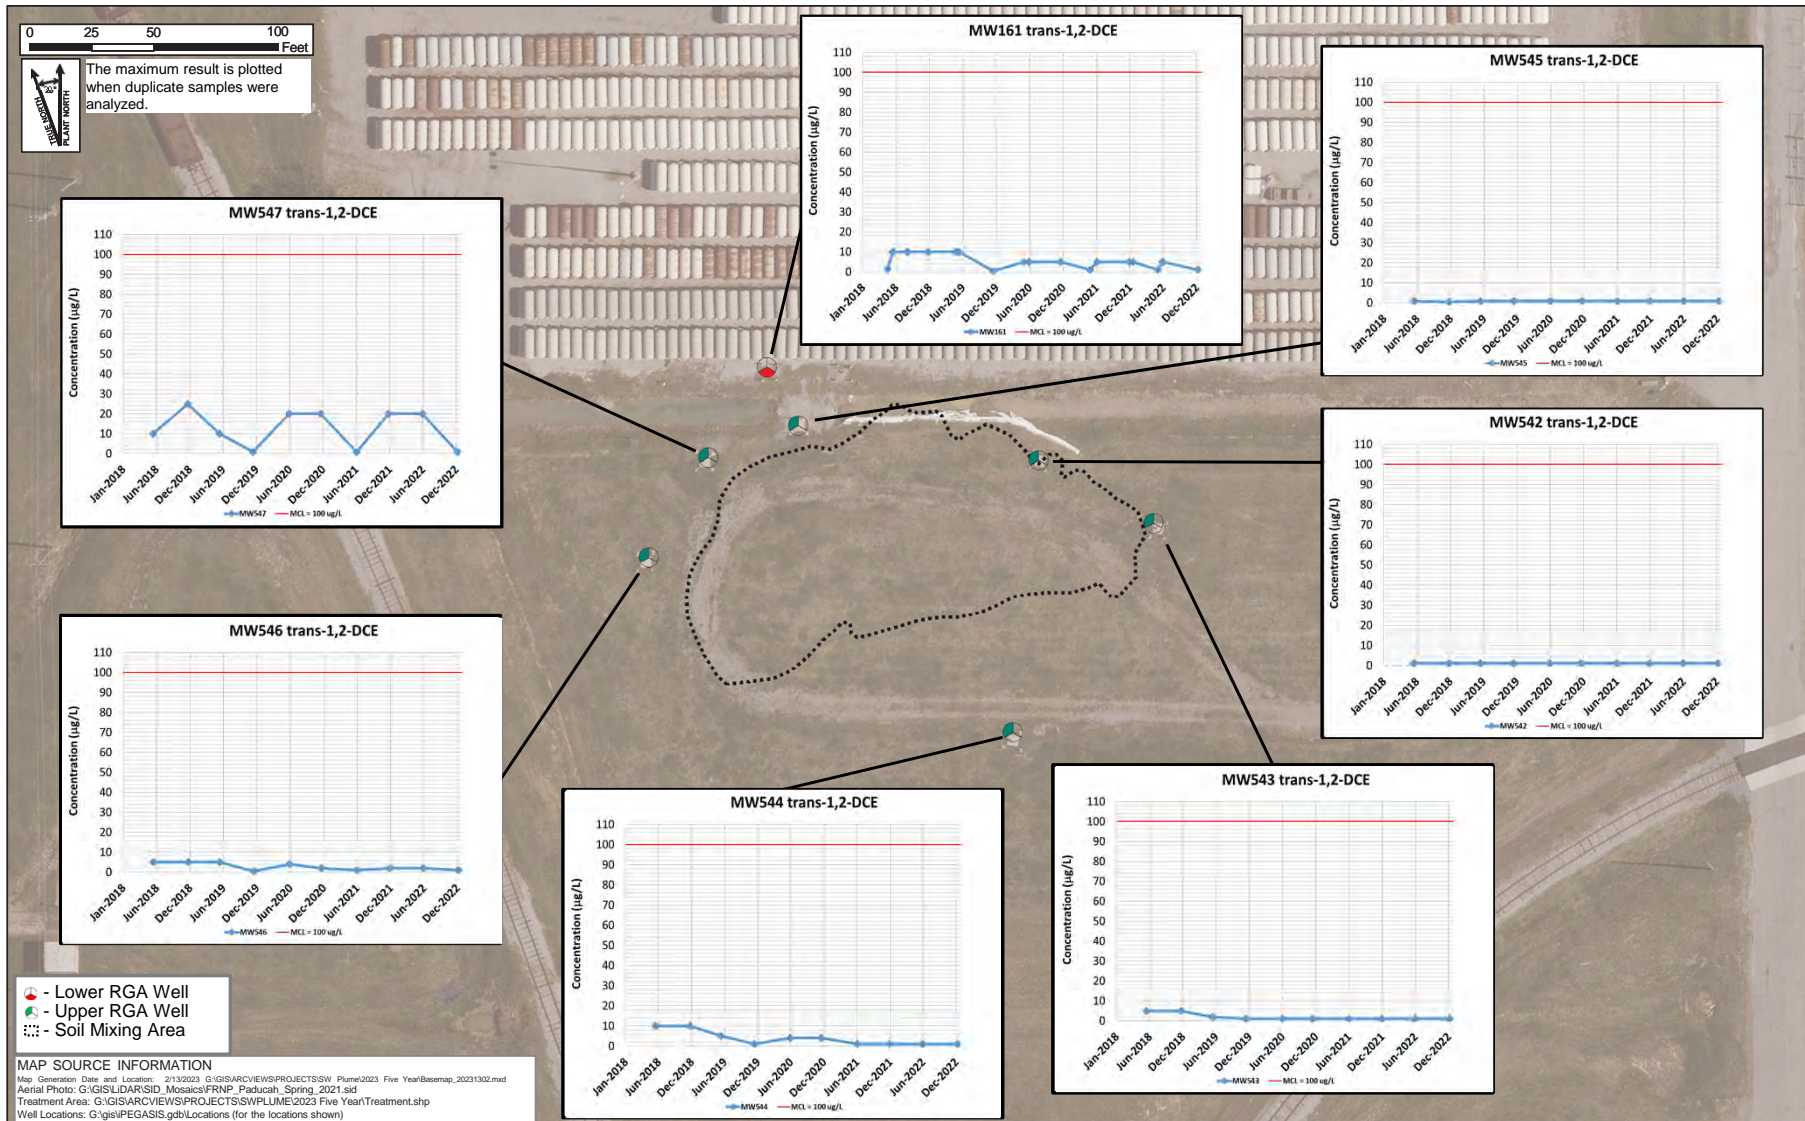
Figures 10.9 through 10.13 present the VOC contaminant levels in each MW as sampled during this reporting period. The field RA was completed in 2015. Two MWs, MW543 and MW544, are upgradient to the soil mixing area (Figure 10.4). Wells MW542, MW545, MW546, MW547 and MW161 are located downgradient to the soil mixing area. Since the implementation of the field RA, all MWs have seen decreased levels of all COCs over time. This is an indication that the RA has been generally effective. During the last two years of this five-year reporting period, contaminants in upgradient wells have remained generally at or near the required groundwater MCL levels for each VOC. Downgradient wells are exhibiting contaminant levels at levels near to or above the groundwater MCL contaminant levels for TCE, *cis*-1,2-DCE, and vinyl chloride. As such, the downgradient wells are not exhibiting groundwater contaminant levels that would allow attainment of RAO 3 to be declared. As indicated in the ROD, however, the attainment of the groundwater protection remediation goal is expected to require approximately 68 years. As of the end of this reporting period, approximately six years have passed since soil mixing was completed.

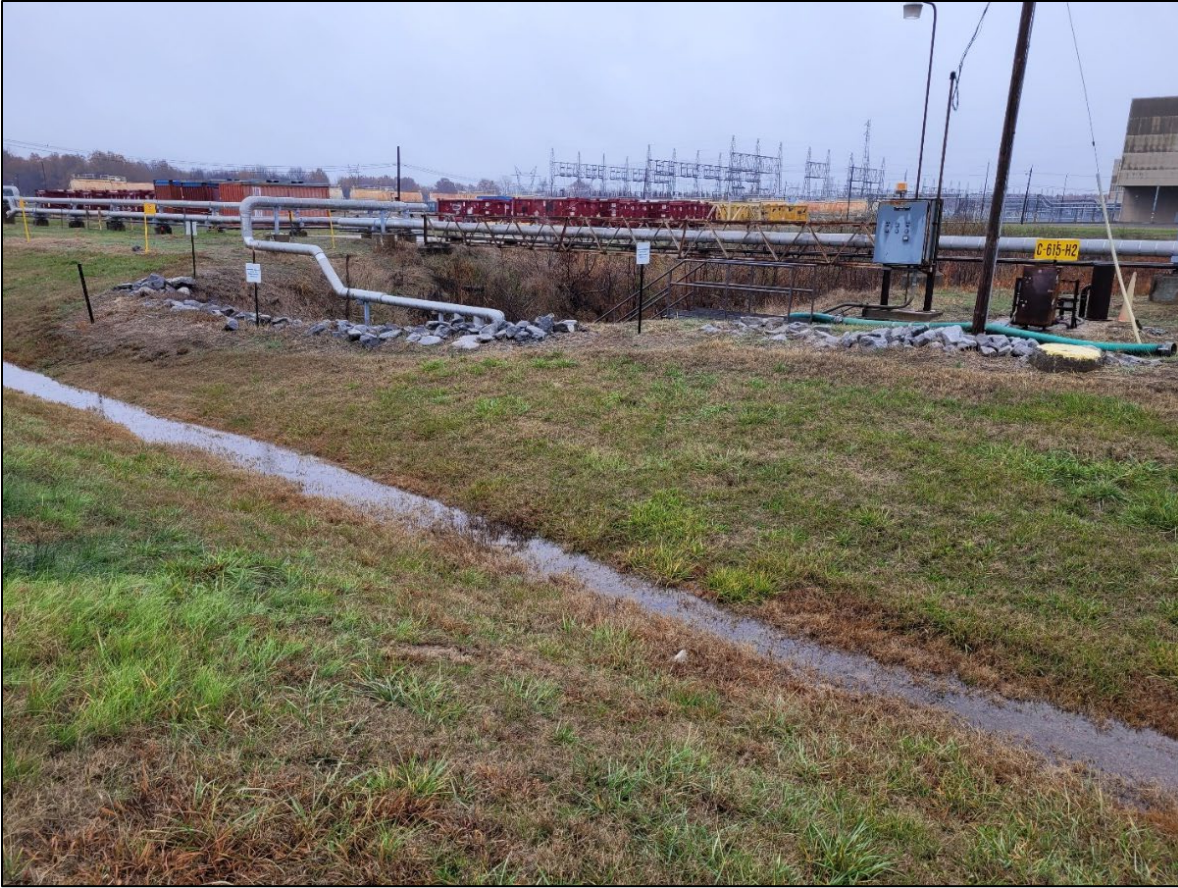
**Figure 12.3. NSDD and Gabion Structure**

A residual risk evaluation was prepared as a result of a recommendation in the 2008 Five-Year Review to determine if the remedy for Sections 1 and 2 of the NSDD could be optimized (e.g., risks were at a level that would support modification of institutional controls and/or cessation of five-year reviews). The evaluation showed that the cleanup goals of the ROD were met.
