**TRANSMITTAL OF CORRECTED DOCUMENT FOR THE CALENDAR YEAR 2023 FIVE-YEAR REVIEW FOR REMEDIAL ACTIONS AT THE PADUCAH GASEOUS DIFFUSION PLANT, PADUCAH, KENTUCKY (FIFTH SYNCHRONIZED FIVE-YEAR REVIEW), DOE/LX/07-2492&D2/R1**

**CY 2023 Five-Year Review for  
Remedial Actions  
at the Paducah Gaseous Diffusion Plant,  
Paducah, Kentucky  
(Fifth Synchronized Five-Year Review)**

The purpose of this fifth synchronized Five-Year Review is to determine whether the remedies at the U.S. Department of Energy (DOE) Paducah Site<sup>3</sup> remain protective of human health and the environment and to evaluate the implementation and performance of the selected remedies. The methods, findings, conclusions, and recommendations of the reviews of 13 projects are documented in this report.

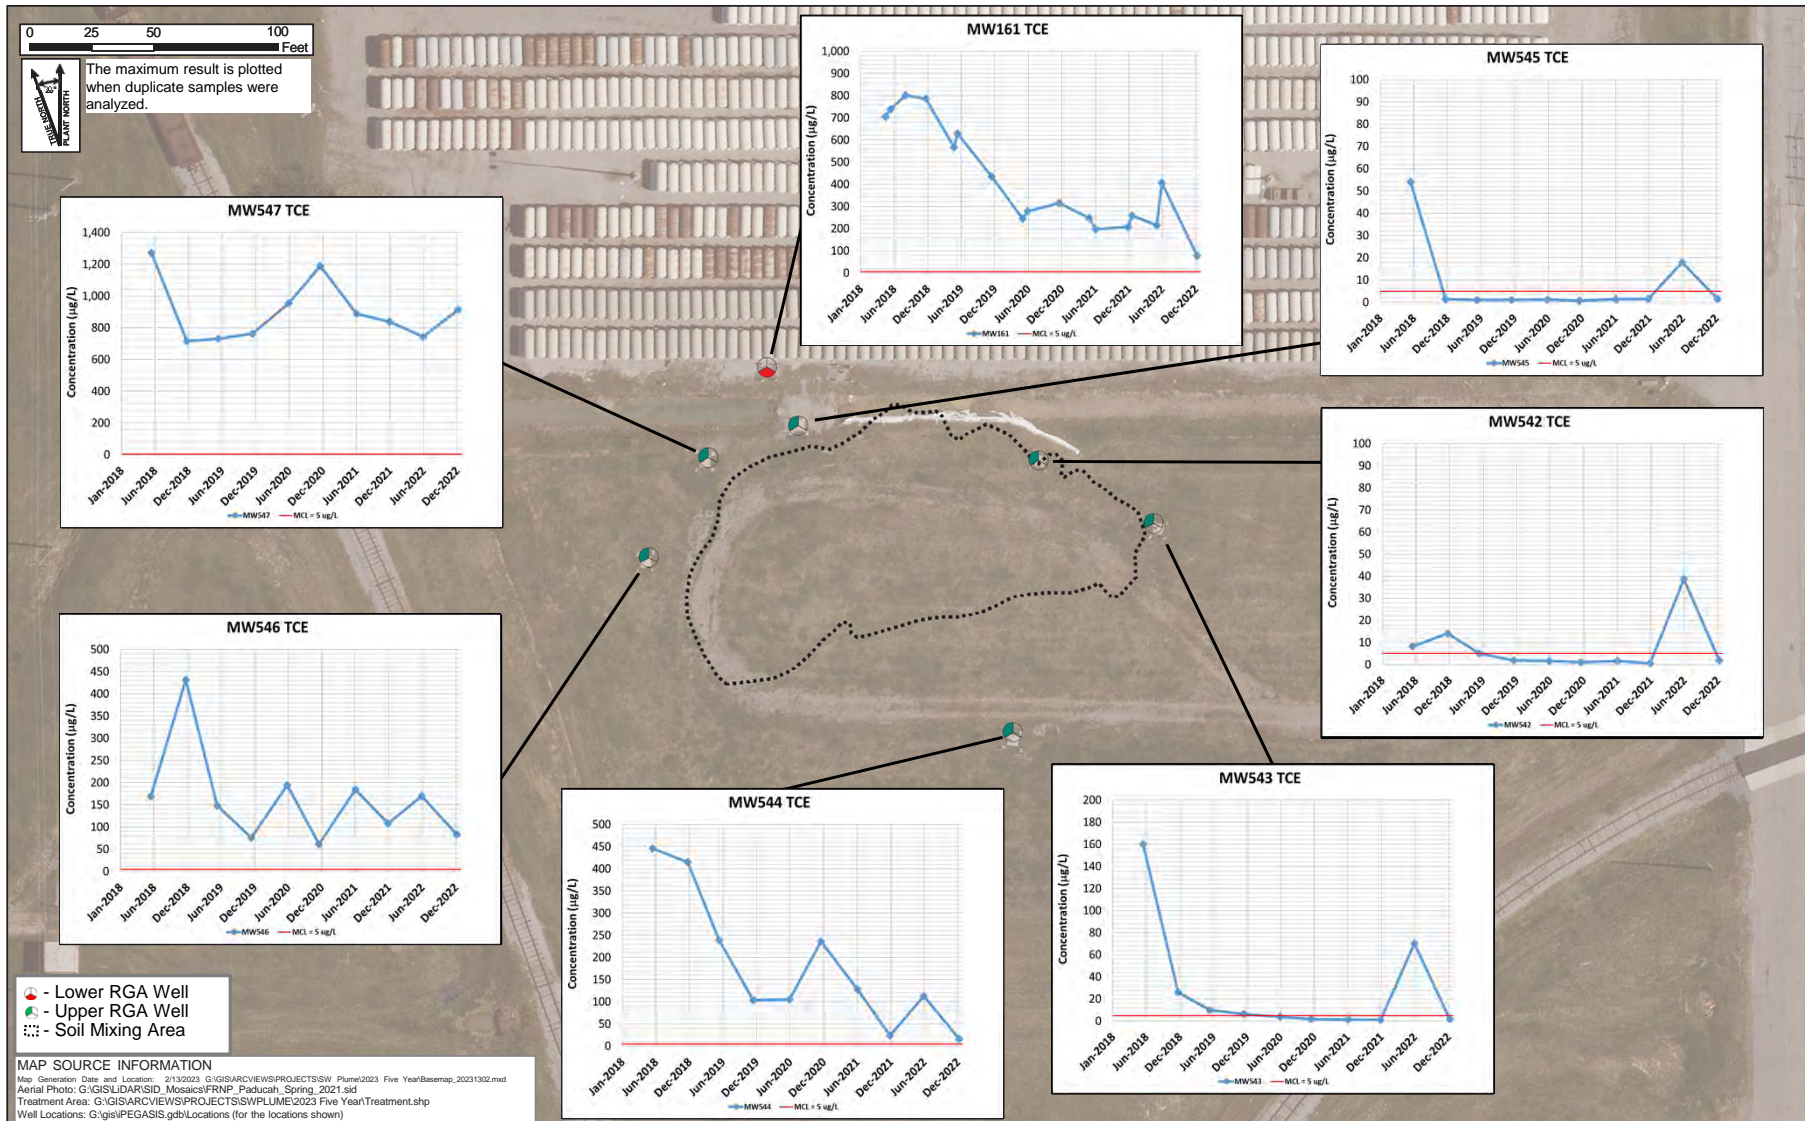
Figure 10.9. SWMU 1 TCE Trends

Figures 10.9 through 10.13 present the VOC contaminant levels in each MW as sampled during this reporting period. The field RA was completed in 2015. Two MWs, MW543 and MW544, are upgradient to the soil mixing area (Figure 10.4). Wells MW542, MW545, MW546, MW547 and MW161 are located downgradient to the soil mixing area. Since the implementation of the field RA, all MWs have seen decreased levels of all COCs over time. This is an indication that the RA has been generally effective. During the last two years of this five-year reporting period, contaminants in upgradient wells have remained generally at or near the required groundwater MCL levels for each VOC. Downgradient wells are exhibiting contaminant levels at levels near to or above the groundwater MCL contaminant levels for TCE, *cis*-1,2-DCE, and vinyl chloride. As such, the downgradient wells are not exhibiting groundwater contaminant levels that would allow attainment of RAO 3 to be declared. As indicated in the ROD, however, the attainment of the groundwater protection remediation goal is expected to require approximately 68 years. As of the end of this reporting period, approximately six years have passed since soil mixing was completed.

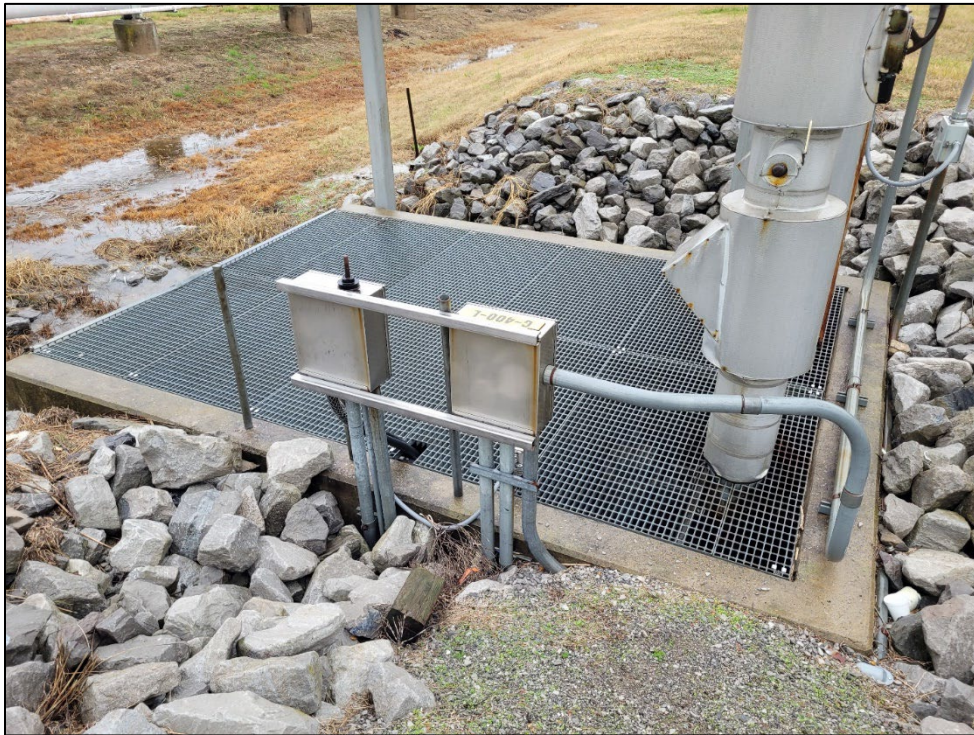
On December 8, 2022, a site inspection of the following facilities associated with the NSDD IRA was conducted by the five-year review team, the facility manager, KDEP, and a representative from DOE’s support contractor: (1) the C-400-L Lift Station and associated piping (Figure 11.2), (2) the C-616-L Lift Station and associated piping (Figure 11.3), and (3) the gabion installed at the C-615-K Lift Station (Figure 11.4). There was no excessive debris over the gabion screens. The aboveground piping was in good condition, the insulation was intact, and the metal jacket covering was not rusted or deteriorated. The lift stations appear to be functioning properly. The facility manager participated as part of the inspection team and did not have any concerns.

**Figure 11.2. C-400-L Lift Station**

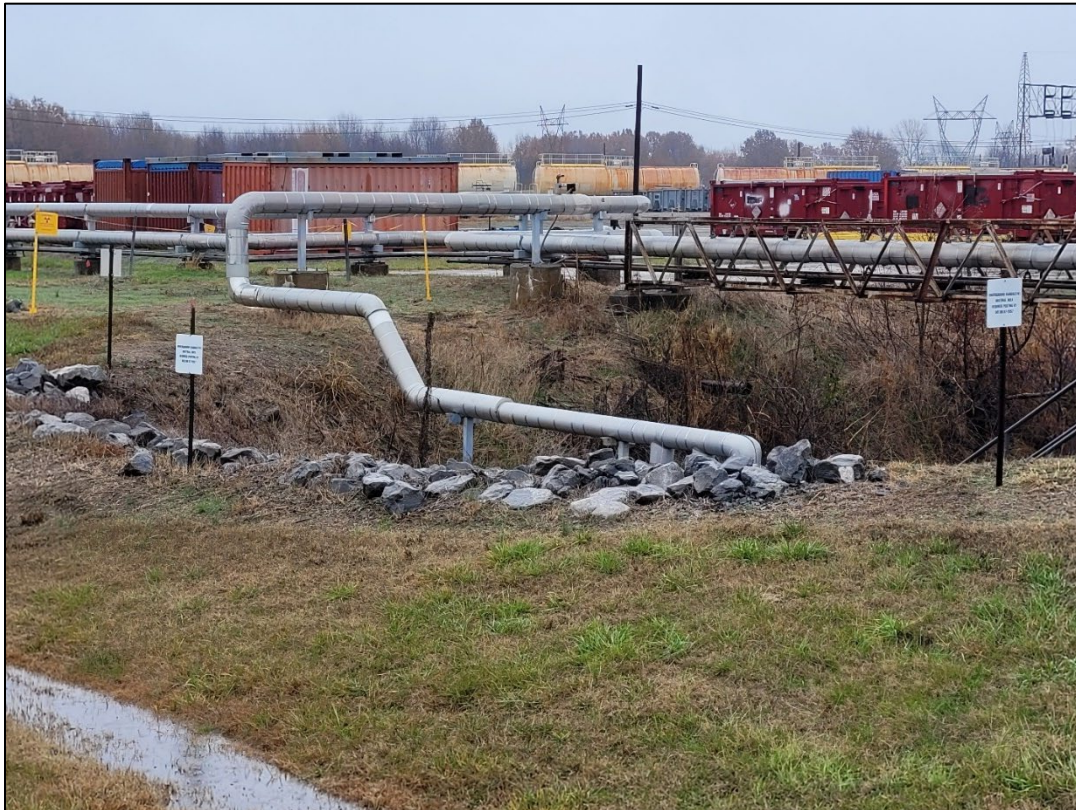
**Figure 11.4. Gabion Structure**

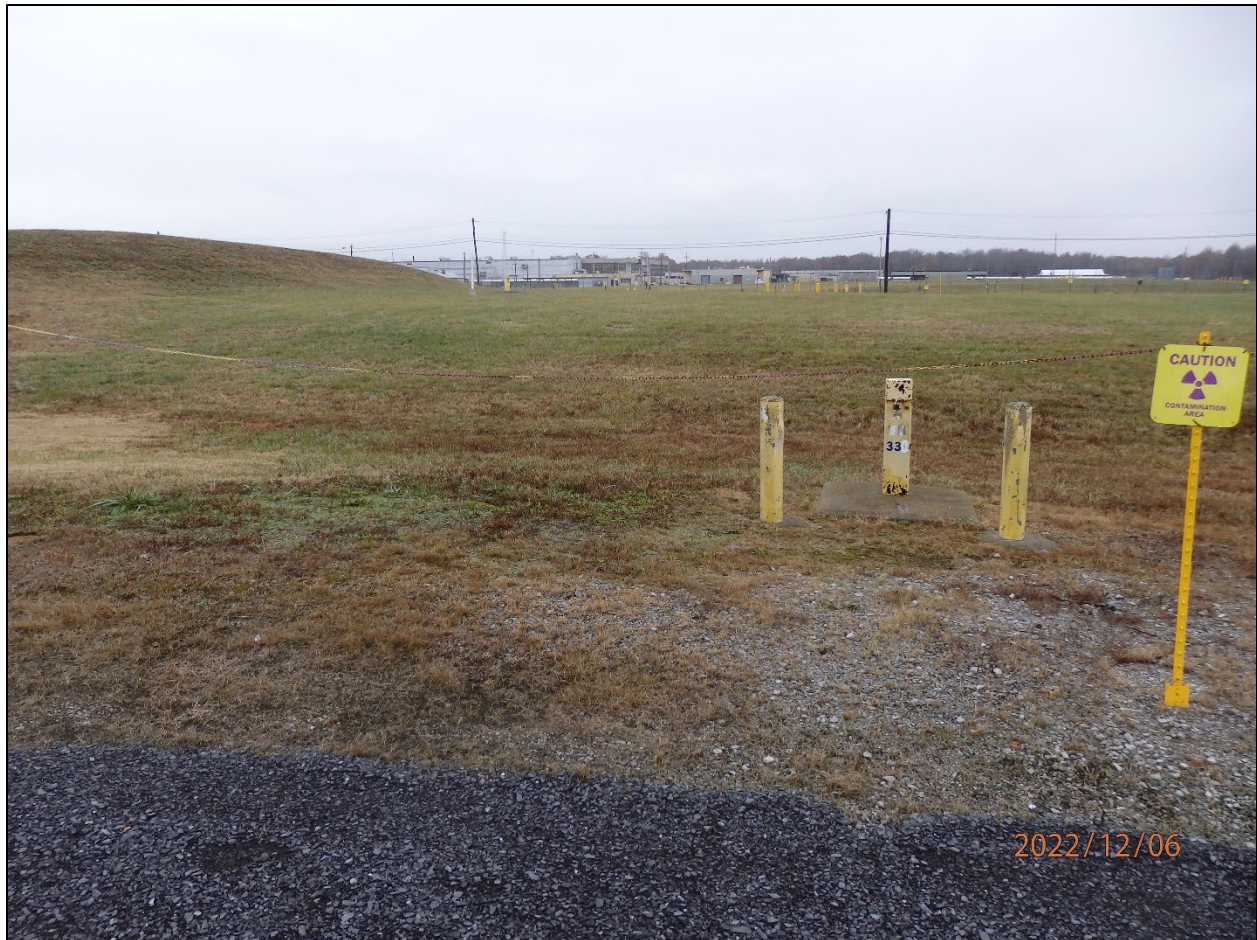
**Figure 17.2. C-749 Uranium Burial Ground (Looking South)**
