### **TRANSMITTAL OF THE FIVE-YEAR REVIEW FOR REMEDIAL ACTIONS AT THE PADUCAH GASEOUS DIFFUSION PLANT, PADUCAH, KENTUCKY, DOE/LX/07-2492&D1**

*CY 2023 Five-Year Review for Remedial Actions at the Paducah Gaseous Diffusion Plant, Paducah, Kentucky (Fifth Synchronized Five-Year Review), DOE/LX/07-2492&D1*

**DOE/LX/07-2492&D1  
Secondary Document**

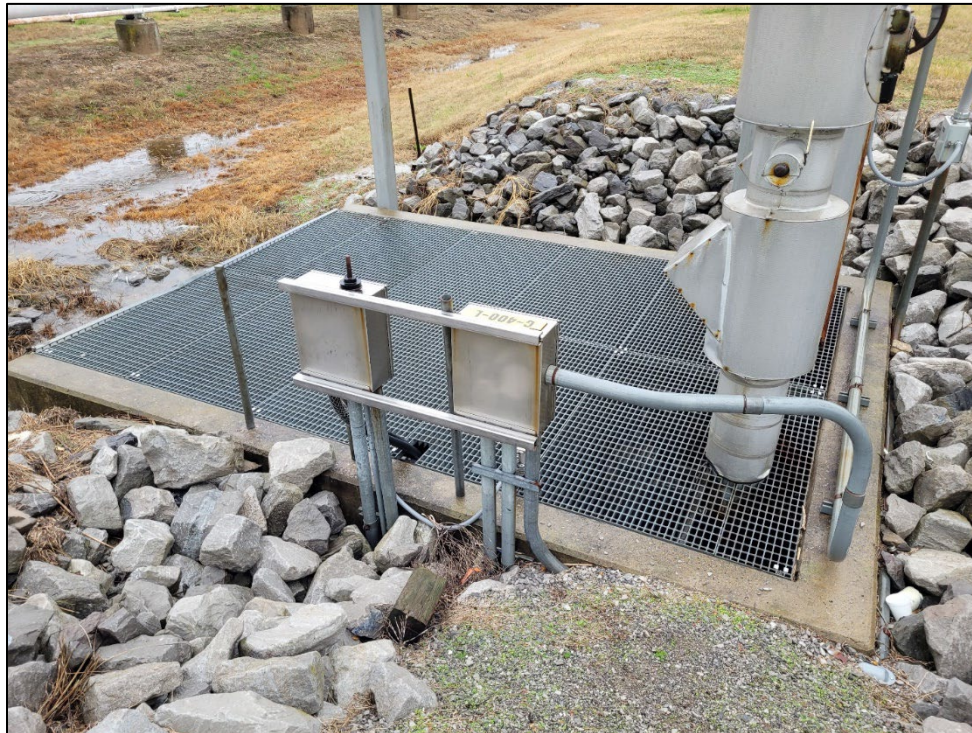
**Figure 11.2. C-400-L Lift Station**

On December 8, 2022, a site inspection of the following facilities associated with the NSDD IRA was conducted by the five-year review team, the facility manager, KDEP, and a representative from DOE’s support contractor: (1) the C-400-L Lift Station and associated piping (Figure 11.2), (2) the C-616-L Lift Station and associated piping (Figure 11.3), and (3) the gabion installed at the C-615-K Lift Station (Figure 11.4). There was no excessive debris over the gabion screens. The aboveground piping was in good condition, the insulation was intact, and the metal jacket covering was not rusted or deteriorated. The lift stations appear to be functioning properly. The facility manager participated as part of the inspection team and did not have any concerns.

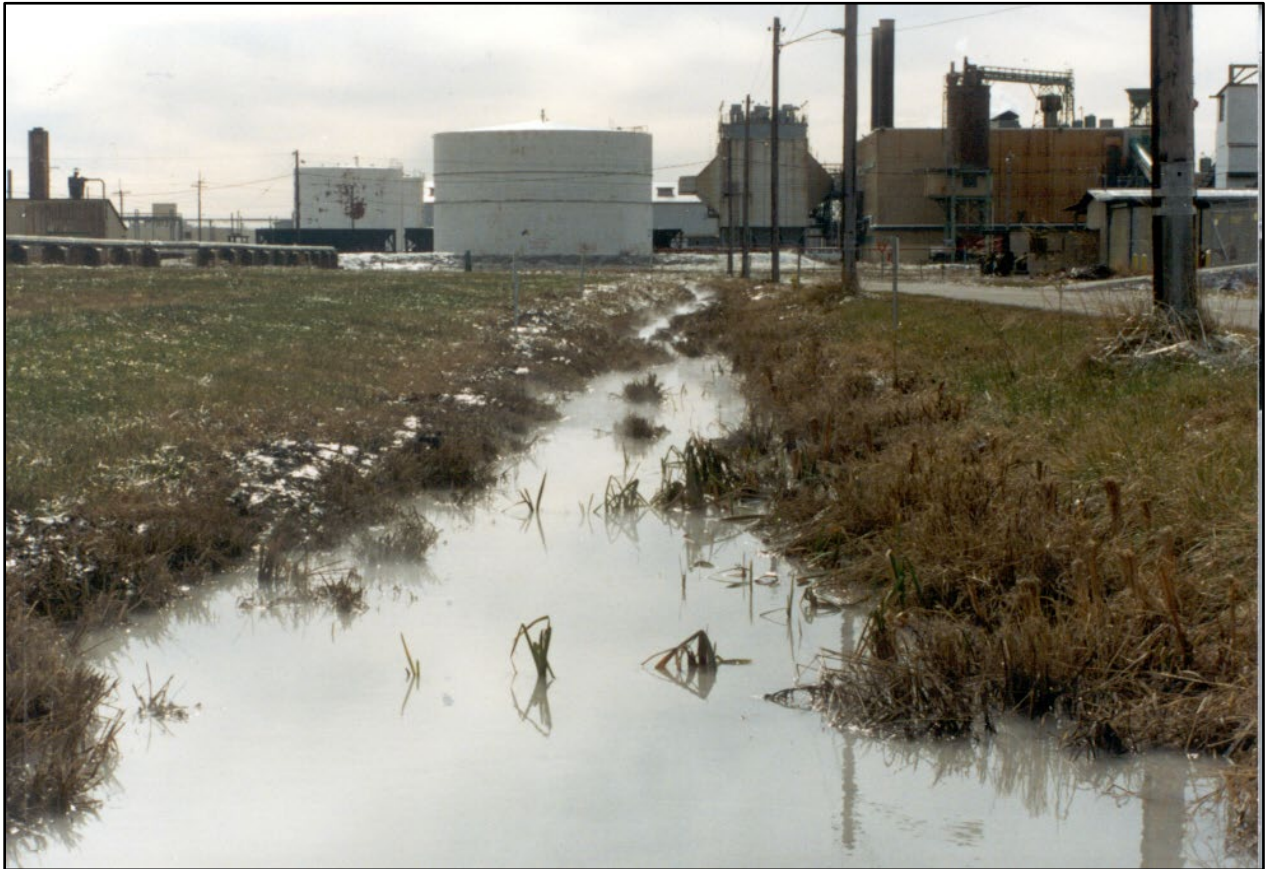
**Figure 12.2. NSDD Sections 1 and 2 before Remedial Action**

Figures 12.2 and 12.3 show “before and after” views of the NSDD Sections 1 and 2. The total cost of excavation of Sections 1 and 2, construction of the detention basin, and disposal of approximately 3,200 yd<sup>3</sup> of soil in the C-746-U Landfill was \$12.2M, according to the *Remedial Action Completion Report for the North-South Diversion Ditch Sections 1 and 2 at the Paducah Gaseous Diffusion Plant, Paducah Kentucky*, DOE/OR/07-2195&D2 (DOE 2005d).

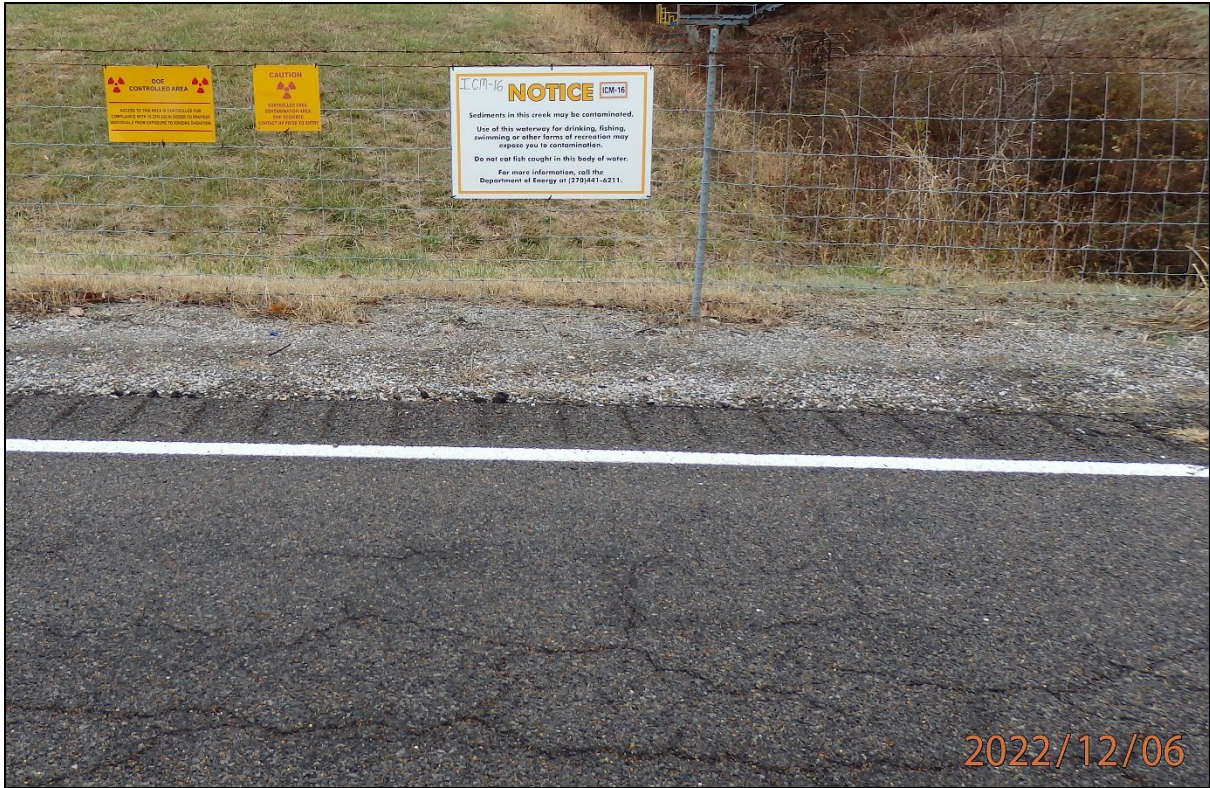
Figure 15.2. Sign and Fencing Installed for the Surface Water ICM

Yes. Potential users of creeks, ponds, or streams outside the facility security fence are warned that contact with contaminated water and sediment may pose potential dangers, as detailed in Section 15.5, “Site Inspection.” Sediments and water continue to be monitored through the Environmental Monitoring Program in accordance with the KPDES Permit, and results are made available through the Annual Site Environmental Report.

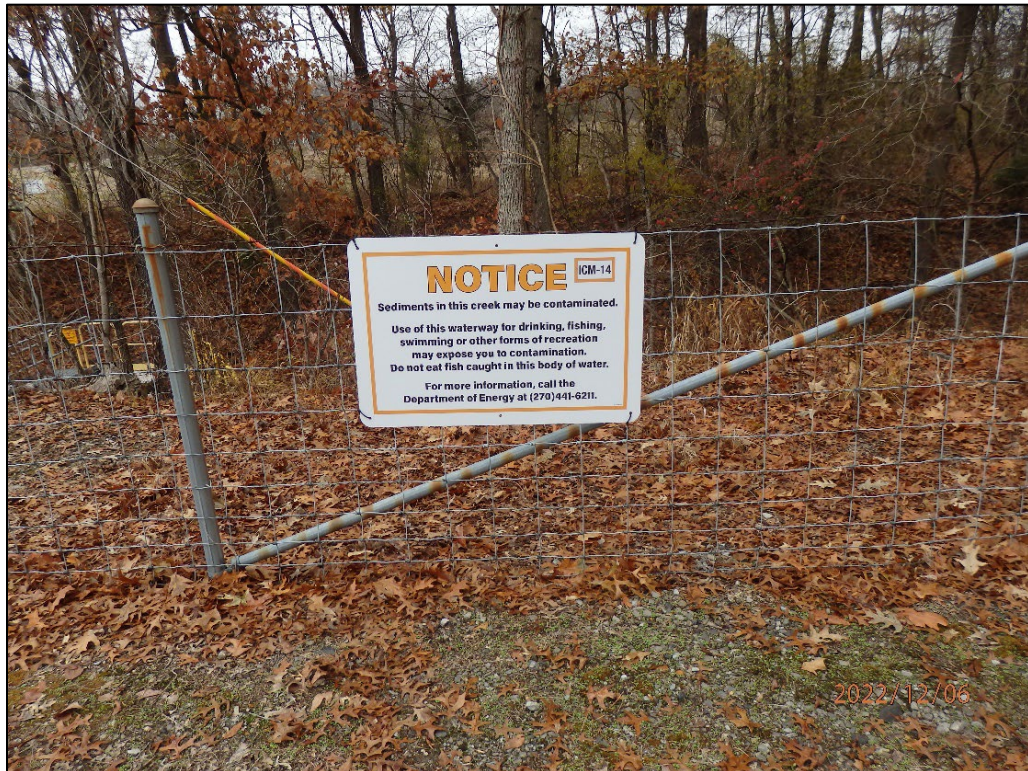
Figure 15.3. Sign and Fencing Installed for the Surface Water ICM

The locations of the signs and fences were inspected on December 6, 2022, by the five-year review team, the facility manager, and a representative from DOE’s support contractor. The ICM signs all were legible (see Figures 15.2 through 15.4 for examples). Also, at all locations the Surface Water ICM signs were posted along with “KEEP OUT,” “NO TRESPASSING,” and radiological warning signs. The fences at all locations were in place.

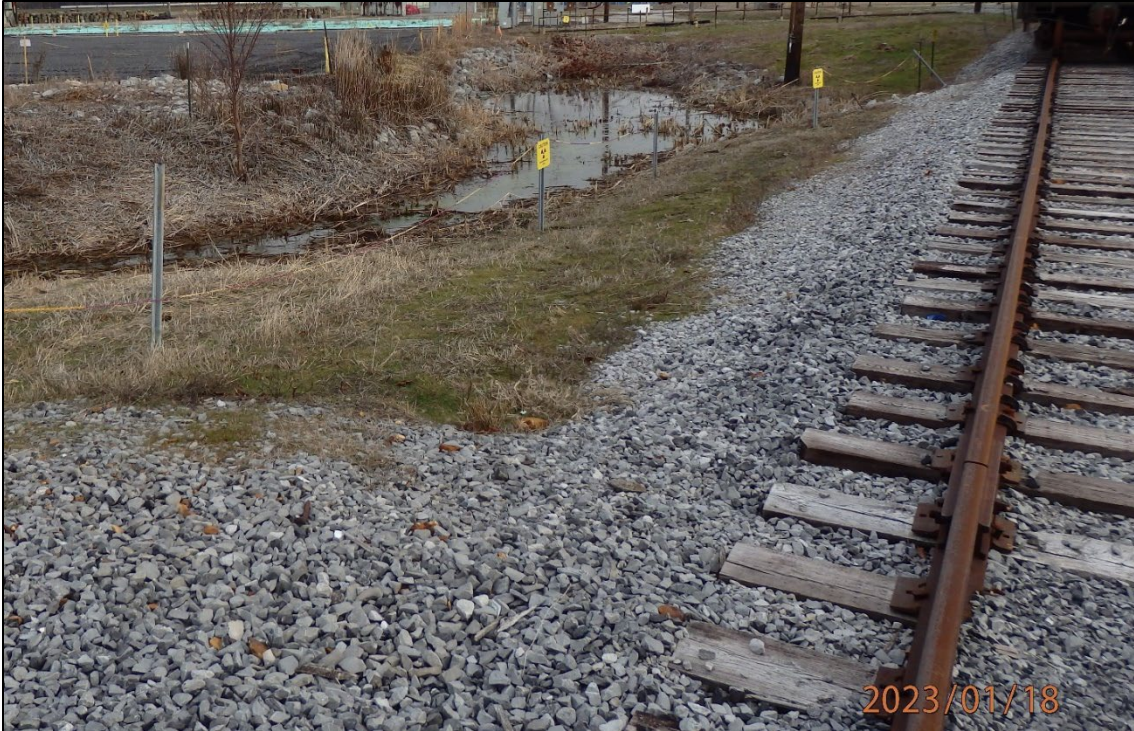
**Figure 16.2. KPDES Outfall 001 Internal Ditches, January 18, 2023 (Looking Northwest)**

Figures 16.2 through 16.4 show current views of internal ditches and areas associated with KPDES Outfalls 001, 010, and 015. The total cost of excavation and disposing of the approximately 10,160 yd<sup>3</sup> of soil in the C-746-U Landfill and 12,517 yd<sup>3</sup> of soil at EnergySolutions was \$18,312,363, according to the *Removal Action Report for Contaminated Sediment Associated with the Surface Water Operable Unit (On-Site) at the Paducah Gaseous Diffusion Plant, Paducah, Kentucky*, DOE/LX/07-0357&D2 (DOE 2011a).
