### **DE-EM0004895: APPROVAL OF THE REVISED CONSULTATION PACKAGE FOR THE C-200 GUARD AND FIRE HEADQUARTERS FACILITY**

# C-200 Guard and Fire Headquarters

Facility Overview Briefing

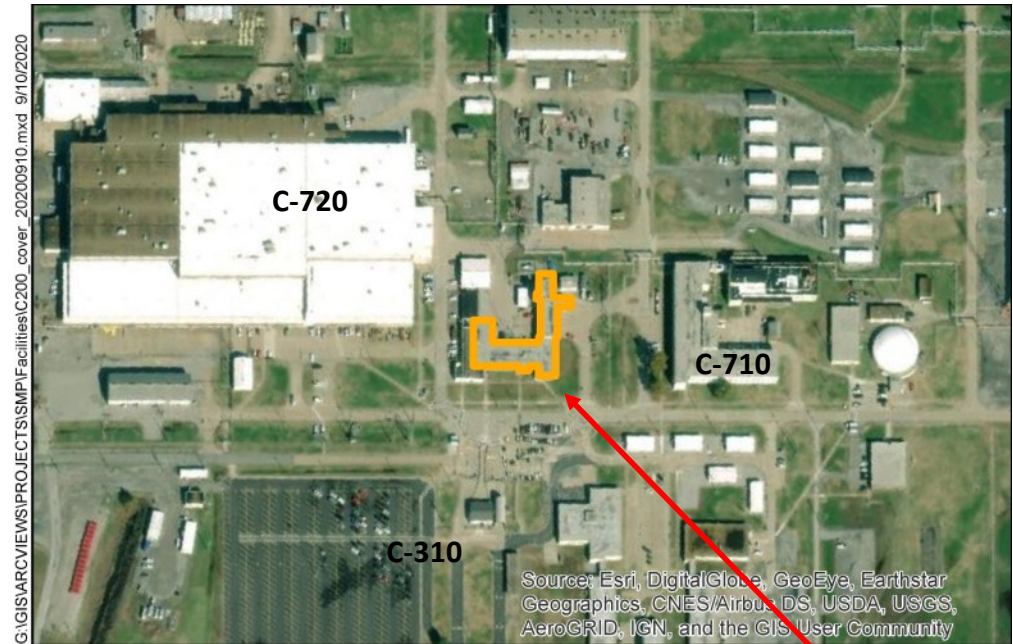
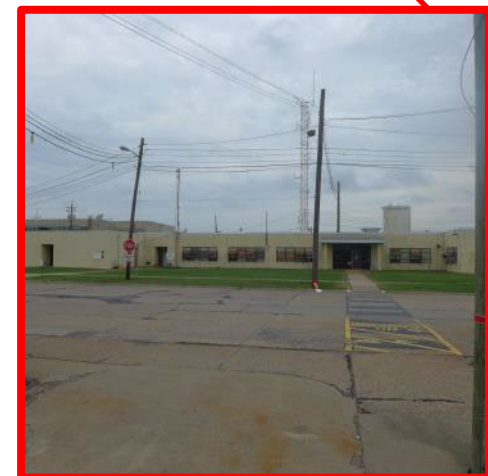
C-200 Photo: 8/2020

# Construction History

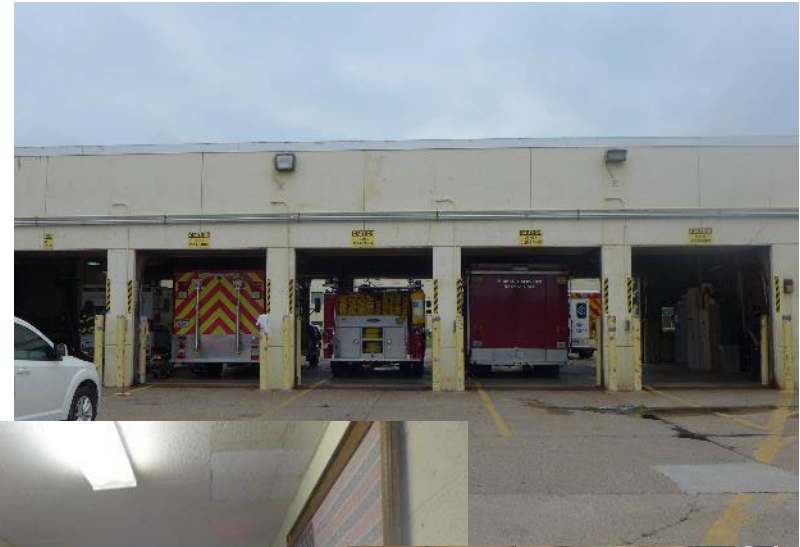
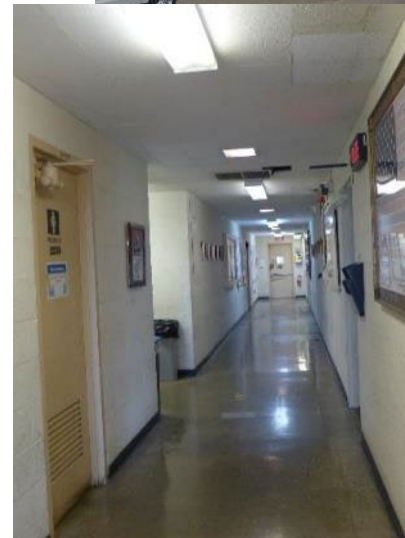
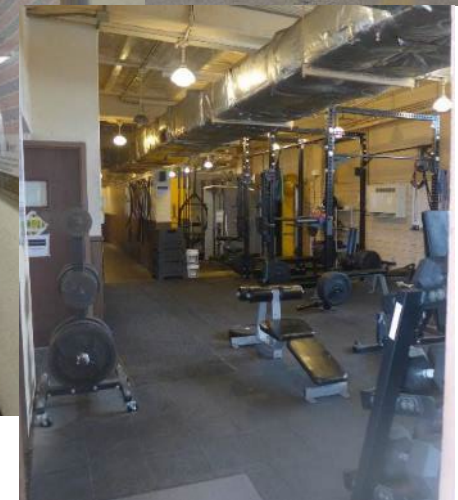
C-200 Photos: 8/2020

- C-200 has housed the facilities and equipment for security, guard, and fire protection personnel since initial construction.
- C-200 includes administrative offices, kitchen, breakroom, changing areas, training/workout area, storage and maintenance areas of emergency related equipment, garage bays for emergency vehicles, and historically, a Photo Lab/Dark Room.
- C-200 was a station point for the Federal Emergency Management Agency's National Area Warning System. Telephones along with other related equipment were located in the C-200 building.

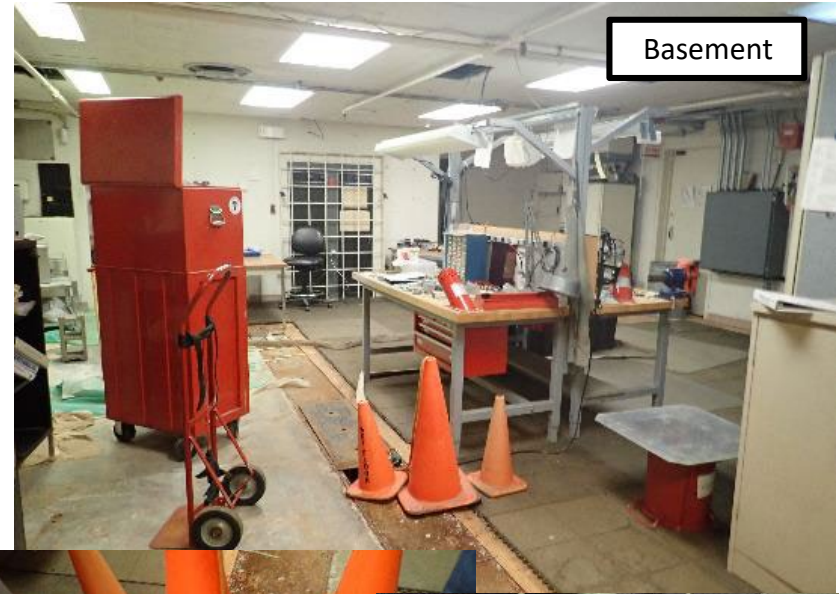
Basement

- The basement area has served as both a security office and central control room for emergency response.
- The facility contains a diesel fueled generator in the basement for emergency back-up power.
- USEC leased the facility in the early 1990s and continued use for its intended purpose until USEC ceased operations in 2014.
- The facility was transitioned from USEC to DOE in 2014.
- Continues to operate and serve as the Fire Headquarters.

- ❑ Currently houses the site fire services and associated equipment.
- ❑ The basement is currently not being used to occupy personnel due to flooding during heavy rains.

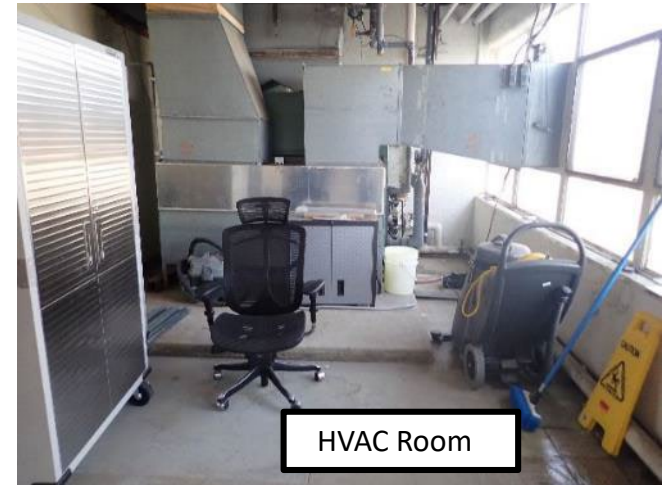
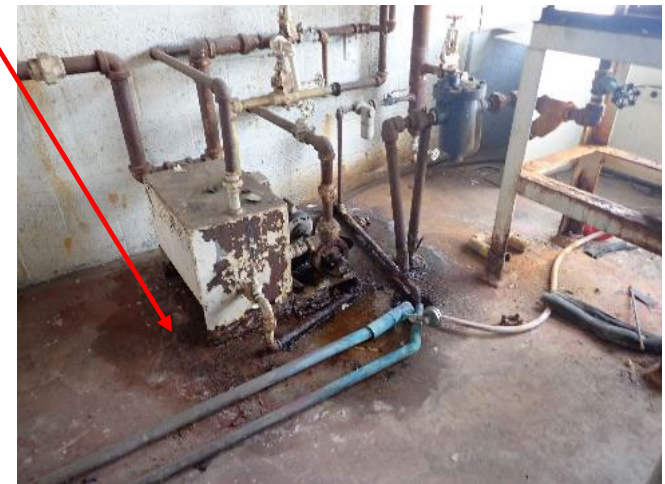
C-200 Facility Photos: 10/2020

- ❑ Floor drains are present on the first floor.
- ❑ Floor staining evident from past water leakage and drain overflow from the recirculating water system used to heat the facility in the winter.

- ❑ Radiological posting (contamination area) is present for a small sink drain.
- ❑ Small quantities of chemicals associated with fire services have been properly stored in accordance with chemical storage requirements. Lead from prior weapons maintenance use may be present but has not been confirmed.

- ❑ Floor drains and air vents will be delineated, isolated prior to demolition, and could have materials that contain heavy metals, but this is not confirmed.

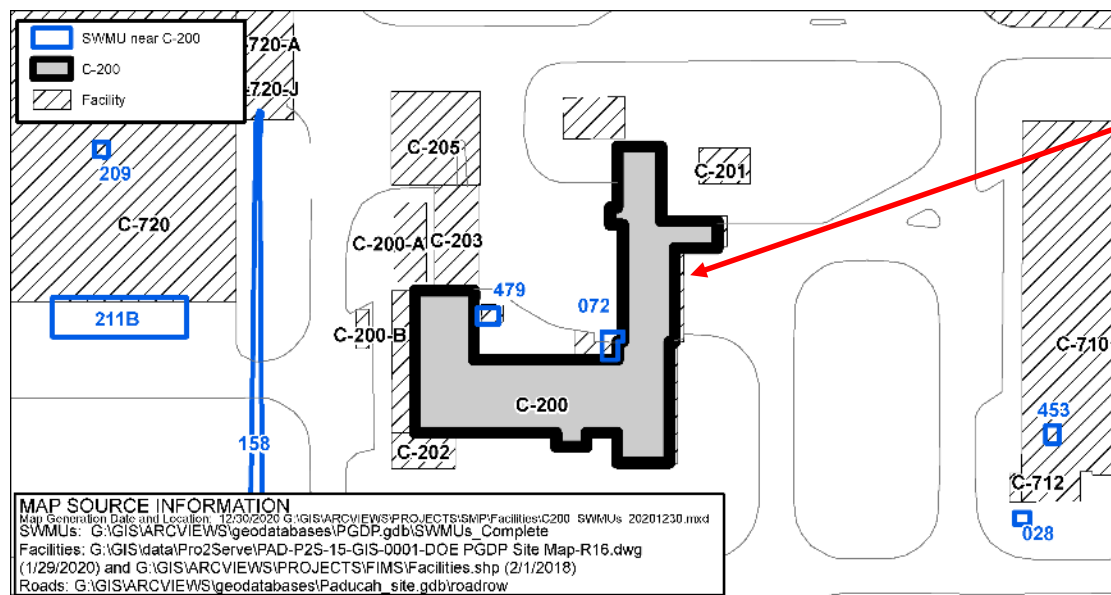
- The C-200 Guard and Fire Headquarters is not designated as a SWMU/AOC.

SWMU No.	Facility Name	Current Status	NFA Approval By
28	C-712 Laboratory Equalization Tank slab and underlying soils	Soils and Slabs OU	
72	C-200 Underground Gasoline Tanks	NFA	EPA HSWA Class 1 Permit Mod 3/17/1993; KDWM (UST C-200A; UST Branch) 11/23/1999
158	Chilled-Water System Leak Site	Soils OU	
209	C-720 Compressor Shop Pit Sump slab and underlying soils	Soils and Slabs OU	
211B	C-720 TCE Spill Site Southeast	GWOU/ Soils and Slabs OU	
453	S-710-46	NFA	KDWM 9/11/2003
479	C-204 Disintegrator Building	NFA	KDWM 6/3/2002

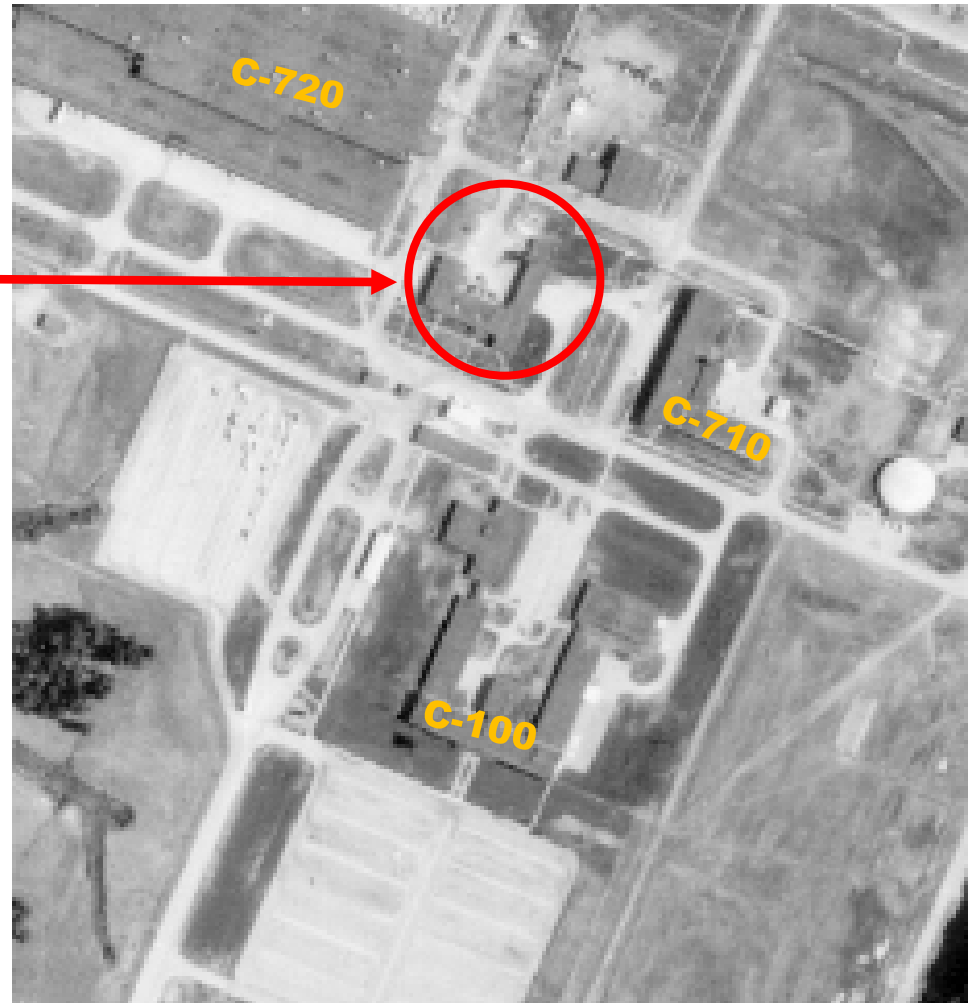
# C-200 Aerial Photograph

Modified from Aerial Photo: July, 1971 (ADZ-4LL-53)
