## C-300 Central Control Building

Facility Overview Briefing

November 9, 2021

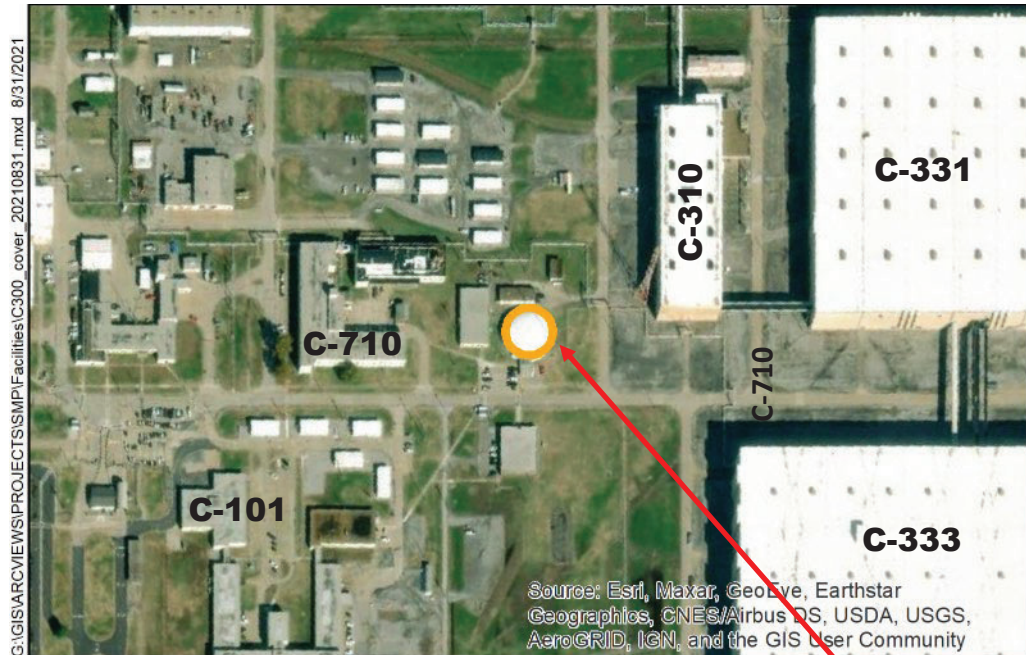
C-300 Building Photo: 9/2021

- C-300 is located within the Paducah Site security fence, west of the C-310 Purge and Product Building and east of the C-710 Technical Services Building.
- The facility was constructed in 1953 as a low, circular, reinforced-concrete structure with a dome-shaped roof with south, east, and west door entrances.
- It consists of a main ground level floor with an elliptical one-story wing on the south façade, and a basement level with a poured slab with estimated slab thickness of ~ 8 inches.
- The facility has a diameter of ~100 ft with a total area of approximately 16,022 ft<sup>2</sup> for both the main level and basement.

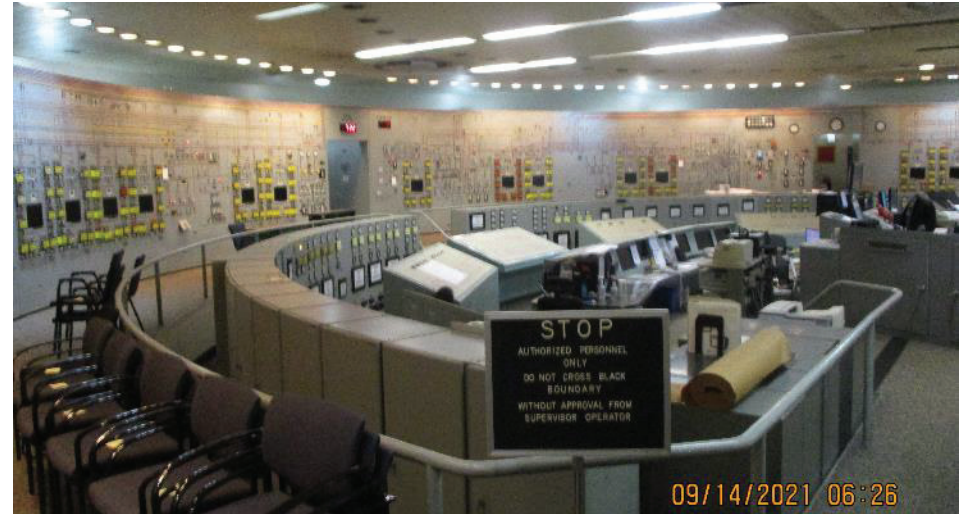
- The main ground level floor houses the various administrative areas (e.g., offices, break rooms, bath rooms) and main instrumentation panels and controls to support plant monitoring and oversight.

Central Control Room on Main Ground Level Floor

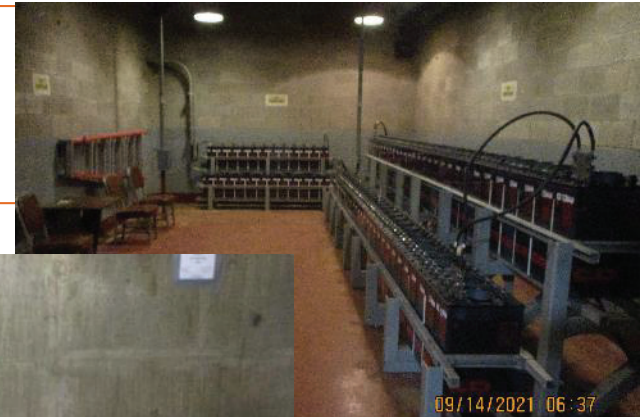
- ❑ Lead-acid battery bank in the basement for emergency back-up power.
  - ❑ The bathrooms and kitchen gravity drain to the sanitary sewer system.
  - ❑ The basement has floor drains and sump pits that collect condensate overflow, footer water, and floor drain water which is discharged to the plant storm sewer via sump pumps.

- ❑ The only known chemical spills or releases that were identified include a leaking acid battery in 2019 which was immediately addressed and condensation/leaks from the chilled water associated with the HVAC system in the basement.

Lead-acid battery bank in basement for emergency back-up power (right)

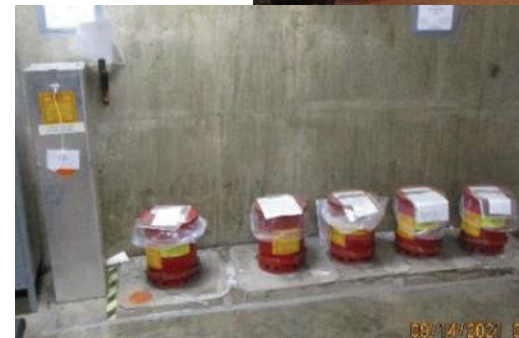
- ❑ Satellite accumulation areas (SAA) for collection and disposal of fluorescent light bulbs, batteries, aerosol cans, and fuses.
  - ❑ No chemicals are being stored except for normal janitorial supplies (e.g., cleaning products, wasp spray) stored in small quantities and in accordance with regulatory requirements and site procedures.

SAA for fluorescent light bulb and batteries (left)

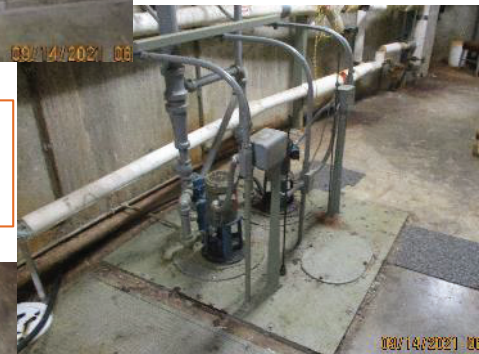
Sump pump/pit in the basement floor of the mechanical room (right)

- ❑ Deactivation will include removal of any accessible loose items being stored (to the extent practicable) prior to demolition.
  - ❑ Any floor drains will be delineated, documented, and isolated prior to demolition.

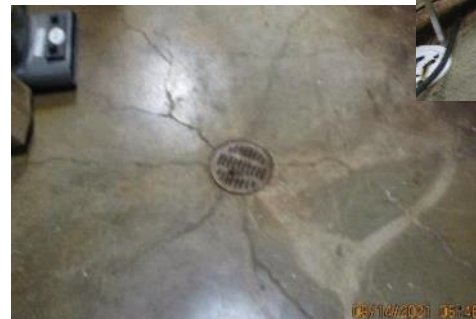
Floor drain (left)
