# C-303 Supervisory Control and Data Acquisition System

Facility Overview Briefing

March 4, 2021

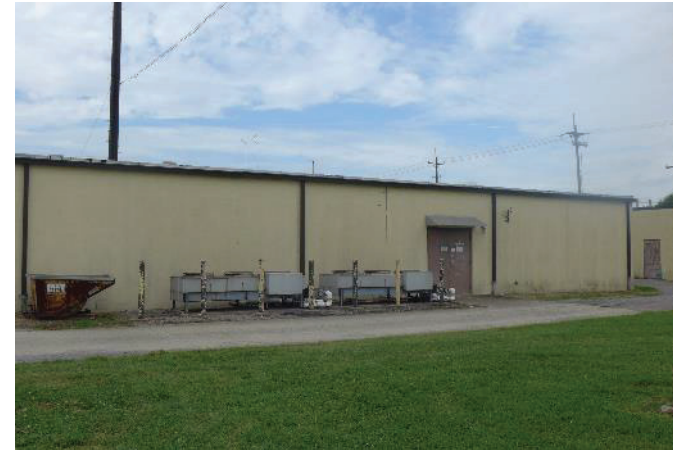
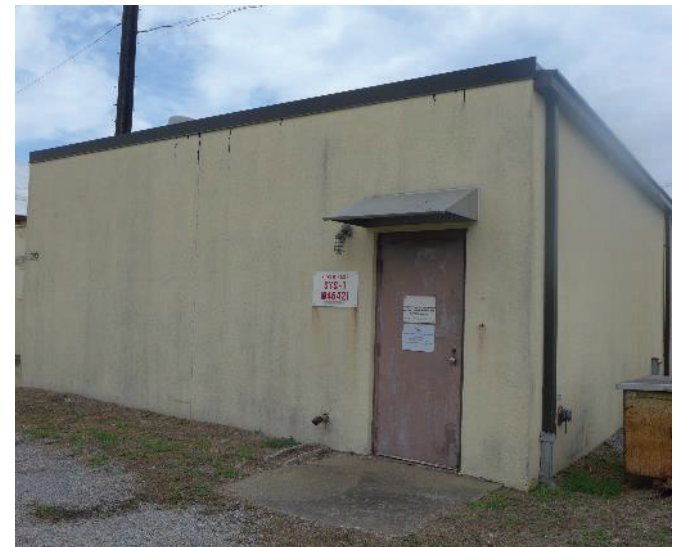
C-303 Facility Photos: 8/2020

- C-303 has been operated since its initial construction, in conjunction with the C-300, C-302, and C-320 facilities to support the Paducah Site central operations and control function.
  - ❑ Eastern portion of the building houses data acquisition computers and has a halon fire extinguishing system.
  - ❑ Western portion of the building houses electrical switchgear and had a lead-acid batteries bank for backup power; it also has a fire sprinkler system.
- During USEC lease of the facility in the early 1990s, USEC continued to use the facility to support the Paducah Site central operations and control function until USEC ceased operations in 2014.
- C-303 was transitioned from USEC to DOE in 2014 and continues to be operated for its above mentioned purpose.

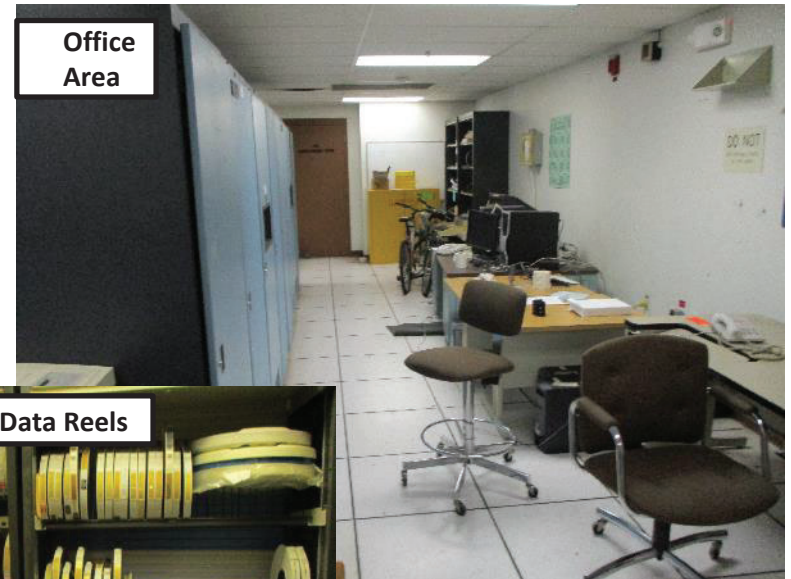
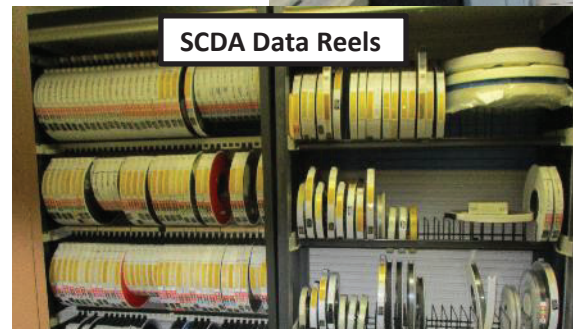
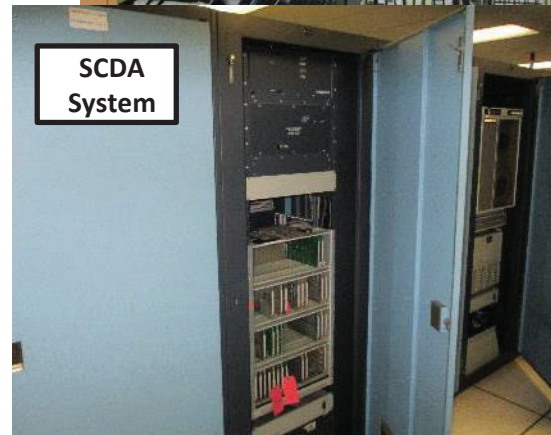
C-303 Photos: 10/2020

- C-303 is still operational and currently housing the ADT Fire Alarm System.
- Walkdown inspection conducted in October 2020 and employee interviews confirmed no unusual conditions.
  - ❑ Various equipment and data reels associated with the Supervisory Control and Data Acquisition (SCDA) computers.
  - ❑ No floor sumps or basements.
  - ❑ No known chemical spills.
  - ❑ The 125-V DC Battery Bank is shutdown and the lead batteries have been removed.
  - ❑ Flammable storage cabinet with small quantities of chemical products managed in accordance with applicable requirements.

- ❑ Deactivation will include removal of any accessible loose items being stored, to the extent practicable, prior to demolition.
- Pending ceasing of operation, deactivation, and availability of funding, proceeding with demolition and disposal of C-303 (aboveground structure) outside of the FFA/CERCLA process, contingent upon the fact that no additional changes have occurred that would affect the CERCLA determination of the facility prior to demolition, is recommended.

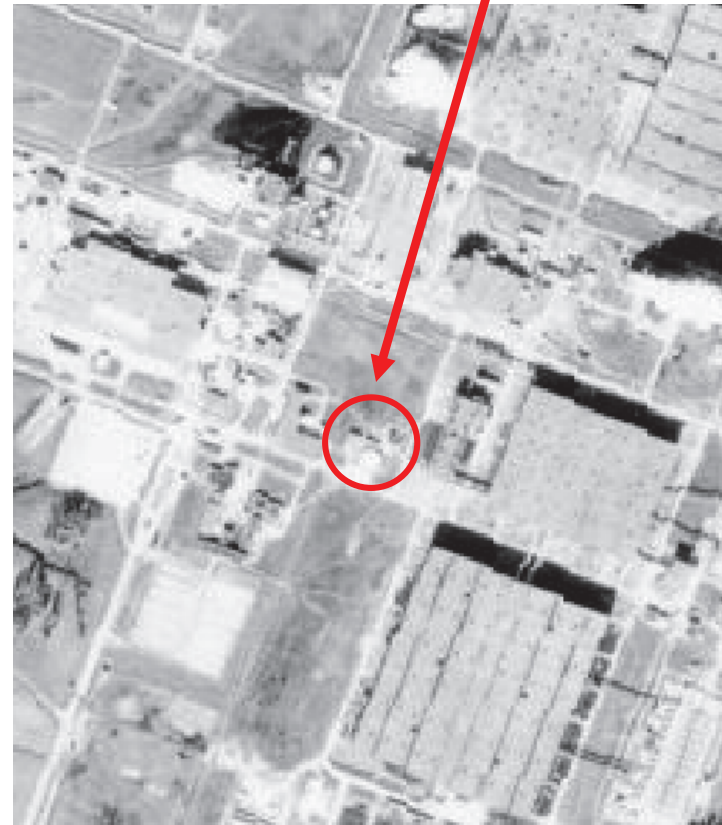
Modified from Aerial Photo: 1983

**C-303 is present in  
1983 Photo**
