# C-601 Nitrogen Generator Building Addition

Facility Overview Briefing

March 24, 2021

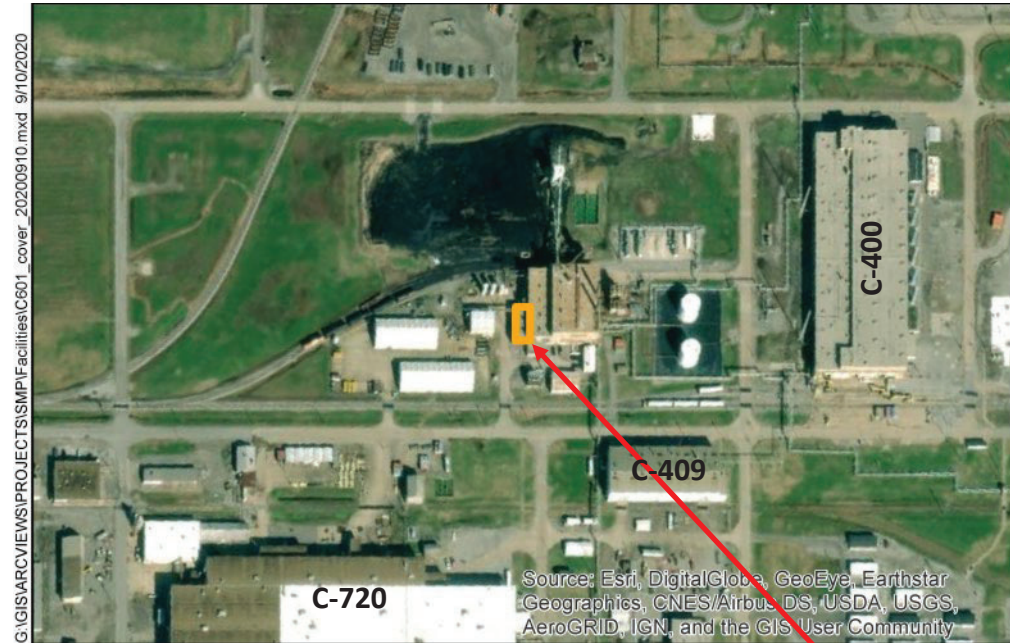
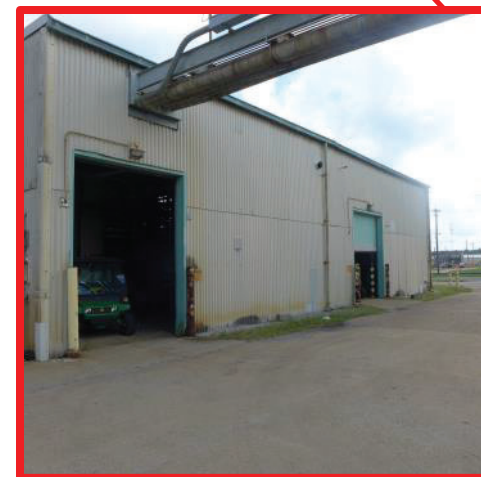
C-601 Facility Photo: 8/2020

- C-601 is located within the Paducah Site security fence, west of C-600.
- Construction began in 1959 (Section 1) and was finished in 1960 (Section 2).
- Construction consists of two joined sections (Sections 1 and 2) of structural steel and corrugated cement asbestos (transite) siding on a concrete foundation.
- Section 1 (1959) of the facility is approximately 1,248 ft<sup>2</sup>.
  - ❑ Measuring ~ 32ft x ~39 ft.
- Section 2 (1960) of the facility is approximately 1,120 ft<sup>2</sup>.
  - ❑ Measuring ~ 32ft x ~35 ft.

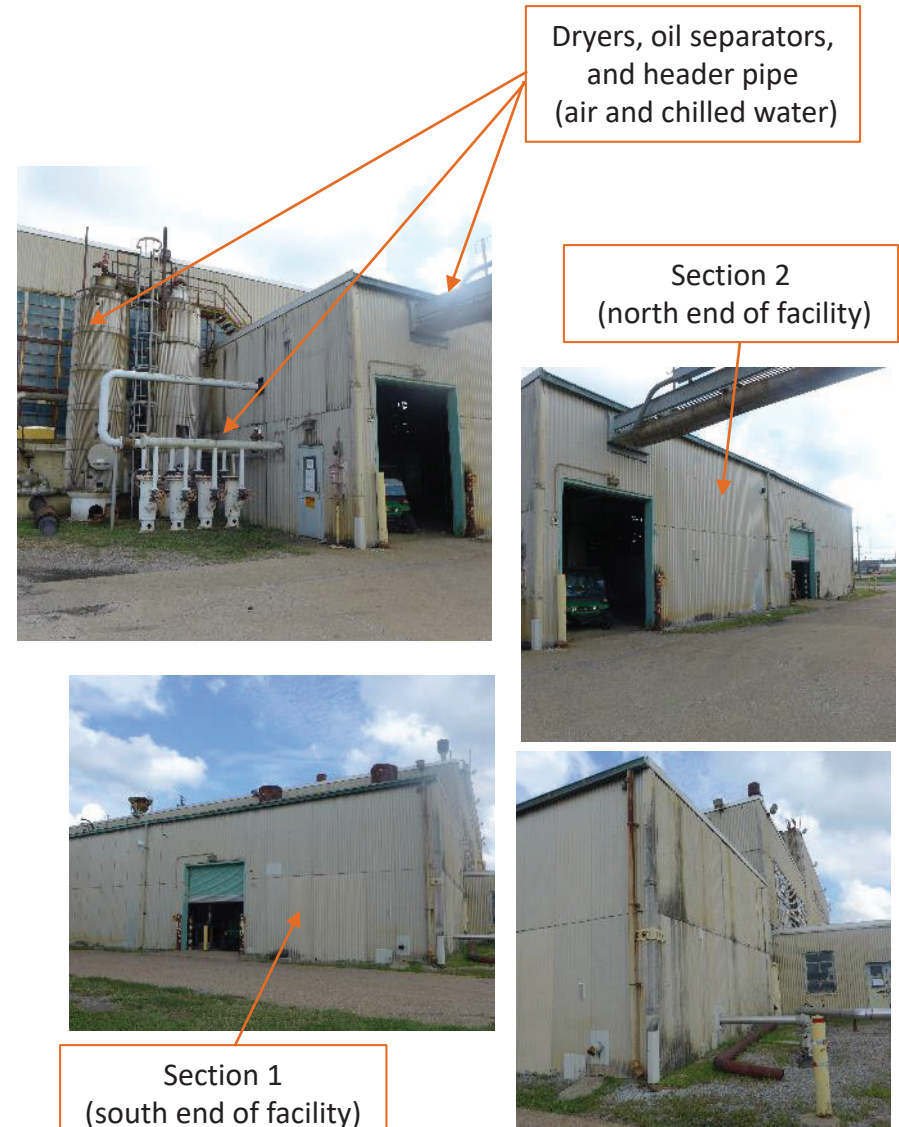
C-601 Facility Photos: 8/2020

- C-601 operated as a support facility to supply liquid and gaseous nitrogen to the Paducah Site from 1960 to approximately 2007.
  - ❑ C-601 liquid nitrogen equipment consisted of a 5-stage compressor, sieve beds, a separation column, storage facilities, piping, and a cooling vessel.

- USEC leased the facility in the early 1990s and continued to use C-601 to supply liquid and gaseous nitrogen until approximately 2007 when the system was removed and lines were cut and capped.

- In 2007, USEC upgraded the plant air system and installed a Centac® air compressor and Lectrodryer® system in C-601.
  - ❑ The Centac® air compressor and Lectrodryer® system tied into existing plant air receivers located in C-601.

- C-601 transitioned from USEC to DOE in 2014 and continued to support the plant air system until approximately 2016 when the Centac® air compressor and Lectrodryer® system were taken out-of-service.

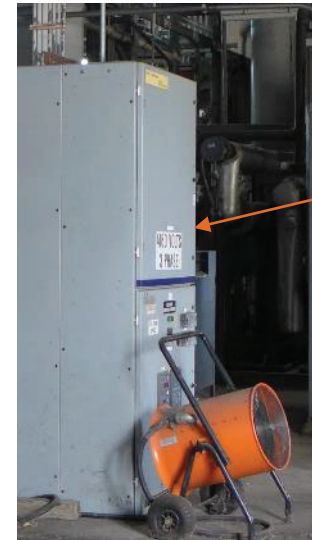
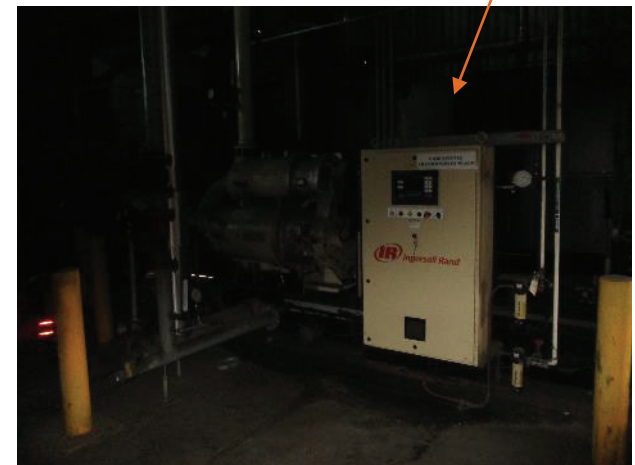
C-601 Facility Photos: 8/2020

- Walkdown inspection conducted in October 2020 and employee interviews confirmed no unusual conditions.
  - ❑ No floor sumps; however, floor drains are present.
  - ❑ Not used for radiological storage; facility does not contain any radiological postings.
  - ❑ Lubricants for compressors are properly stored in the facility.
    - 60 gal of oil remains in the Centac® air compressor
    - One 55-gal drum of Shell BG oil
    - One 55-gal drum of Conoco Synco R&O Oil (Centac® oil)
  - ❑ GSA (floor sweep) and SAA (light bulbs).
  - ❑ Minor oil leaks from compressors that were immediately addressed; no known chemical spills.
  - ❑ A 24-inch plant water line runs underneath the facility.

Electrical Switch Gear

Centac® Air Compressor

- ❑ Deactivation will include removal of any accessible loose items being stored (to the extent practicable) prior to demolition.
  - ❑ Floor drains will be delineated and isolated prior to demolition.

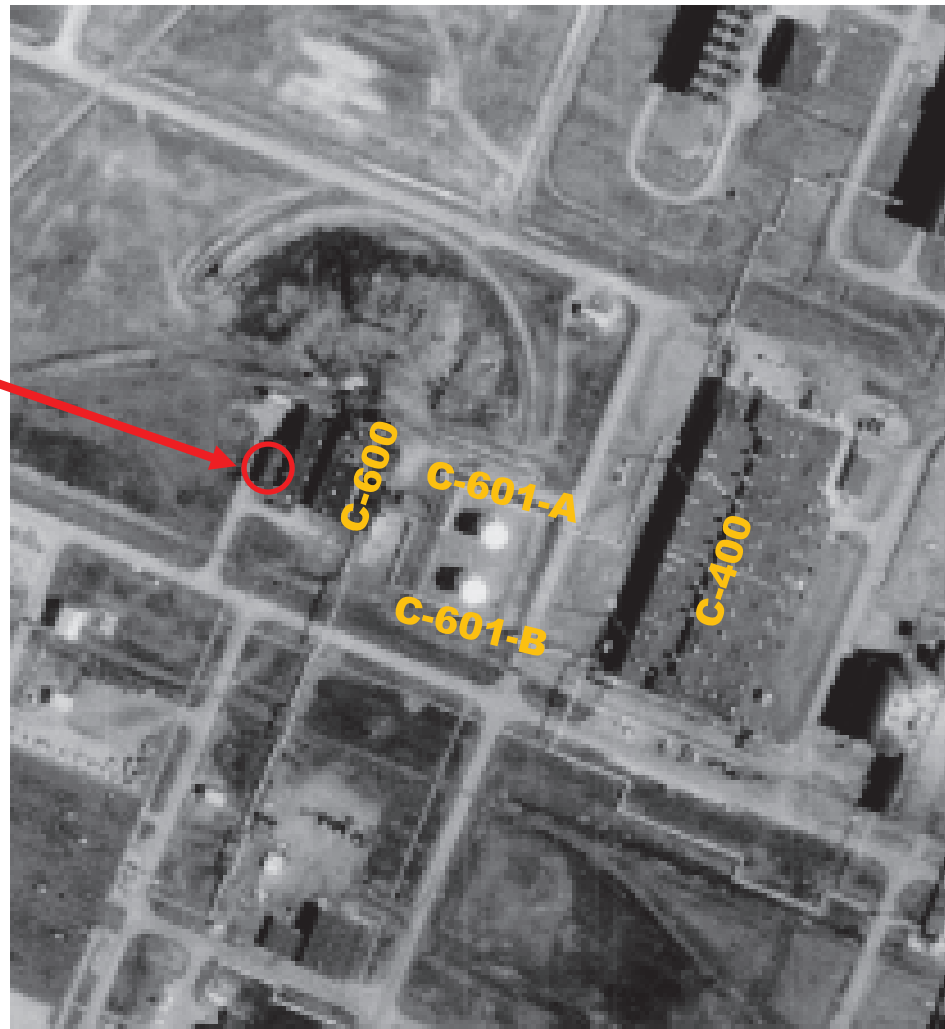
**C-601**

Modified from Aerial Photo: July 3, 1971 (ADZ-4LL-52)
