C-607 Emergency Air Compressor Generator Build (Building)

Facility Overview Briefing

March 24, 2021

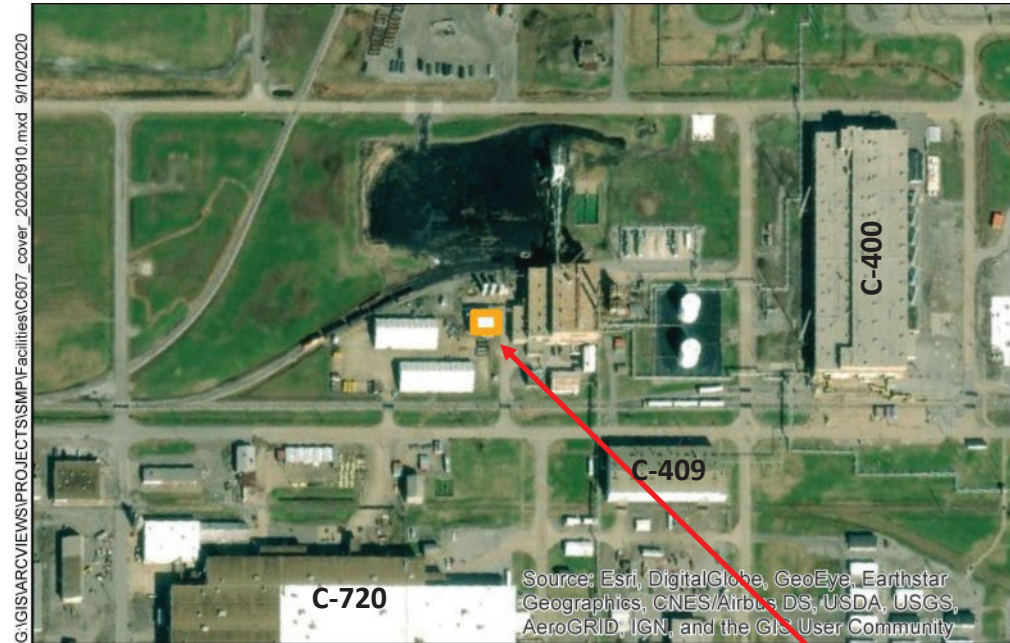
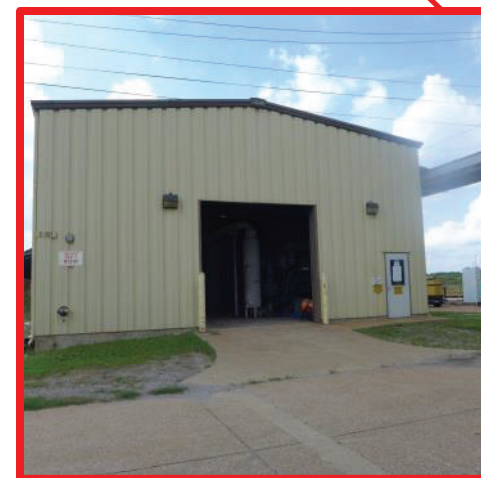
C-607 Facility Photo: 7/2020

- C-607 is located within the Paducah Site security fence, west of C-600.
- The facility was constructed in 1985.
- The facility is constructed of prefabricated metal with a cement wall panel (transite) on a concrete foundation.
- The facility is approximately 2,000 ft².
 - ❑ Measuring ~40 ft x ~50 ft.

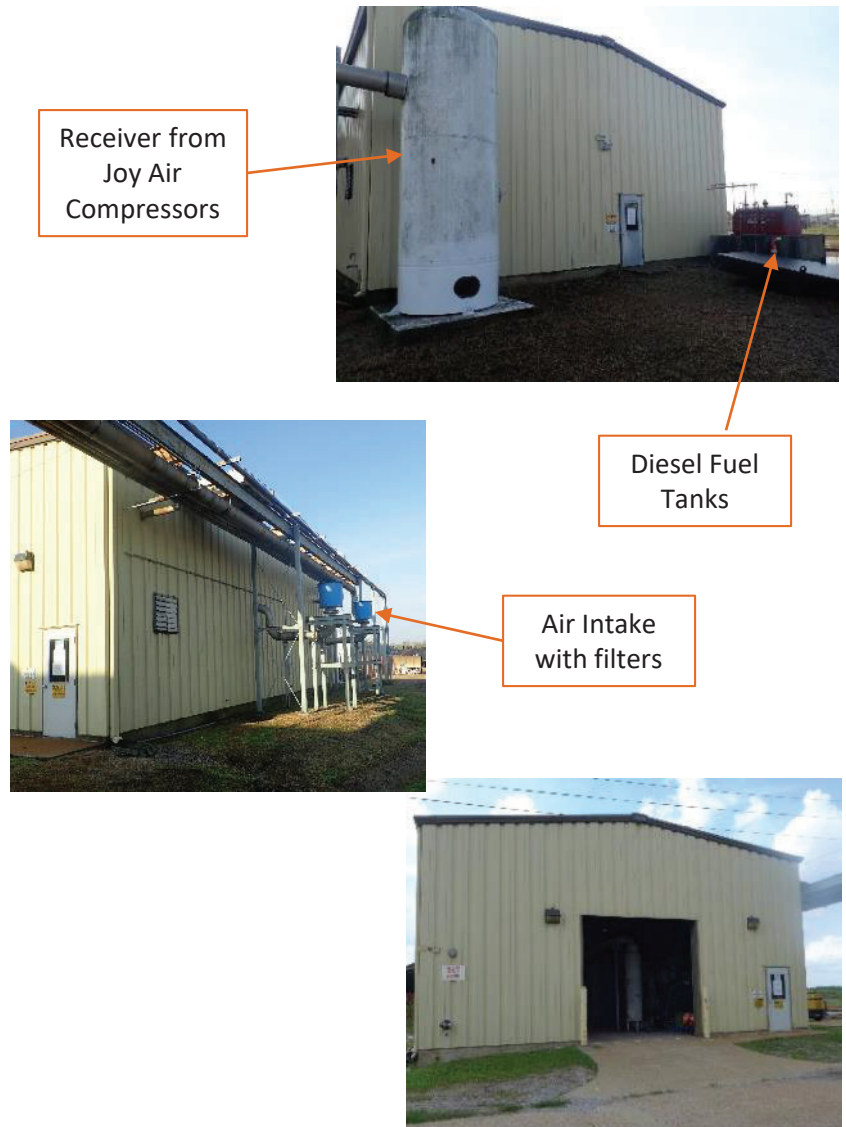
- USEC leased the facility in the early 1990s and continued to use C-607 as a backup support facility to supply plant air to process instrumentation and expanded the sodium thiosulfate system in C-607 to also provide treatment at K008.

- C-607 transitioned from USEC to DOE in 2014 and continued to operate as a backup support facility that supplied plant air for process instrumentation until the system was placed in shutdown in 2016 and power to the system was disconnected.

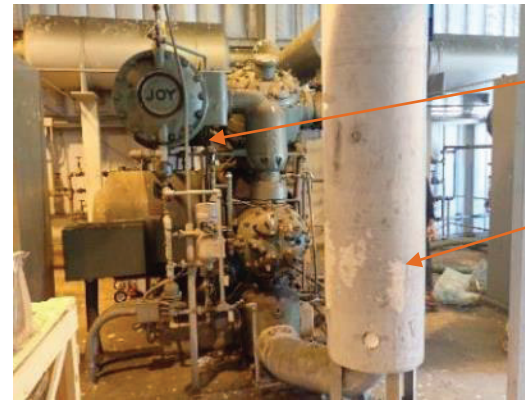
Joy Air Compressor with Discharge Vessel

- ❑ C-607 plant air equipment consisted of two Joy air compressors, a diesel driven generator, air intake and air discharge vessels, electrical transformer, cooling system, and piping.

- ❑ No floor sumps; however, floor drains are present.
 - ❑ Not used for radiological storage; facility does not contain any radiological postings.
 - ❑ Compressors still contain oil.

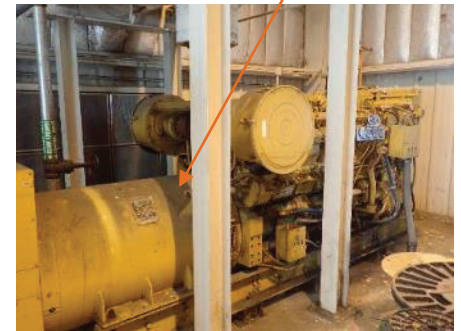
Diesel Generator

- ❑ Generator has been drained.
 - ❑ Diesel tanks located inside and outside have been drained.
 - ❑ No Generator Staging Area (GSA) or Satellite Accumulation Area (SAA).

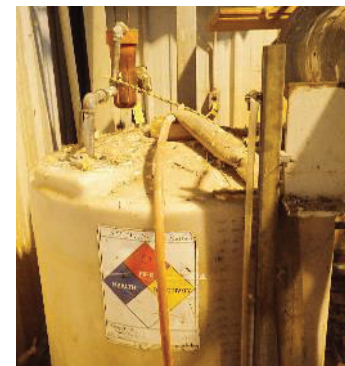
Sodium Thiosulfate unit

- ❑ Compressors were capable of running on either normal or emergency generated power.
 - ❑ C-607 also contained a sodium thiosulfate system to dechlorinate the cooling water used to cool the compressors prior to discharge.

- The use of the sodium thiosulfate system in C-607 for treatment at K008 was discontinued in approximately 2017 when it was determined that the treatment provided at C-615 was sufficient.
- C-607 contains a variety of equipment that served as backup support for supplied air; all of which have been taken out-of-service.
 - ❑ Joy air compressors with discharge vessels (2)
 - ❑ Diesel driven generator
 - ❑ Diesel tanks (inside and outside) (2)
 - ❑ Sodium thiosulfate unit
 - ❑ Cooling system
 - ❑ Motor control center
 - ❑ High voltage panels and switchgear
 - ❑ Equipment panels
- C-607 is currently used as a temporary storage facility for miscellaneous equipment and parts from the Stores Warehouse that support C-615 activities.

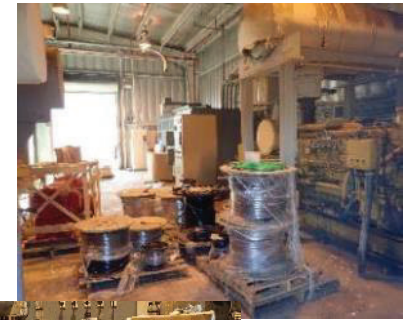
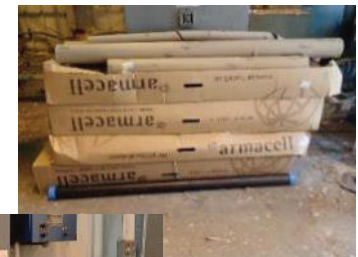
C-607 Facility Photos: 10/2020

- C-607 is used as a temporary storage facility for miscellaneous equipment and parts from the Stores Warehouse that support C-615 activities.
- Walkdown inspection conducted in October 2020 and employee interviews confirmed no unusual conditions.

- ❑ Battery charging station has been disconnected.
 - ❑ Minor oil leaks contained within the building from compressors that were immediately addressed; minor historical diesel spill associated with filling inside diesel tank that was immediately addressed.

- ❑ Cement wall panel and other asbestos containing materials.

- ❑ Deactivation will include removal of any accessible loose items (including the lead acid batteries) being stored (to the extent practicable) prior to demolition.

- ❑ Floor drains will be delineated and isolated prior to demolition.
- Pending ceasing of operation, deactivation, and availability of funding, proceeding with demolition and disposal of the C-607 facility (aboveground structure) outside of the FFA/CERCLA process, contingent upon the fact that no additional changes have occurred that would affect the CERCLA determination of the facility prior to demolition, is recommended.
