C-611-Q 36" Raw Water Line Booster Station

Facility Overview Briefing

March 22, 2021*

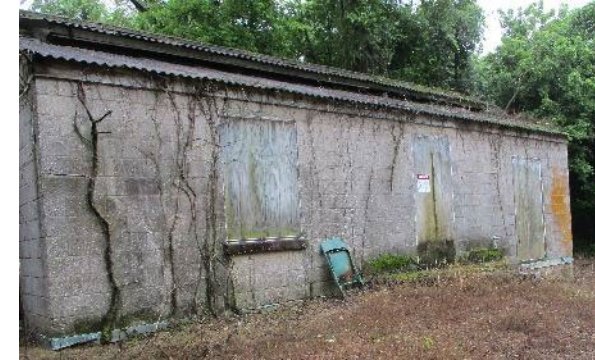
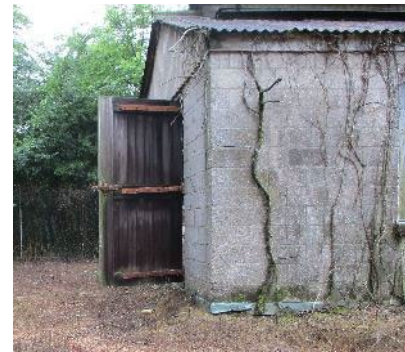
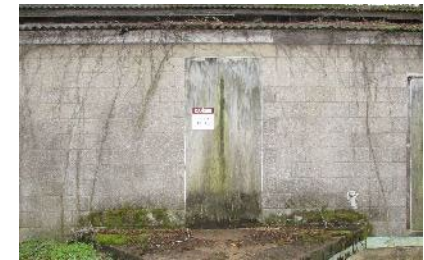
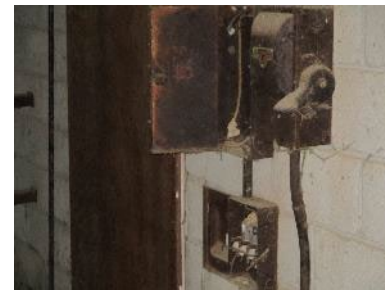
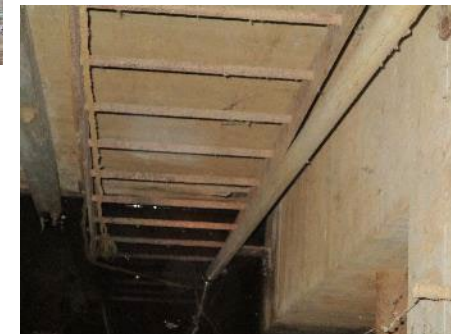
- C-611-Q is no longer operational nor is it used for a storage facility to support the Water Treatment Plant.
- Walkdown inspection conducted in December 2020 and employee interviews confirmed the following conditions.
 - Sump/basement area (~~measuring ~6 ft x 6 ft~~)* is typical of a water booster station.
 - Pump and sump pump have been removed.
 - Sump/basement area contains some water.
 - No floor drains.
 - No known chemical spills.
 - No radiological contamination.
 - Roofing material is transite and contains asbestos-containing materials.
 - Facility has been disconnected from power.
 - No Generator Staging Area (GSA) or Satellite Accumulation Area (SAA).

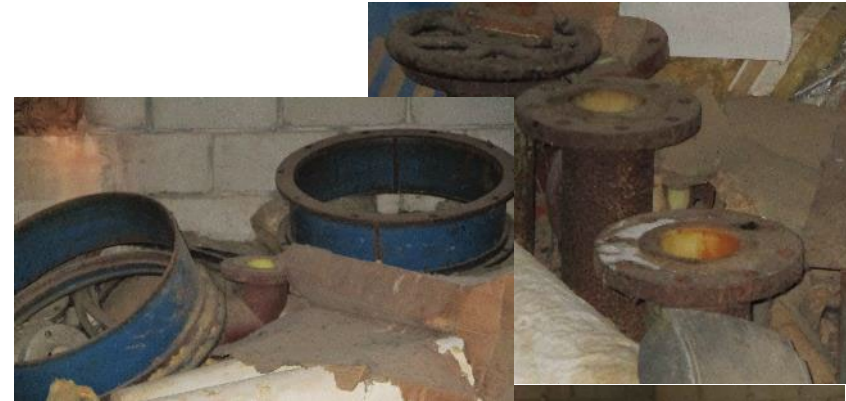
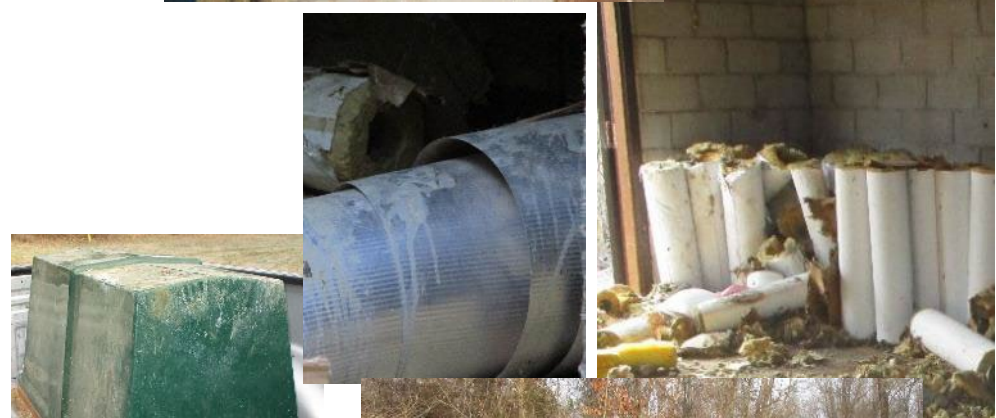
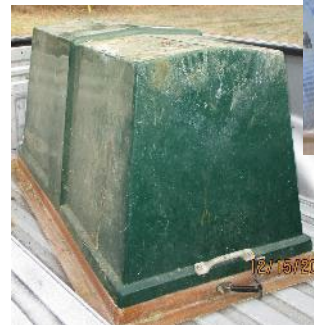
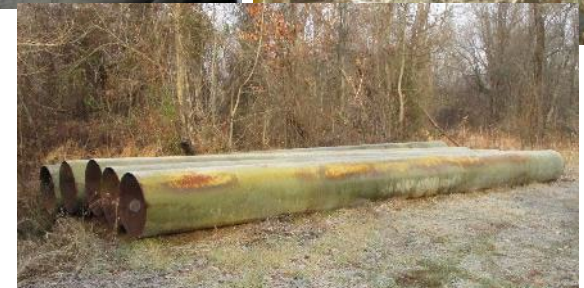
C-611-Q Facility Photos: 7/2020 and 12/2020

Vent Pipe

Pump Pad Area

Basement/Sump Area
