C-611-Q 36" Raw Water Line Booster Station

Facility Overview Briefing

March 24, 2021

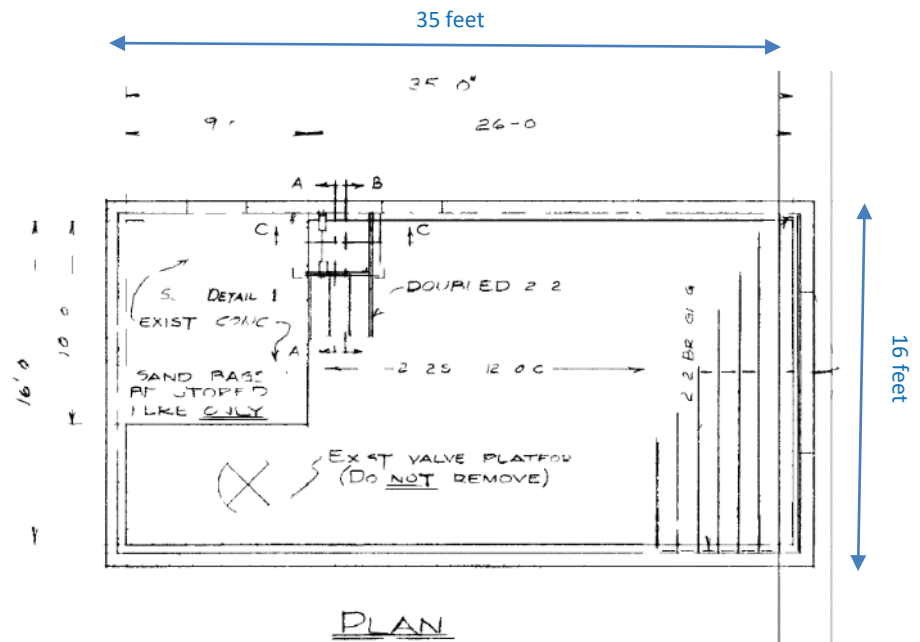
Floor Plan View: Excerpt from Engineering Drawing C-PA-P4113, dated 1954

- C-611-Q is located outside the Paducah Site security fence and the Property Protection Area, near the intersection of Old Ogden Landing Road and the Landfill Access Road. It is north of C-335 and east of C-616-E.
- A construction update to the C-611-Q facility occurred in 1955.
 - ❑ C-611-Q was part of a sizable upgrade to the Water Treatment Plant and No. 1 Raw Water line that was originally constructed for the Kentucky Ordinance Water Works (KOW) in 1942.
- The facility is constructed of unit masonry with a small basement/sump area measuring approximately 6 ft x 6 ft x 10 ft.
 - ❑ Approximately 80% of the facility contains a wooden floor with a small concrete pad measuring ~ 6 ft x 8 ft on north west corner.
- The facility is approximately 560 ft².
 - ❑ Measuring ~16 ft x ~35 ft.

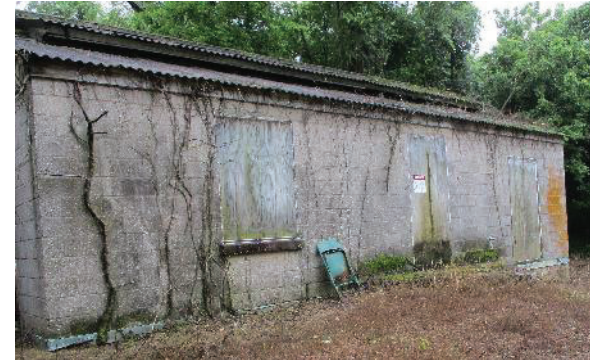
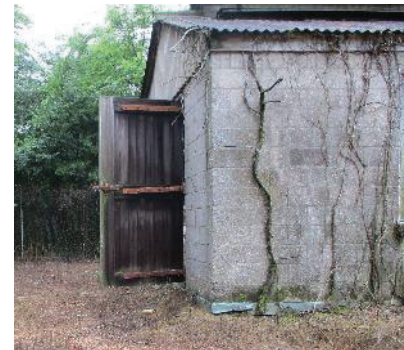
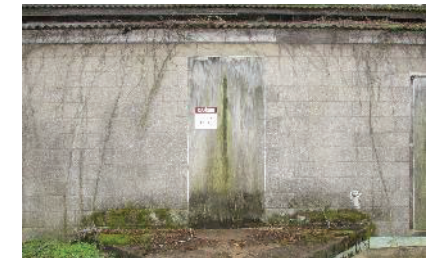
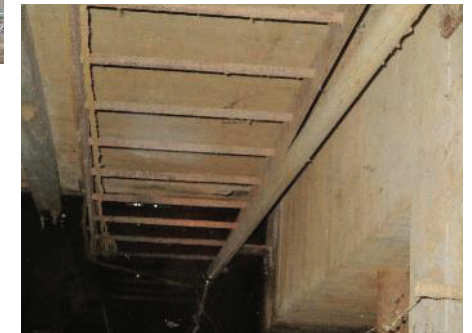
C-611-Q Facility Photos: 7/2020 and 12/2020

- C-611-Q transitioned from USEC to DOE in 2014.
- In December 2020, DOE determined that C-611-Q was no longer required for storage.
- Miscellaneous items were removed from the facility and properly disposed of or targeted for re-use or transfer to Paducah Area Community Reuse Organization (PACRO); no RCRA items were discovered.
 - ❑ Pipe insulation
 - ❑ Flanges
 - ❑ Pipe and pipe spools
 - ❑ Metal flashing
 - ❑ Fiberglass covers
 - ❑ Large steel piping
- The facility has been locked and posted with signage restricting entry.

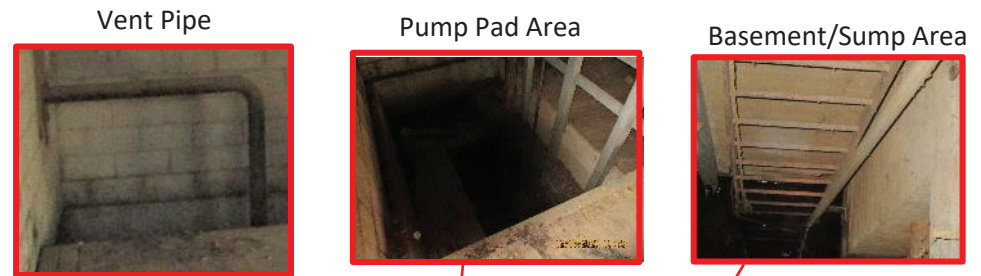
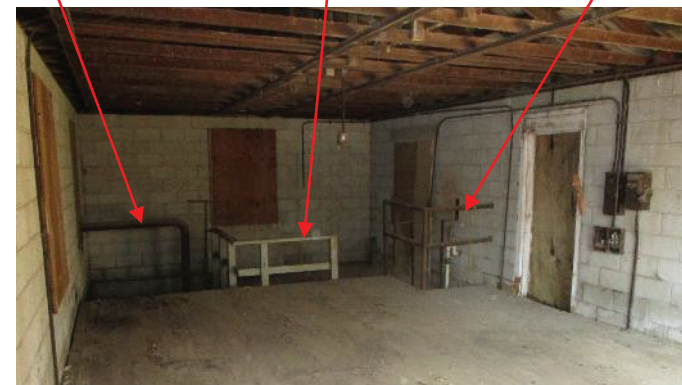
West Side View

- C-611-Q is no longer operational nor is it used for a storage facility to support the Water Treatment Plant.
- Walkdown inspection conducted in December 2020 and employee interviews confirmed the following conditions.
 - Sump/basement area (measuring ~6 ft x 6 ft) is typical of a water booster station.
 - Pump and sump pump have been removed.
 - Sump/basement area contains some water.
 - No floor drains.
 - No known chemical spills.
 - No radiological contamination.
 - Roofing material is transite and contains asbestos-containing materials.
 - Facility has been disconnected from power.
 - No Generator Staging Area (GSA) or Satellite Accumulation Area (SAA).
