C-615-H Sewage Lift Station

Facility Overview Briefing October 19, 2021

Reflects consultation with EPA and Kentucky in accordance with the Site Management Plan that occurred on October 18, 2021.

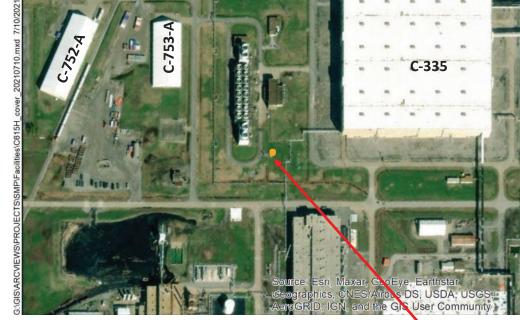
C-615-H Facility Photo: 7/2021

- C-615-H is located within the Paducah Site security fence, southwest of the C-335 process building.
- ➤ The facility was constructed in 1954.
- ➤ The facility is a single-story concrete block building with a vented hatched roof.
 - ☐ The facility contains a subsurface wet well that is constructed of a 72-inch diameter reinforced concrete pipe that is approximately 21.6 ft deep.
 - The wet well houses the subsurface portion of the facility's two pumps.
 - Access to the wet well is via a 16-inch x 24-inch manhole labeled as a confined space.
- > The facility is approximately 124 ft².
 - ☐ Measuring ~13 ft 4 inches x ~9 ft 4 inches

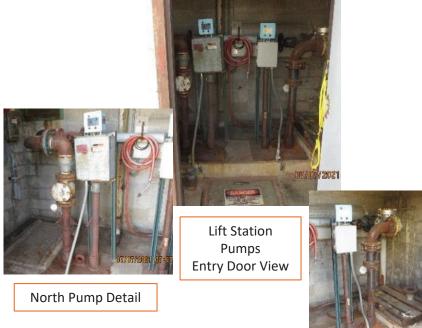
South Pump Detail

- ☐ The pumps located within C-615-H have undergone various upgrades and reconfiguration since the facility's original construction.
 - In 1966, the concrete pad and piping were reconfigured that allowed for upgrading the pumps, which included installation of suction pipes within the wet well.

- In 1993, the suction pipes located in the wet well were replaced with submersible pumps.
 - The submersible pumps require periodic replacement (on average about every two years).
