C-631 Pumphouse and Cooling Tower (Solid Waste Management Unit 86)

Facility Overview Briefing

January 24, 2023

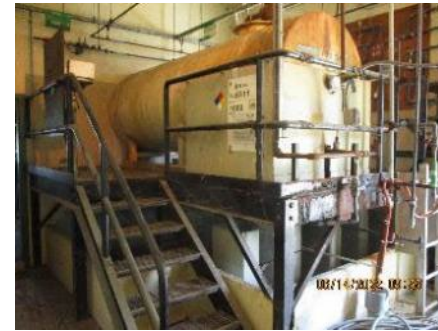
C-631-1 - North Wing
Calgon Room
(Corrosion Inhibitor
Feed Area)

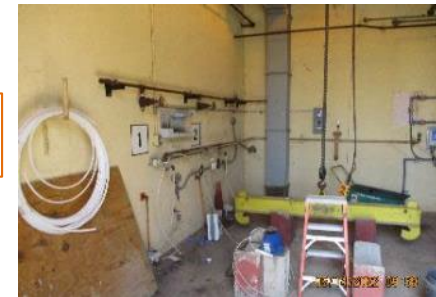
C-631-1 - North Wing
Chlorine Feed Header

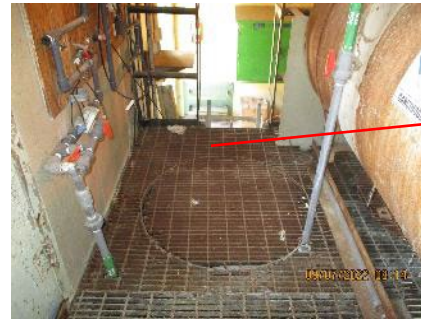
C-631-1 - North Wing Historical Location of 185-gal Tank

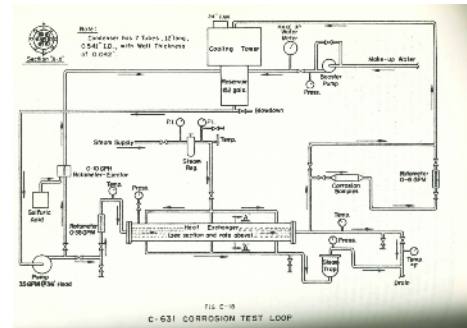
CORROSION TEST LOOP

- From 1960 – 1962 the Pilot Plant Corrosion Test Loop operated.
 - ❑ Test loop was a small scale system located within the center section of C-631-1
 - ❑ Designed to simulate conditions encountered in the actual process system.
 - ❑ Tested corrosion inhibitors prior to their introduction into the RCW plants. (Five inhibitors were tested.)
 - ❑ One floor drain that drained into the influent flume and/or sump.
 - ❑ Test loop has been removed and is no longer located in C-631-1. (Date removed unknown.)

Pilot Plant Corrosion Test Loop Diagram and Historical Photos Excerpt - Operations Division Training Manual – Utilities Operations, KYD-1482, July 1962

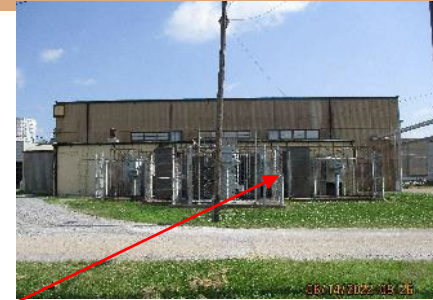
- Lean-to measures ~9 ft x ~11 ft x ~12 to 14 ft.
- In 1988, approximately 3–5 gal of transformer oil containing 22 ppm polychlorinated biphenyls (PCBs) leaked from a hose fitting on a transformer during maintenance operations (1988 ASER).

- ❑ All of the oil was contained on the concrete transformer pad.
 - ❑ The spill was cleaned up in accordance with PCB regulations.
- USEC leased the facility in the early 1990s and continued to use C-631-1 as a pump house until enrichment operations ceased at C-331/C-333 in 2013 and ancillary support required for C-620 and the HPFWS was no longer needed (2021).

C-631-1 - South Wing External Transformers

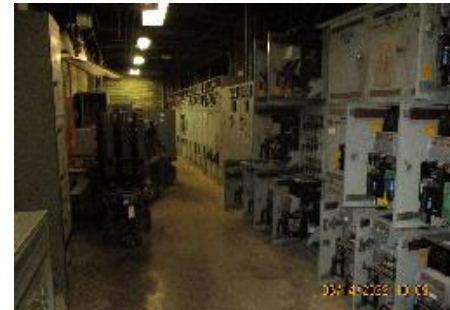
- In 2010, a chlorine leak was identified in some piping that enabled chlorine gas to travel in the conduits that lead back into the switchgear.
 - ❑ Breakers, terminals, and bus work were corroded.

C-631-1 - South Wing
Interior Switchgear Room

- ❑ Leak was repaired; switchgear was cleaned and repaired/replaced as needed.
- In 2013, C-631-1 was shutdown from an enrichment support standpoint; however, one RCW pump (RCW Pump #6) remained operational and continued to recirculate water in support of C-620 and the HPFWS until 2021.

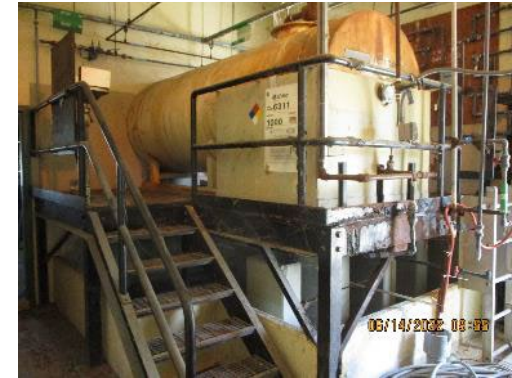
- ❑ Waste was associated with the chemical tanks that contained corrosion inhibitors (including sulfuric acid).
 - ❑ Waste included crusty residues, sludges, liquids or a combination thereof.

C-631-1 North Wing
Diked Area Beneath Corrosion Inhibitor Tanks

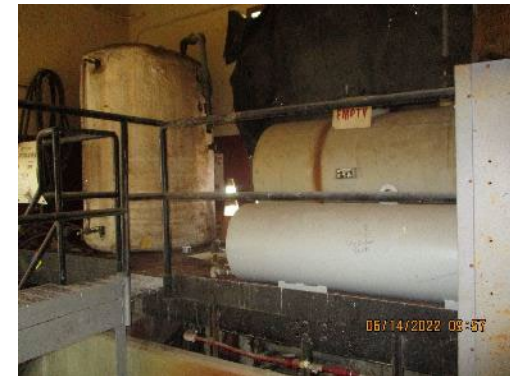
- In 2022, the RCW supply and return lines to the synchronous condensers in the C-531-1 switchyard were drained and air-gapped.
- As of 2022, sulfuric acid pigs and tanks are still present; marked as empty with valves in the open position.

C-631-1 North Wing
Sulfuric Acid Pig and Tanks

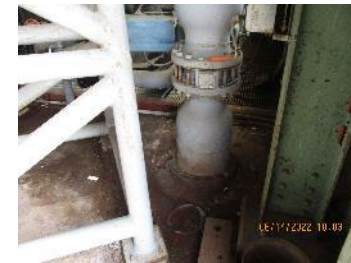
- Minor oil staining around several of the RCW and HPFWS pumps.
- Chromated water leaks have occurred within the center structure of the facility.
- Oil spill in February 2017 associated with #5 HPFWS pump (see slide 14).

C-631-1 - Center Structure Pump Relief Surge Entry to Wet Well

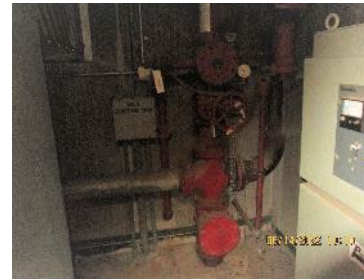
C-631-1 - South Wing
Transformer Sprinkler System

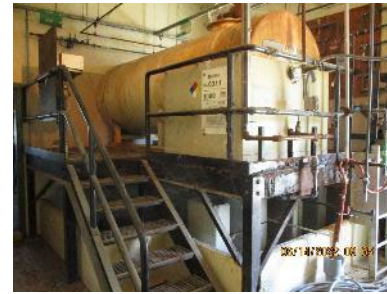
- Calgon room housed tanks of corrosion inhibitors including the 185 –gal tank for high chromate treatment for C-631-3; area within the dike contained solid waste exceeding TCLP limits for chromium, mercury, and lead that have been removed.

C-631-1 - North Wing
Calgon Area

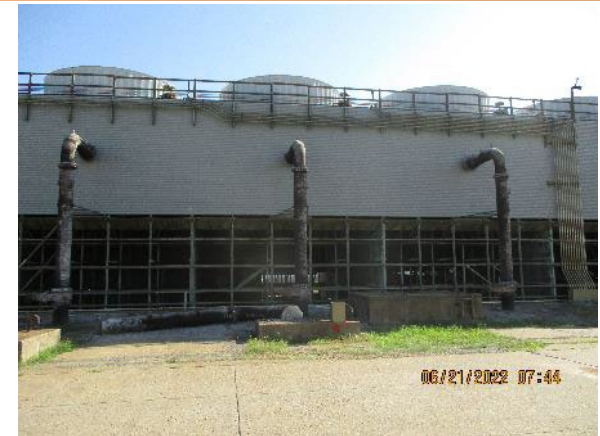
- Brown rot fungi growth quickly became a problem for the cooling towers.
 - ❑ In 1958, a program was initiated to combat fungus deterioration.
 - ❑ Replaced infected wood with new pressure treated redwood.
 - Cooling tower structural members, fill, mist eliminators, outer wall, cell partitions, and deck were originally constructed of California redwood.
 - ❑ Treated remaining wood with fungicide solutions (most susceptible areas only).
 - ❑ All cell plenum chambers, tower deck, outer sidewalls, and tower tops were treated periodically with one of two types of fungicide solutions:
 - Sodium pentachlorophenate.
 - Double diffusion method – first spraying with a solution of zinc sulphate and arsenic acid followed by a second spraying with a solution of sodium bichromate.
 - ❑ Fungicide treatment was discontinued in 1987.

C-631-2 Cooling Tower – South Side

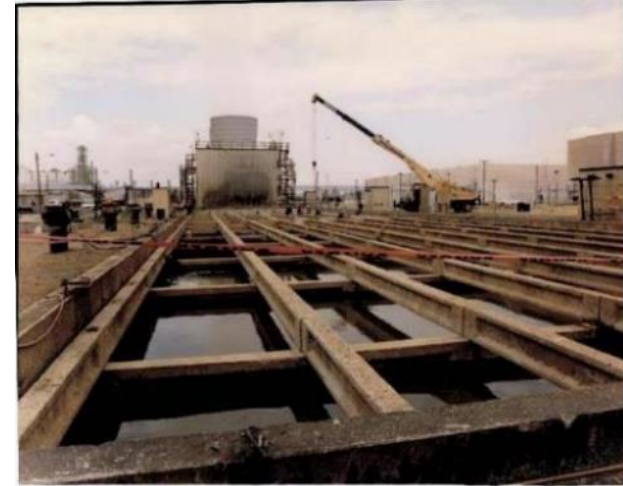
- In 1993-1994, the main cooling tower was replaced down to the basin.
 - ❑ The overall footprint of the cooling tower was adjusted and the height and length of the new cooling tower was reduced.
 - Height reduced from approximately 40 ft to approximately 32 ft.
 - Length reduced from approximately 240 ft to approximately 180 ft.
 - Modified from 8 to 6 pairs of back-to-back cooling tower cells; total of 12 rather than 16 cooling tower cells.
 - Modified from 8 risers to 6 risers.
 - ❑ Downsized because the cooling tower load designed for in the 1950s was not required for C-331 and the new tower design was more efficient.

Historical photo of main cooling tower replacement project
(Photo of C-631 Main Cooling Tower)

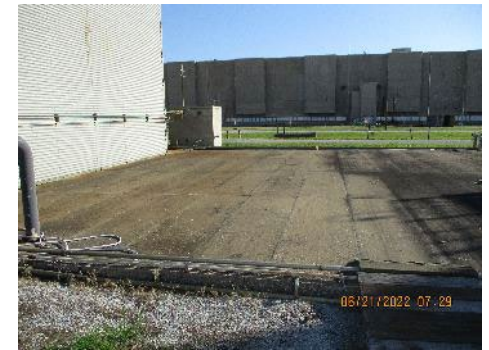
C-631-2 Cooling Tower – East Side
(Area Where Cells Formerly Existed)

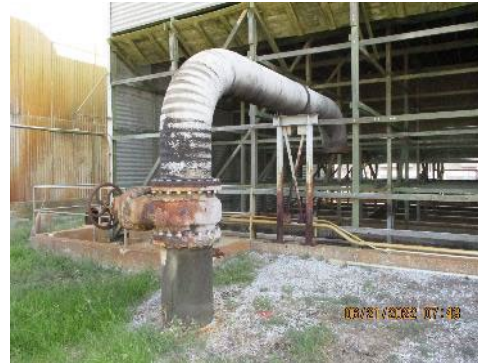
- C-631-2 transitioned from USEC to DOE in 2014.
- In January 2021, the RCW from the basin was no longer required to support C-620.
- In November 2021, conversion to a “dry-hybrid” fire system was completed, the HPFWS pumps were removed from service, and the RCW water remaining in the basin was no longer required to support the HPFWS, including C-611-R.
 - ❑ The basin and influent flume have not been drained and remain full of water; draining has not occurred in order to prevent hydrostatic pressure changes that could cause collapse or floating of the subsurface structure.
 - ❑ Calcium hypochlorite tablets are added once a month to keep the water from becoming septic.

C-631-2 RCW Return Line

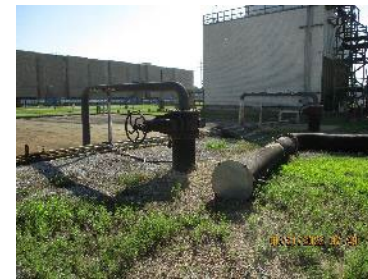
- ❑ Historical chromated water leaks have occurred and were immediately addressed.
 - ❑ No known chemical spills except for chromated water leaks.

C-631-2 - Examples of RCW Return Line

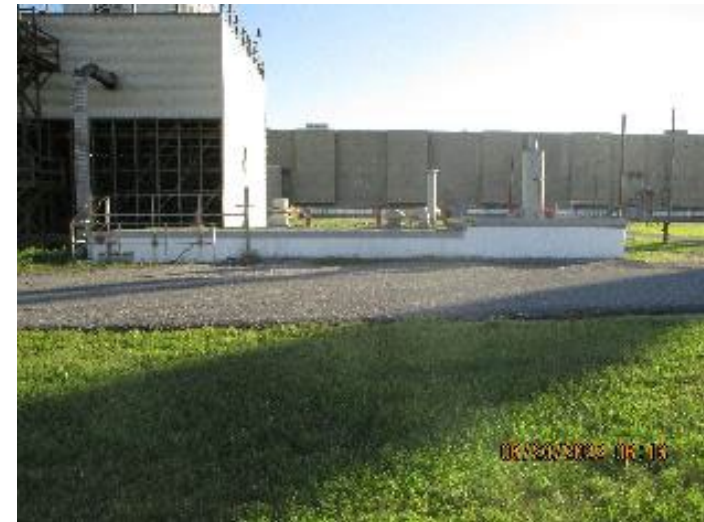
- ❑ Floor drains and grating are present; drain into a single 3 ft x 3 ft x 3 ft sump that drains back into the C-631 basin.

C-631-3 - Pump House (Firewater)
South Side

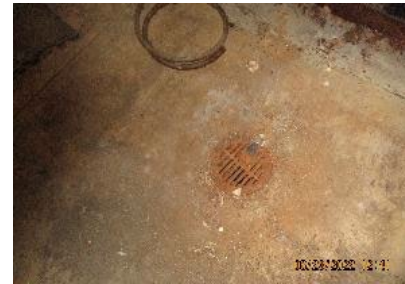
C-631-4 - Floor Drains

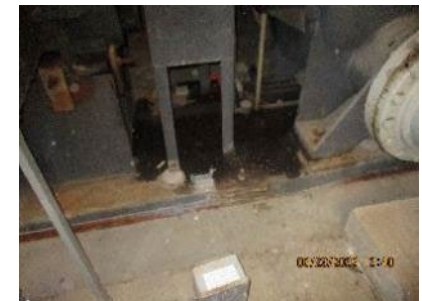
C-631-4 - Oil Staining

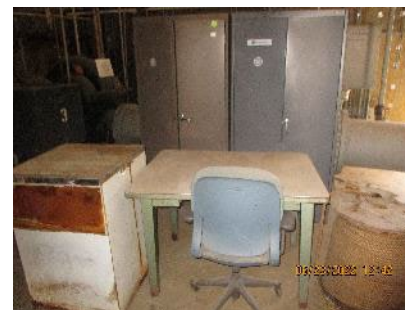
C-631-4 – Loose Equipment and Empty Storage Cabinets

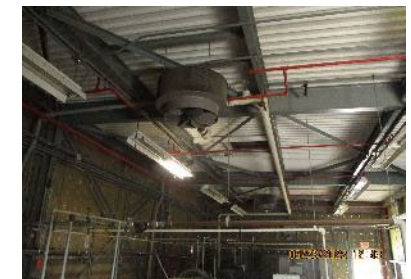
C-631-4 – Ceiling Ventilation and Steam Heater

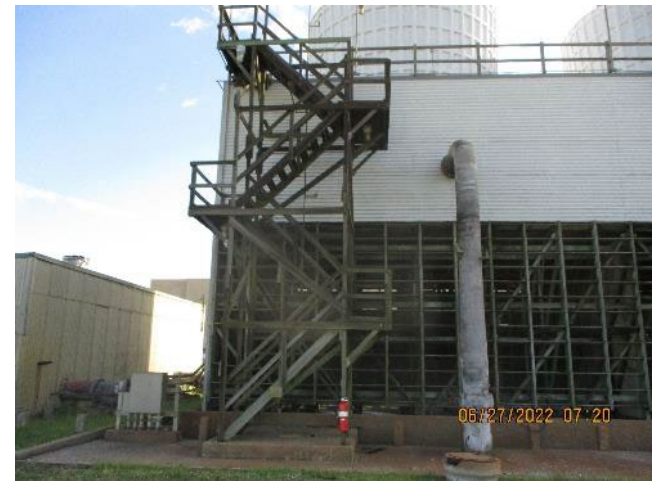
C-631-5 South Side – Riser No. 11

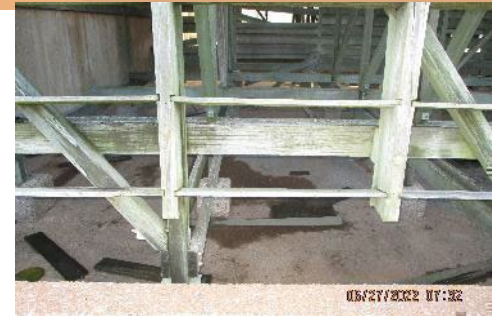
C-631-5 – Structural Frame

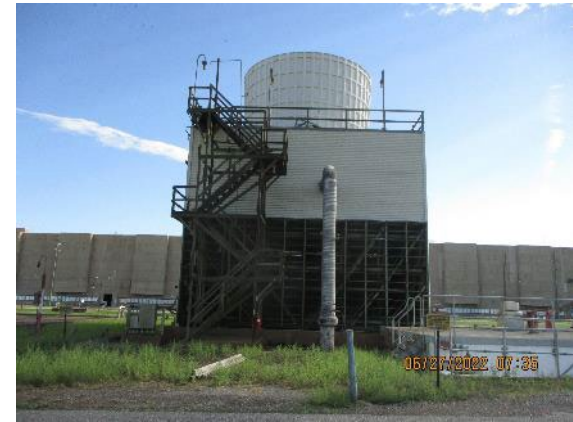
C-631-6 – South Side and No. 9 Riser

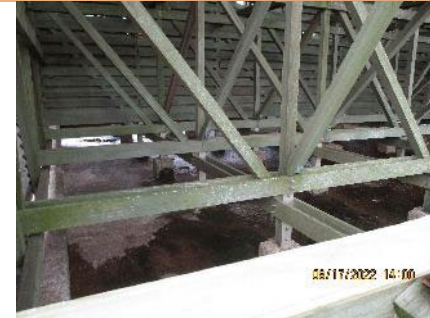
C-631-6 – Structural Frame
