# C-635-6 Recirculating Heat Utilization Pump House

## Facility Overview Briefing

July 16, 2021

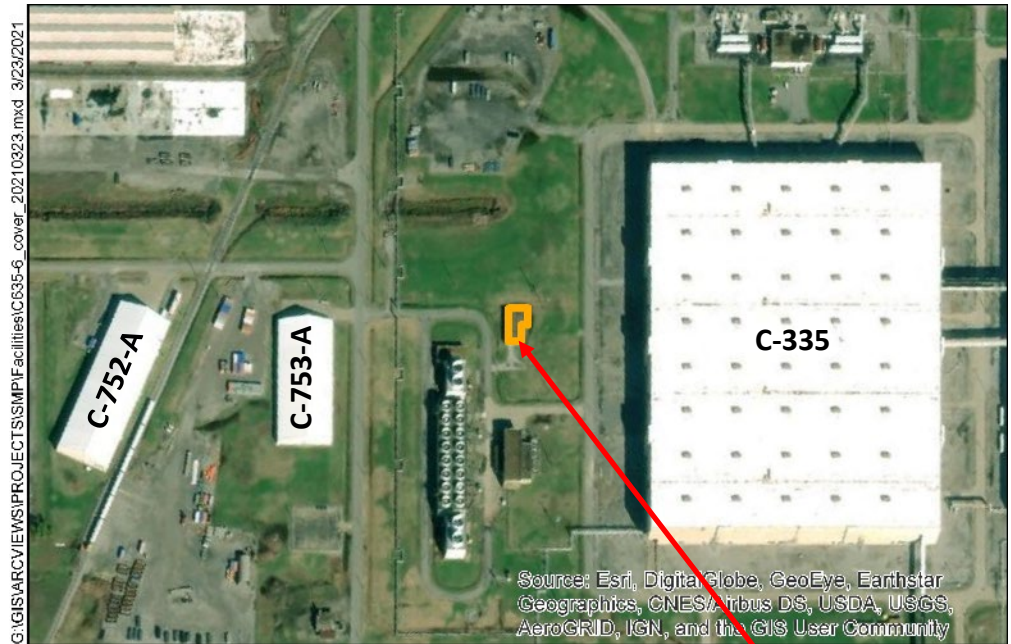
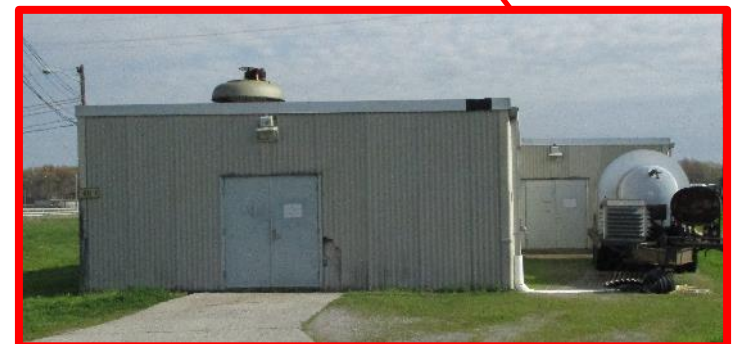
C-635-6 Facility Photo: 4/2021

- C-635-6 is located within the Paducah Site security fence, west of the C-335 process building.
- The facility was constructed in 1983.
- The facility is a structural steel building with asbestos cement corrugated panels (transite).

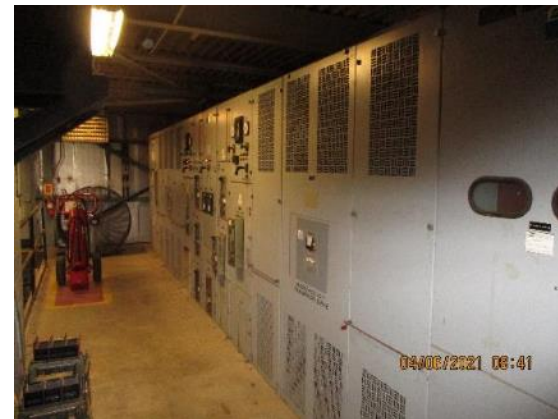
Transformer Electrical Switchgear System Section – Above Grade

- ❑ Cement corrugated siding (transite).
  - ❑ Transformer with a 480-volt electrical switchgear.
    - Transformer is a dry-type transformer and does not contain any oil.

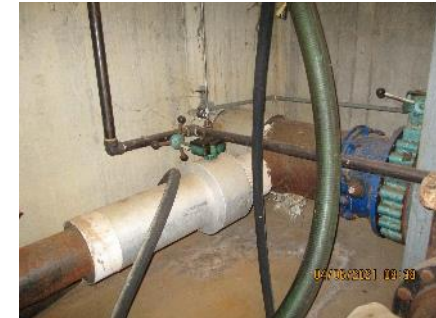
C-335 Supply Header

- ❑ The C-635-6 waste heat utilization pump house was “blanked” (e.g., blocked) from the C-335 process building RCW system and converted to a closed-loop system.
- ❑ Heat was supplied off the C-600 steam system and recirculating heat system (RHS) water was pumped through C-635-6 to various buildings.
- ❑ The buildings supported by the modified C-635-6 RHS system included: C-100, C-101, C-102, C-200, C-710, and C-720 (Note: C-400 and C-750 were removed from the system).

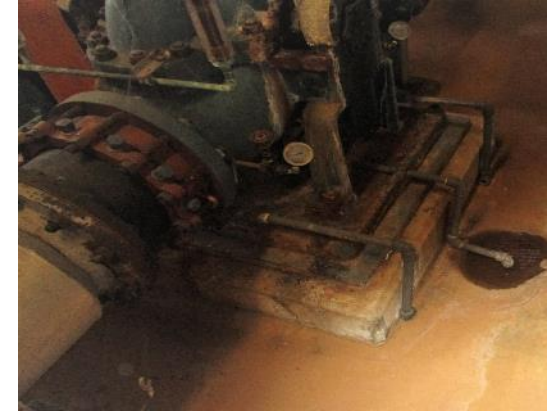
Floor Drain

- ❑ Six floor drains and a single sump are present.
  - ❑ Chromated water leaks have occurred within the facility; however, the water was returned to the RCW system via the floor drains which drained into the floor sump, where the chromated water was piped to a header return associated with the RCW system.

- ❑ Deactivation will include removal of any accessible loose items being stored (to the extent practicable) prior to demolition.
  - ❑ Any floor drains will be delineated, documented, and isolated prior to demolition.
