C-720-D Transformer Building

Facility Overview Briefing

July 13, 2021

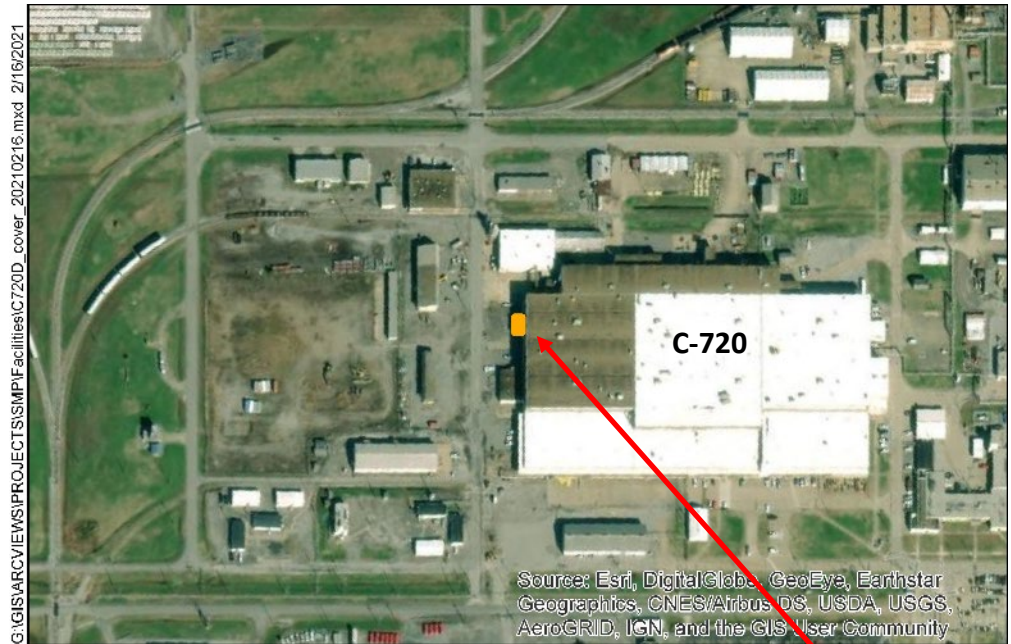
C-720-D Photo: 3/2021

- C-720-D is located within the Paducah Site security fence, west side of the C-720 Maintenance and Stores Building.
- The facility was constructed in 1970.
- The facility is constructed of prefabricated metal, on an elevated concrete slab (8-inch thick).
 - ❑ The structure is fully enclosed with pedestrian doors on the north and south ends.
 - ❑ The structure was specifically designed and constructed to house the switchgear transformer and substation located on the west side of C-720.
 - ❑ Sump pumps and floor drains were not included as part of the structure design and a facility walkdown has confirmed that no floor drains or sumps are present.
- The facility is approximately 480 ft².
 - ❑ Measuring ~ 15 ft x ~ 32 ft.

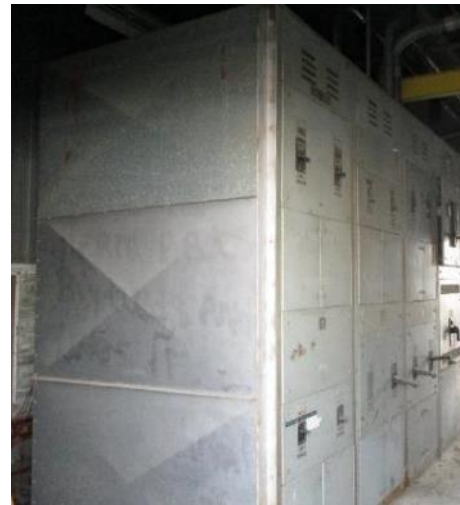
Interior of C-720-D

- C-720-D has housed the switchgear transformer and substation located on the west side of C-720 from its construction in 1970 to present.
 - ❑ Transformer with a 480-volt electrical switchgear.
 - ❑ Transformer is a dry-type transformer and does not contain any oil.
 - ❑ Supplies power to C-720, C-743, and C-744 facilities.
- USEC leased the facility in the early 1990s and continued to use C-720-D to house the switchgear transformer and substation.
- C-720-D transitioned from USEC to DOE in 2014 and the facility has continued to be used for its intended purpose to house the switchgear transformer and substation located on the west side of C-720.

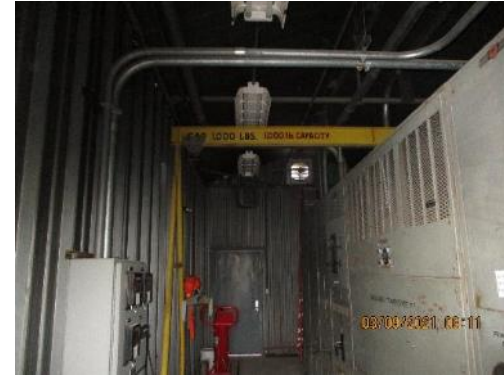
Interior View of C-720-D

- C-720-D continues to house the switchgear transformer and substation located on the west side of C-720 and supplies power to C-720, C-743, and C-744 facilities.
- Walkdown inspections conducted in March and April 2021 and employee interviews confirmed no unusual conditions.
 - ❑ Transformer with a 480-volt electrical switchgear.
 - ❑ Transformer is a dry-type transformer and does not contain any oil.
 - ❑ Supplies power to C-720, C-743, and C-744 facilities.
 - ❑ Facility contains a fire extinguisher, ladder, and table with additional fuses.
 - ❑ No floor sumps or floor drains are present.
 - ❑ No generator staging area (GSA) or satellite accumulation area (SAA).
 - ❑ No known chemical spills.
 - ❑ Not used for radiological storage; facility does not contain any radiological postings.

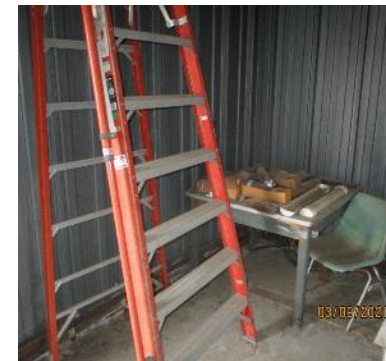
Ladder and additional fuses

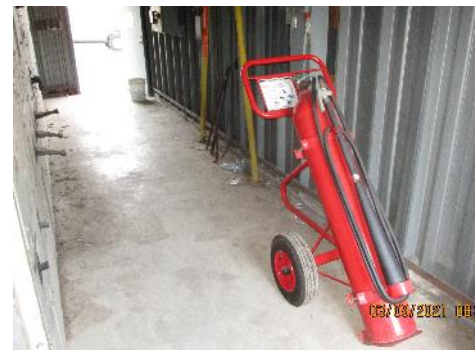
Fire Extinguisher

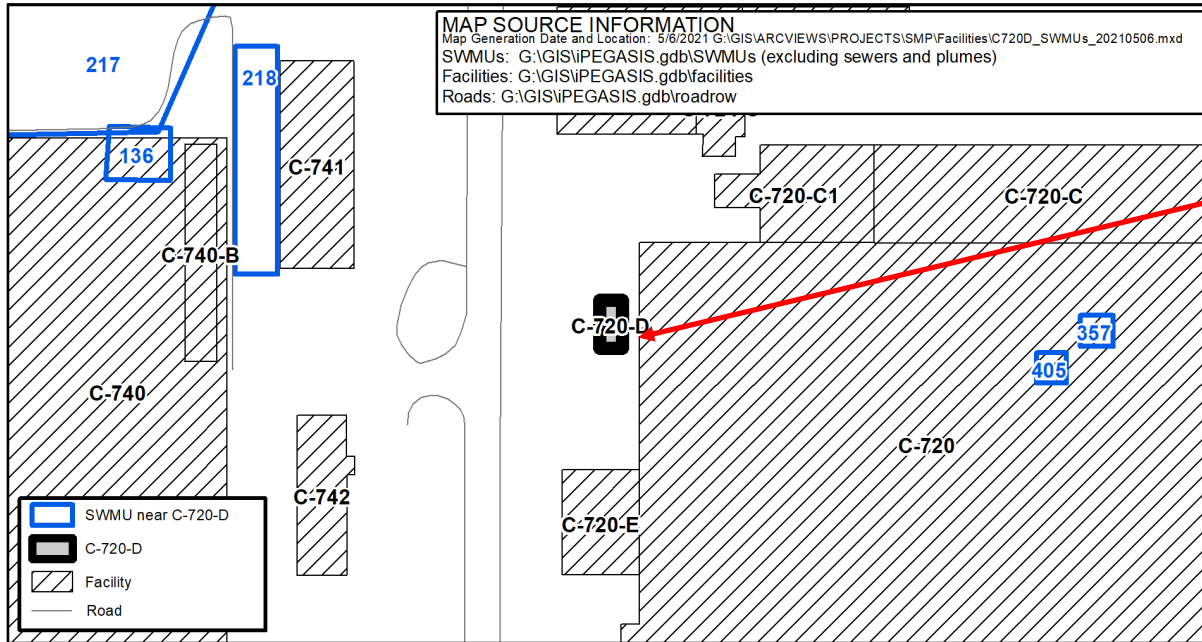
C-720-D is not designated as a SWMU/AOC.

SWMU No.	Facility Name	Current Status	NFA Approval By
136	C-740 TCE Spill Site	NFA	EPA and KY via WAG 1&7 ROD 8/10/1998
217	OS-06	Soils OU	
218	OS-07 slab and underlying soils	Soils and Slabs OU	
357	DMSA C-720-02	NFA	KDWM 4/24/2009
405	G-720-22	NFA	KDWM 2/14/2003
