C-720-G Warehouse

Facility Overview Briefing

July 13, 2021

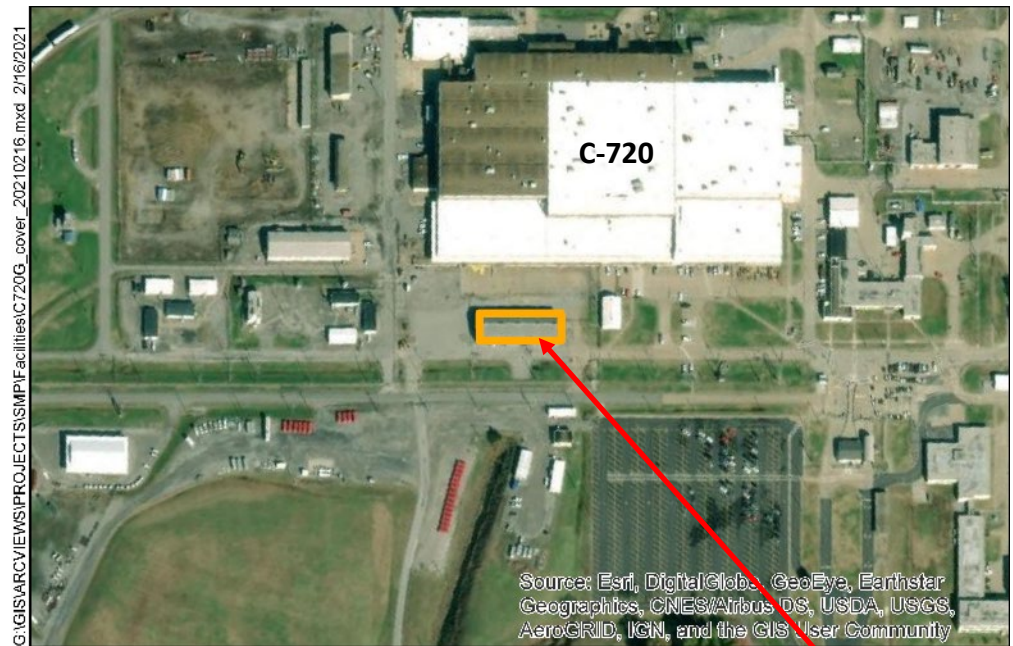
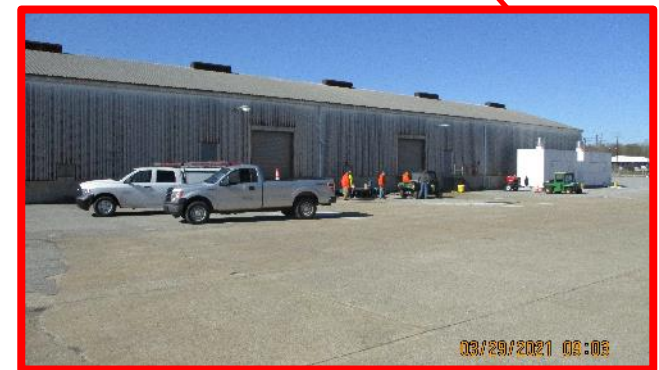
C-720-G Photo: 3/2021

- C-720-G is located within the Paducah Site security fence, in the southwest corner of the plant just south of the C-720 Building.
- Construction was completed in 1976.
- Construction consists of a one-story prefabricated metal building constructed on a concrete foundation.
- The facility is approximately 10,920 ft².
 - ❑ Measuring ~182 ft x ~60 ft.

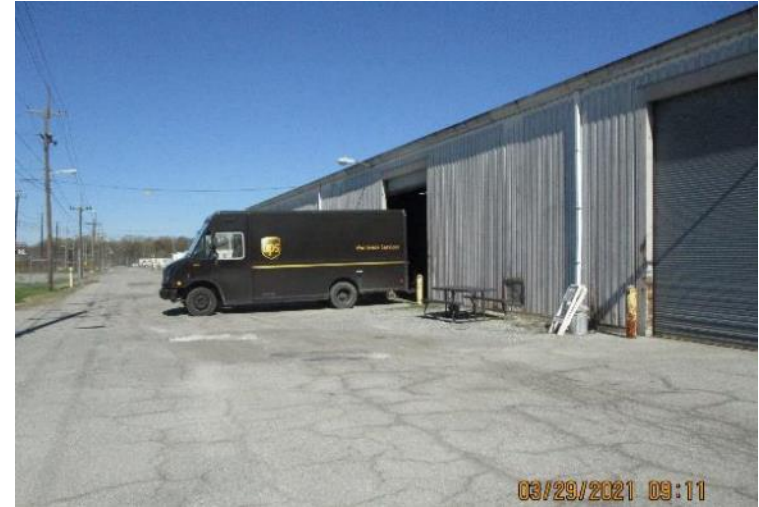
Exterior of C-720-G

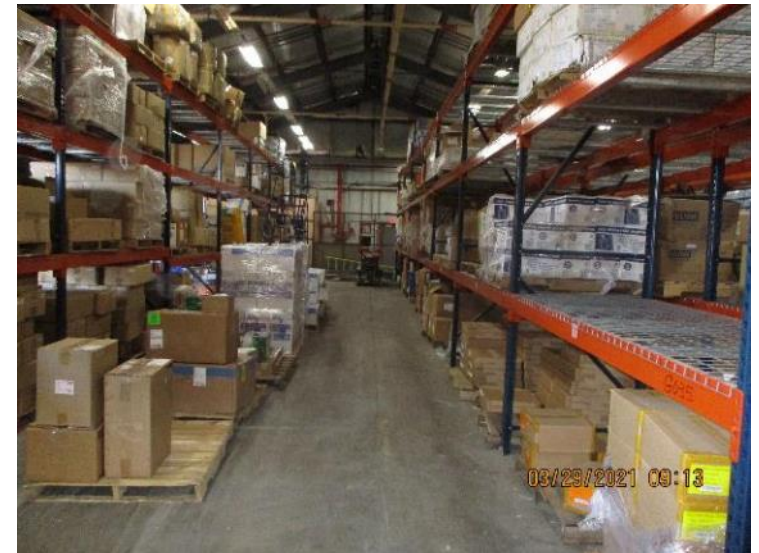
Interior of C-720-G

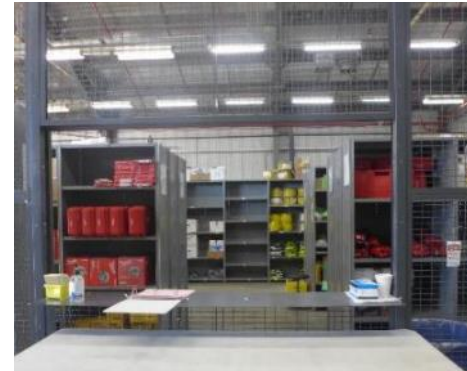
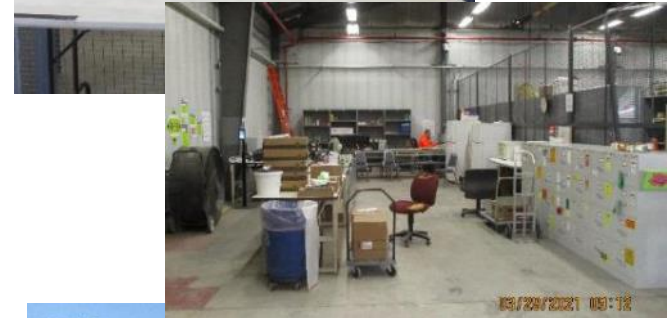
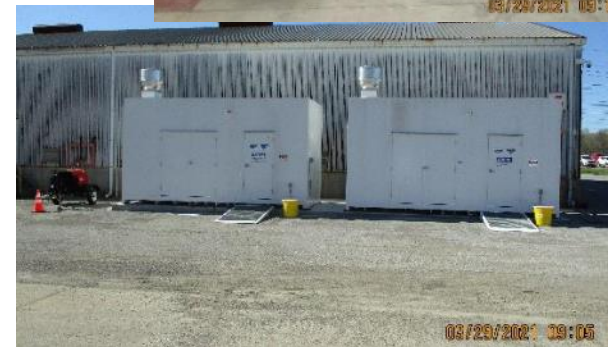
- ❑ Area contains office space and warehouse storage with items well organized and properly stored.
 - ❑ No floor sumps; however, the facility contains a sewer manhole.

- ❑ Two newly installed chemical storage trailers (referred to as TOX boxes) located outside which stores newly purchased chemical products (e.g., hand sanitizer, spray paint, insect repellent, grease, cleaners, hydraulic lubricant).

Photos from top to bottom: interior warehouse storage, office space, and exterior chemical storage trailers/TOX boxes (2021)

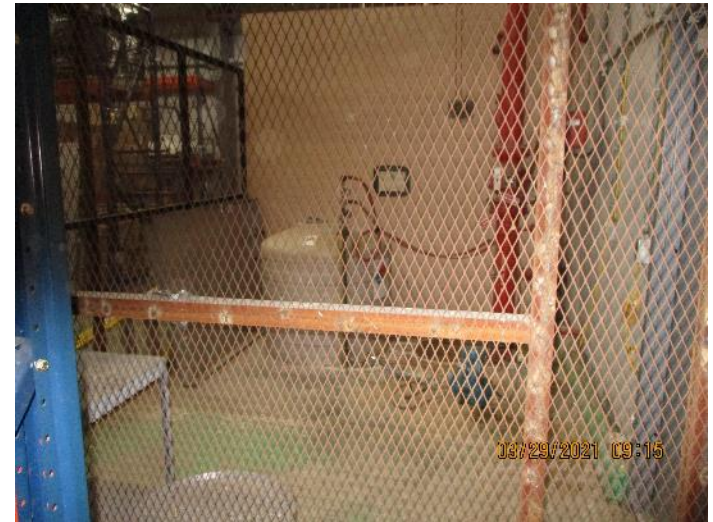
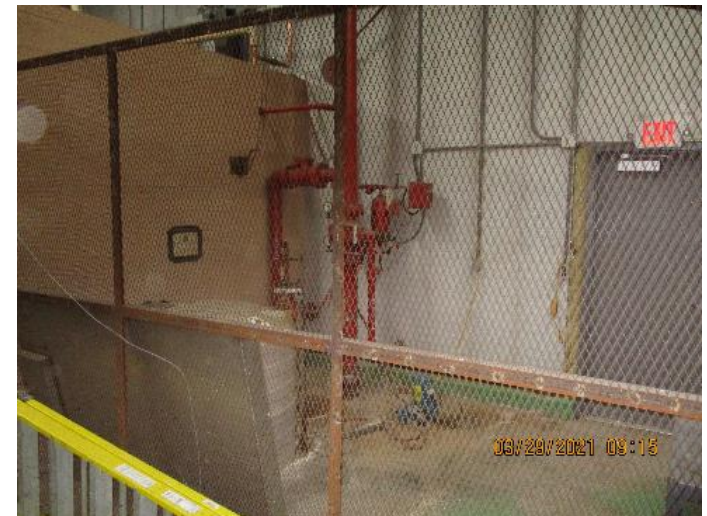
- Walkdown inspection conducted in March 2021 identified an inactive chemical feed station that is no longer in operation.
 - ❑ Located on the west wall of the facility and operated from 1997 to 2018.
 - ❑ Distributed sodium thiosulfate from a poly tank (~200 gal) into the storm sewer manhole located outside the northwest corner of the building.
 - ❑ Used to treat/reduce chlorine levels in plant sanitary water originating from C-333 and C-720 prior to discharge to KPDES Outfall 009.
 - ❑ The station is no longer in operation and all sodium thiosulfate has been removed.

Photo (3/2021) of Sodium Thiosulfate Chemical Feed Station.

- ❑ Deactivation will include removal of any accessible loose items being stored (to the extent practicable) prior to demolition.
 - ❑ Any floor drains and the storm sewer manhole will be delineated, documented, and isolated prior to demolition.

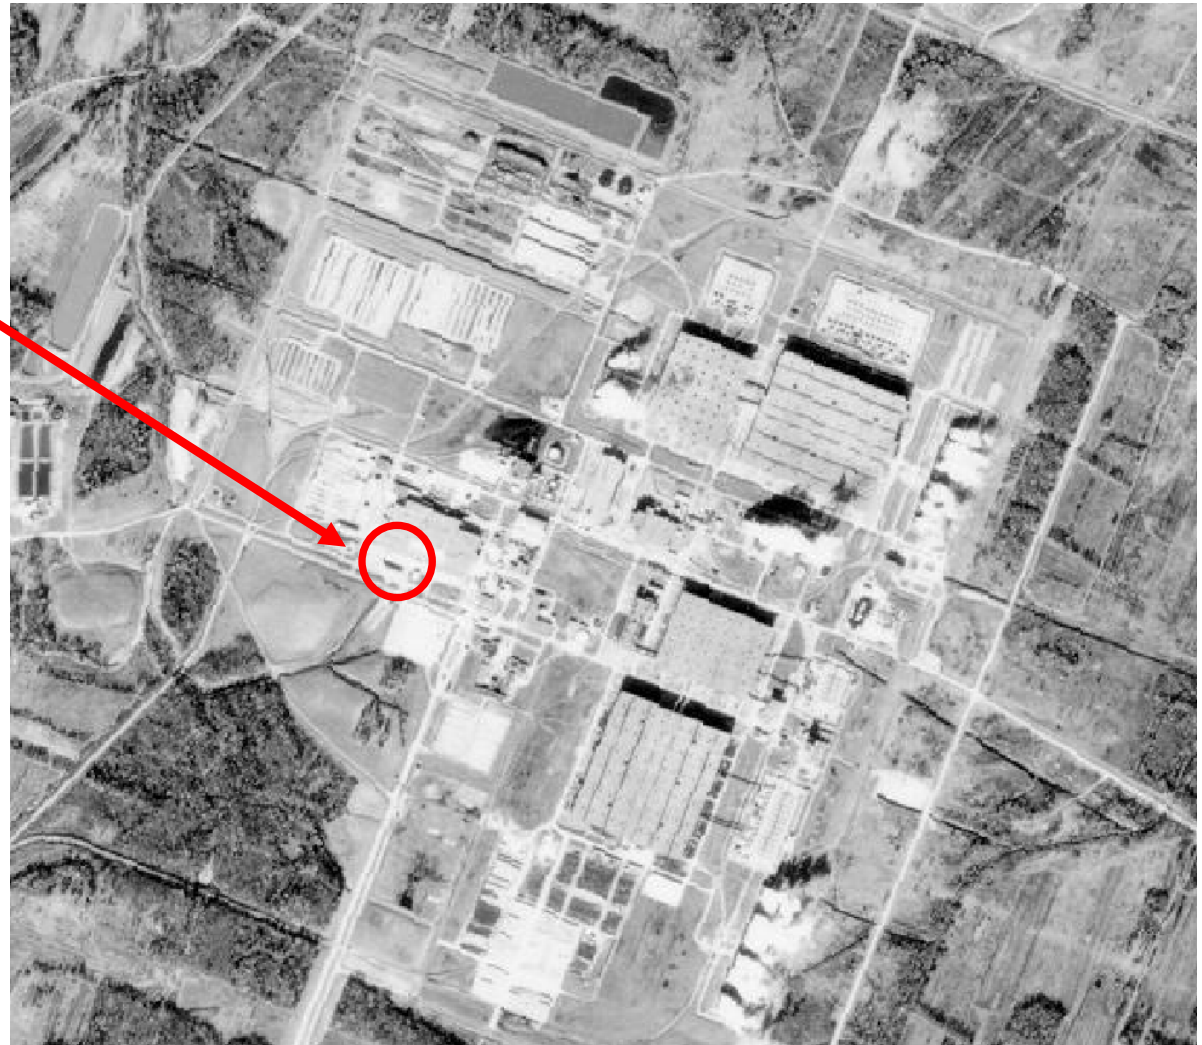
Modified from Aerial Photograph: 1983

Portion of aerial photograph taken in 1983, depicting C-720-G.
