C-727 90-Day Mixed Waste Accumulation Facility (C-727-90-Day-Area)

Facility Overview Briefing
Presented September 9, 2020
Updated May 20, 2021

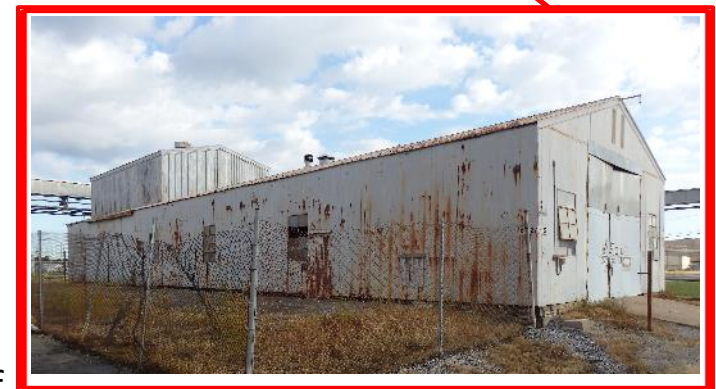
C-727 Facility Photo: June, 2020

- Aerial photo confirms construction in the early 1950s during initial plant construction.
- Consist of a prefabricated steel building constructed on a 6-inch concrete slab.
- Located within the PGDP security fence north of C-310 and west of C-331.

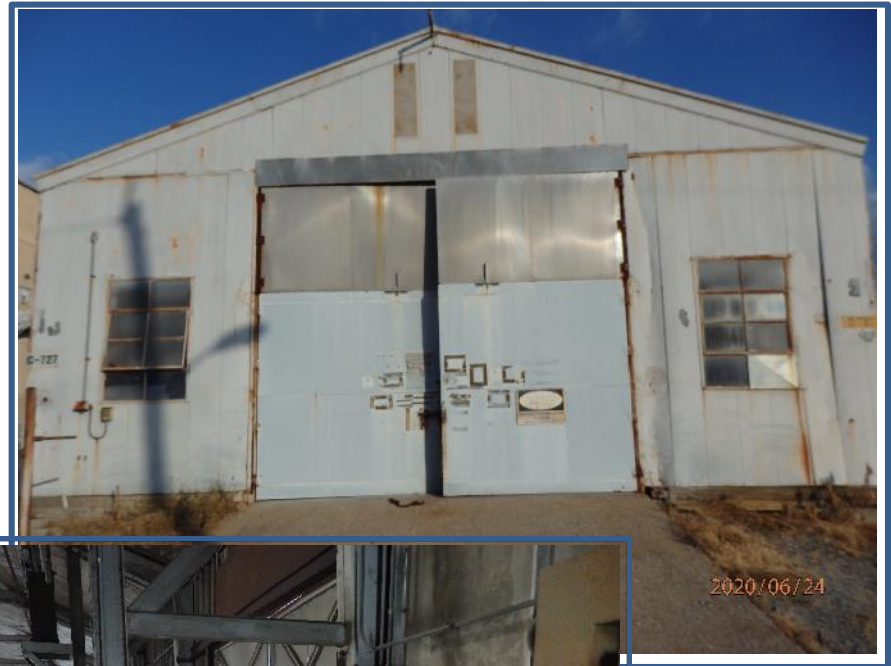
C-727- 90-Day Area

- Transitioned back from USEC to DOE in 2014 as a non-RCRA storage facility.
- Following transition to DOE, C-727 underwent deactivation to prepare it for demolition.
- Contents of the building have been removed and it is not in use.
- Listed in Appendix 6 of the SMP pending further CERCLA determination.
