C-742 Cylinder Storage Building

Facility Overview Briefing July 13, 2021

Reflects consultation with EPA and Kentucky in accordance with the Site Management Plan that occurred on June 28, 2021.

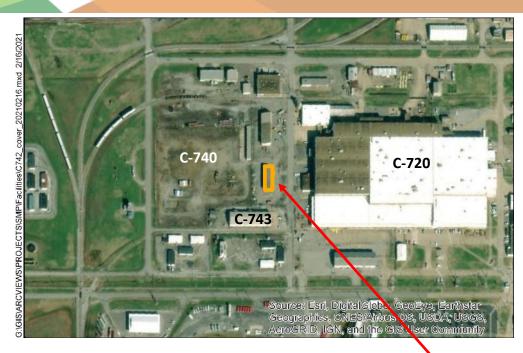
- ➤ The C-742 Cylinder Storage Building is a candidate for future demolition and disposal, contingent upon funding priorities.
- Listed in Appendix 6 of the Site Management Plan (SMP); requires consultation with EPA and Kentucky for CERCLA screening prior to demolition.

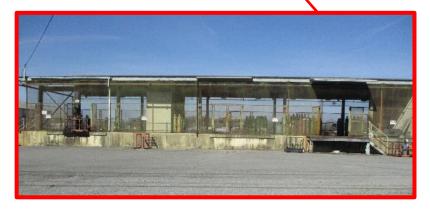
- ➤ This presentation is intended to serve as consultation, providing the basis for demolition and disposal of the aboveground structure outside of the FFA/CERCLA process.
- ➤ The remaining slab, vault, and soils will be subject to a future CERCLA evaluation under Geographical Area (GA) 14.

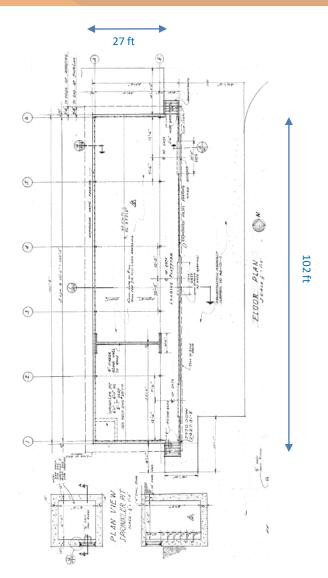
- ➤ The facility is constructed of an open structural steel frame with a corrugated transite roof on an elevated concrete foundation.
 - ☐ The structure was specifically designed and constructed for the storage of gas cylinders, is caged, and has a support wall that divided flammable cylinders from inert cylinders.

- ☐ The structure is approximately three and one-half feet above ground elevation to allow for easy transfer of cylinders to and from the facility.
 - ☐ The structure is not fully enclosed; it is open on three sides.

- □ The structure has a small enclosed office area on the north end measuring \sim 12 ft x \sim 20 ft.
 - The structure has a vault (labeled as a confined space) on the south end that houses the sprinkler system measuring \sim 6 ft x \sim 6 ft x \sim 8 ft.

- \triangleright The facility is approximately 2,754 ft².
 - Measuring ~ 27 ft x ~ 102 ft.

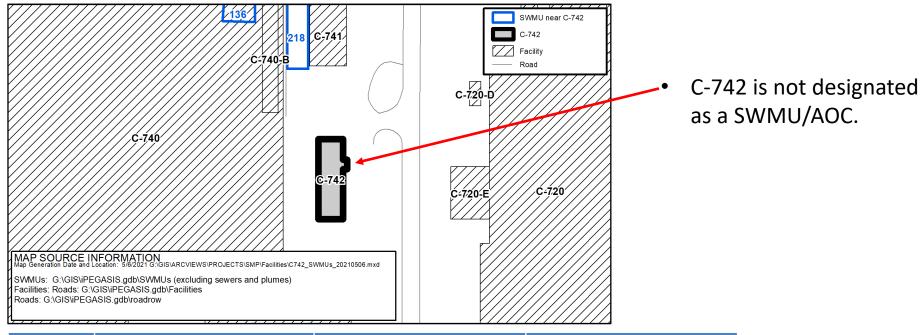
Environmental Impacts

SWMU No.	Facility Name	Current Status	NFA Approval By
136	C-740 TCE Spill Site	NFA	EPA and KY via WAG 1&7 ROD 8/10/1998
218	OS-07 slab and underlying soils	Soils and Slabs OU
