# C-742-B Drying Agent Cylinder Storage Building

Facility Overview Briefing  
May 11, 2020

DOE briefed EPA and Kentucky on November 6, 2019, with details concerning the demolition and disposal of this facility. This briefing reflects those discussions and includes incorporation of comments received from EPA and Kentucky during those discussions.

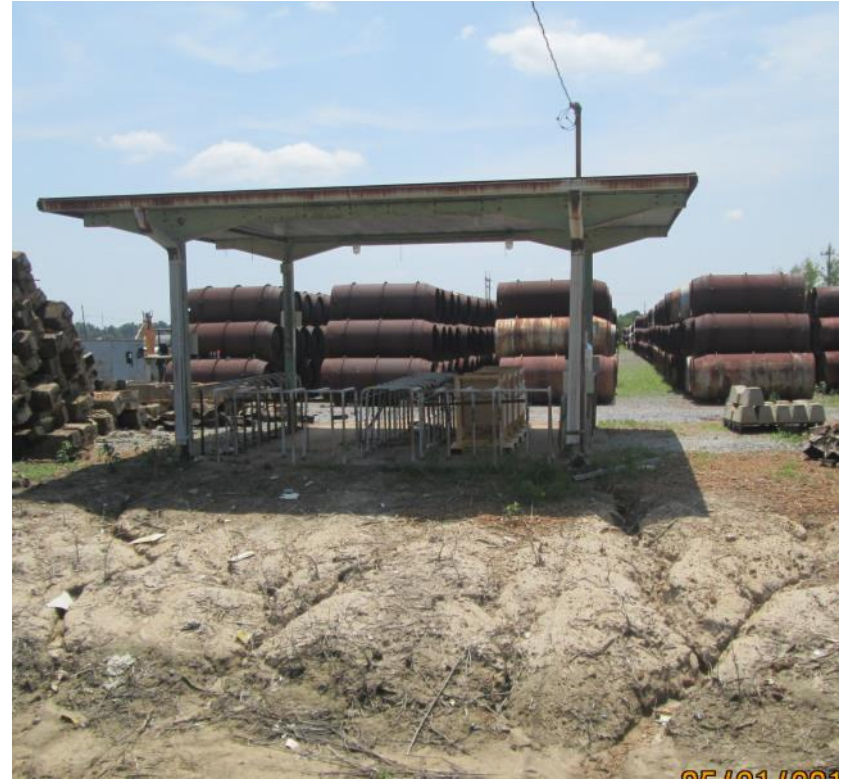
Pre-Demo: 2014

- Documents and interviews both indicate the facility was used exclusively to store  $\text{ClF}_3$  gas cylinders.
- A remote location was selected to construct the facility due to the hazardous nature of chlorine trifluoride ( $\text{ClF}_3$ ) gas.
- No other chemicals were stored at the facility, nor was it used for any other purpose.

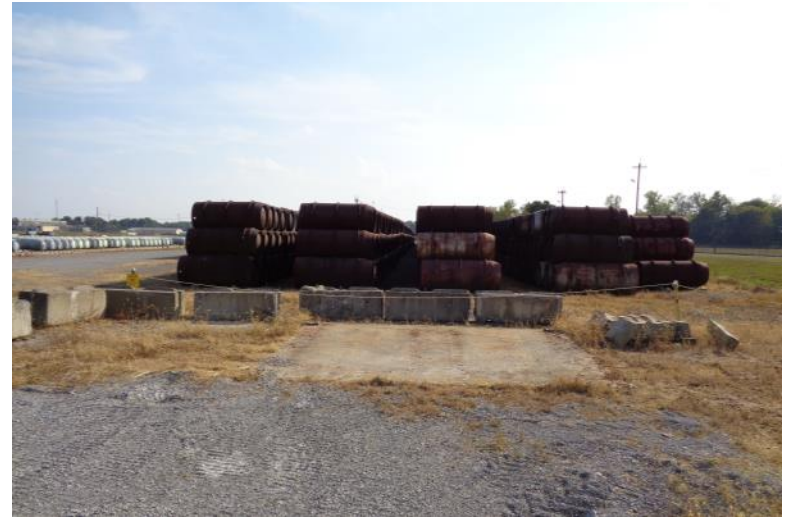
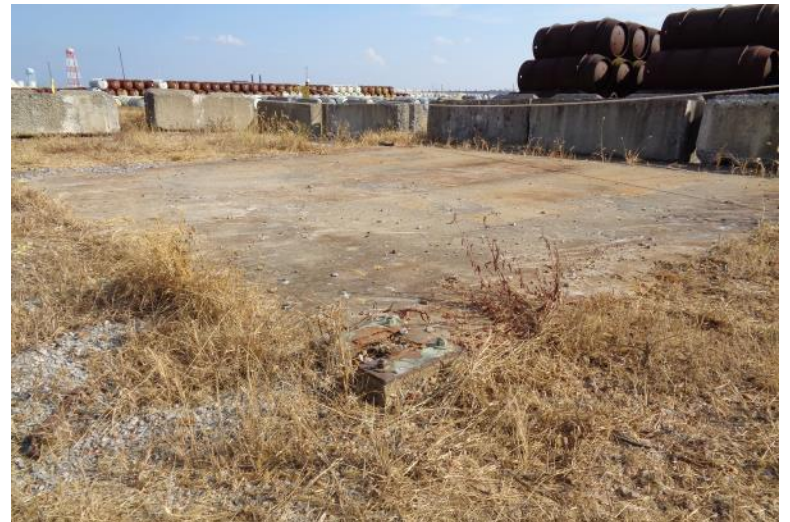
- FRNP demolished and disposed of the “aboveground” structure in April of 2019; all  $\text{ClF}_3$  gas cylinders had been removed prior to demolition.
- Removed demolition debris met the WAC for disposition in the U-Landfill.
- Concrete pad and surrounding soils were left in-place.
