# C-745-R1 Cylinder Changeout Building

## Facility Overview Briefing

July 16, 2021

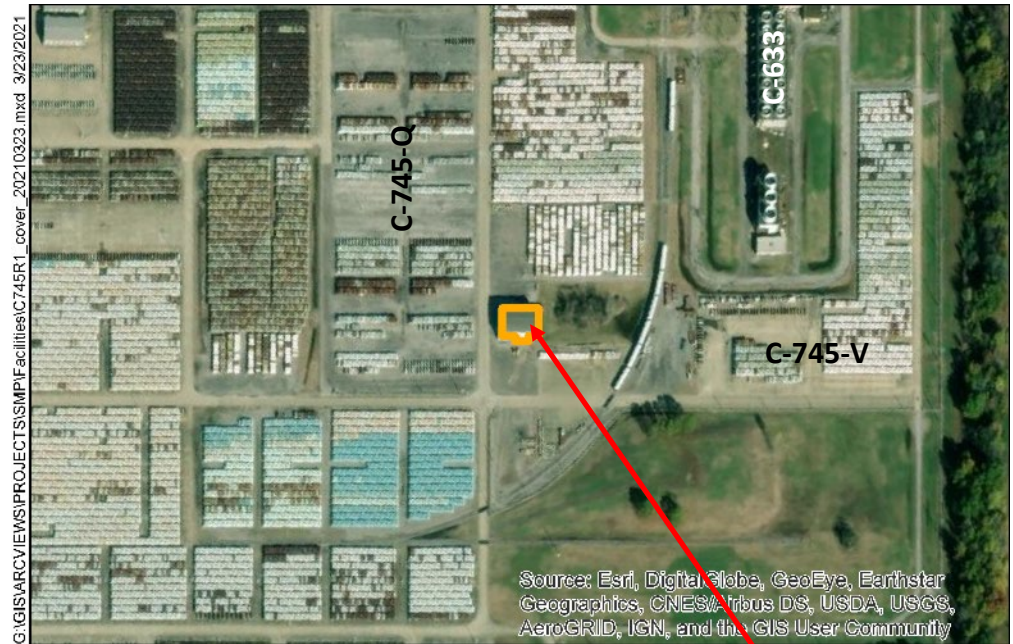
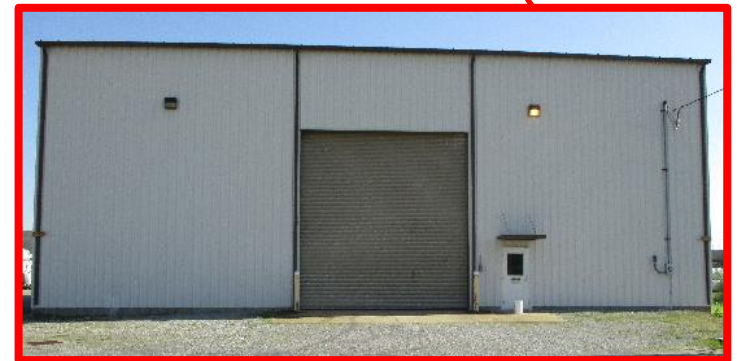
C-745-R1 Facility Photo: 4/2021

- C-745-R1 is located outside the Paducah Site security fence, near the intersection of Alabama Avenue and 16<sup>th</sup> Street. It is southeast of C-745-Q.
- The facility was constructed in 2003.
- The facility is constructed of prefabricated metal on a concrete slab (10-inches thick).
  - ❑ The structure is fully enclosed.
  - ❑ Sump pumps were not included as part of the structure design.
  - ❑ A single floor drain that discharges to the storm drain system is located in the center of the facility.
- The facility is approximately 4,800 ft<sup>2</sup>.
  - ❑ Measuring ~80 ft x ~60 ft.

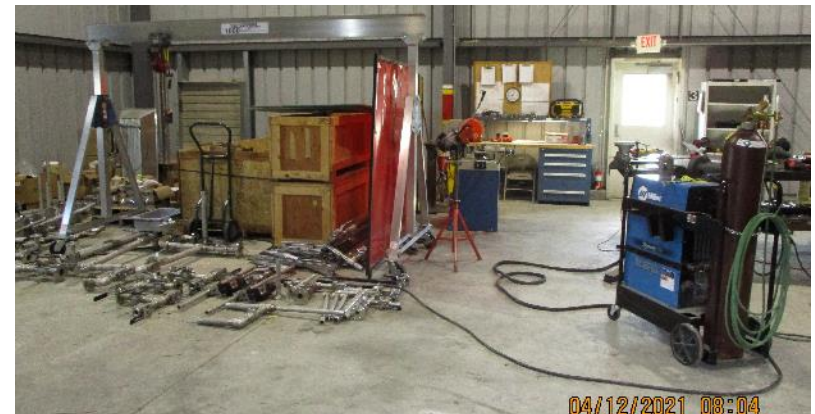
Hot Work Area for Pipe Fabrication

- USEC constructed C-745-R1 in 2003.
- USEC operated C-745-R1 from 2003 to 2014 as a cylinder changeout facility that prepared 30B cylinders for shipment.
  - ❑ 30B UF6 overpacks were brought to the facility; inspected; and repaired, if necessary.
  - ❑ 30B cylinders (previously inspected with valve protector caps installed) were loaded into the overpacks via a forklift and boom.
  - ❑ Overpacked 30B cylinders were prepared for transportation and shipped to an off-site facility.
- C-745-R1 transitioned from USEC to DOE in 2014.
- In 2015, DOE transferred C-745-R1 to DUF6.
- Since 2015, DUF6 has operated C-745-R1 as a waste storage and maintenance shop.
  - ❑ An office trailer is located inside the facility.
  - ❑ The facility includes a hot work area for fabricating stainless steel process piping.

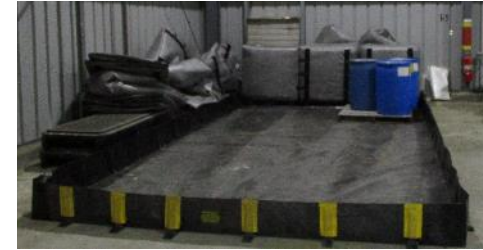
Containment for Propylene Glycol Storage Area

- C-745-R1 is currently used by DUF6 as a storage area and maintenance shop.
- Walkdown inspection conducted in April 2021 and employee interviews confirmed no unusual conditions.
  - ❑ No floor sumps; however, a single floor drain that discharges to the storm drain system is located in the center of the facility.
  - ❑ One generator staging area (GSA), GSA-C-002, containing:
    - Radiologically contaminated equipment.
    - Liquids used in chillers or to decontaminate equipment.
    - Calcium fluoride solids used to regenerate potassium hydroxide.
  - ❑ No satellite accumulation area(s).
  - ❑ No known asbestos-containing materials (ACM) or lead-based paint.
  - ❑ Propylene glycol used to replenish process chillers that cool end products.
  - ❑ Minor leaks of kerosene from heaters and hydraulic oil from forklifts that were immediately addressed; no known chemical spills.

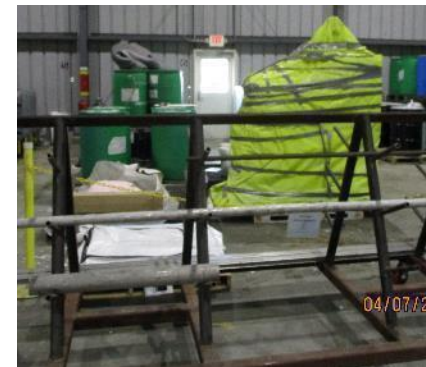
GSA-C-002

- ❑ Building materials used for construction are not known to contain ACM or lead-based paints.
  - ❑ C-745-R1 has a DUF6 GSA containing items listed below that are securely containerized. The GSA is operated in accordance with applicable requirements and procedures with no known releases or spills.

- Radiologically contaminated equipment.
    - Liquids used in chillers or to decontaminate equipment.
    - Calcium fluoride solids used to regenerate potassium hydroxide.

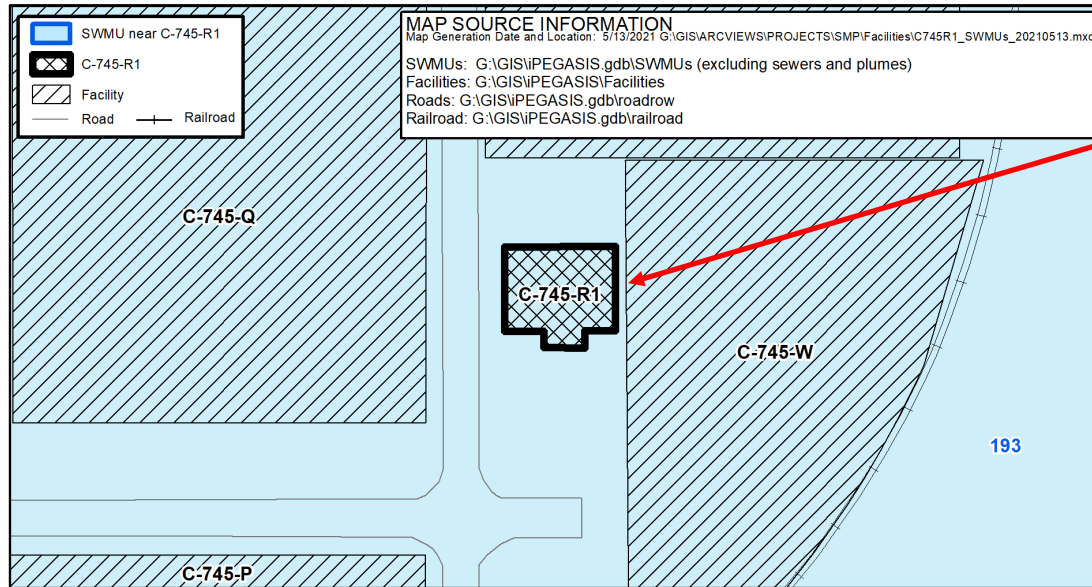
- The C-745-R1 Cylinder Changeout Building is not designated as a SWMU/AOC, but is located within the footprint of SWMU 193.

SWMU No.	Facility Name	Current Status
193	McGraw Construction Facilities (Southside Cylinder Yards)	DUF6 Footprint Underlying Soils OU
