C-755-B Changehouse Building

Facility Overview Briefing

October 19, 2021

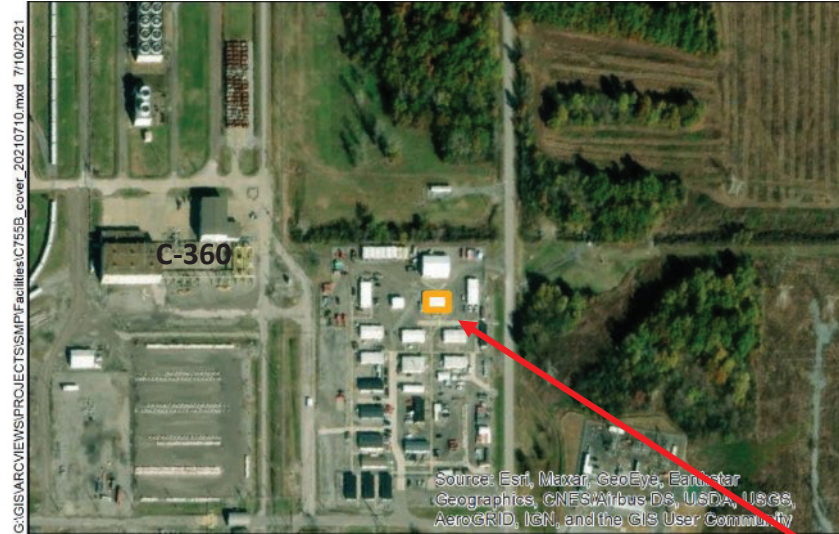
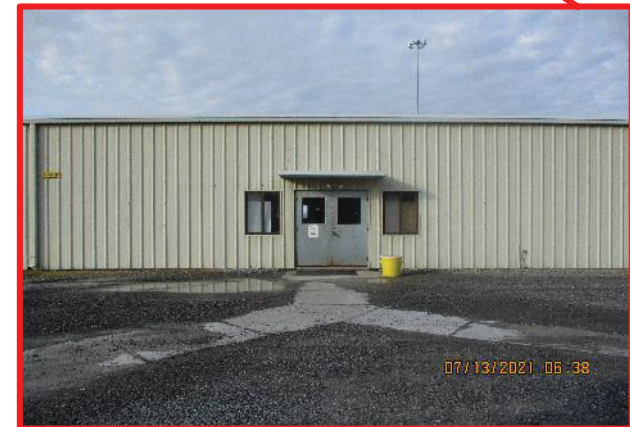
C-755-B Facility Photo: 7/2021

- C-755-B is located outside the Paducah Site security fence, east of C-360 between Patrol Road 3 and Dyke Road.
- The facility was constructed in 1993.
- The facility is constructed of prefabricated metal on a concrete slab (8 inches thick).
 - ❑ The structure is fully enclosed with pedestrian doors on the north and south ends.
 - ❑ Sump pumps were not included as part of the structure design.
 - ❑ Floor drains were included as part of the structure design.
- The facility is approximately 2400 ft².
 - ❑ Measuring ~60 ft x ~40 ft.

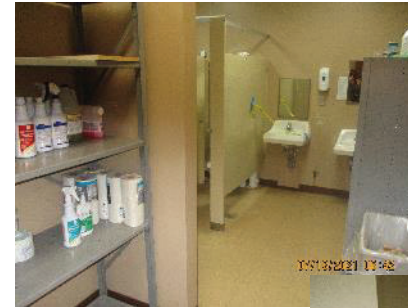
Women's Restroom,
Storage and
Changehouse Lockers

- C-755-B continues to operate as a changehouse.
- Walkdown inspection conducted in July 2021 and employee interviews confirmed no unusual conditions.
 - No floor sumps.
 - Drains associated with the restrooms and showers drain to the sanitary sewer system.
 - Not used for radiological storage, nor does the facility contain any radiological postings.
 - No generator staging area (GSA) or satellite accumulation area (SAA).
 - No known asbestos-containing materials (ACM) or lead-based paint.
 - No known chemical spills.
 - No signs of cracks in concrete pad.
 - Chemical storage cabinets/shelving are present that contain small quantities of chemicals that are stored in accordance with regulatory requirements and site procedures.

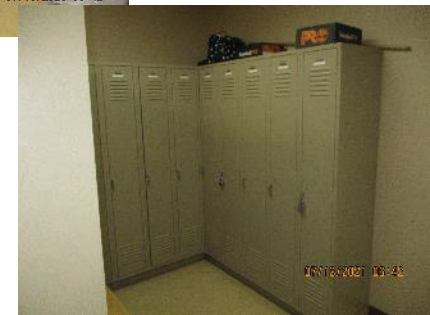
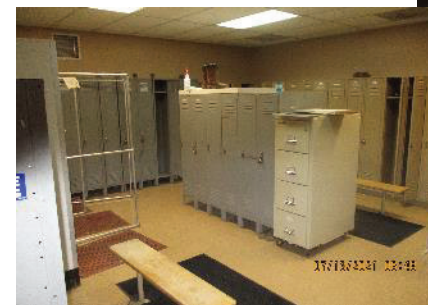
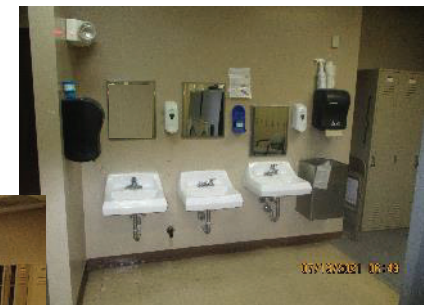
Men's Restroom and
Changehouse Lockers

Note: Photo was edited to remove photographer's reflection from mirror.
